MITIGATION OF EMU CUT GLOVE HAZARD FROM MICROMETEOROID AND ORBITAL DEBRIS IMPACTS ON ISS HANDRAILS

Shannon Ryan ⁽¹⁾, Eric L. Christiansen ⁽²⁾, Bruce A. Davis ⁽³⁾, Erick Ordoñez ⁽⁴⁾

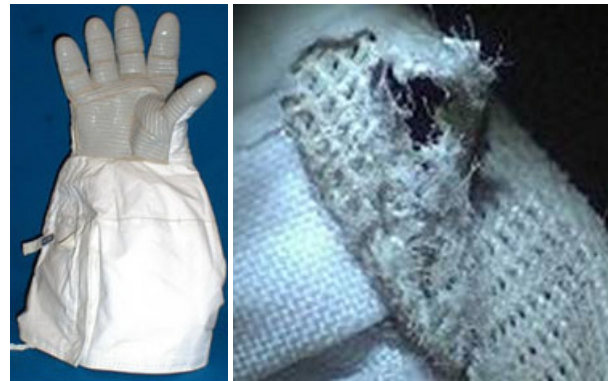
During post-flight processing of STS-116, damage to crewmember Robert Curbeam's Phase VI Glove Thermal Micrometeoroid Garment was discovered (shown in Figure 1). This damage consisted of: loss of RTV-157 palm pads on the thumb area on the right glove and a 0.75 inch cut in the Vectran adjacent to the seam and thumb pad (single event cut), constituting the worst glove damage ever recorded in "the history of going EVA for the U.S. program" [1]. The underlying bladder and restraint were found not be damaged. Evaluation of glove damage showed that the outer Vectran fibers were sliced as a result of contact with a sharp edge or pinch point rather than general wear or abrasion (commonly observed on the RTV pads). Damage to gloves was also noted on STS-118 [2] and STS-120 [3]. A potential source of EMU glove cut hazard is micrometeoroid and orbital debris (MMOD) impact craters on ISS handrails. Returned flight surfaces (see e.g. nitrogen tank assembly handrail in Figure 2) have demonstrated the susceptibility of these structures to regular MMOD impacts.

Figure 1. Damage to crewmember Curbeam's Phase IV glove following EVA 3 of STS-116

Redesign efforts are currently underway to enhance the resiliency of EMU gloves to cut hazards. In the meantime, temporary reinforcements (TurtleSkin® patches) have been added to high wear areas (lower part of thumb and upper part of index finger). Parallel efforts have been made to characterize MMOD impact damage profiles on representative and actual ISS flight hardware and mitigate the cut hazard posed by these profiles on crewmember EMU gloves. In this paper, the results of these characterization and mitigation impact test studies are presented and suggestions for modifications to ground equipment yet to be flown are made.

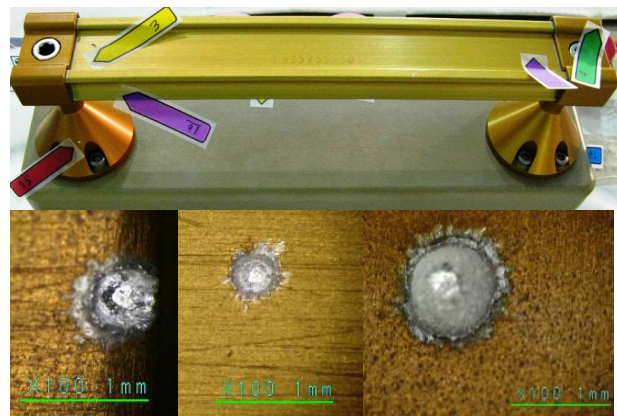
Figure 2. MMOD impacts on the returned nitrogen tank assembly handrail. Top: location of impacts; Below: impact craters 4, 5, 15 (left-to-right)

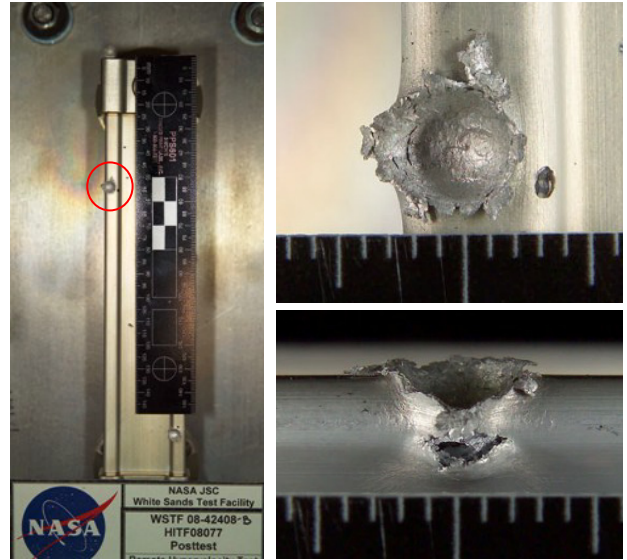
Figure 5: Impact damage on a rectangular ISS handrail induced by impact of a 0.10 cm diameter Al2017-T4 sphere at 6.94 km/s with oblique (45°) incidence

For the rectangular handrail configuration, typical entry hole diameters were 3-4 times that of the projectile

diameter. The damage profiles exhibited protruding crater lips in all cases, with a maximum height of 2.7 mm for impact of a 1.5 mm diameter Al2017-T4 sphere at 6.86 km/s with oblique (45°) incidence (HITF08086). For this test, the projectile impacted upon the thickened corner section of the rectangular handrail. Impacts upon thicker sections of the handrail commonly resulted in damage profiles with more hazardous (i.e. higher) crater lip formations. Generally, it was observed that an increase in projectile diameter leads to an increase in the height of the protruding crater lip. For impacts causing damage to the rear side of the impacted structure (i.e. perforation or spallation), damage features were also characterized. A maximum lip height of 4.6 mm was measured following impact of a 1.8 mm projectile at 7.06 km/s at oblique (45°) incidence on the center of the handrail upper surface.

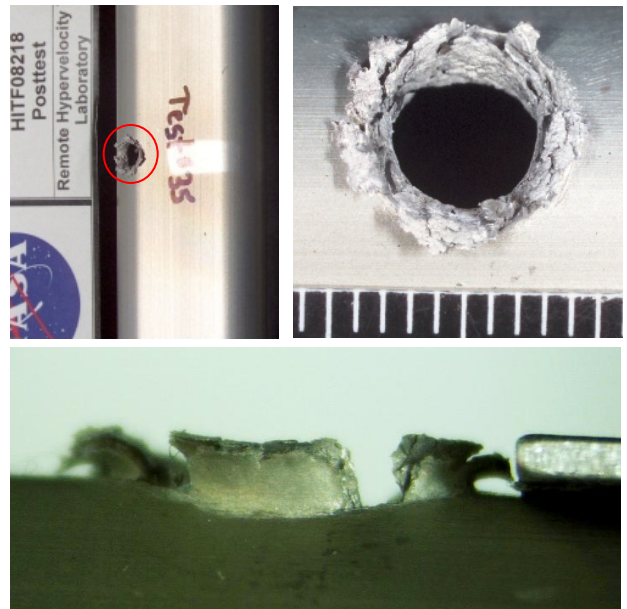
Figure 6: Impact damage on a tubular ISS handrail induced by impact of a 0.15 cm diameter Al2017-T4 sphere at 6.95 km/s with normal (0°) incidence

For the tubular handrail configuration, entry hole diameters were also commonly 3-4 times the diameter of the projectile. However, impact crater lips did not protrude above the handrail surface as much as on the rectangular configuration. The more hazardous crater profiles on the rectangular handrail were found upon the thicker sections. Thus, damage profiles on the thin tubular handrails were not expected to protrude as significantly as on the reinforced sections of their rectangular counterparts. A maximum raised crater lip of 1.9 mm was measured for the tubular handrail, induced by impact of a 1.5 mm diameter Al2017-T4 sphere at 6.95 km/s with normal incidence. None of the 12 impact tests on the tubular handrail resulted in ejection of material from the rear side of the handrail target.

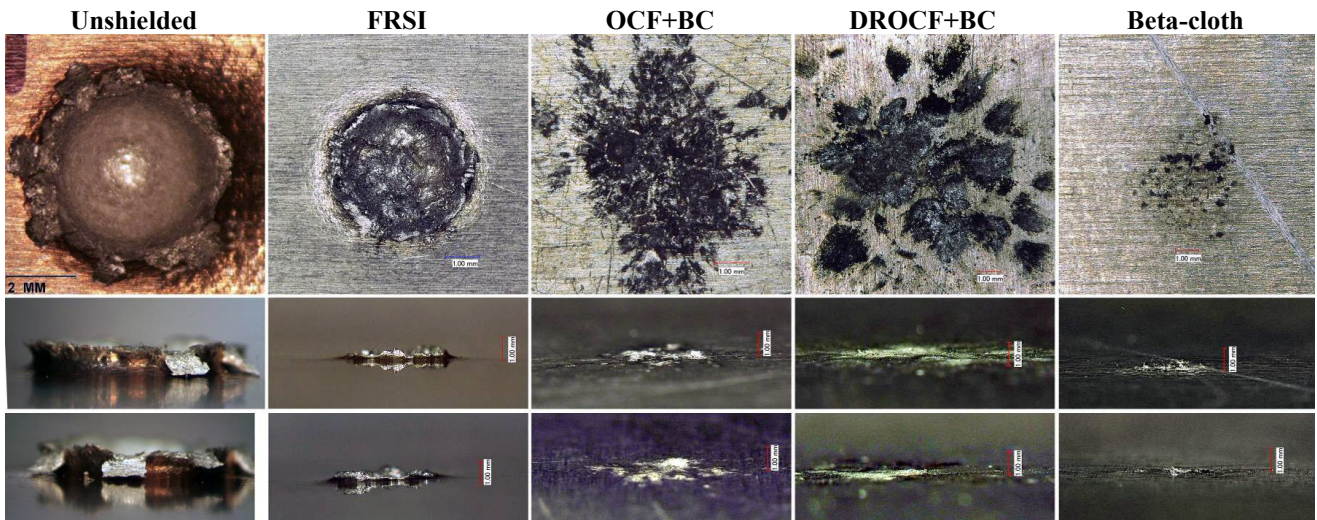
to reduce the diameter, depth and protruding lip height of the baseline target crater. A comparison between the impact generated crater in the unshielded handrail and the handrails covered by flexible overwraps is given in Figure 7. The impact crater in the unshielded handrail target is clearly defined, with a well formed lip protruding above the plate surface. Of the overwrap configurations, only the FRSI target shows a clearly formed crater with a discernable lip. The OCF+BC target shows multiple small craters with minimally-protruding lips, while the DROCF+BC and Beta-cloth target damages are limited to discoloration and shallow denting.

Figure 7: Comparison of impact crater profile in an unshielded ISS handrail-representative Al6061-T6 plate and overwrap-shielded plates impacted at normal incidence by a 1.0 mm diameter Al2017-T4 sphere at 6.77 ± 0.22 km/s

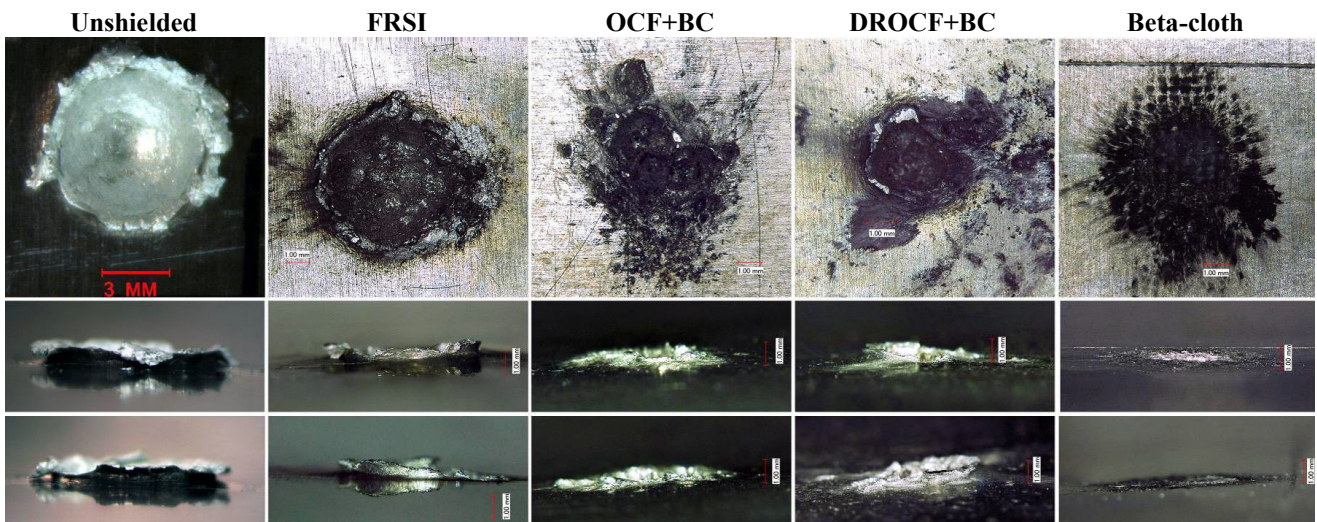
For the oblique impact tests, a crater was formed in the baseline Al6061-T6 target with a diameter of 6.9 mm (maximum), a depth of 2.9 mm, and a maximum raised lip height of 0.8 mm. Similar to the normal impact tests, all four overwrap configurations were effective at reducing the height of the crater lip. In Figure 8 the FRSI target shows a cleanly formed crater with a protruding lip (smaller dimensions than the unshielded target). The OCF+BC target shows multiple overlapping craters, suggesting the projectile was fragmented upon impact with the beta-cloth cover. Although the craters are cleanly formed, there is minimal protrusion of material above the target surface. A similar damage profile is observed on the DROCF+BC target, which shows a single crater cleanly formed with reduced depth, diameter, and raised lip height than the unshielded target. The target plate shielded by the Beta-cloth overwrap shows discoloration and a minimal amount of mechanical damage.

Figure 8: Comparison of impact crater profile in an unshielded ISS handrail-representative Al6061-T6 plate and overwrap-shielded plates impacted at 45° by a 1.5 mm diameter Al2017-T4 sphere at 6.94 ± 0.09 km/s

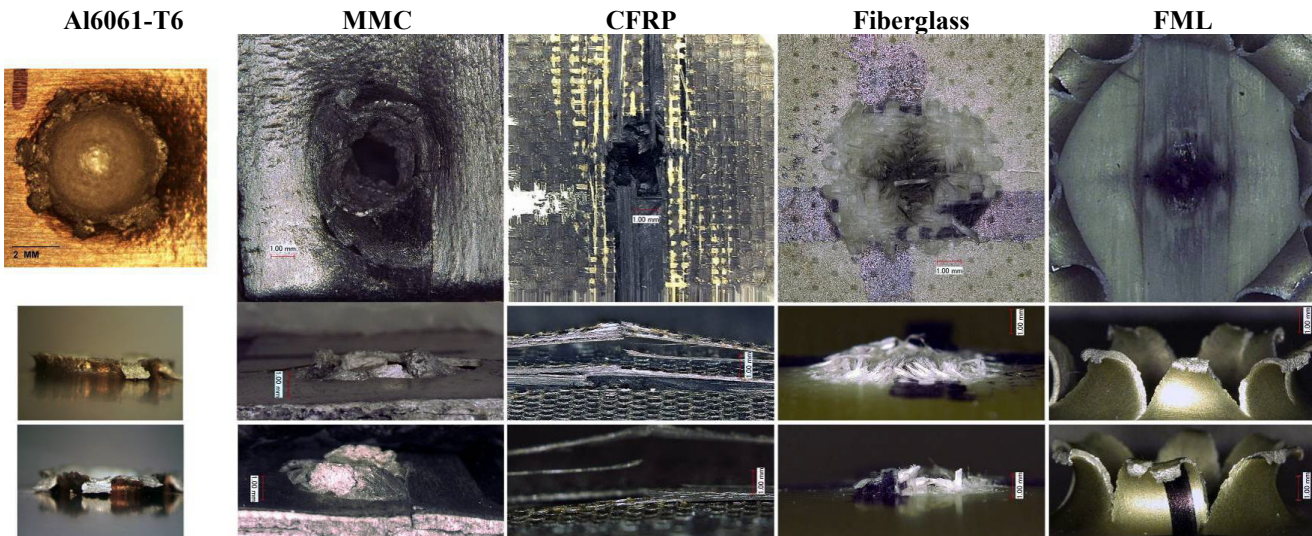
One impact tests was performed on each of the four alternate handrail material targets. A summary of test impact conditions and target damage measurements is given in Table 2. Of the four alternate materials tested, two were found to reduce the height of protruding crater lips (compared to the baseline Al6061-T6 target) for the impact conditions considered, as shown in Figure 9. There was no measureable crater lip on the CFRP target, however there was a large amount of surface spallation about the impact site, including groups of rigid unidirectional fibers that are considered to pose a puncture risk. The outer fabric layer on the CFRP laminate is used to limit the amount of surface spallation; however it is shown that multiple layers may be required to prevent spallation of puncture-hazardous material. The other material to reduce the height of the crater lip was the NP500CR fibreglass. For this

material, the area about the impact site contained fractured and delaminated glass fibers. Although extending above the target surface, these protrusions were not rigid, nor did they extend beyond the local impact site (see Figure 9). Unlike the CFRP, the epoxy has been completely removed from the protruding glass fibers and, as such, they are considered to pose minimal puncture risk. The GLARE fiber metal laminate had the highest crater lip, ~ 3.3 times that of the baseline aluminium alloy. In Figure 9 it can be observed that the outer aluminium layer of the FML peeled back from the composite layer, resulting in a large crater diameter with sharp petalled edges. Having a number of glass/epoxy composite layers on the outer surface of the laminate (instead of an aluminium alloy layer) may reduce the protrusion height of the crater lip. The Nextel 610/pure aluminium metal matrix composite provided a similar

Figure 9: Comparison of impact crater profile in a simulated ISS handrail and alternate handrail materials impacted by a 1.0 mm diameter Al2017-T4 sphere at 6.91 ± 0.08 km/s with normal incidence (0°)

lip height to that of the baseline aluminium alloy. The outer layer of the MMC laminate is seen to have fractured about the impact site, resulting in minimal protrusion above the target surface. However, the second layer did not fracture in a similar manner, resulting in a 1.0 mm measured lip height. The MMC target was penetrated by the projectile, forming an exit hole that was raised 2.45 mm above the rear target rear side. Although the thickness of the MMC laminate was less than the baseline material, penetrating impacts on Al6061-T6 with larger projectiles resulted in rear side damage features less hazardous than that of the MMC. As such, the performance of the MMC is considered worse than the baseline aluminium alloy.
