NASA/TM-2009-215575

Terahertz NDE of Stressed Composite Overwrapped Pressure Vessels – Initial Testing

February 2009

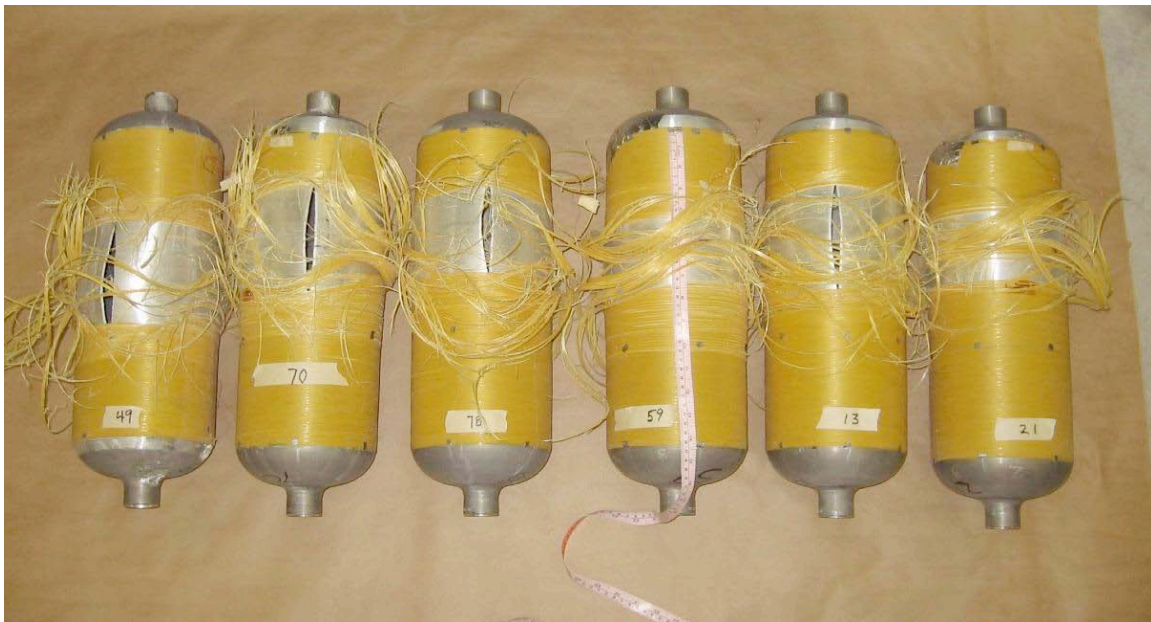
Table 1 and Table 2 indicate bottle status at the end of the aging process. Figure 1 shows a series of COPV bottles that “Failed” or ruptured during aging. Figure 2 is a typical “Pulled” bottle. Pulled bottles showed some visible failure in the overwrap or completed aging without failure. Figure 2 also shows a strain gauge, thermocouple, and a grid of small rectangular silver markers attached to the bottles. As noted in Table 1, bottle number 89 was subjected to high temperature and low stress for 91 hours.

Figure 1: Typical damage of Kevlar COPV bottles that suffered failure.

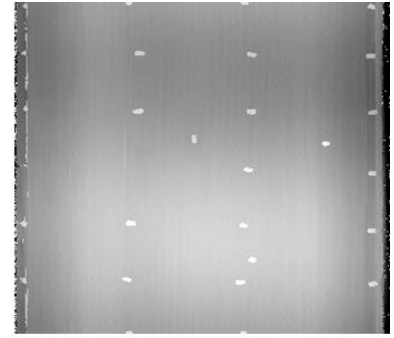
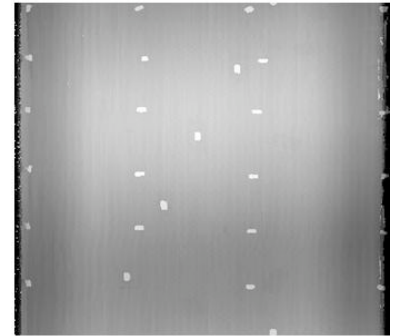
Kevlar back wall time of flight images made from the high temperature and high stress data are shown in Figure 33 and Figure 34. This data combines the effects of the Kevlar and resin index of refraction with the thickness of the layer. The data generally reflects the thickness of the layer with the dark range in the gray scale indicating thinner material and the brighter range indicating thicker material. The images are displayed on the same scale for comparison. There are bottles with significant variations and some with little variation but neither correlated with aging trends. In addition, it is not clear how the thickness variations affect the bottle's life condition without additional data indicating the bottle's effective age.

Figure 34: Time of flight images of high stress aged bottles.

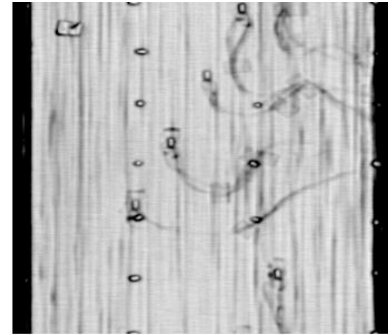
Narrow band frequency amplitude images from the high temperature and high stress data are shown in Figure 37 and Figure 38. Frequency amplitude images were generated from the time domain terahertz data after applying a 150GHz narrow band filter to mimic MSFC's Millimeter Wave (microwave) inspection results. This was done to investigate the origins of the anomalous short dark streaks in their images. Microscopic inspection of the bottles after identifying this anomaly indicated surface variations corresponding to the dark streaks. In particular, periodic thickness variations and small bumps resulting from manufacturing processes were observed. At 150GHz, the front to back wall phase front interference is maximized as the over wrap thickness approaches 1mm. Further examination of this anomaly is required to determine any contribution to bottle failure.

Figure 37: Peak-to-peak images of high temperature aged bottles at 150GHz.
