Solar Alpha Rotary Joint Anomaly: The Materials & Processes Perspective

Aging Aircraft 2009

May 5th, 2009

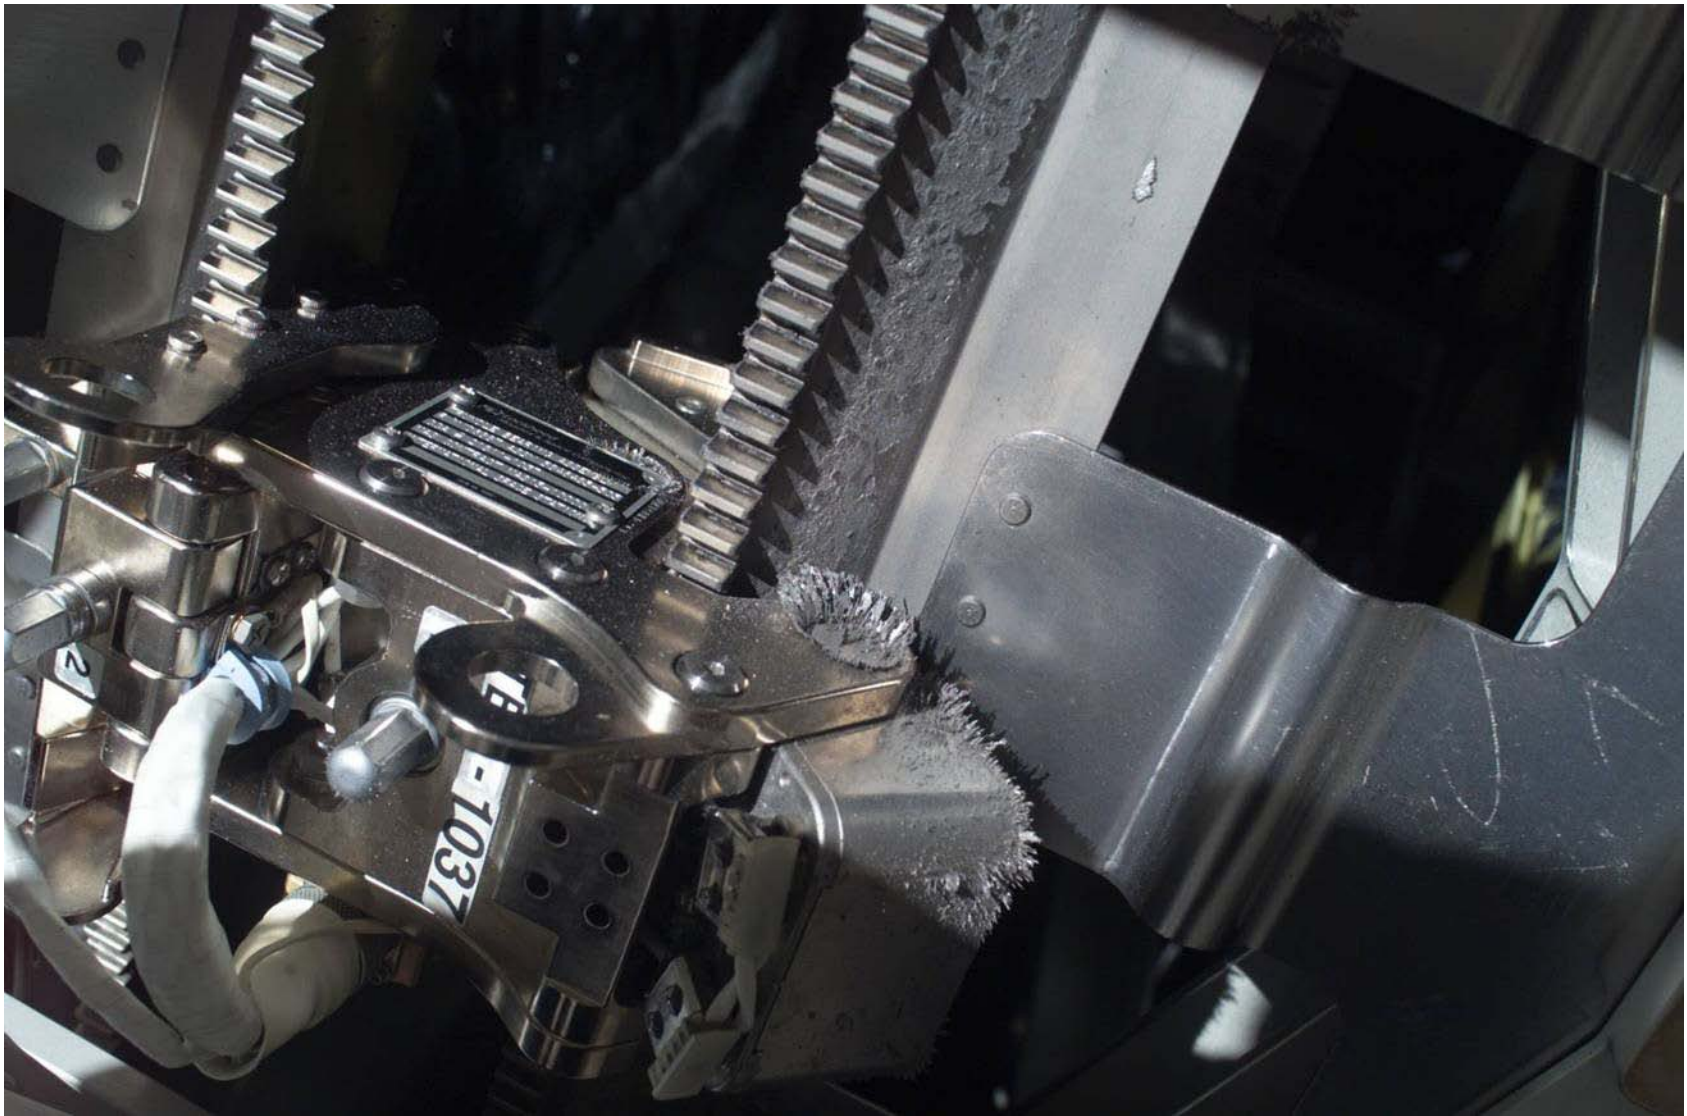
Starboard SARJ – Metallic Debris

- **Anomalous telemetry and noticeable vibrations prompted a visual inspection of the SARJ mechanism.**
- **Metallic debris was observed throughout the vicinity of the mechanism, including on the surface of the race ring.**
 - **Debris exhibited slight magnetic effects, aligning with available magnetic fields.**
- **Samples were taken via tape-lift from starboard SARJ. Multiple accessible surfaces were sampled including the area of rolling contact.**
- **One of the Trundle Bearing Assemblies (TBAs) was returned to ground for examination.**
 - **Samples were taken from all rollers, the housing and packaging of the TBA.**
- **Nitride control coupons and maskant interface coupons from the original nitriding process were retrieved and used for metallographic analysis.**

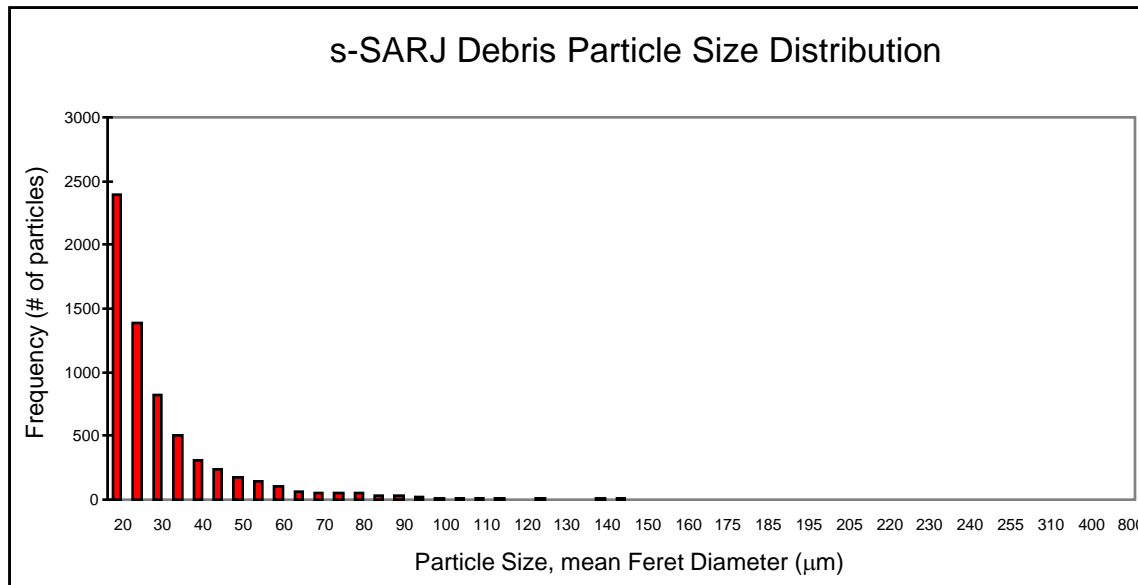
Image analysis particle size distribution

- Majority of debris is nitrided 15-5 PH Steel
 - Some gold, fluorinated grease, trace contaminants
- Only source of nitrided 15-5 PH steel is the race ring
- Particle size distribution skewed to fine particle size (less than 50 μm)

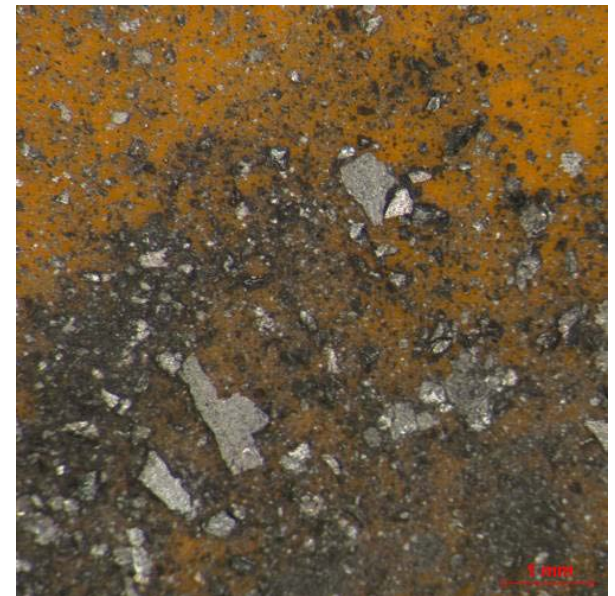
Stereomicroscope image.
Reference magnification: 20X

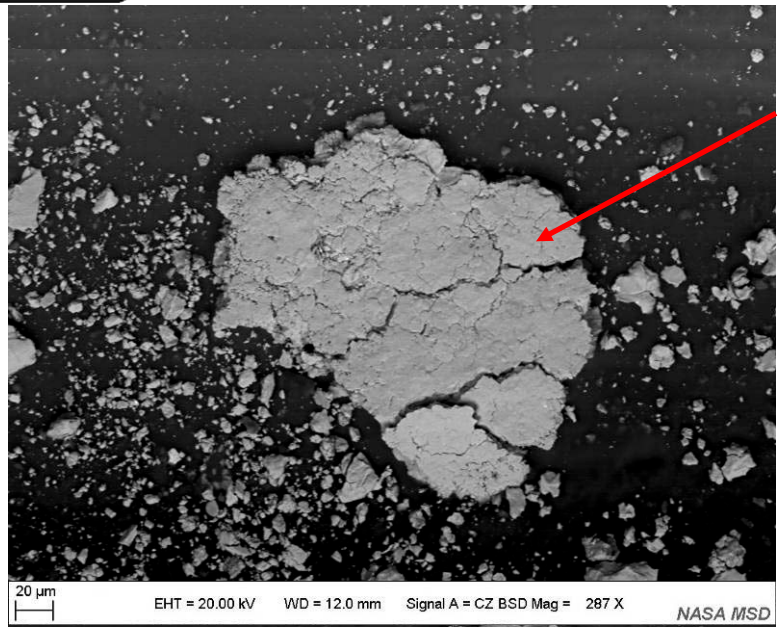
Agglomeration.

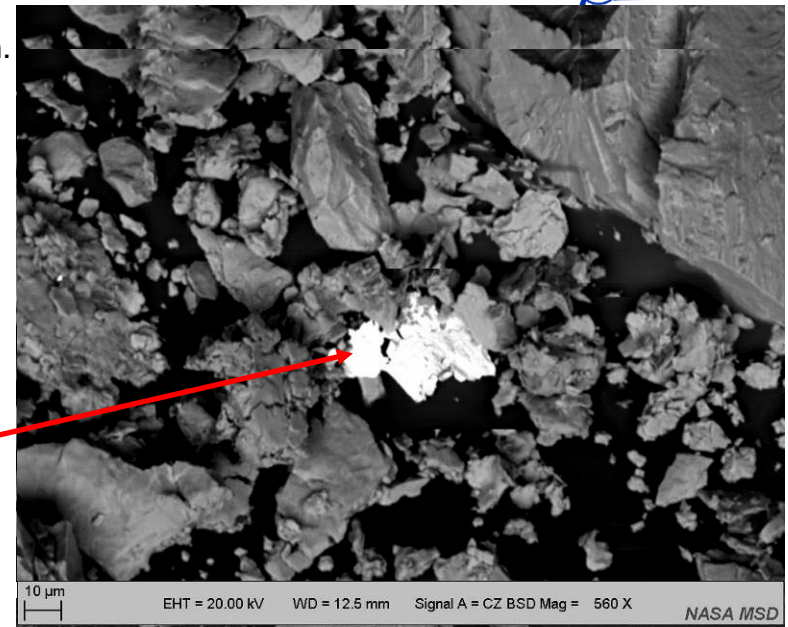
Gold particle showing atomic contrast.

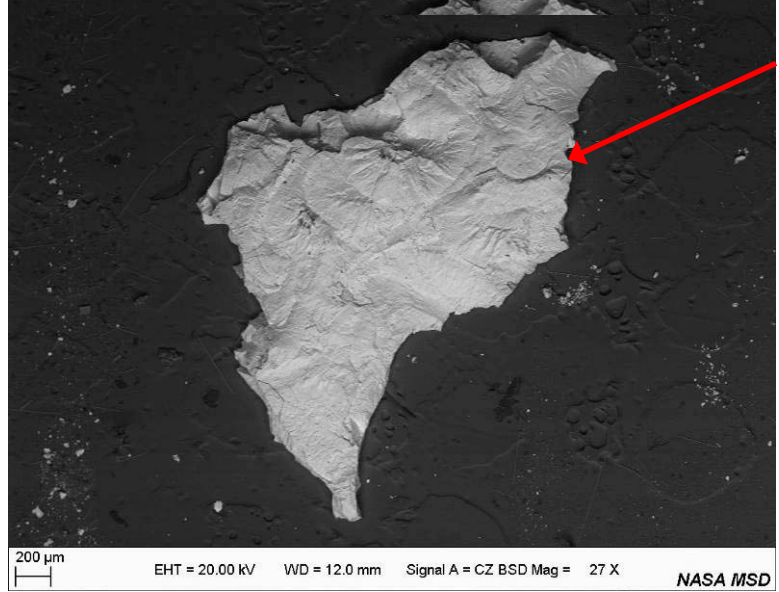
Evidence of crack arrest lines.

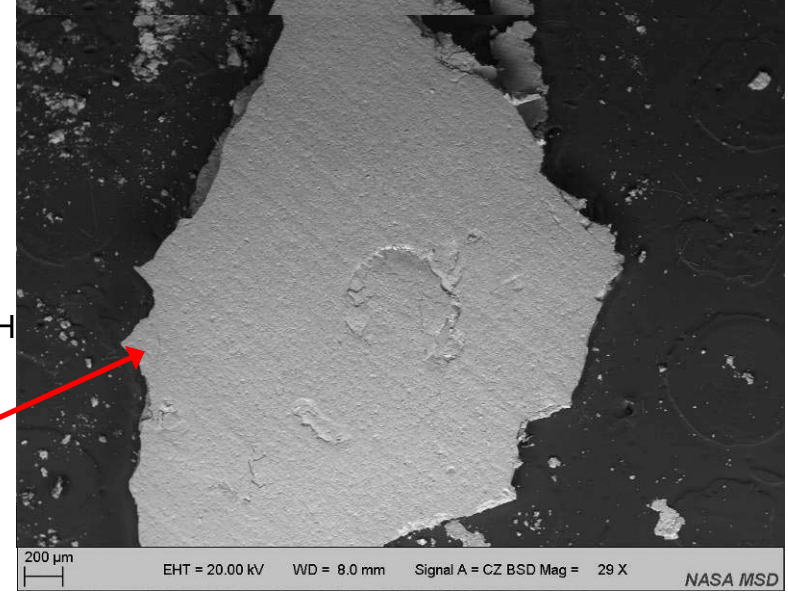
Original 15-5 PH nitrided surface with machine markings.

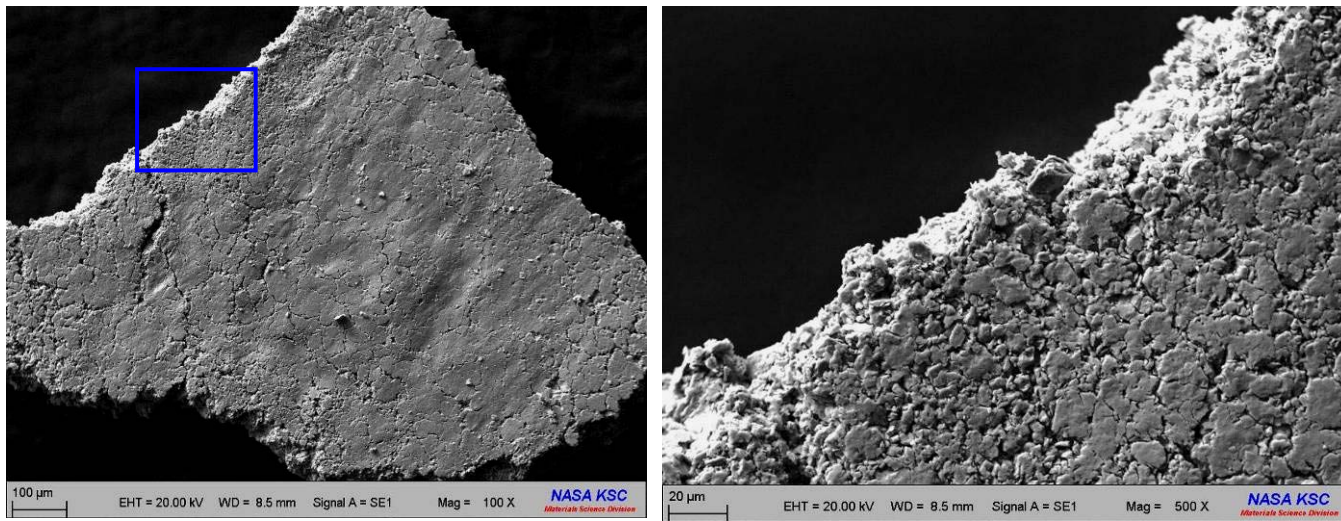
- Friable large particles are actually agglomerations of small particles

Nitrided 15-5 PH agglomerated fragment from Tape Sample 31
imaged under high vacuum.

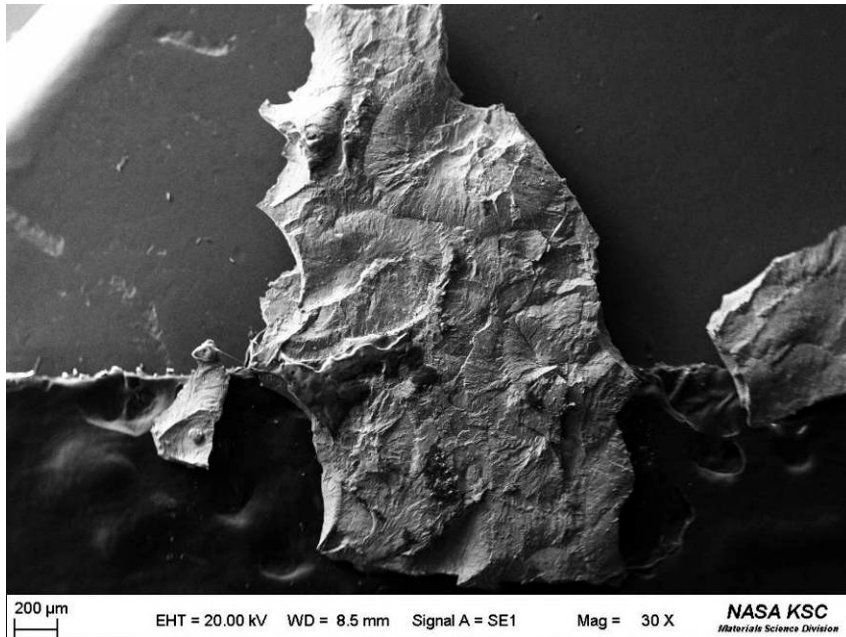
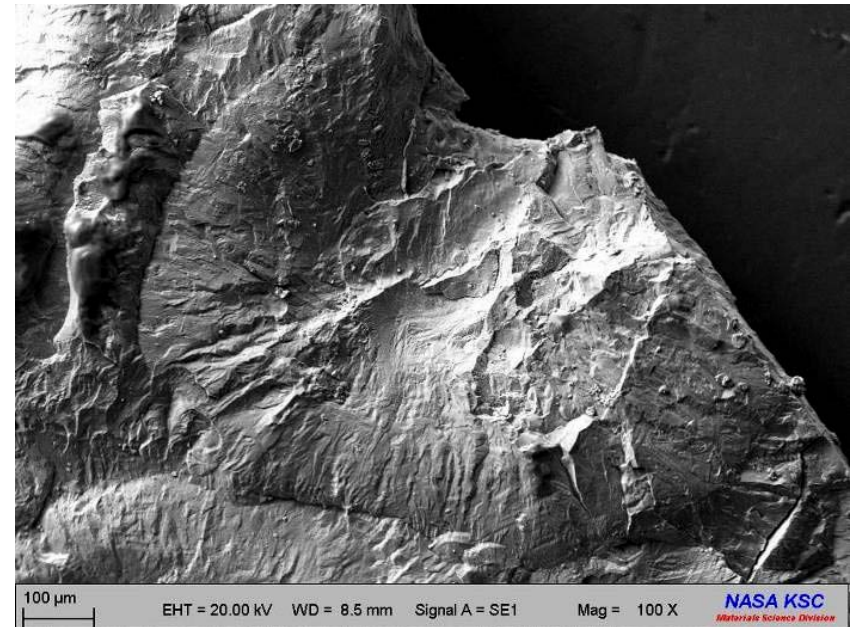
- Chip-Type fragments often exhibit crack initiation and arrest features
- Multiple initiation sites indicate a system-wide condition

Nitrided 15-5 PH Chip-Type fragment from Tape Sample 31 imaged under high vacuum showing fracture surface and crack initiation/arrest features. Reference magnifications: 30X (left), 100X (right)

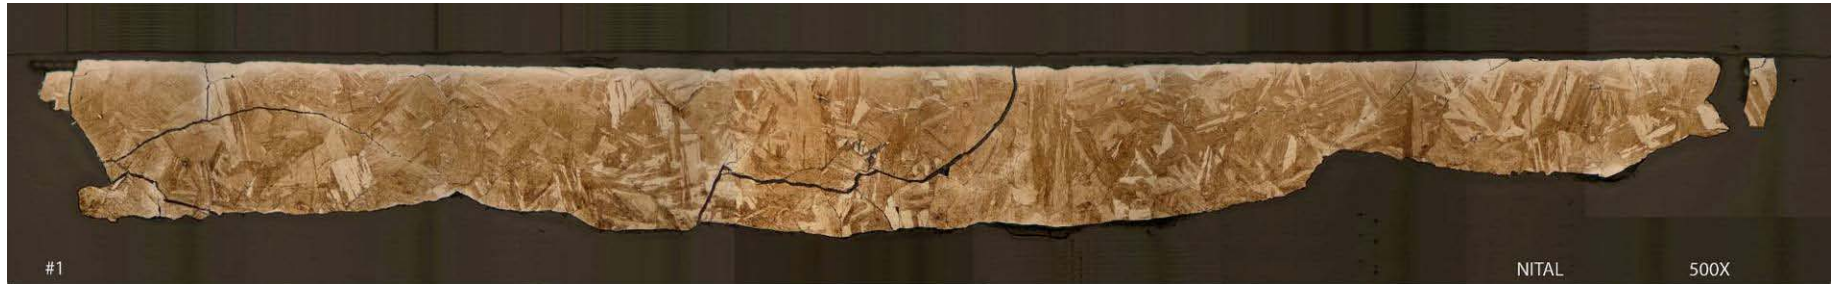
Nitrided 15-5 PH Chip-Type fragment from Tape Sample 31 imaged in cross section, showing original surface (with residual white layer) and transgranular fracture surface after 2% Nital etch

- **When viewed in cross-section, the propagation path does not appear to preferentially follow areas of intergranular networking**
- **Cracking is transgranular**

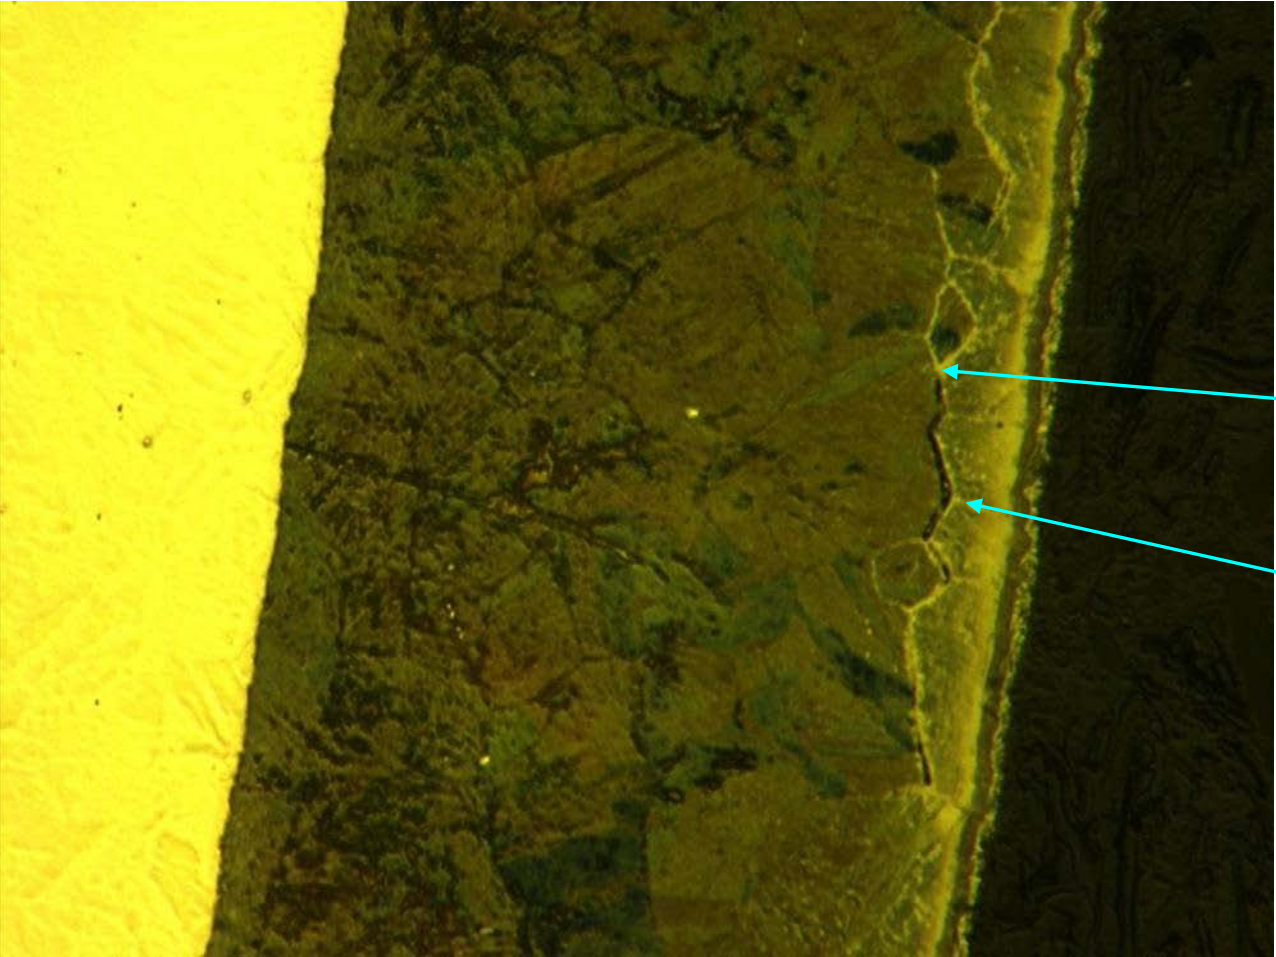
**Metallurgical Evaluation of SARJ Race Ring S/N 4
Sample Coupon (Polished, Etched and View @1000X)**

Networking

Intergranular voids
(appear like cracks)

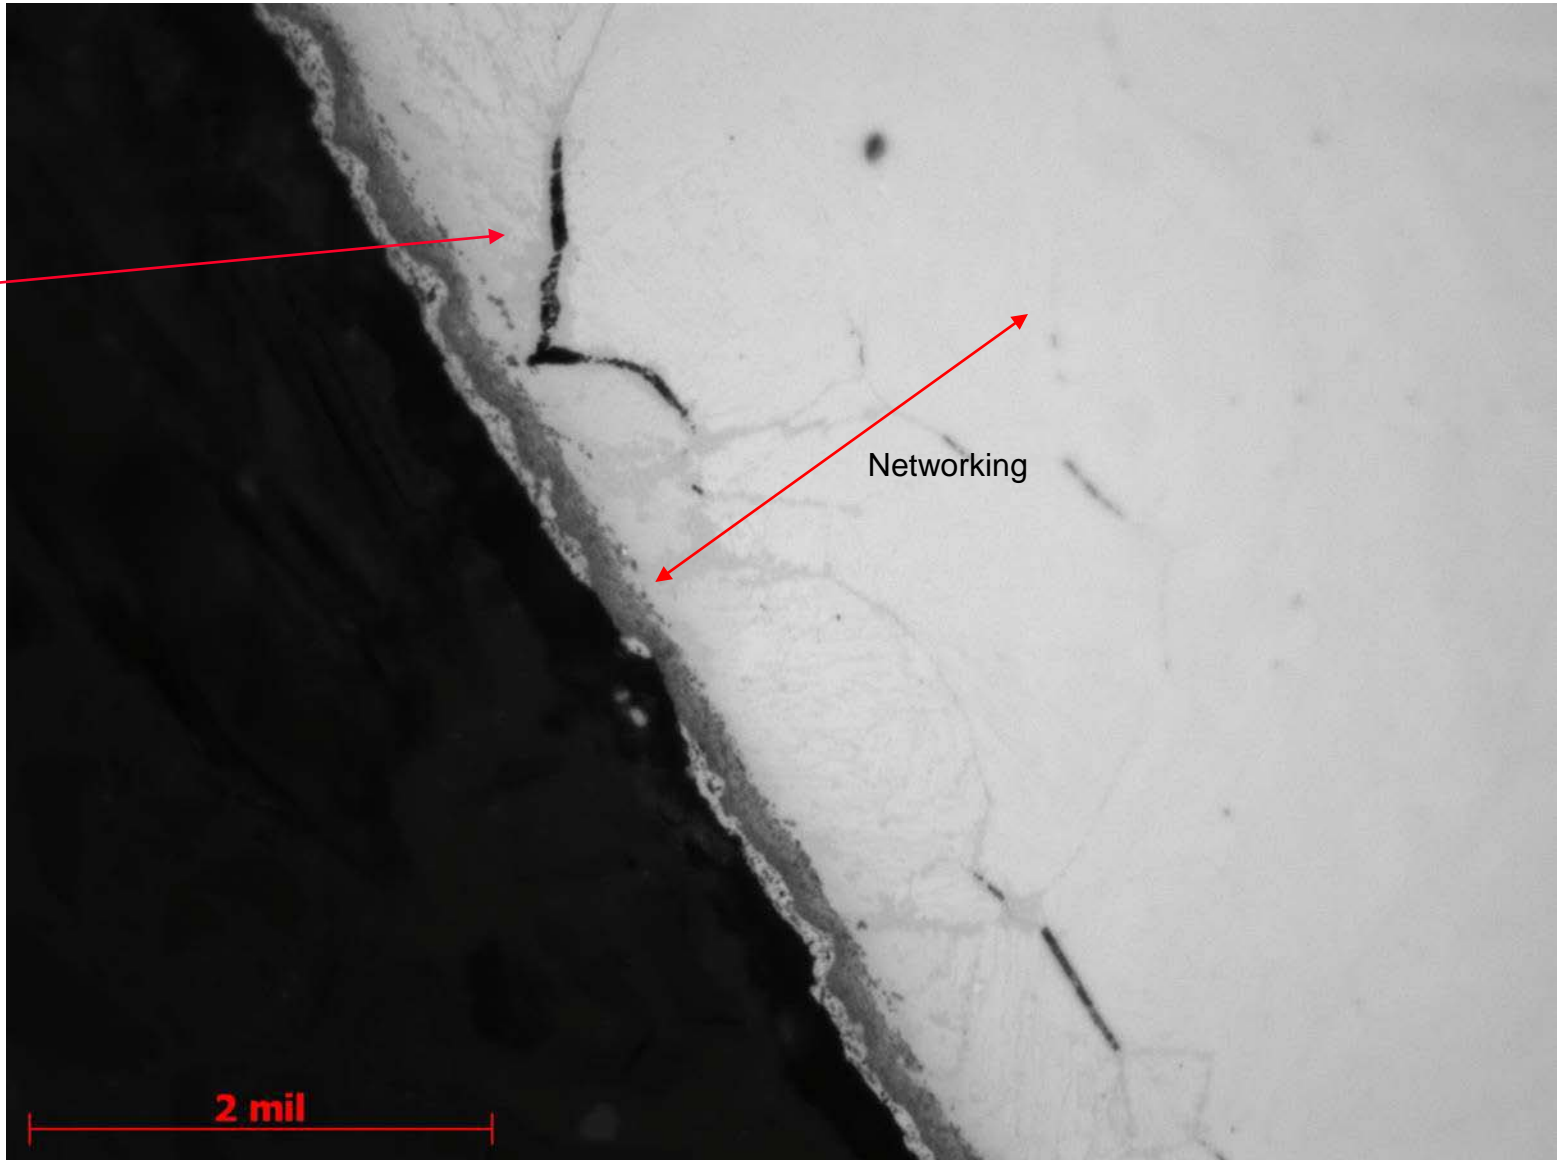
Nitride Control Coupon

Separation /
void

Networking

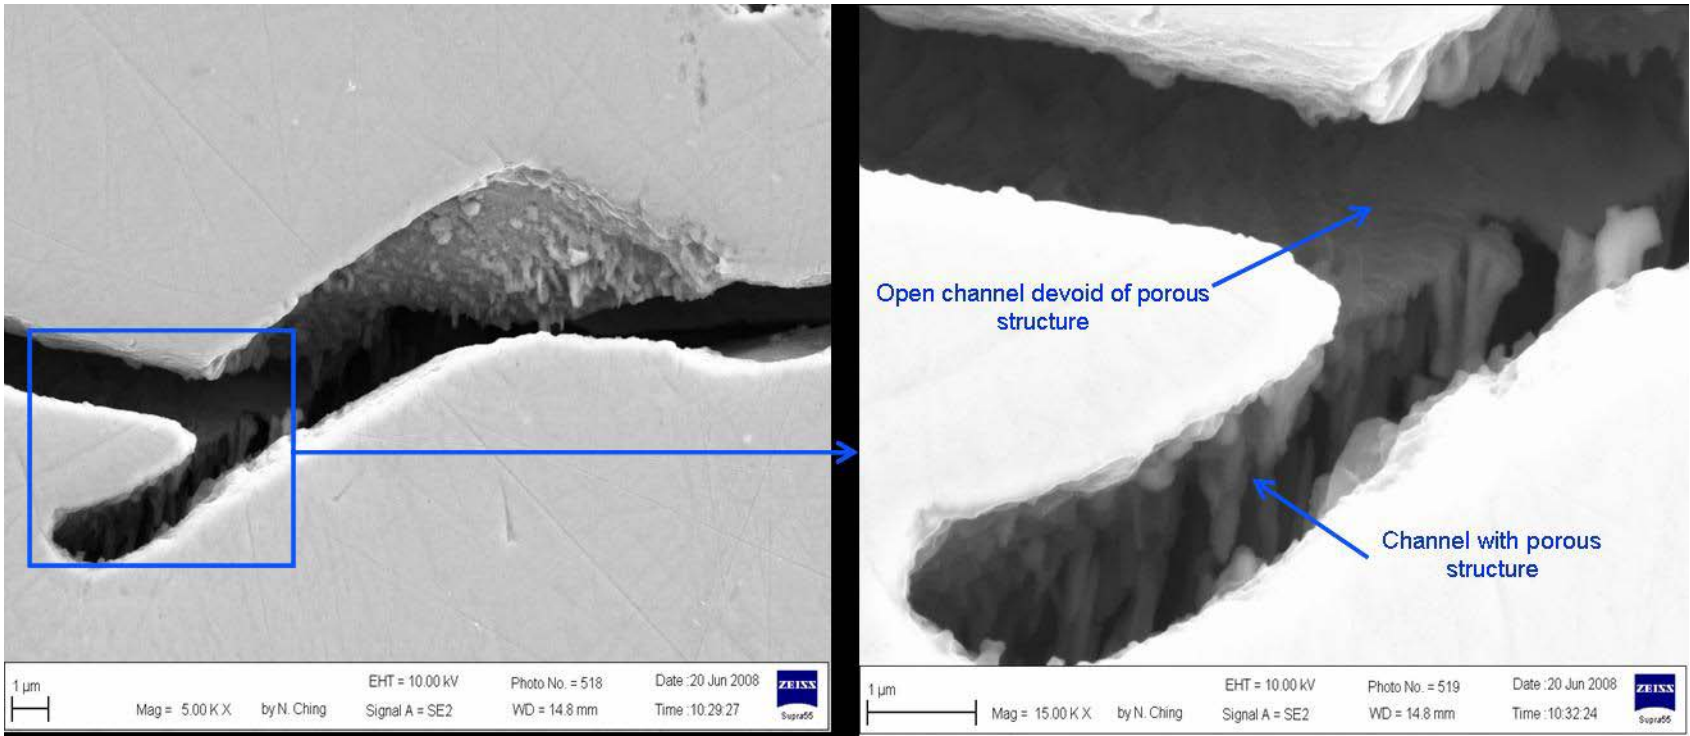
DIGS in Nitrided Rolling Test Coupon

Sectioned and polished nitrided rolling test coupon. Branching of DIGS with different degree of porosity in each branch. Upper branch has a smooth surface and forms a single void while lower branch has a rough surface suggesting the existence of an earlier porous structure.

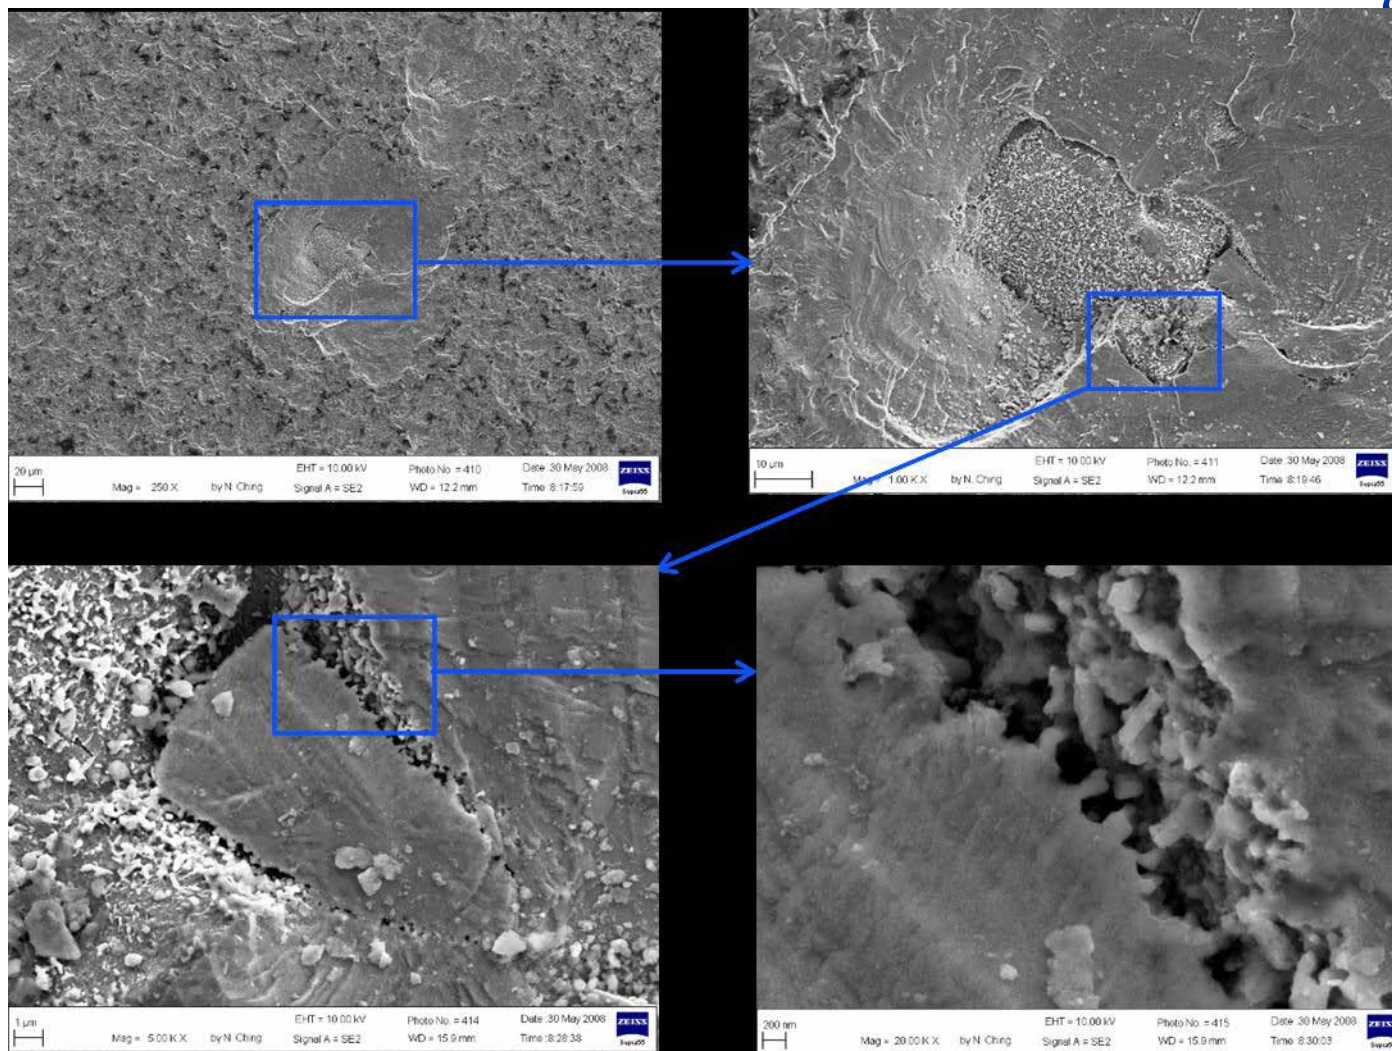
DIGS in Nitrided Rolling Test Coupon

Progressively increased magnification illustrating the porous nature of DIGS in nitride test coupon.

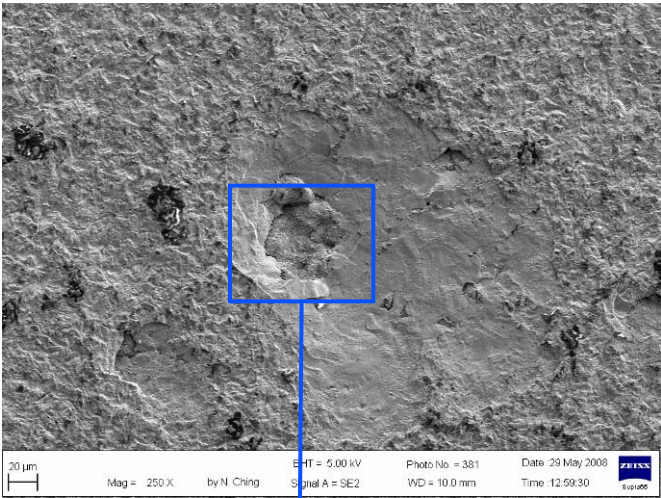
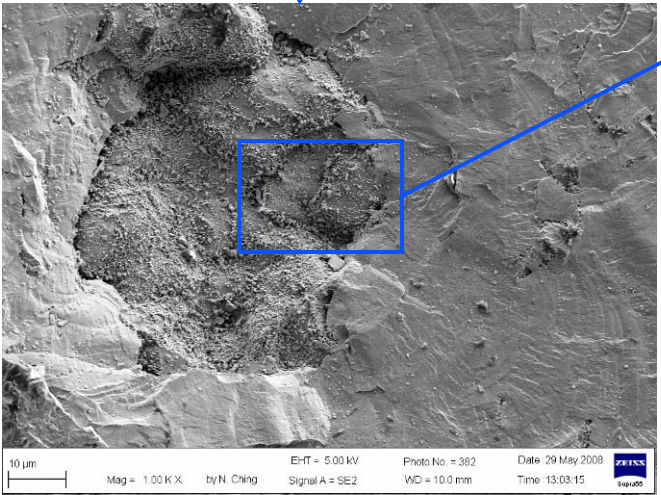
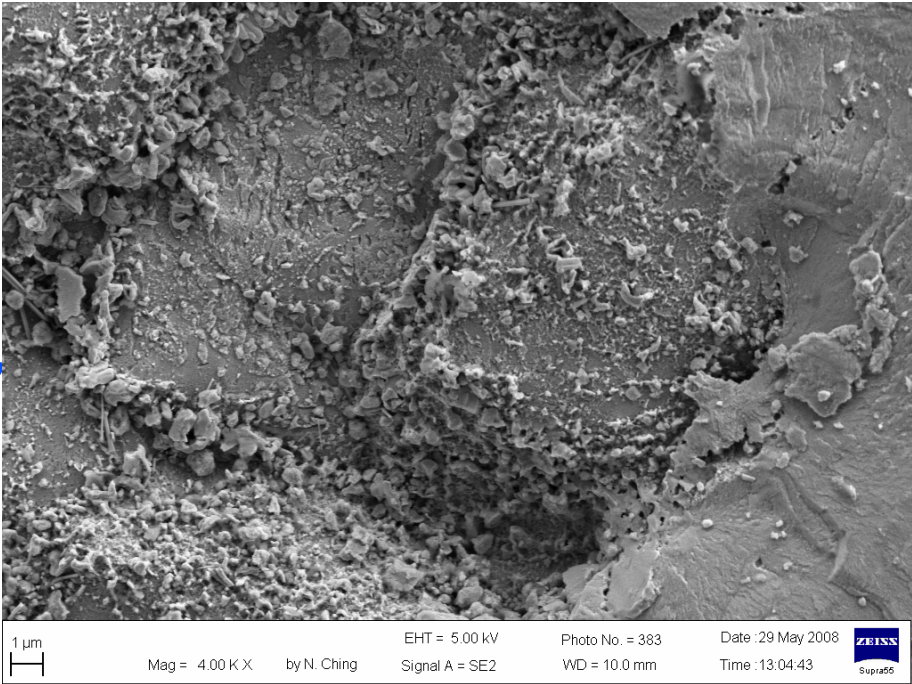
DIGS in Nitrided Rolling Test Coupon

Spalls created during the rolling test are associated with DIGS. Cracks originate in DIGS and propagate radially to form spalls.

Fragmented DIGS porous structure is shown as debris

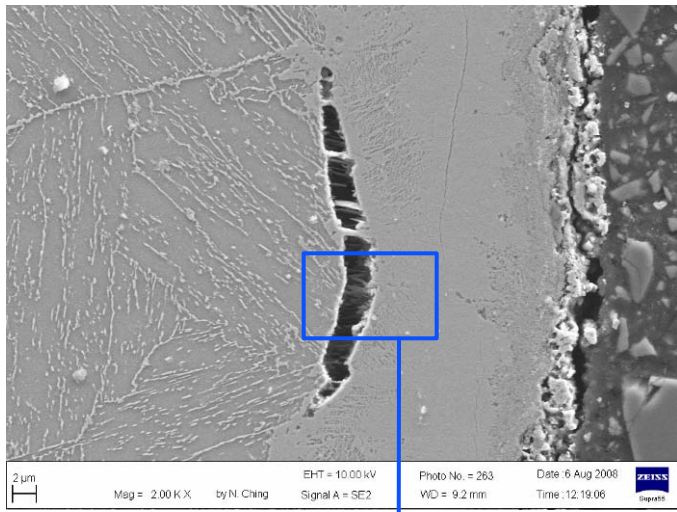
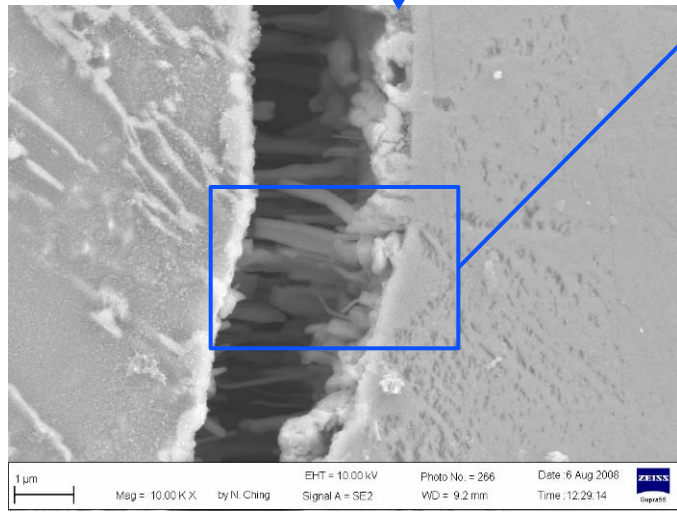
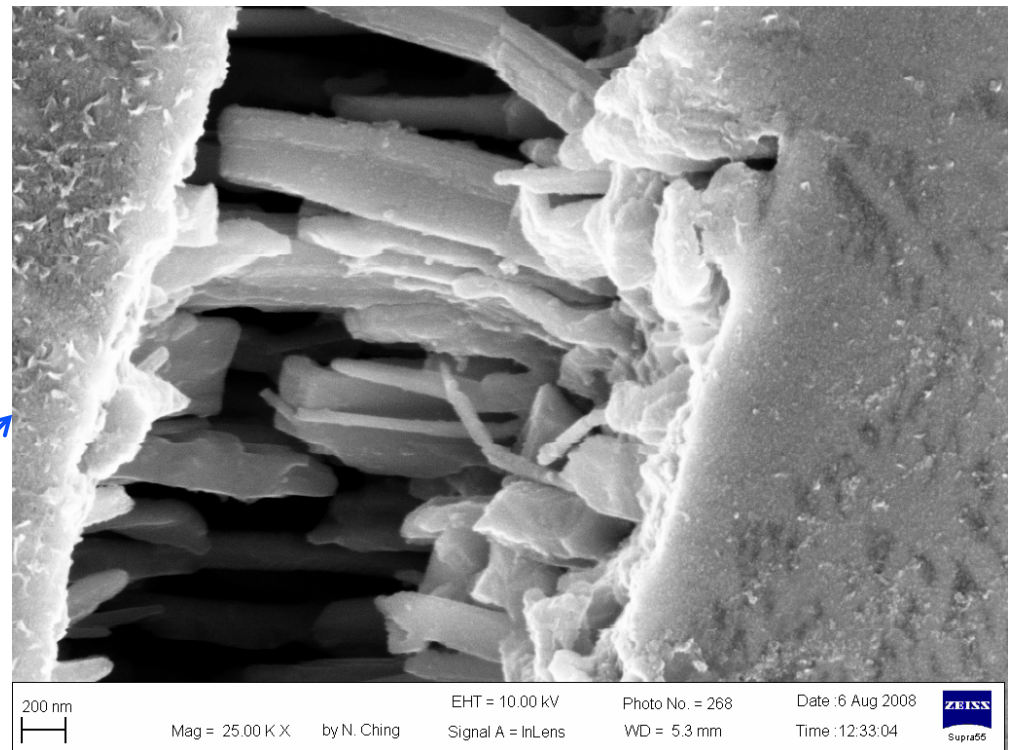
DIGS in Nitride Control Witness Coupon

Polished metallographic sample exhibiting DIGS.
The degree of porosity and the type scaffolding structure remaining inside each DIGS varies and at times appears as a nanostructure.

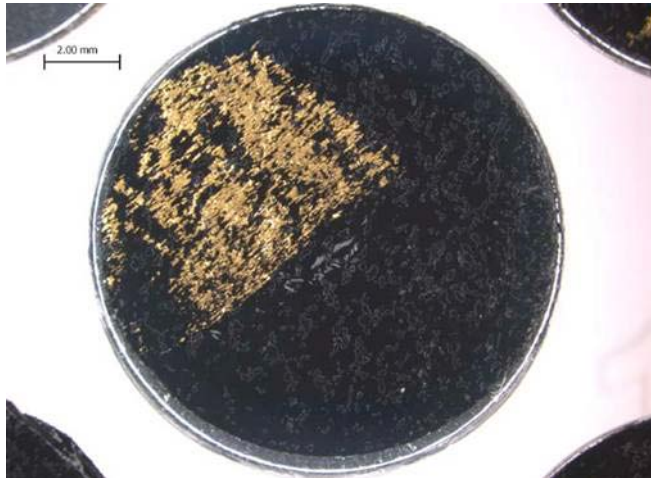
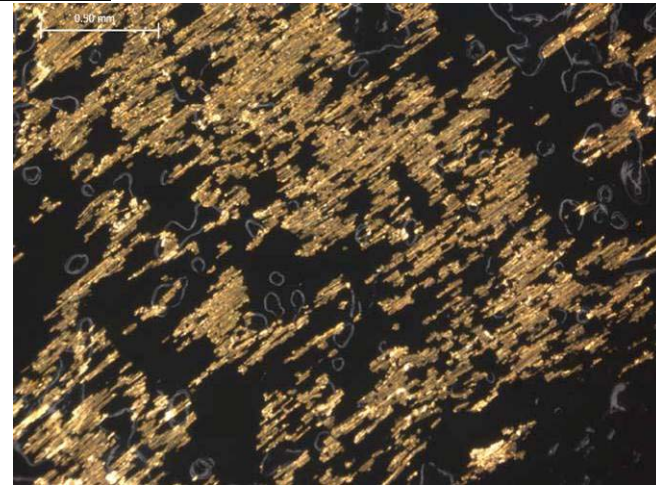
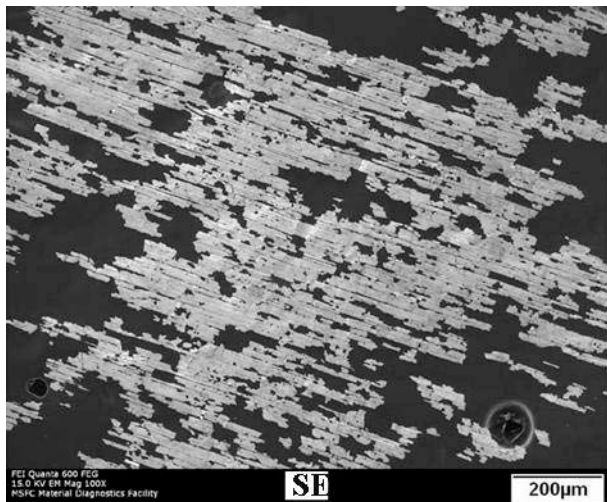
TBA 1045, Datum A, Test #2, Carbon Tape

- Gold removed from TBA 1045 was segmented into strips, typical for all TBA roller tape tests with gold adhesion failures.

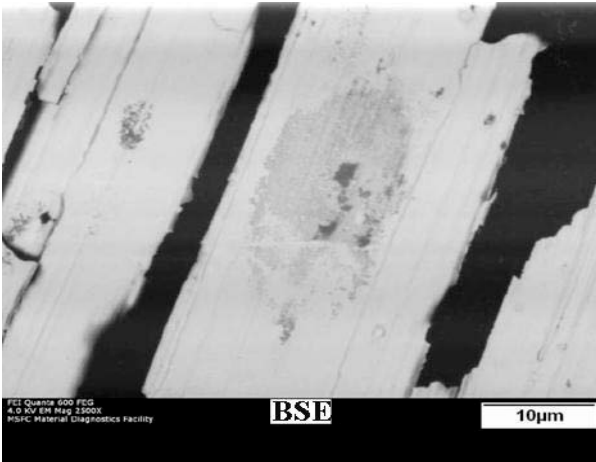
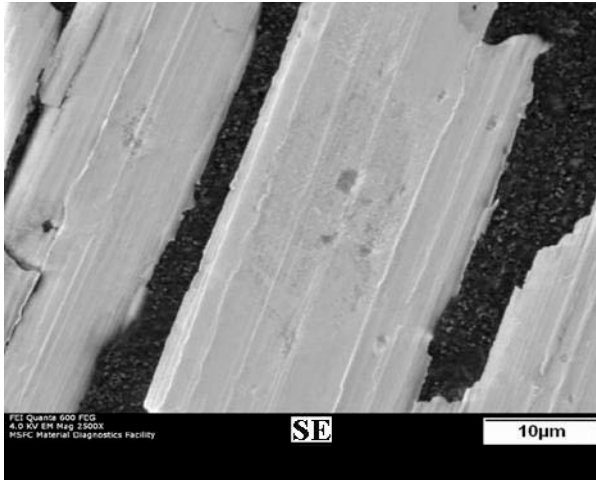
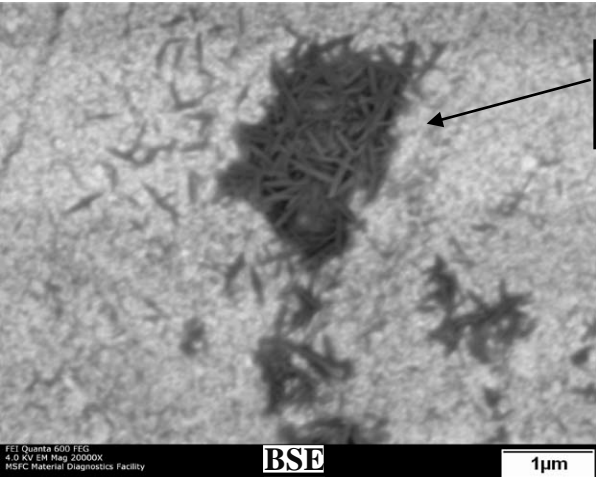
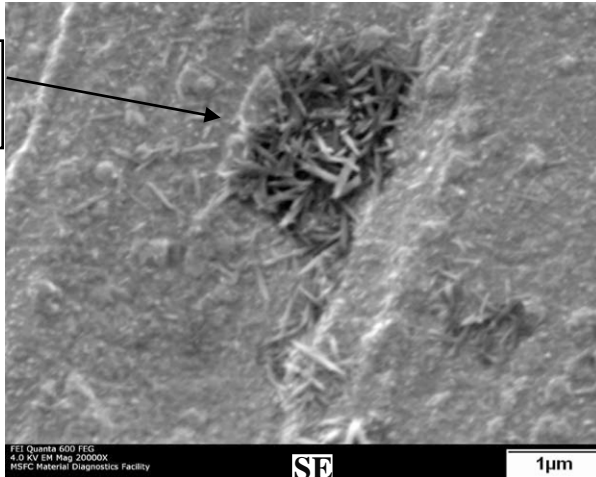
TBA 1005, Outer 45, Test #1, SEM

Iron Oxide (by elemental analysis)

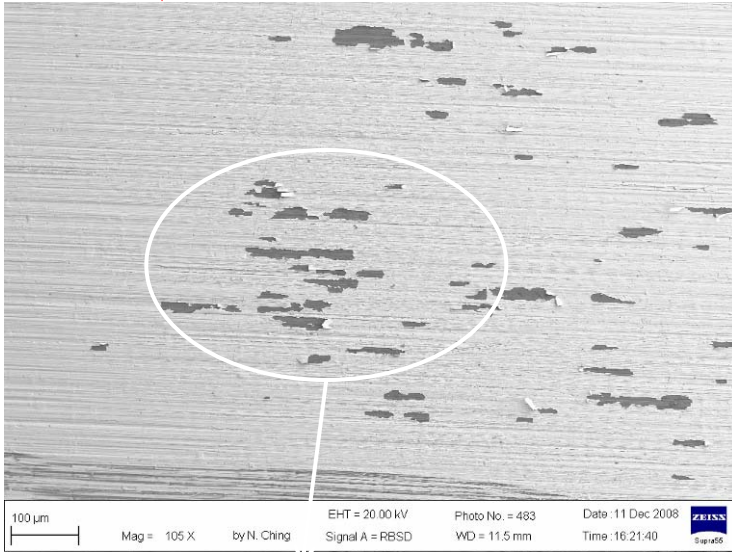
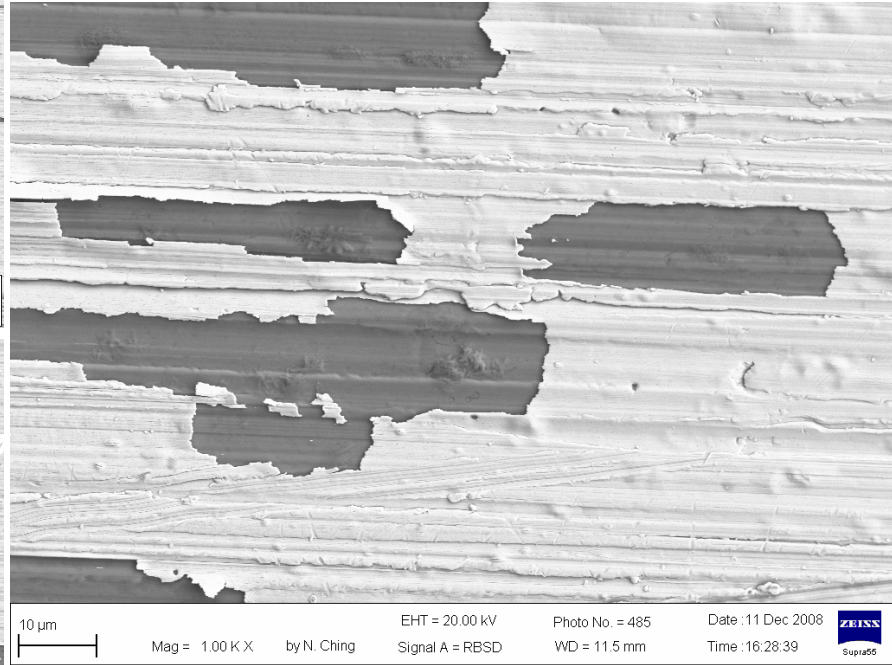
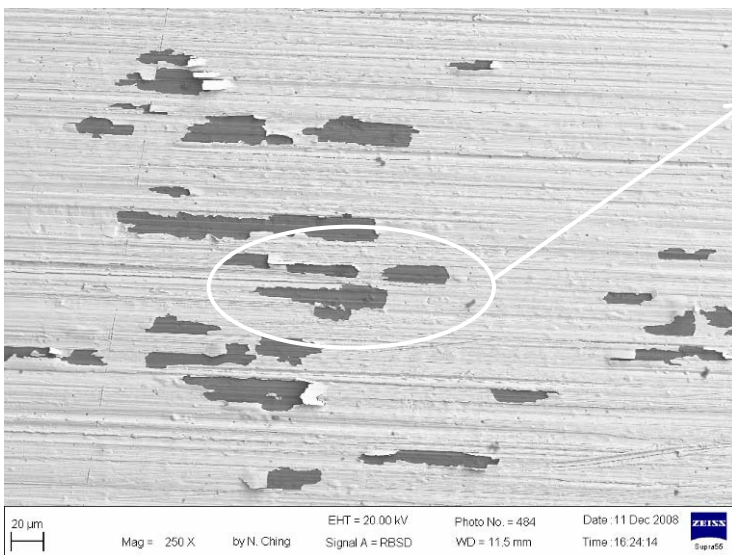
Accelerated Aging Test

- **After seven more days of accelerated testing (21 days total), gold adhesion loss was widespread and very similar to tape test results from the flight spares**

- **Comparable area of iron oxide corrosion observed, undercutting adhesion between gold coating and substrate**

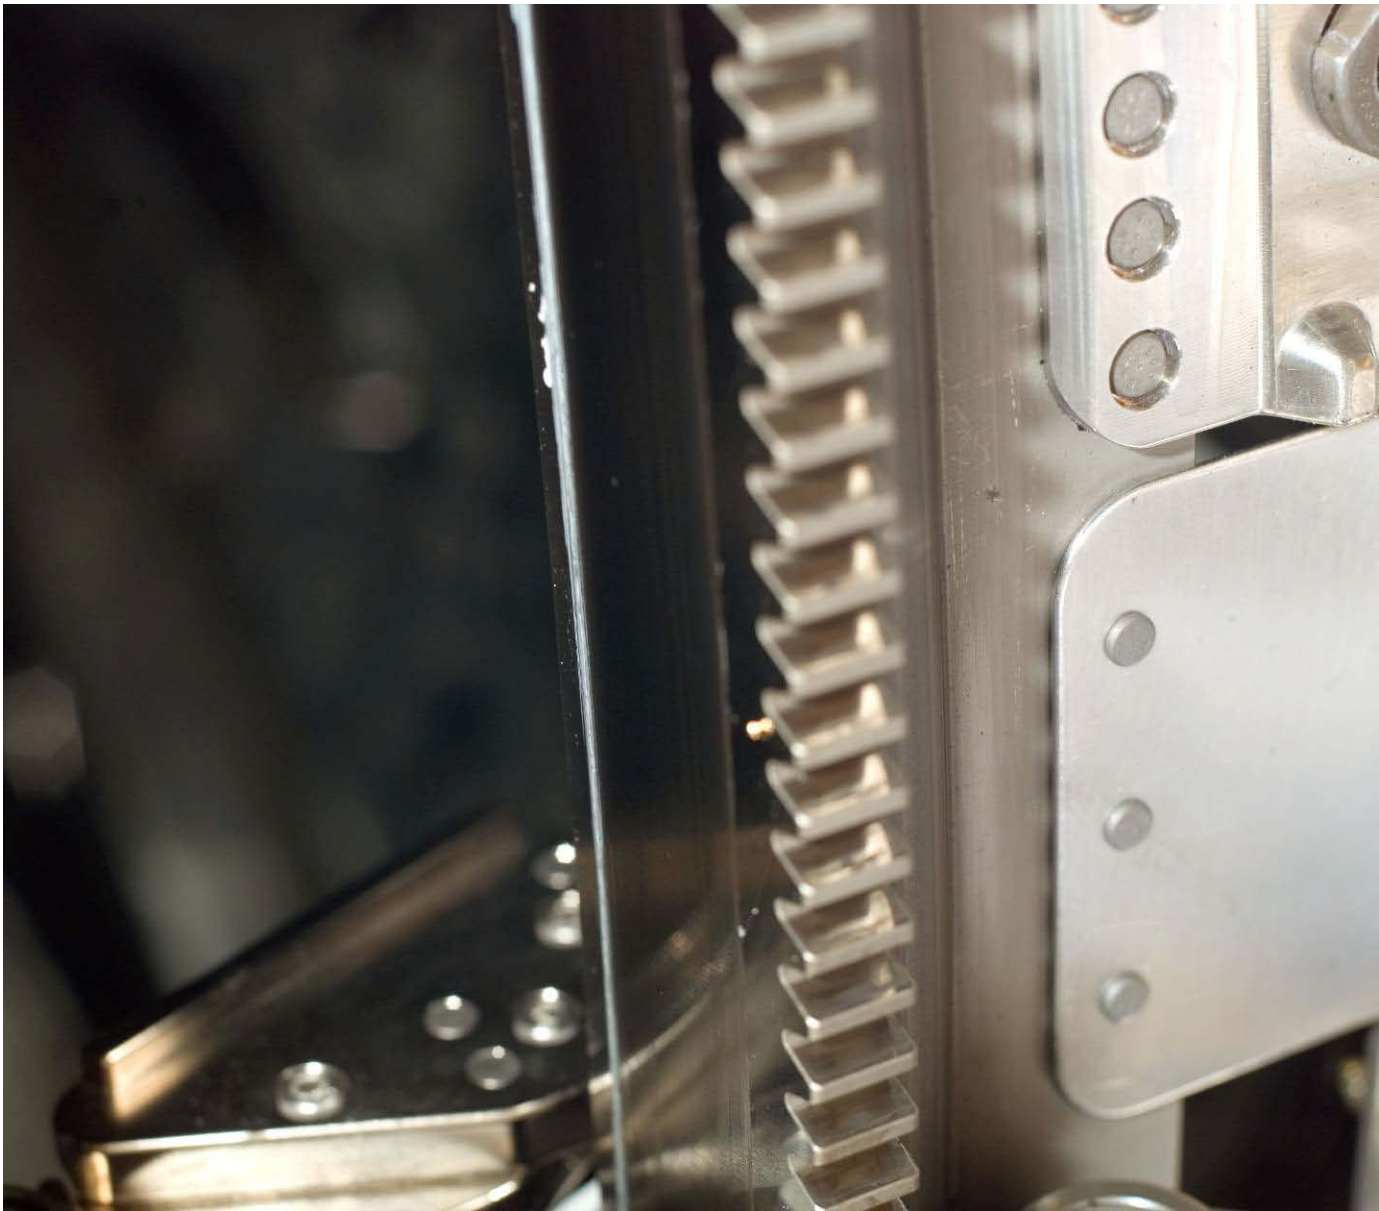
Port SARJ - Evidence of Unintentional Grease

- **Port SARJ has not displayed anomalous behavior to date, an inspection was conducted to assess the status of the race ring surface**
 - **Did not observe any obvious visible damage**
- **Inspection indicated the presence of a continuous streak of white substance along one edge – determined to be Braycote 601, which is used elsewhere in the mechanism**
- **A small number of tape-lift samples were taken from the non-rolling contact surface**
 - **Debris collected consisted of ~30% 15-5PH, ~70% 440C, and a small amount of gold particulate.**
 - **Composition of debris is consistent with expected wear of the SARJ mechanism, based on comparison with residual debris from hardware qualification tests**
