NACA RM SE57K25

ENDURANCE EVALUATION OF SINTERED, POROUS, STRUT-

SUPPORTED TURBINE BLADES MADE BY FEDERAL-

MOGUL-BOWER-BEARINGS, INCORPORATED,

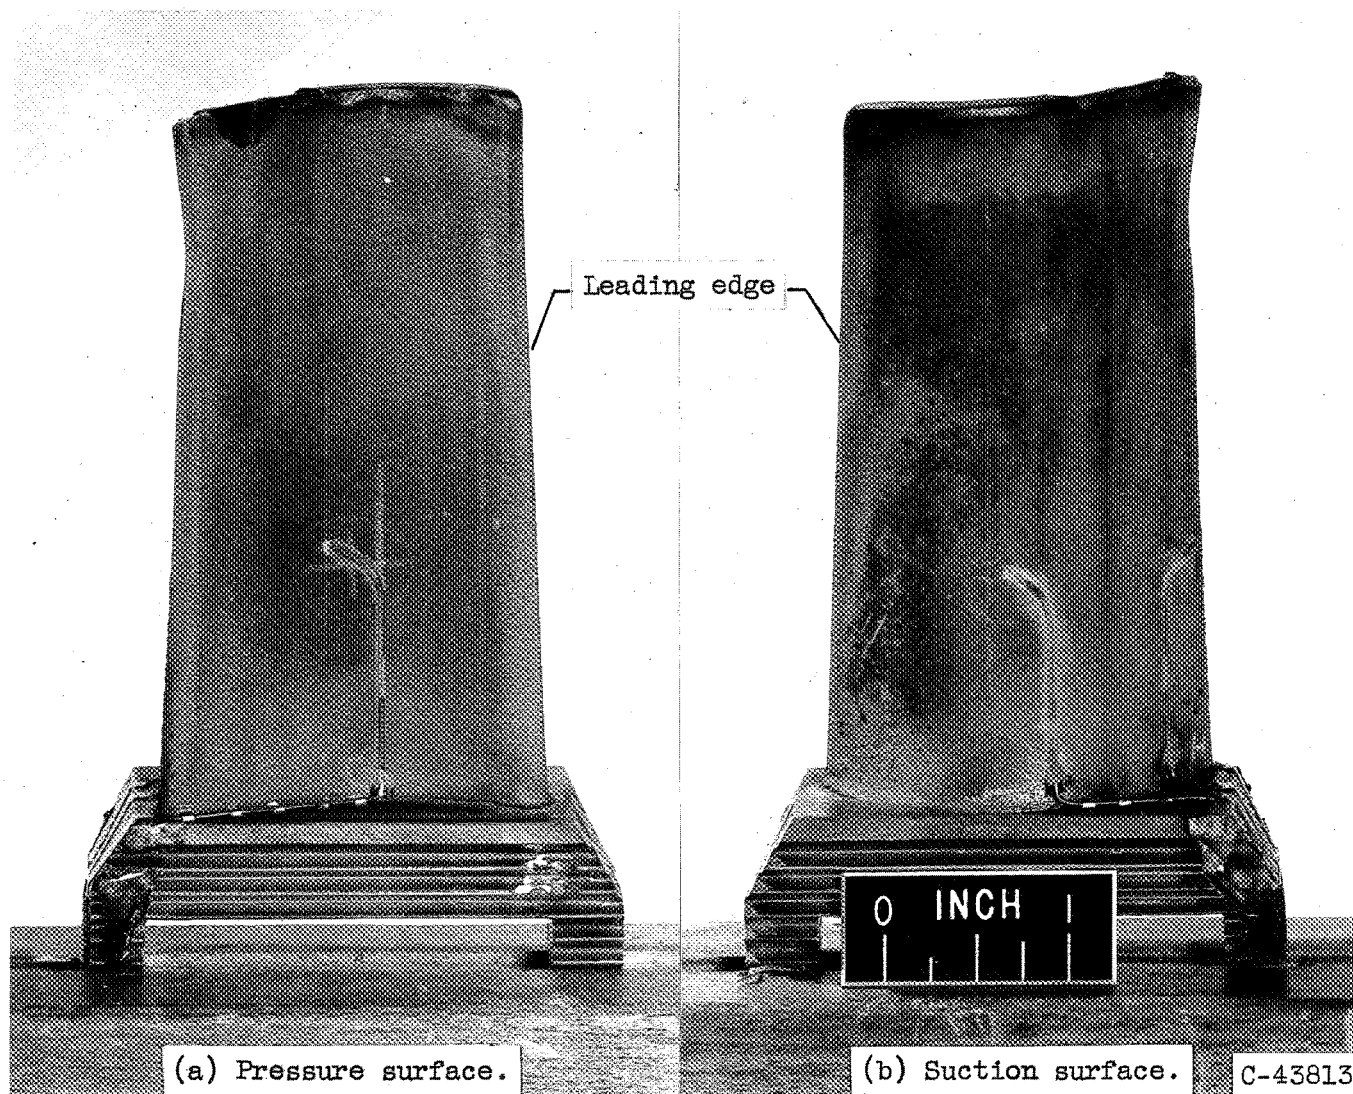
Blades 38 and 52 were first operated in the test engine with sheet metal tip caps that were made of 0.015-inch-thick Inconel. In order to maintain the maximum shell temperature, as indicated by the thermocouples, at a value of 1000° F, a coolant-flow ratio (cooling-air weight flow per blade per combustion-gas weight flow per blade) of about 0.10 was required. After 42 minutes of operation at rated test conditions, blade 38 failed in the extreme tip region, as shown in figure 6. The failure was confined to the trailing-edge region of the blade and extended radially inward a maximum of 1/4 inch on the pressure surface (fig. 6(a)). The suction surface was undamaged except in the extreme tip region (fig. 6(b)). The failure apparently originated when the sheet metal cap broke away from the porous shell along the weld between the cap and blade shell.

During the investigation of blades 38 and 52, cracks appeared in the porous-shell material in the root of the blade where the shell joined the base platform (see figs. 6 to 8). The closeup view of the crack shown in figure 8 was typical of those found on both blades after operating only 42 minutes (time of first failure on blade 38). In an attempt to avoid such cracks, a fillet weld having about a 1/8-inch radius was provided at the root of blade 52 after it had been operated for 42 minutes. A similar fillet weld was provided on blade 38 when the built-up welded tip cap was provided. After the fillet weld was applied, no further evidence of cracking at the blade root was observed on either blade 38 or 52.

Figure 6. - Failure of tip region on blade 38.

Because of the large amount of damage, blade 52 was no longer operable. Blade 38, however, was repaired by grinding the tip back about 1/4

inch so that all the damaged tip area was removed. A new blade cap was installed by using a different capping method. Because the built-up welded cap was attached directly to the strut and did not depend upon the porous-shell material for support, this cap was believed to be more durable than the sheet metal cap used initially.

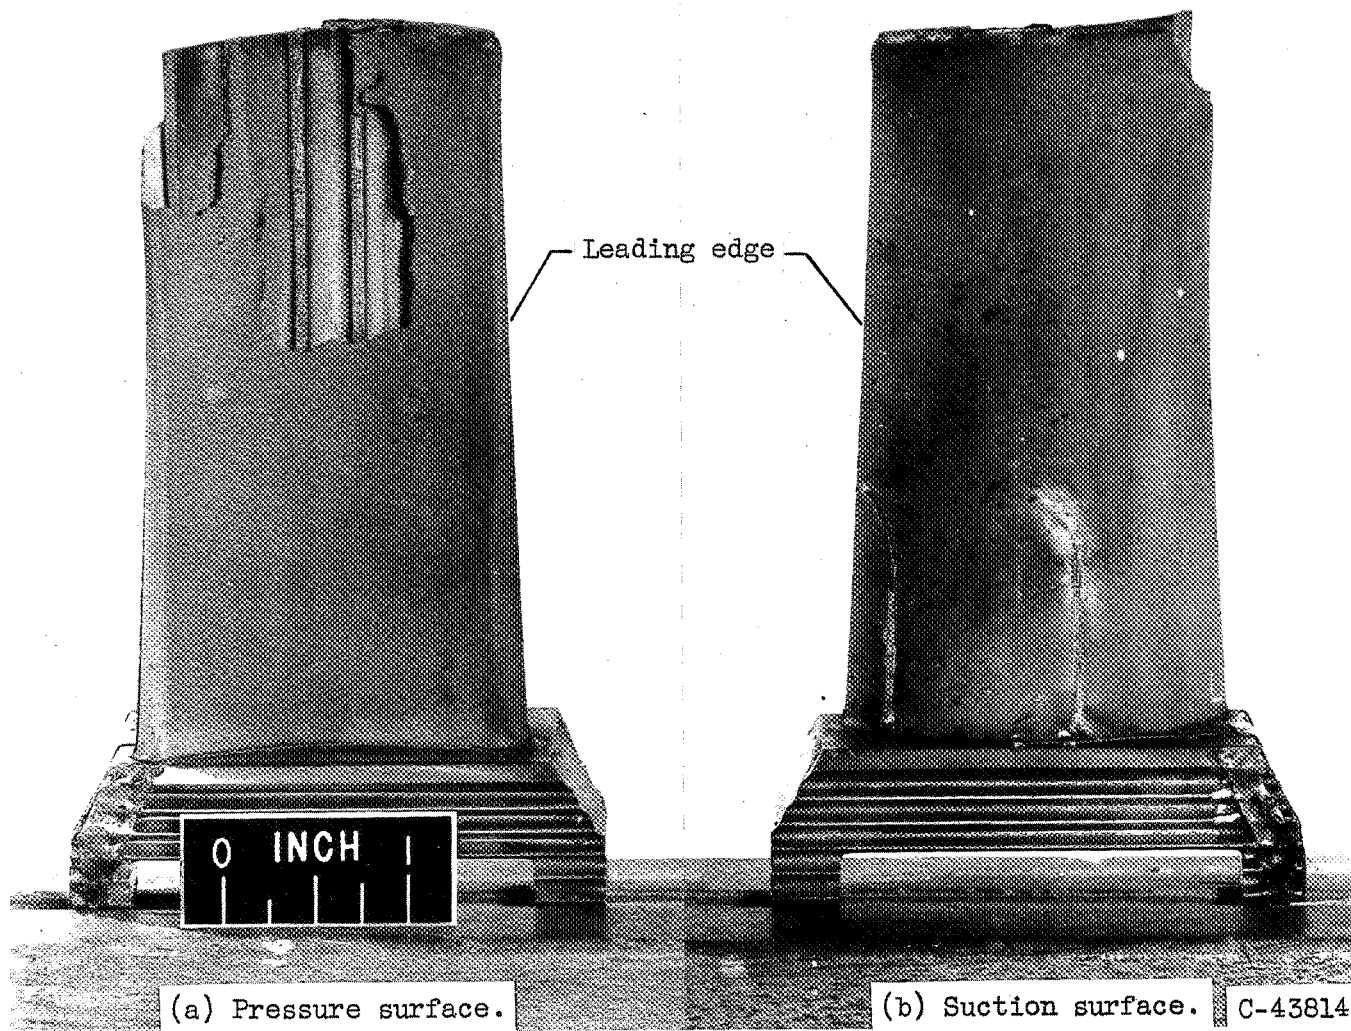
When blade 38 failed, blade 52 was not damaged extensively. A very fine crack in the shell material of blade 52 was observed. The crack was on the pressure surface about 1/2 inch from the trailing edge, and it extended radially inward from the blade tip about 1/2 inch. Operation of blade 52 was continued with the crack in the shell until a total time of 5 hours and 19 minutes was accumulated at rated test conditions. At this time the blade failed in the tip region, as shown in figure 7. The damage to blade 52 was much more extensive than that on blade 38. However, the initial mode of failure was believed to be the same for both blades; that is, the tip cap broke away from the blade shell at the weld joint between cap and shell. After the failure of the tip cap occurred on blade 52, the engine probably was operated for a slightly longer period of time than for blade 38 before failure was detected. When failure of the tip cap occurs, cooling air is permitted to flow directly out of the blade tip rather than through the porous blade shell. This causes an increase in blade shell and strut temperature. Inasmuch as the shell material has little strength above a temperature of about 1200° F, portions of the shell can overheat locally and break away from adjacent parts of the shell. Overheating of the blade also might weaken the bond between the shell and strut lands and permit portions of the shell to break away from the strut. Examination of figure 7(a) indicates that possibly both modes of failure were present in the failure of blade 52.

Figure 7. - Failure of shell and tip on blade 52.

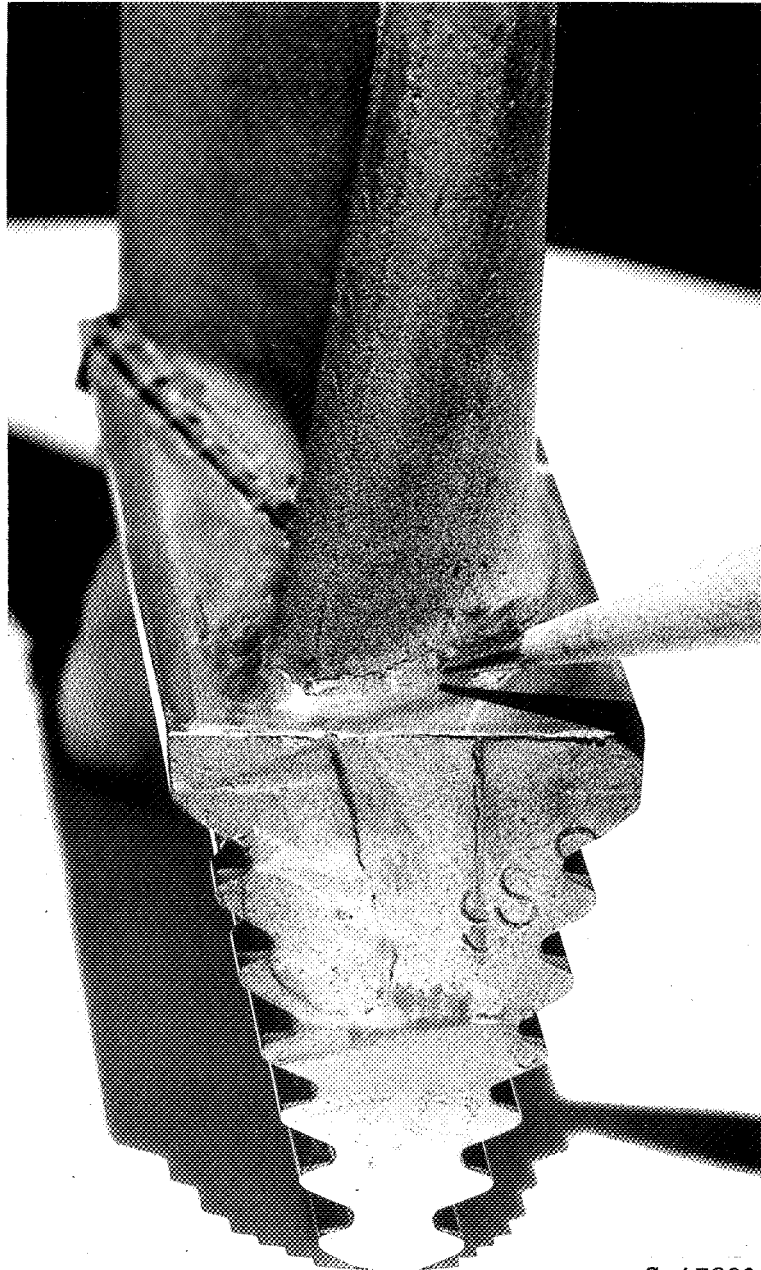
Figure 8. - Crack at junction of porous shell and base platform of blade 38.

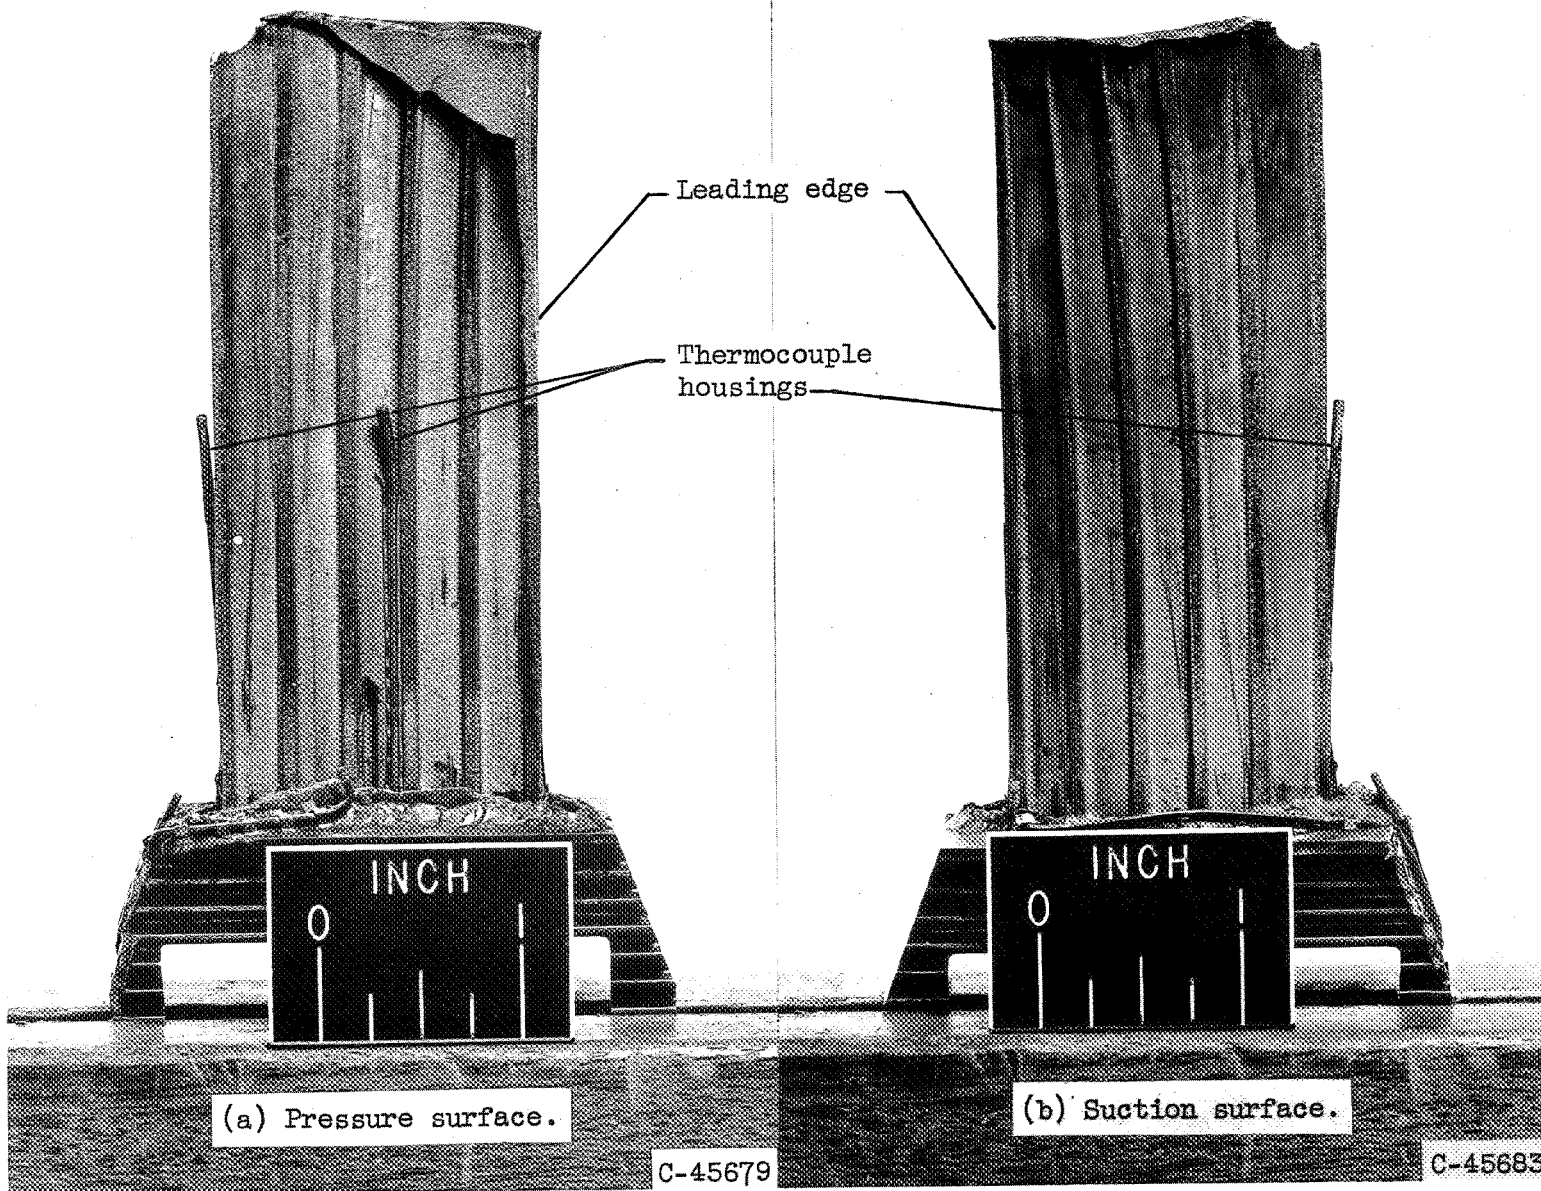
Blade 20 failed after 3 hours and 40 minutes of rated engine speed operation. Essentially all of the blade shell separated from the strut, as shown in figure 9. Only a small amount of the blade shell remained at the extreme tip of the blade on the pressure surface (fig. 9(a)). The built-up welded tip cap also remained intact, as shown in figure 9.

Visual inspection of the strut of blade 20 after failure showed evidence of incomplete bonding of the shell material to the lands of the strut in many places. Possibly the shear strength of the attachment between the strut lands and the porous shell may have been inadequate; thus a portion of the shell may have broken away from the strut and caused a hole to form in the blade surface. If such a hole were large enough to cause a significant drop in the pressure of the cooling air inside the blade, airflow through the porous material would decrease. This could result in overheating of the shell with consequent loss of strength in the porous material and in the bond between shell and strut lands, and thus result in failure of the shell, as shown in figure 9. The thermocouple housings in figure 9 were installed in the strut before the porous shell was attached. At one time these housings were expected to be used for the installation of thermocouples incased in metal tubes (see the reference thermocouple of ref. 8). Accordingly, the tube-incased thermocouple would have been slid into the thermocouple housing and thus obtain a temperature in the strut. No strut temperatures were measured in the present investigation, and the housings were not used. When blade 20 failed, however, the housings apparently became dislodged and bent away from their original flush-mounted position in the strut.

Figure 9. - Failure of shell on blade 20.

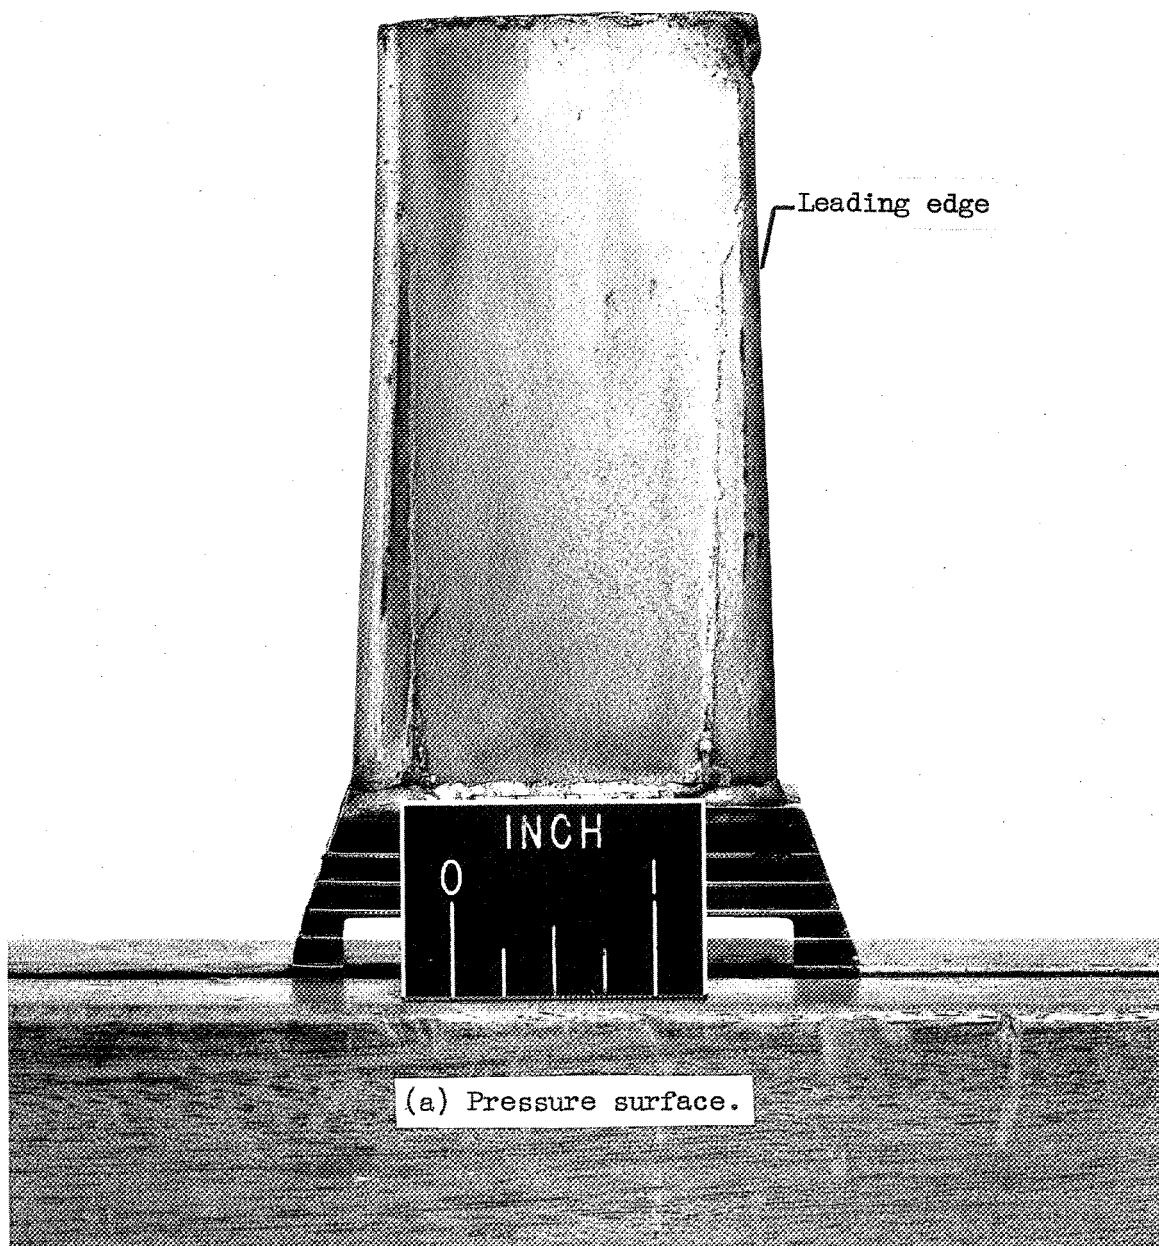
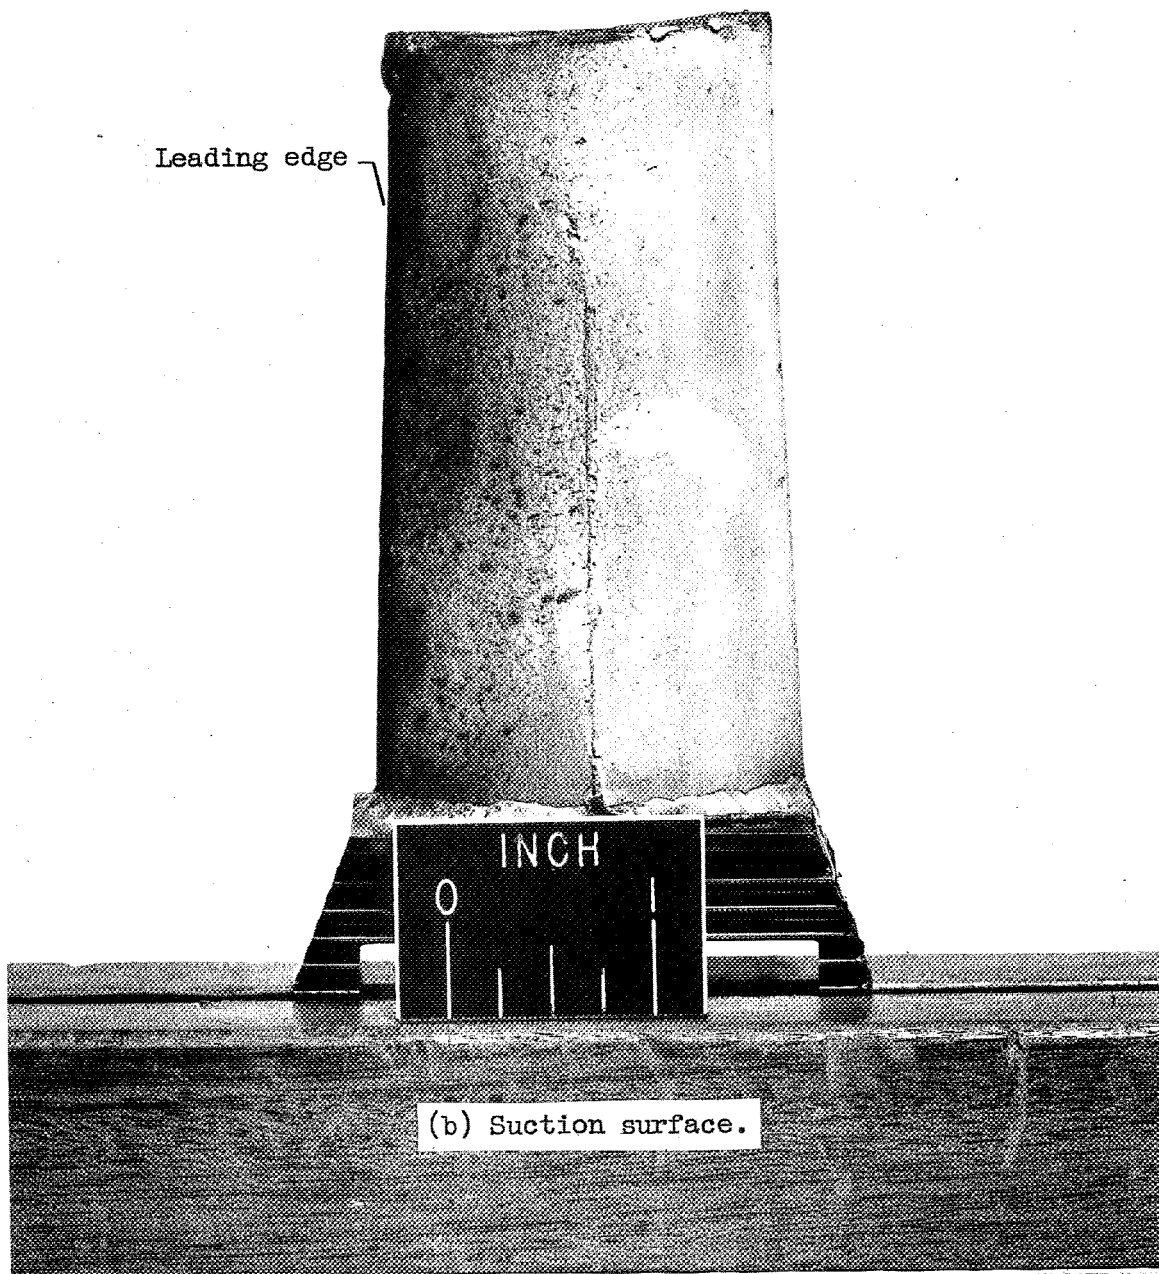
The remaining blade (number 24) was not damaged, and operation of this blade was continued. Blade 24 was operated for a total of 31 hours and 26 minutes without failure. After this operation the blade shell was in generally good condition, as shown in figure 10. The built-up welded tip cap also showed no evidence of impending failure. The relatively large dark areas that can be seen near the leading edge on the suction surface of blade 24 (fig. 10(b)) were caused by a scorching effect that the combustion gases have upon the temperature-indicating paints after extended periods of operation. The blade spots also seen in figure 10(b) appeared to be small deposits of carbon that apparently impinged upon the blade and embedded themselves in the shell during operation.

Although there was no actual failure of the shell of blade 24, cracks occurred in the root region of the blade, as shown in figures 10 and 11. The cracks occurred in the shell material immediately adjacent to the fillet weld. These cracks started to appear after about 5 or 6 hours of operation and grew slightly with time for about another 5 hours. Inasmuch as the shell does not support any of the centrifugal load on the blade, the cracks are not particularly harmful from a structural standpoint. If they become large enough, however, excessive amounts of cooling air may flow out of the crack and cause other parts of the blade to overheat or require additional quantities of cooling air to satisfactorily cool the entire blade shell. Although the root cracks on blade 24 appeared to be rather large, they did not appear to alter the airflow requirements of the blade to a marked degree; this was concluded from the fact that, for a given cooling-air pressure at the inlet to the turbine rotor, the cooling-air flow remained constant with blade operating time. This also indicated that the carbon deposits mentioned previously did not appreciably affect the over-all permeability of the blade.

Figure 10. - Blade 24 after 31 hours and 26 minutes of rated-engine-speed operation.

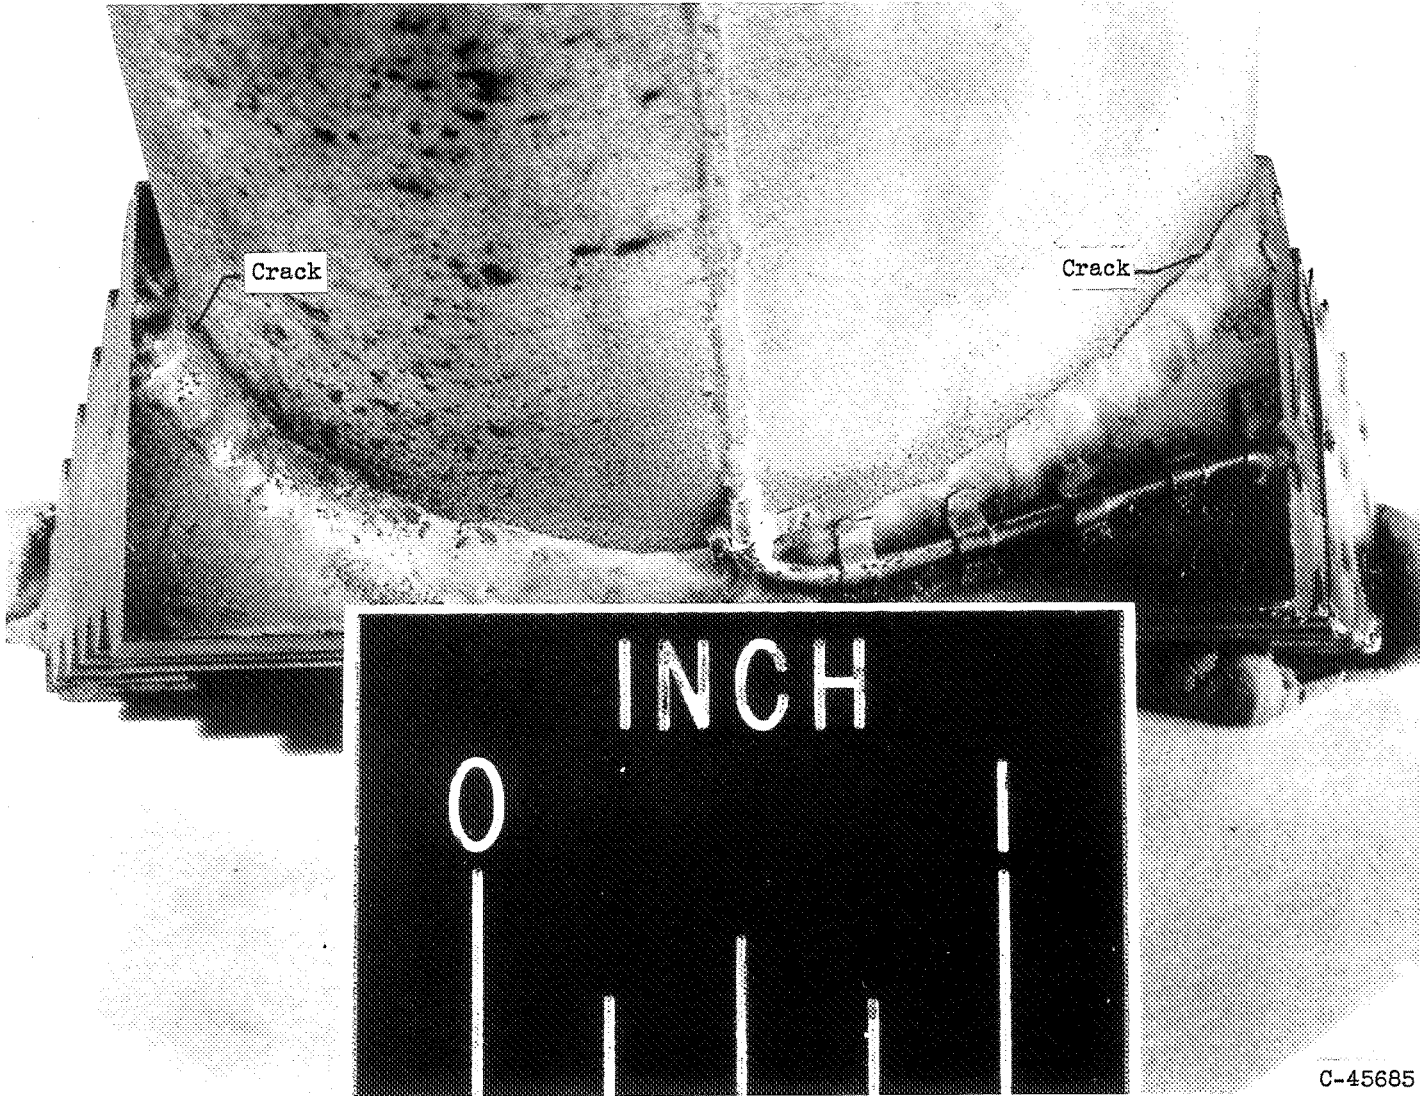
Figure 11. - Crack at junction of porous shell and fillet weld on blade 24.
