NASA/TM—2009—214759

Adhesion Testing of Firebricks From Launch Pad 39A Flame Trench After STS-124

Paul E. Hintze
NASA Kennedy Space Center, Florida

Jerome P. Curran
ASRC Aerospace Corporation, Kennedy Space Center, Florida

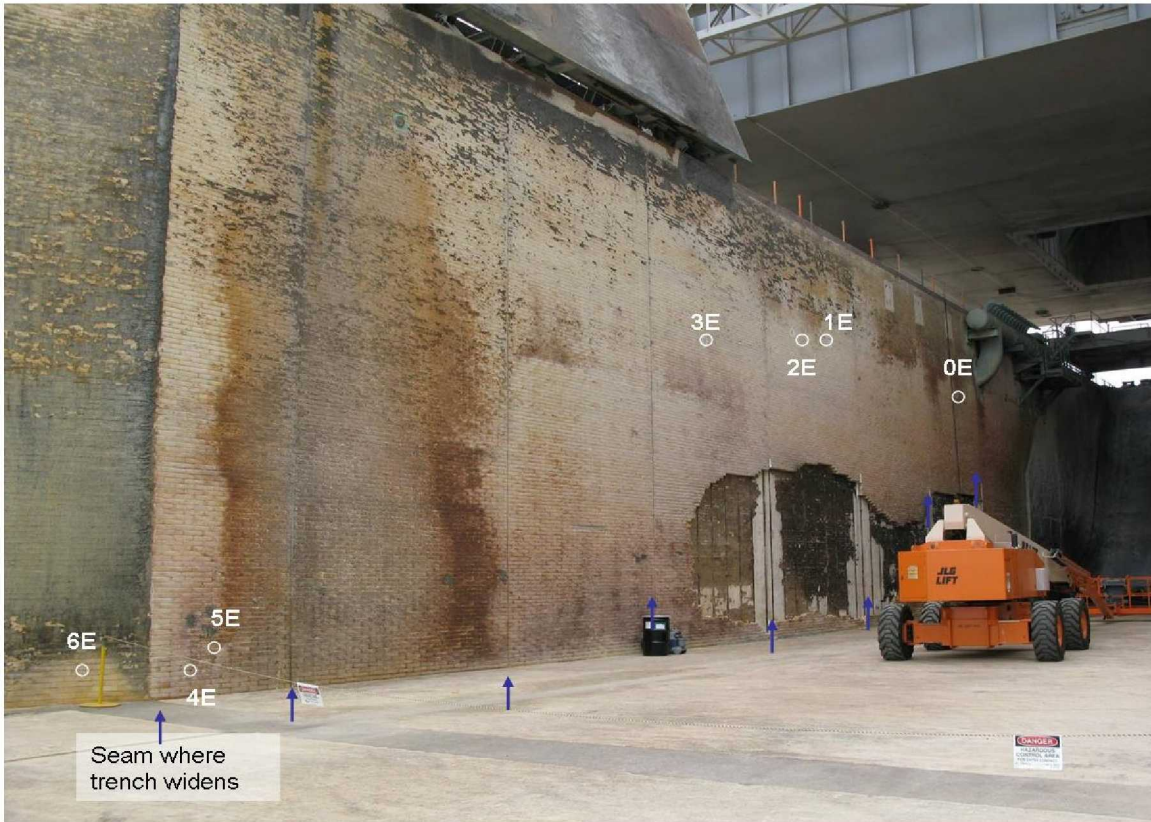
Figure 2. Core locations on the east wall of the trench

Blue arrows show seam locations.

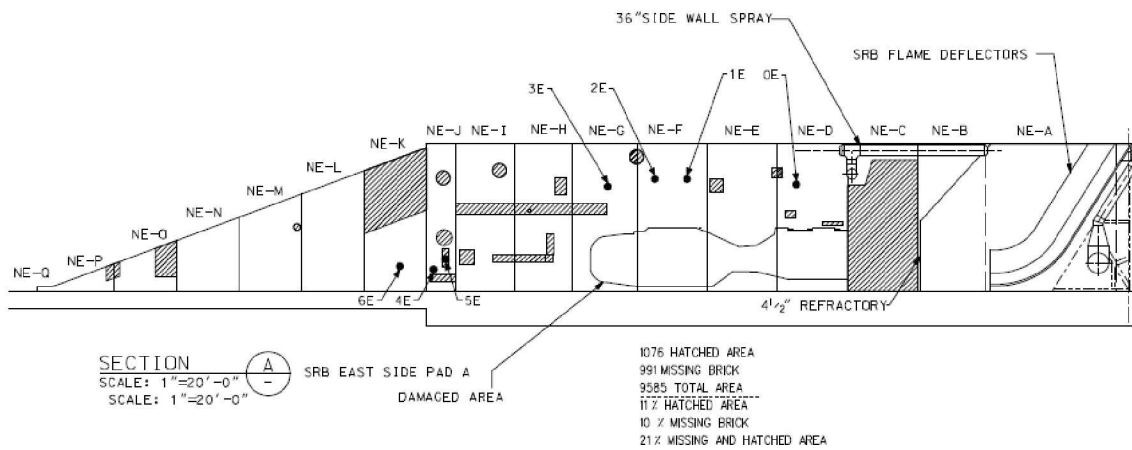
Figure 3. Core locations on the east wall of the trench

Cross-hatched areas sounded hollow according to the hammer test.

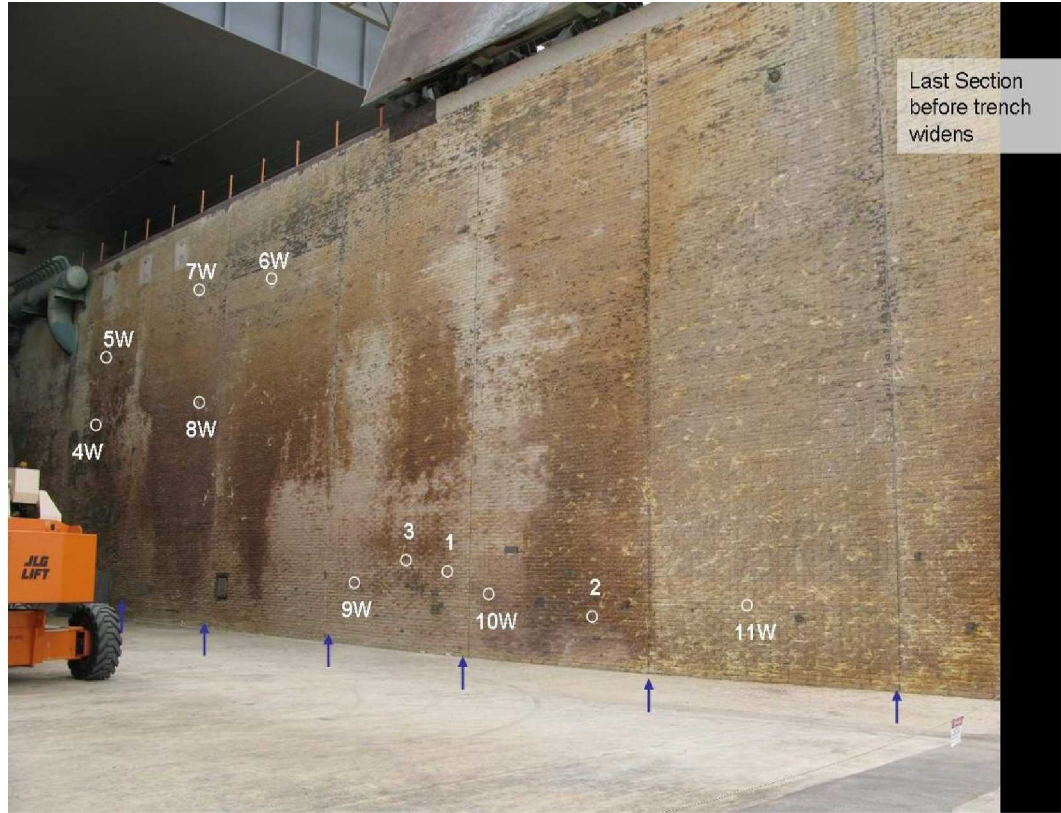
Figure 4. Core locations on the west wall of the trench

Blue arrows show seam locations.

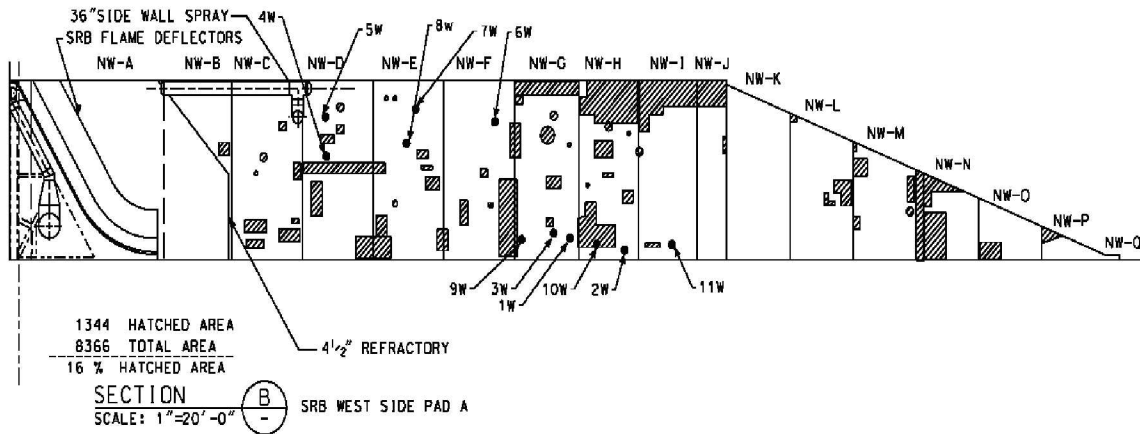
Figure 5. Core locations on the west wall of the trench

Cross-hatched areas sounded hollow according to the hammer test.

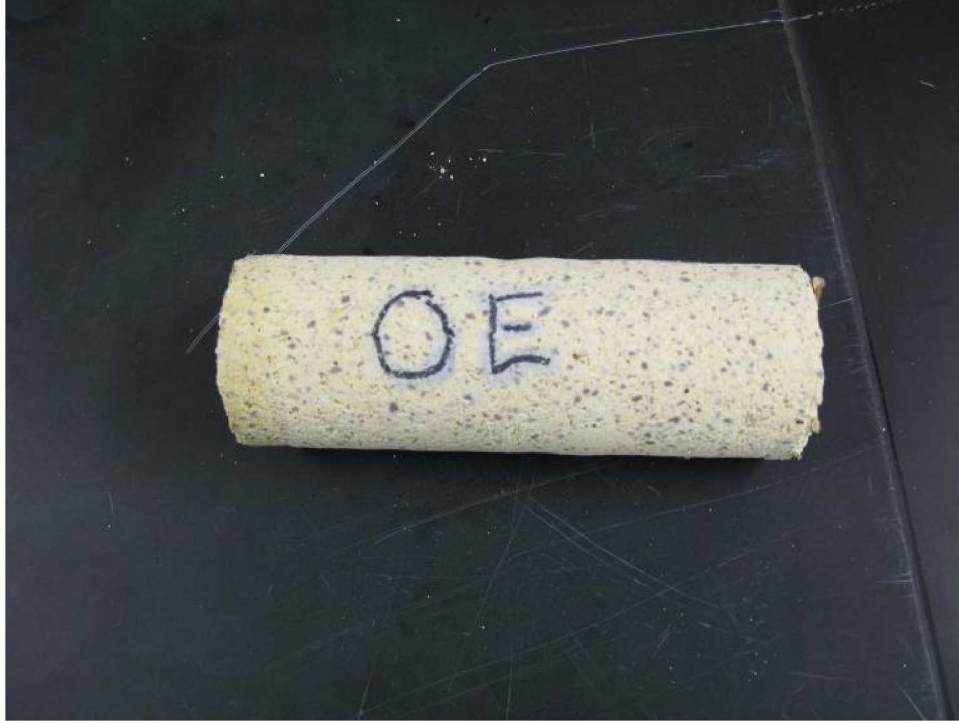
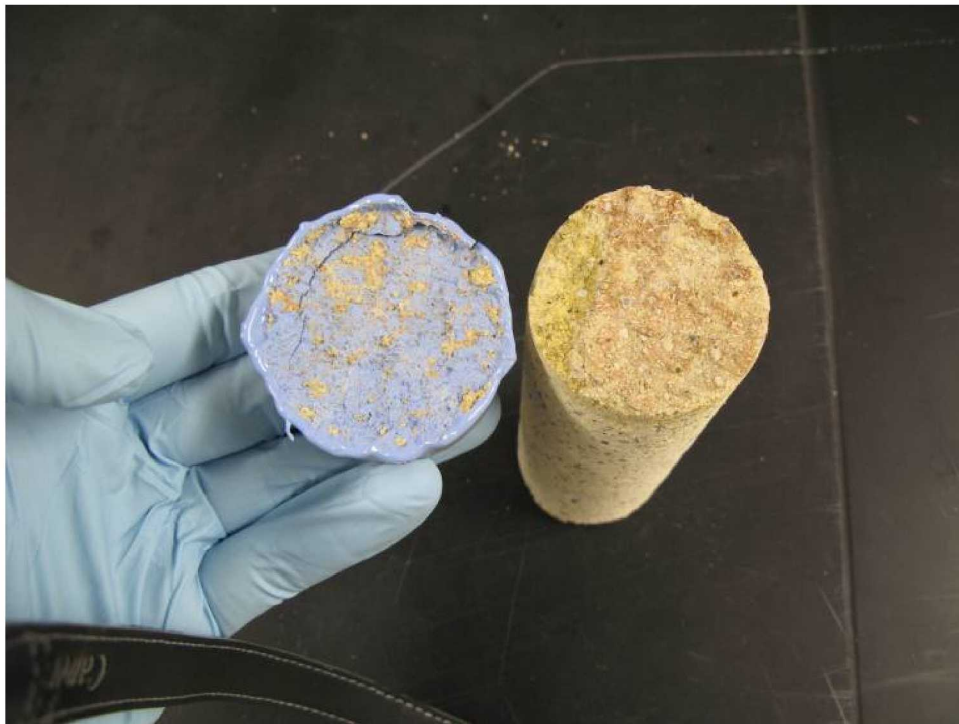
The pull test failed at the adhesive/firebrick interface.

Figure 6. Core 0E – successful test: failed at 60 psi (side image of core and outer surface of core and pull stub).

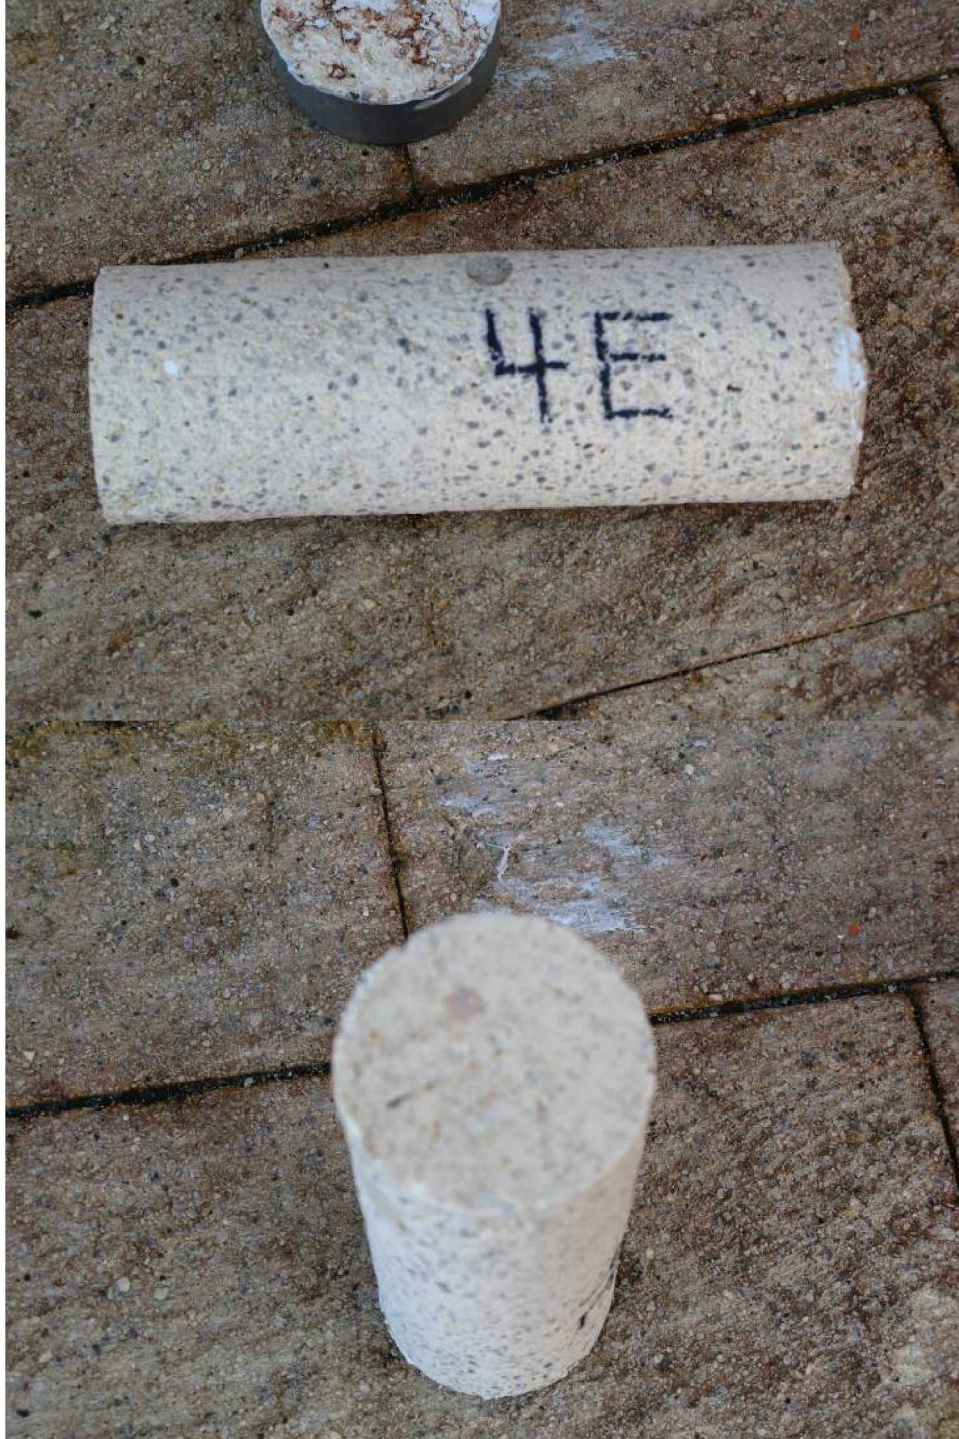
No epoxy was found on the core

Figure 14. Core 4E – side image of core and back end of core, closest to the concrete wall

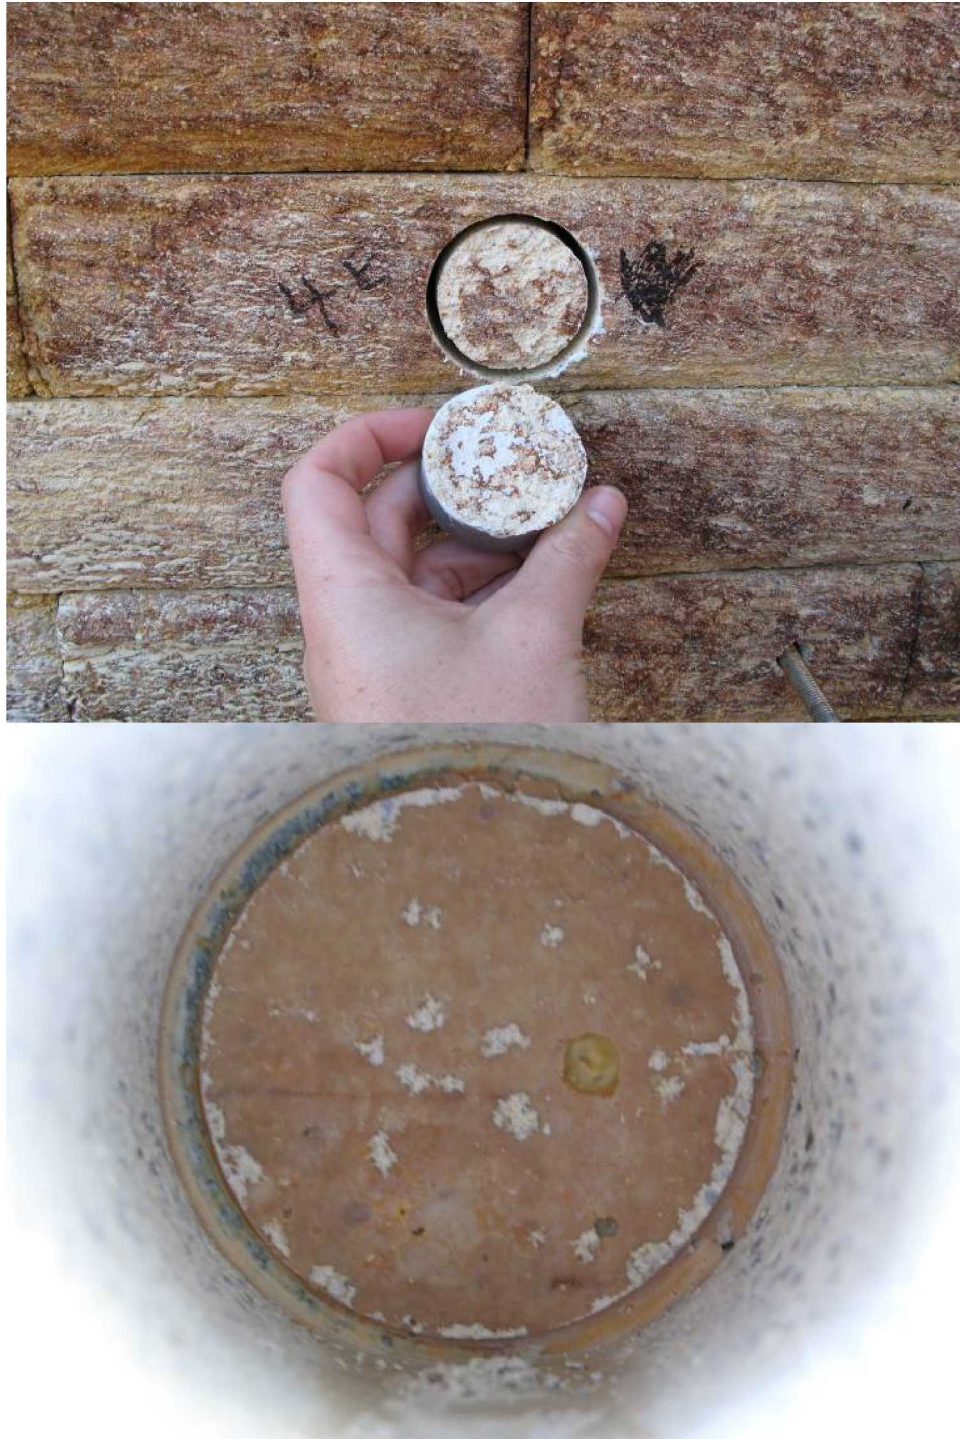
Figure 15. Core 4E – successful test: failed at 114 psi (pull stub and core face and the image inside the brick after the core was removed)

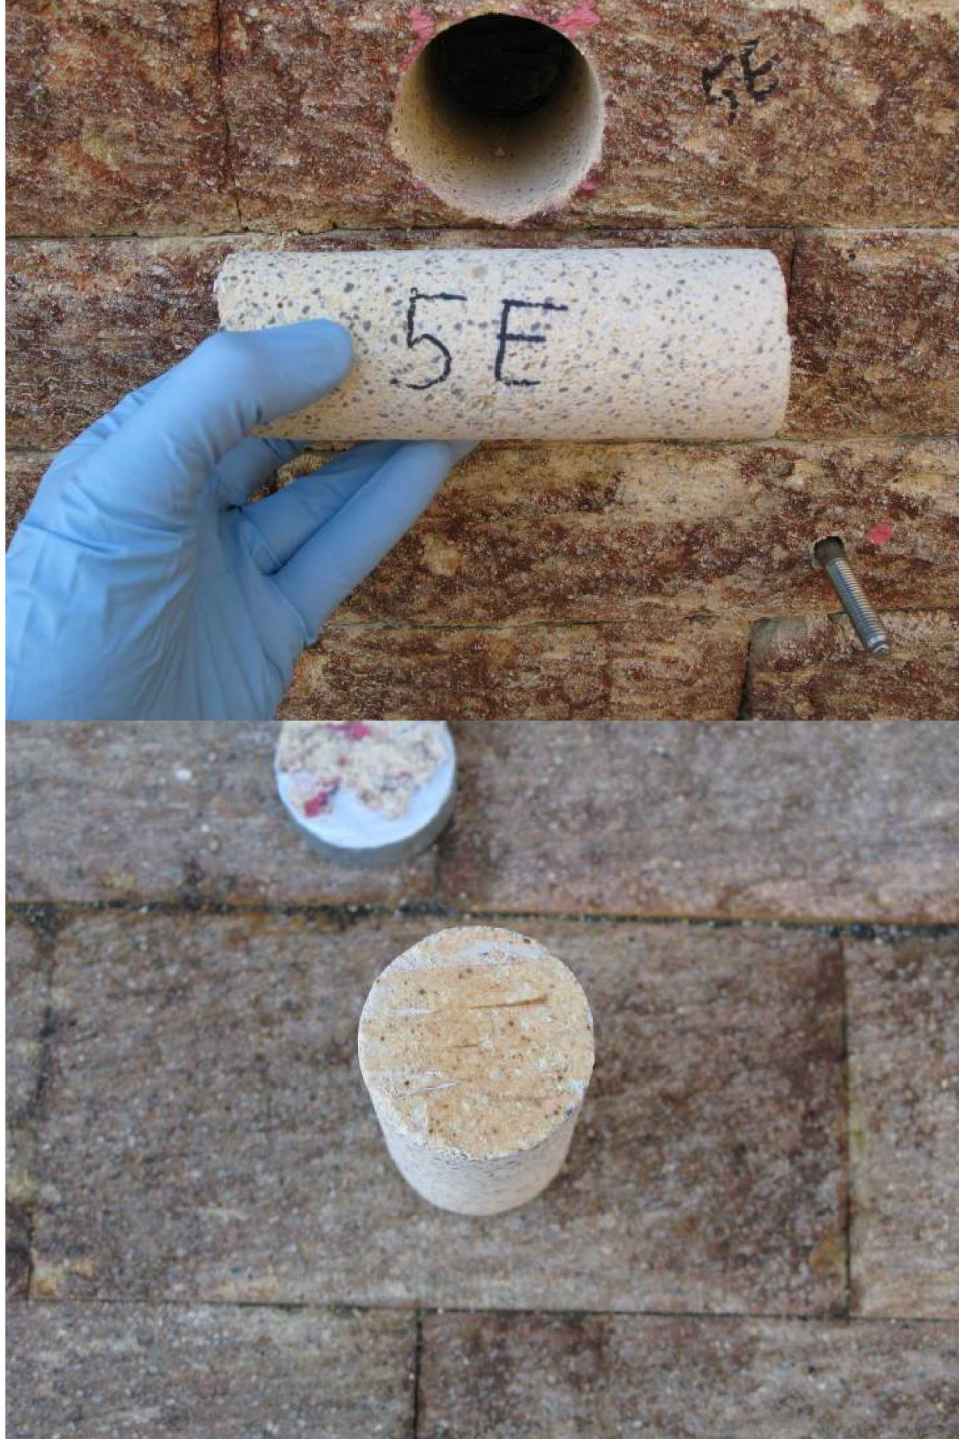
No epoxy was found on the core.

Figure 16. Core 5E – side image of core and back end of core, closest to the concrete wall

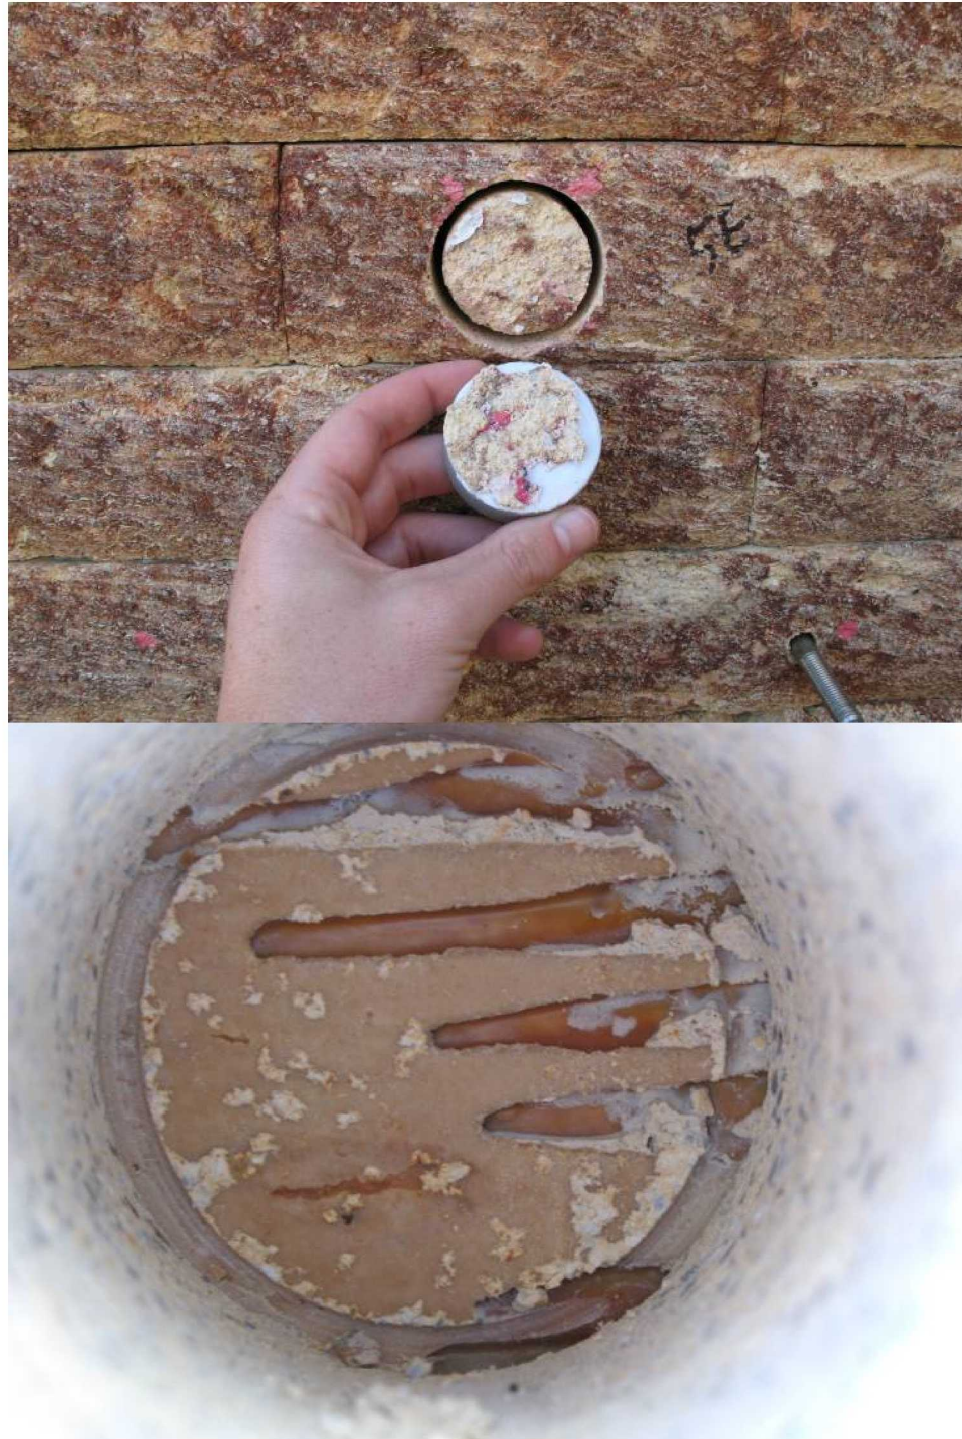
Figure 17. Core 5E – successful test: failed at 82 psi (pull stub and core face and the image inside the brick after the core was removed)

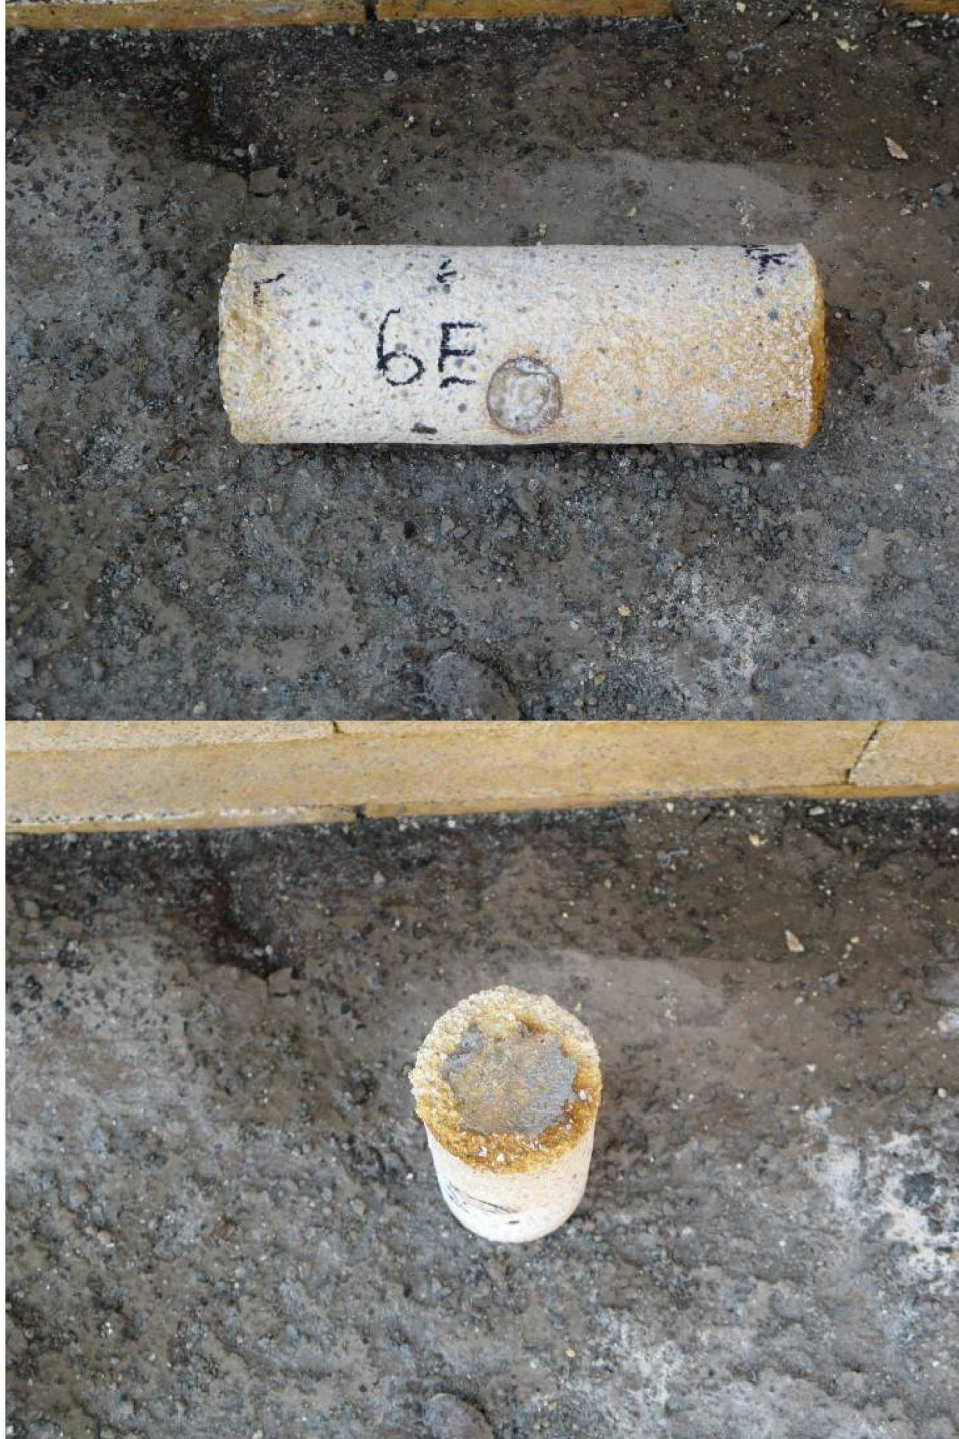
Some epoxy was found on the core.

Figure 18. Core 6E – side image of core and back end of core, closest to the concrete wall

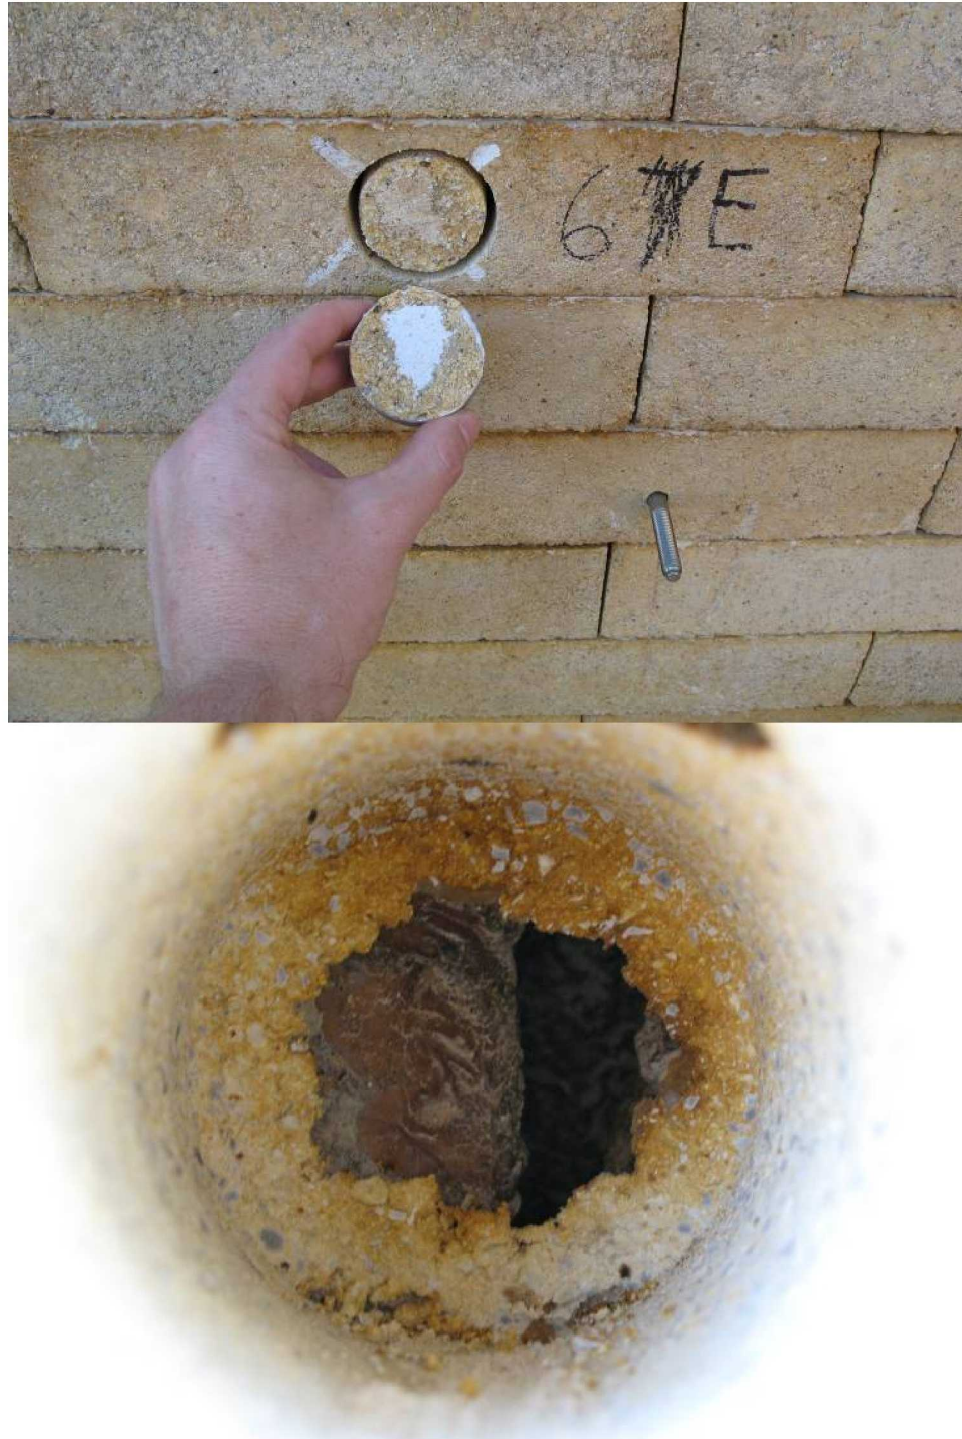
Figure 19. Core 6E – successful test: failed at 107 psi (image of pull stub and core face and the image inside the brick after the core was removed)

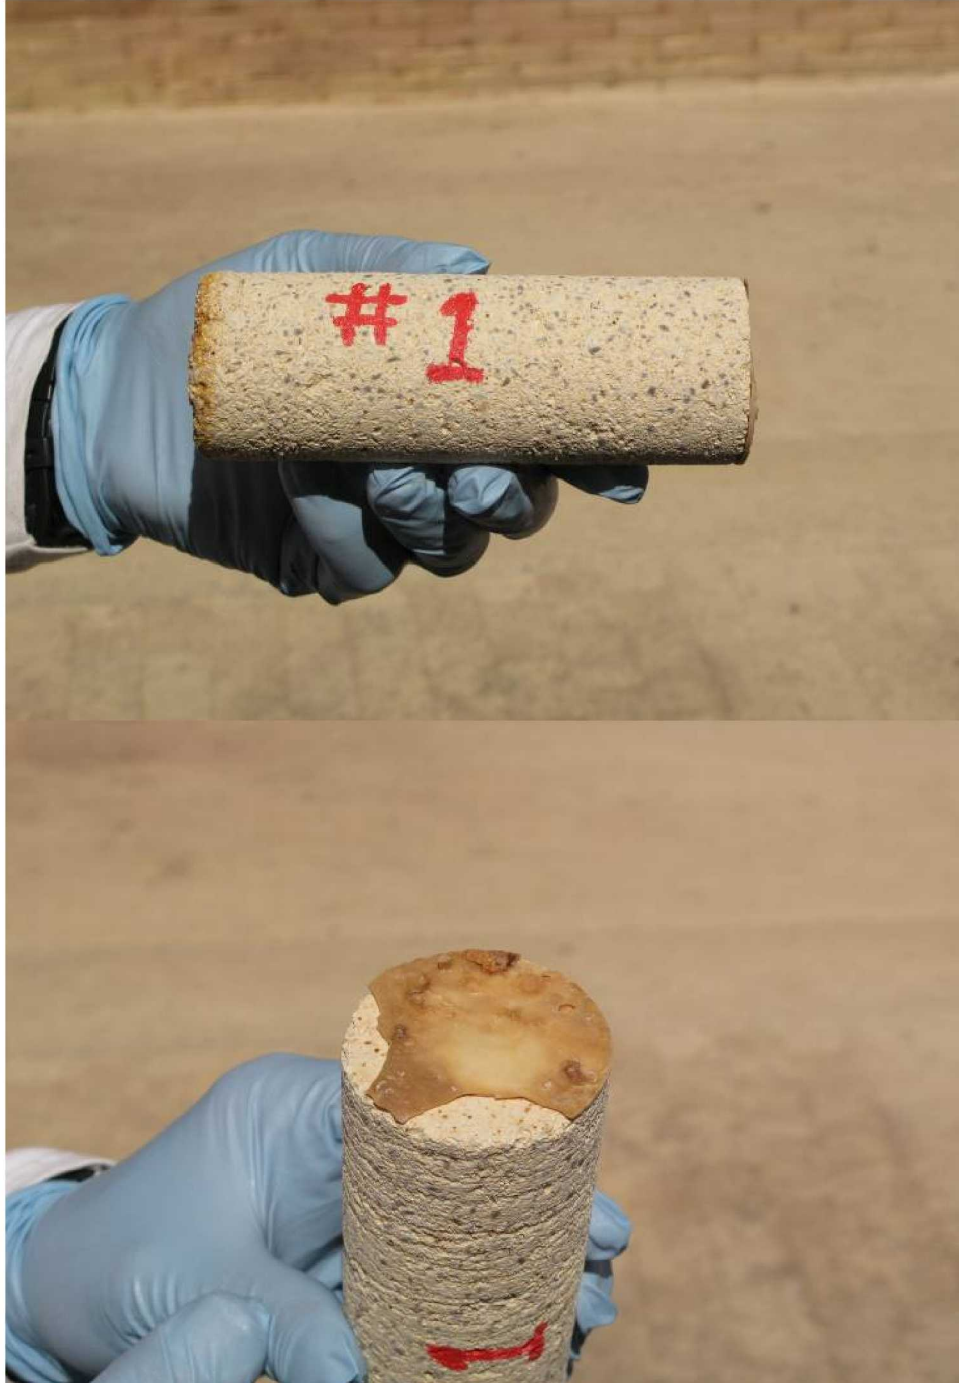
Core became loose during drilling. Then an additional section of the concrete was cored out. Epoxy covered the entire inner surface when pulled, but it flaked off easily

Figure 20. Core 1 – side view of core and inner surface of core

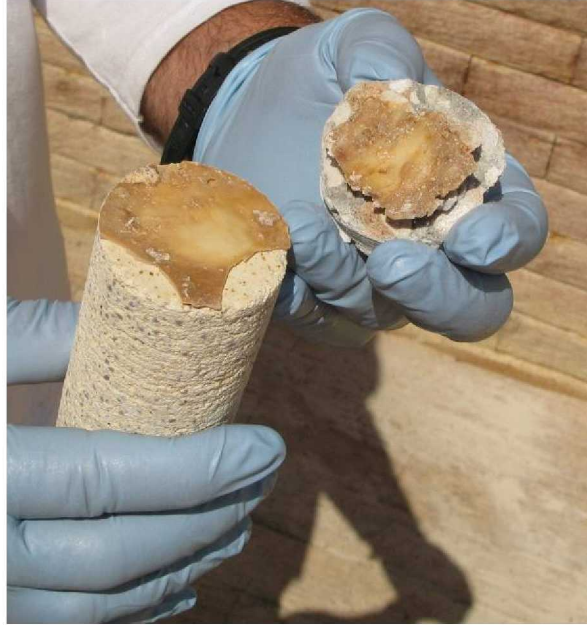
Core became loose during drilling. Then an additional section of the concrete was cored out. Both sections had epoxy, but the sections did not appear to be bonded together. It appears as if the epoxy was applied to the brick and to the concrete, but they never made contact.

Figure 21. Core 1 – inner surface of the core and a small core of concrete that was removed

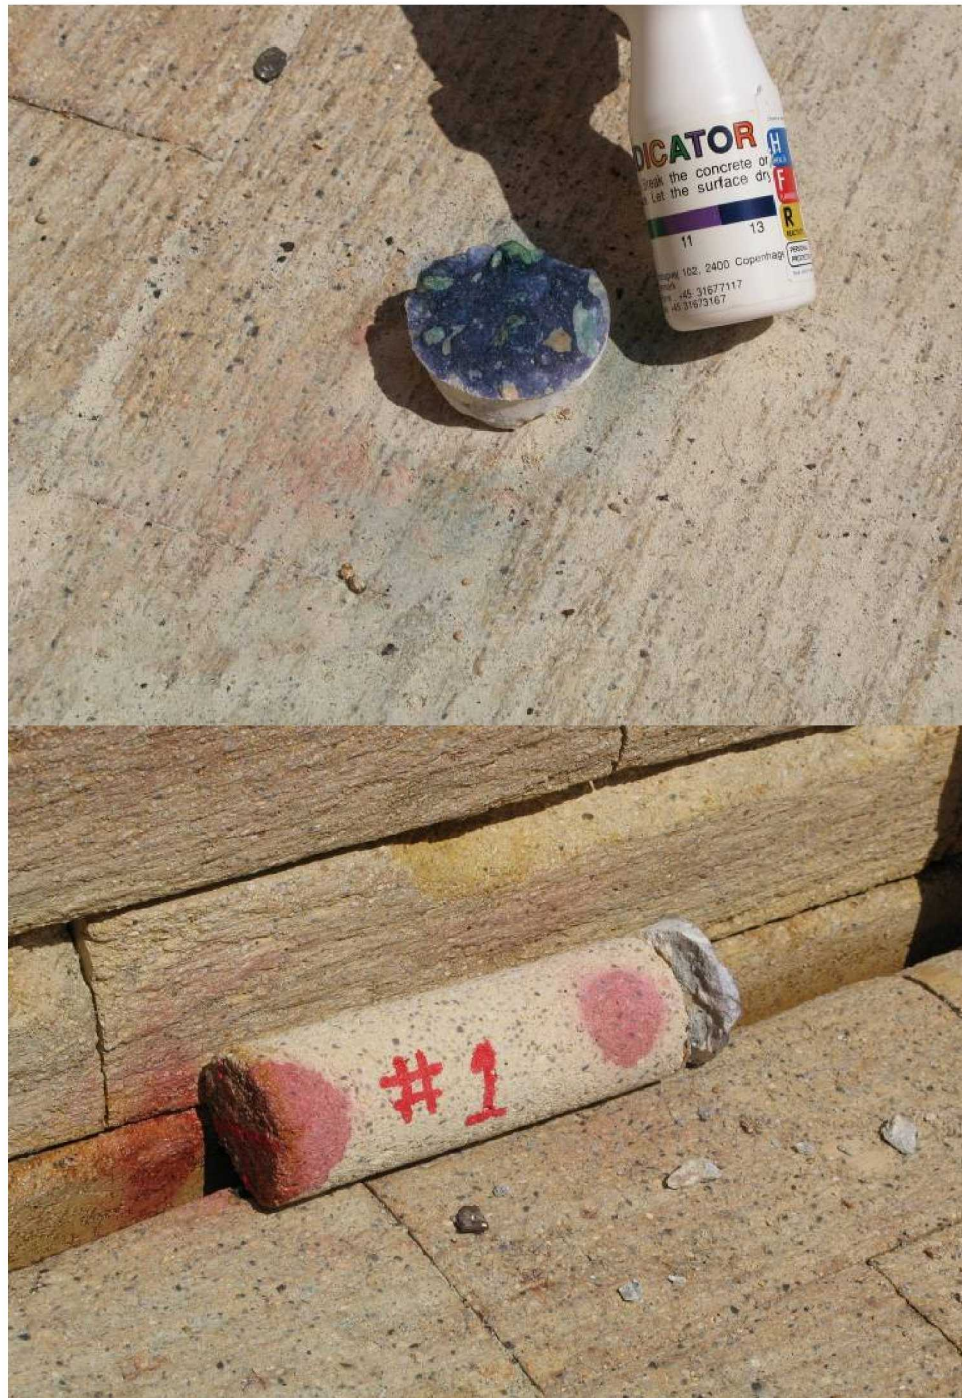
A universal pH indicator was sprayed on core 1 from the west wall and the small amount of concrete that was removed after drilling. The pH of the concrete was found to be about 13, which is appropriate and indicates the concrete is in good shape. The pH of the firebrick was checked at the face and near the back side. The pH of the back side appeared to be near 11, while the face was more acidic with a pH of 5. The proper pH for the bulk of the firebrick is unknown, but it was clear that the face was more acidic than the bulk.

Core became loose during drilling. After coring the firebrick, an additional section of the concrete was cored out. The pH testing was done on the concrete and firebrick.

Figure 22. Core 1 – pH of the concrete was about 13, which is appropriate for concrete, and pH of the brick was more acidic

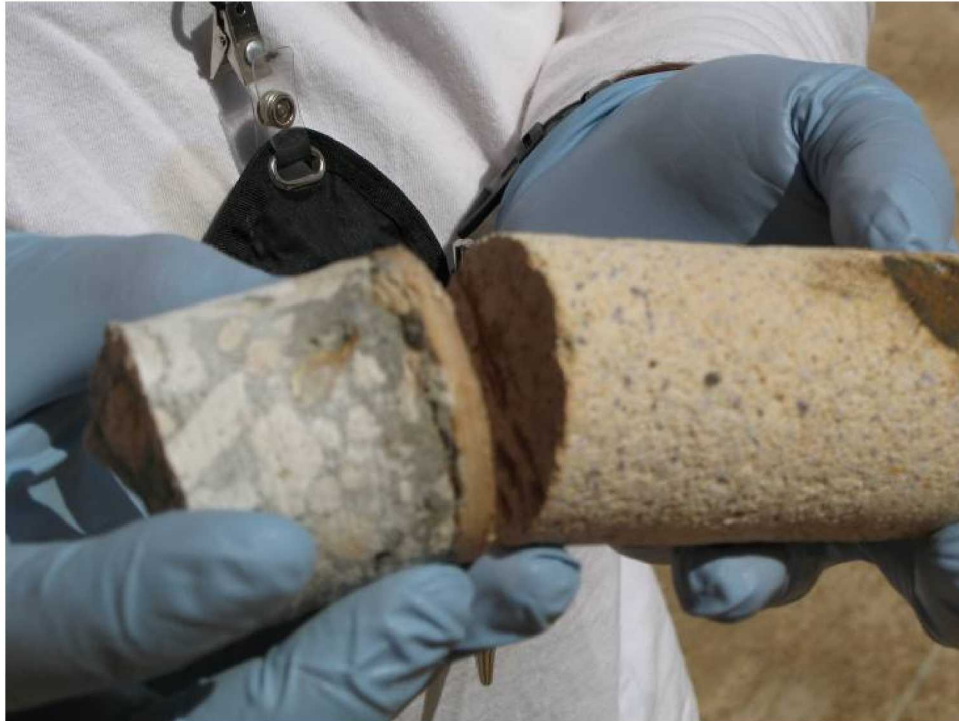
The core remained attached to the concrete wall after drilling to a depth of 6 inches from the face of the brick. Drilling continued after the initial 6 inches to try to get a complete core. There was adhesion failure between the firebrick and the epoxy when the deeper drilling occurred. Hammer testing showed this to be a solid brick.

Figure 23. Core 2 – adhesion failure

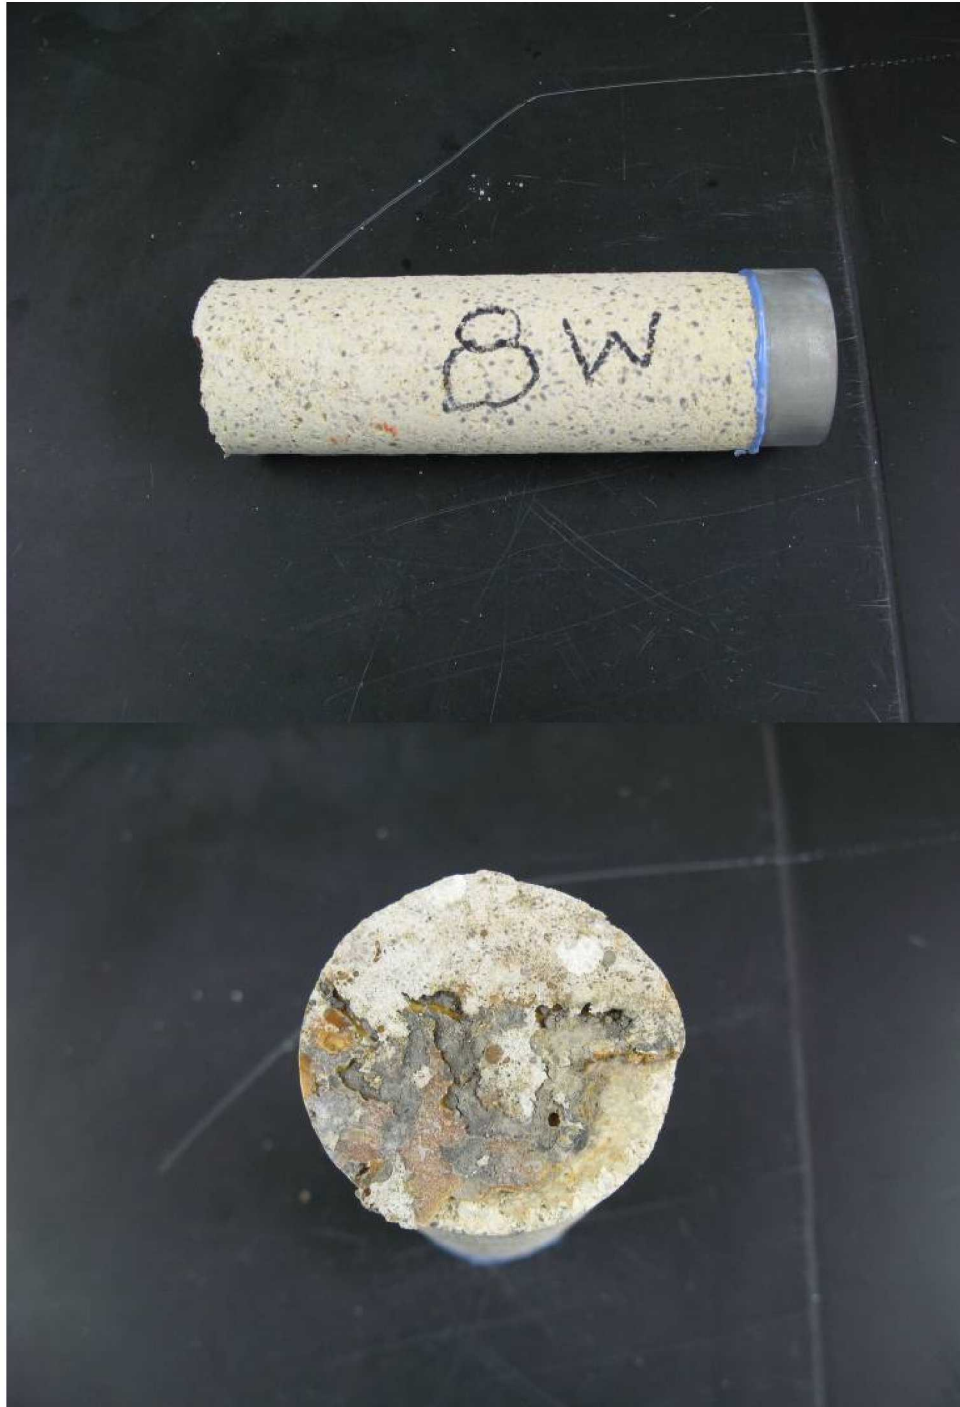
This was the only pull test that resulted in the entire core being removed.

Figure 34. Core 8W – successful test: failed at 82 psi (side view of core with pull stub still attached and interior surface of core, with epoxy and/or concrete still attached)

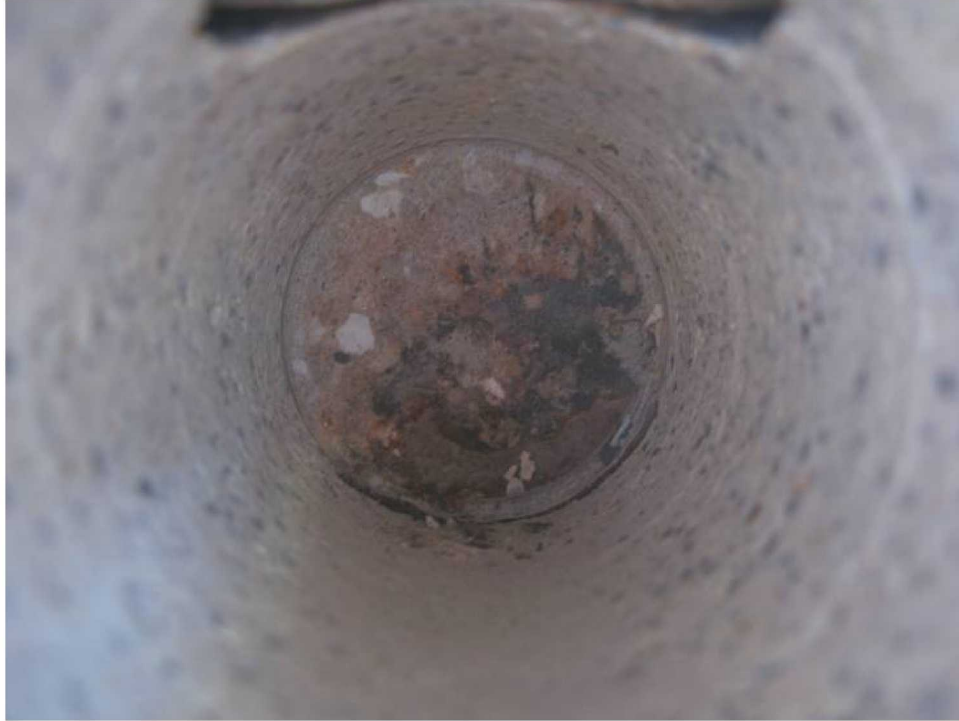
This was the only pull test that resulted in the entire core was removed.

Figure 35. Core 8W – inside the brick after the core was removed

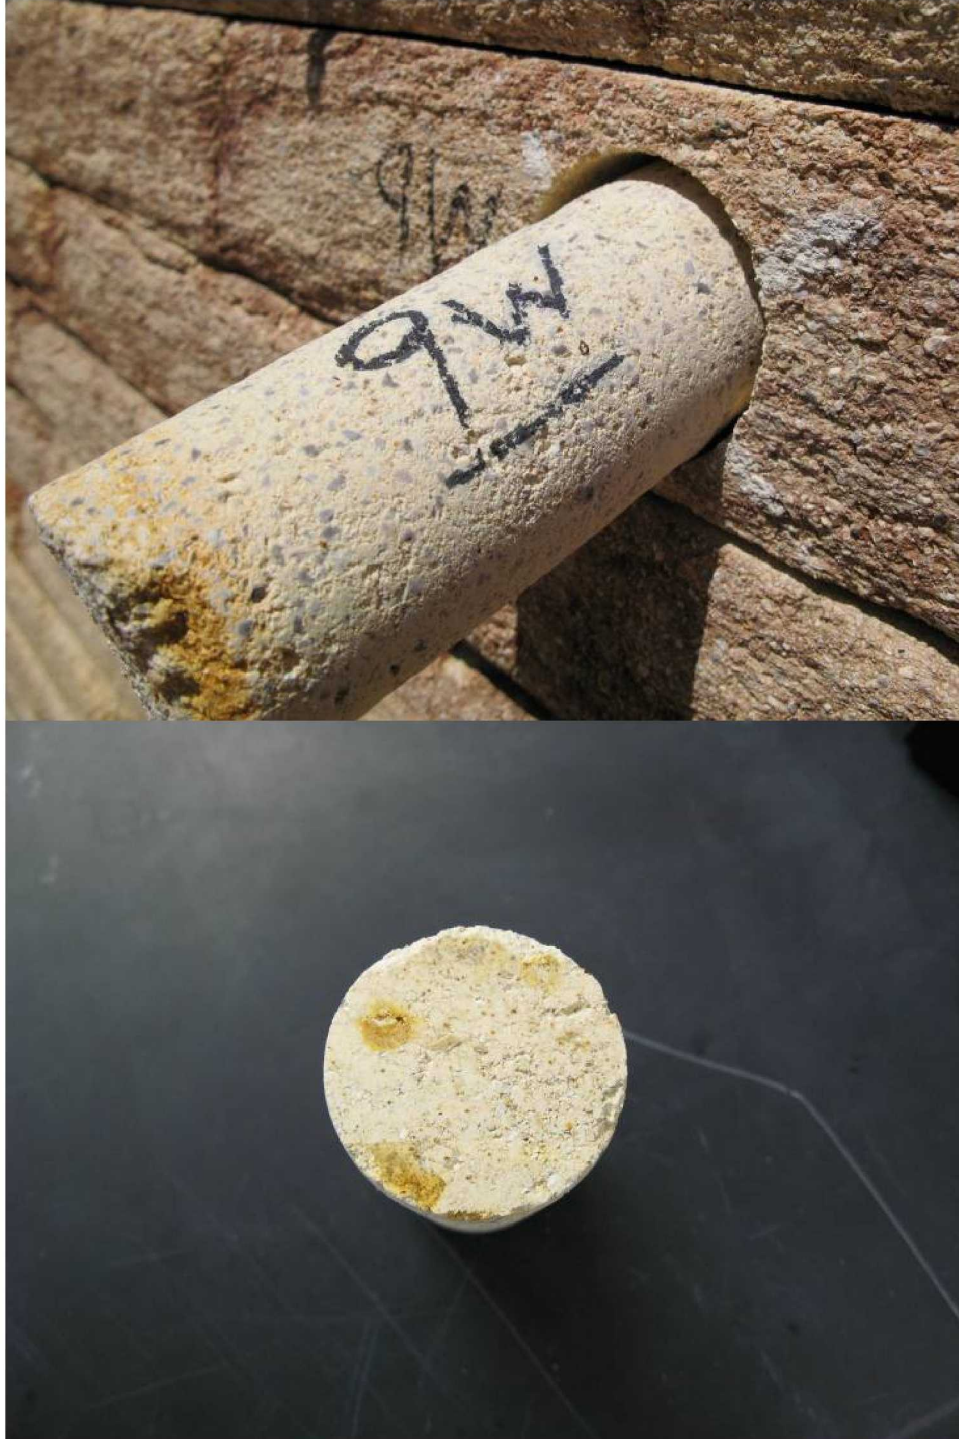
No epoxy was found on the core.

Figure 36. Core 9W – side image of core and back end of core, closest to the concrete wall

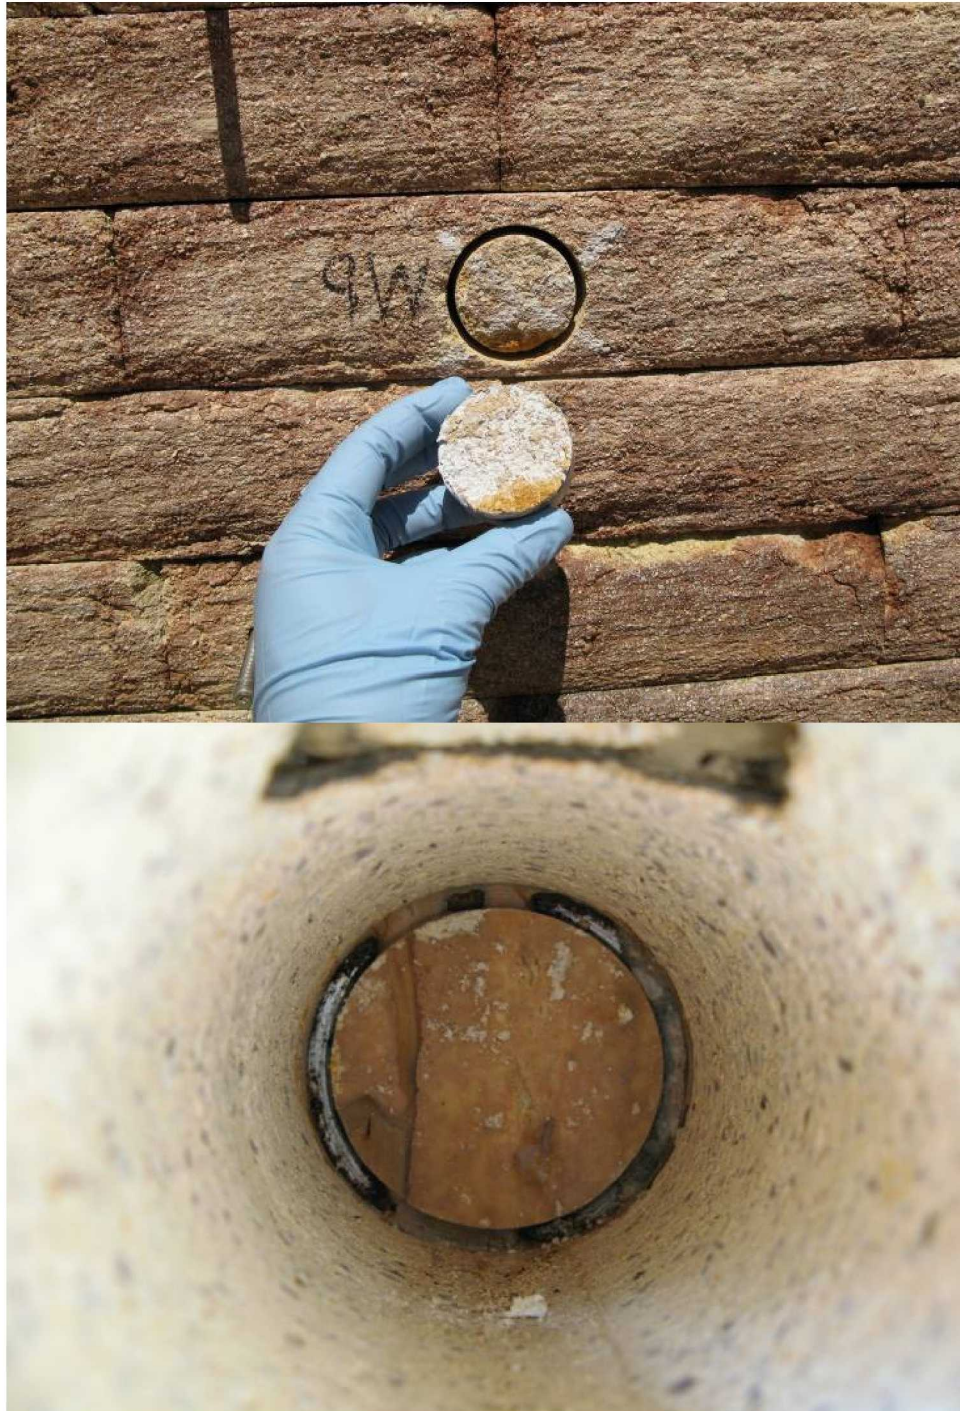
There is evidence of corrosion shown at the concrete/firebrick interface.

Figure 37. Core 9W – successful test: failed at 54 psi (pull stub and core face and inside the brick after the core was removed)
