NASA/TM—2009—214759

Adhesion Testing of Firebricks From Launch Pad 39A Flame Trench After STS-124

Paul E. Hintze
NASA Kennedy Space Center, Florida

Jerome P. Curran
ASRC Aerospace Corporation, Kennedy Space Center, Florida

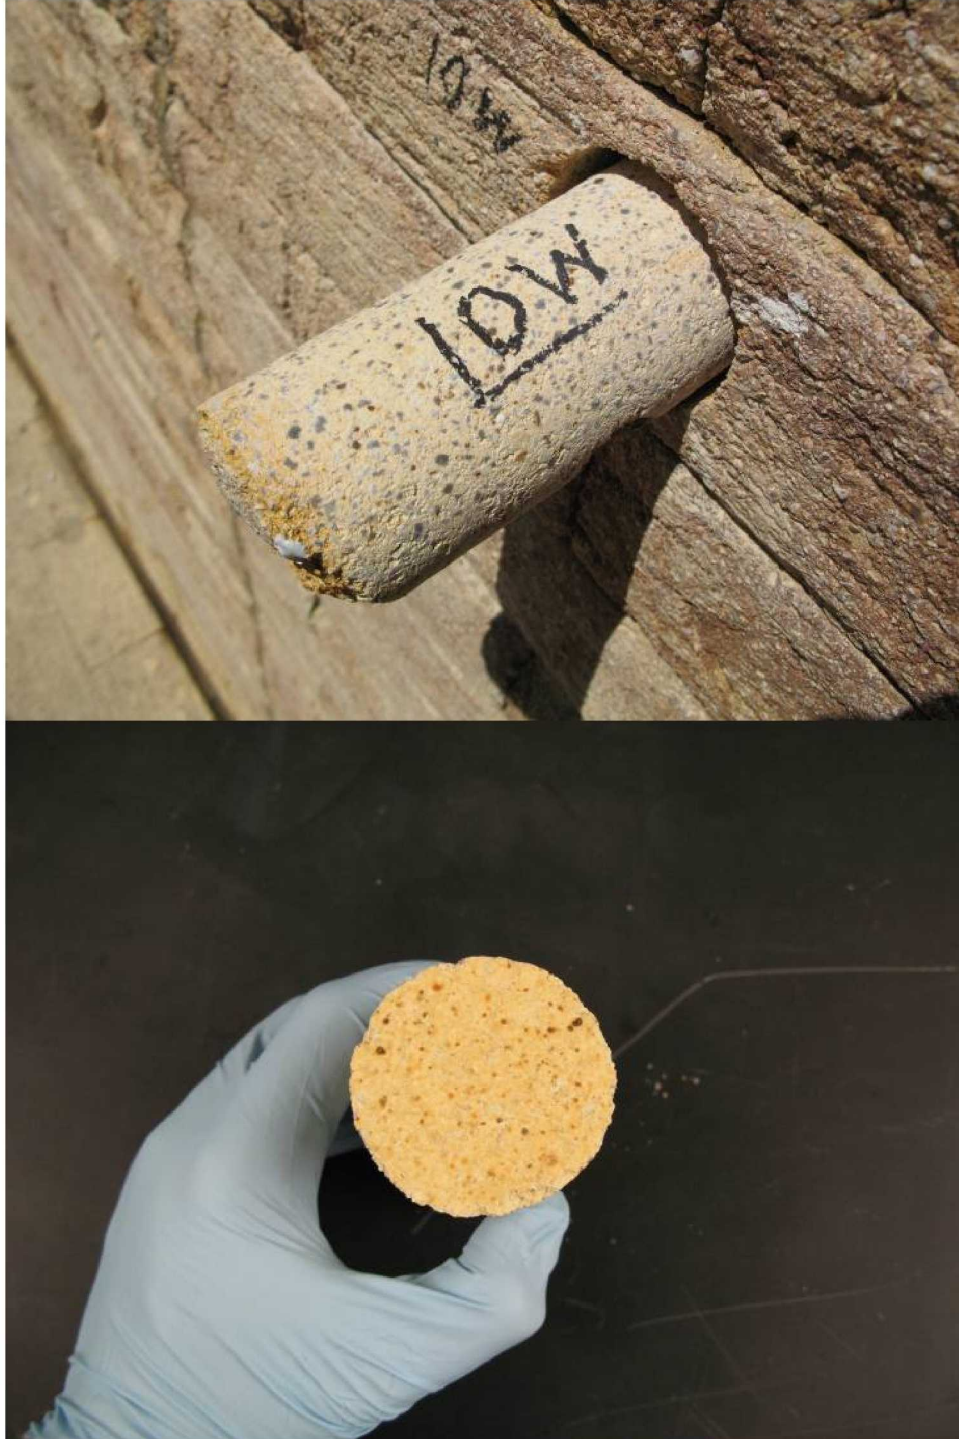
No epoxy was found on the core.

Figure 38. Core 10W – side image of core and back end of core, closest to the concrete wall

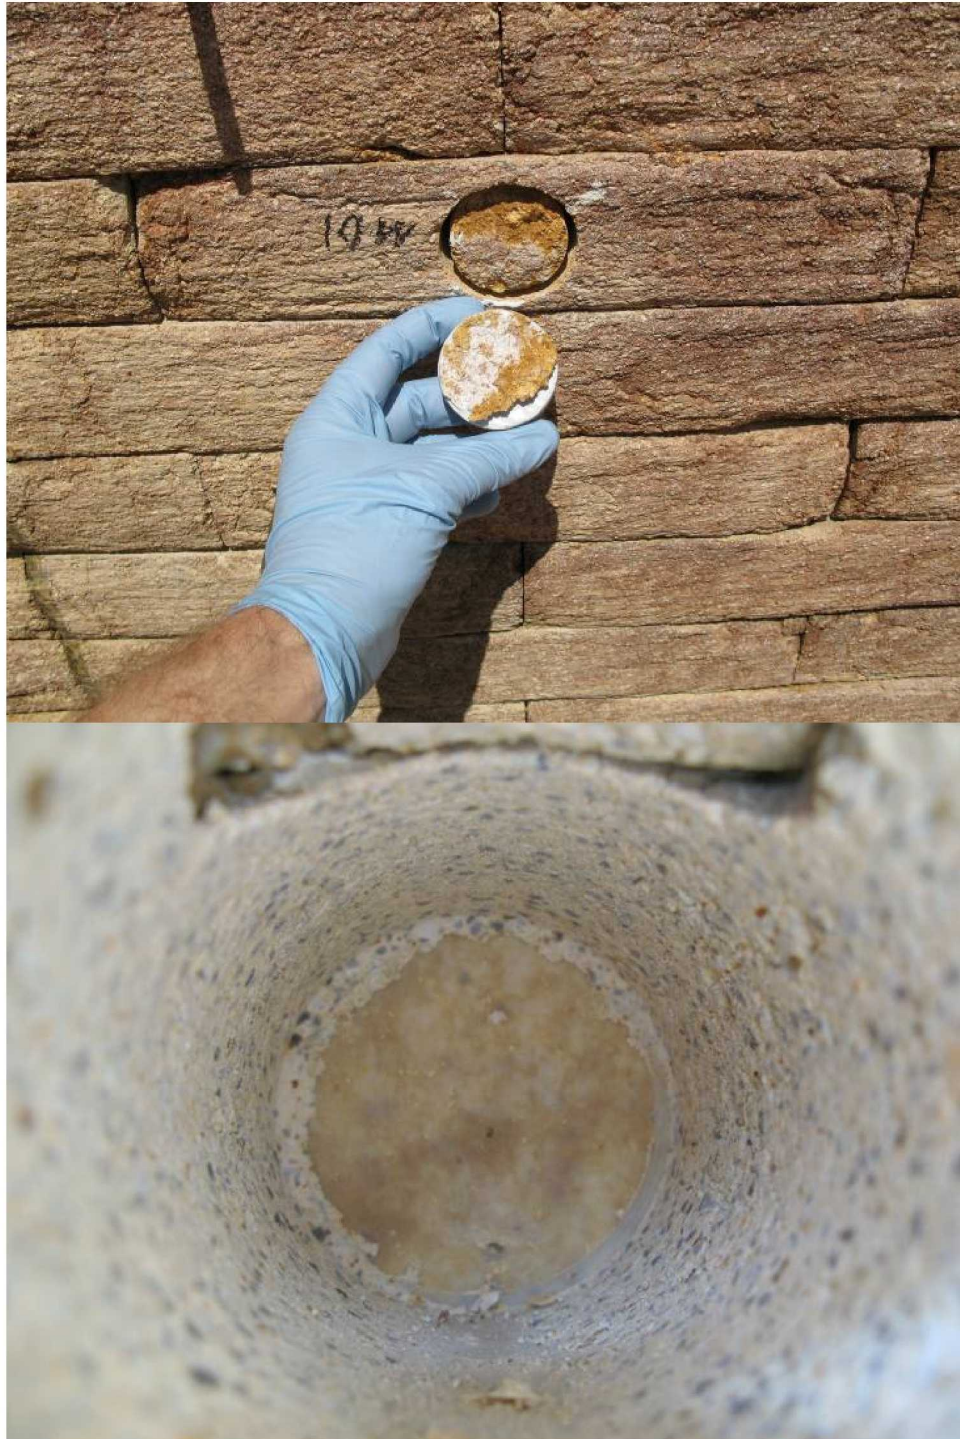
Figure 39. Core 10W – successful test: failed at 101 psi (pull stub and core face and inside the brick after the core was removed)

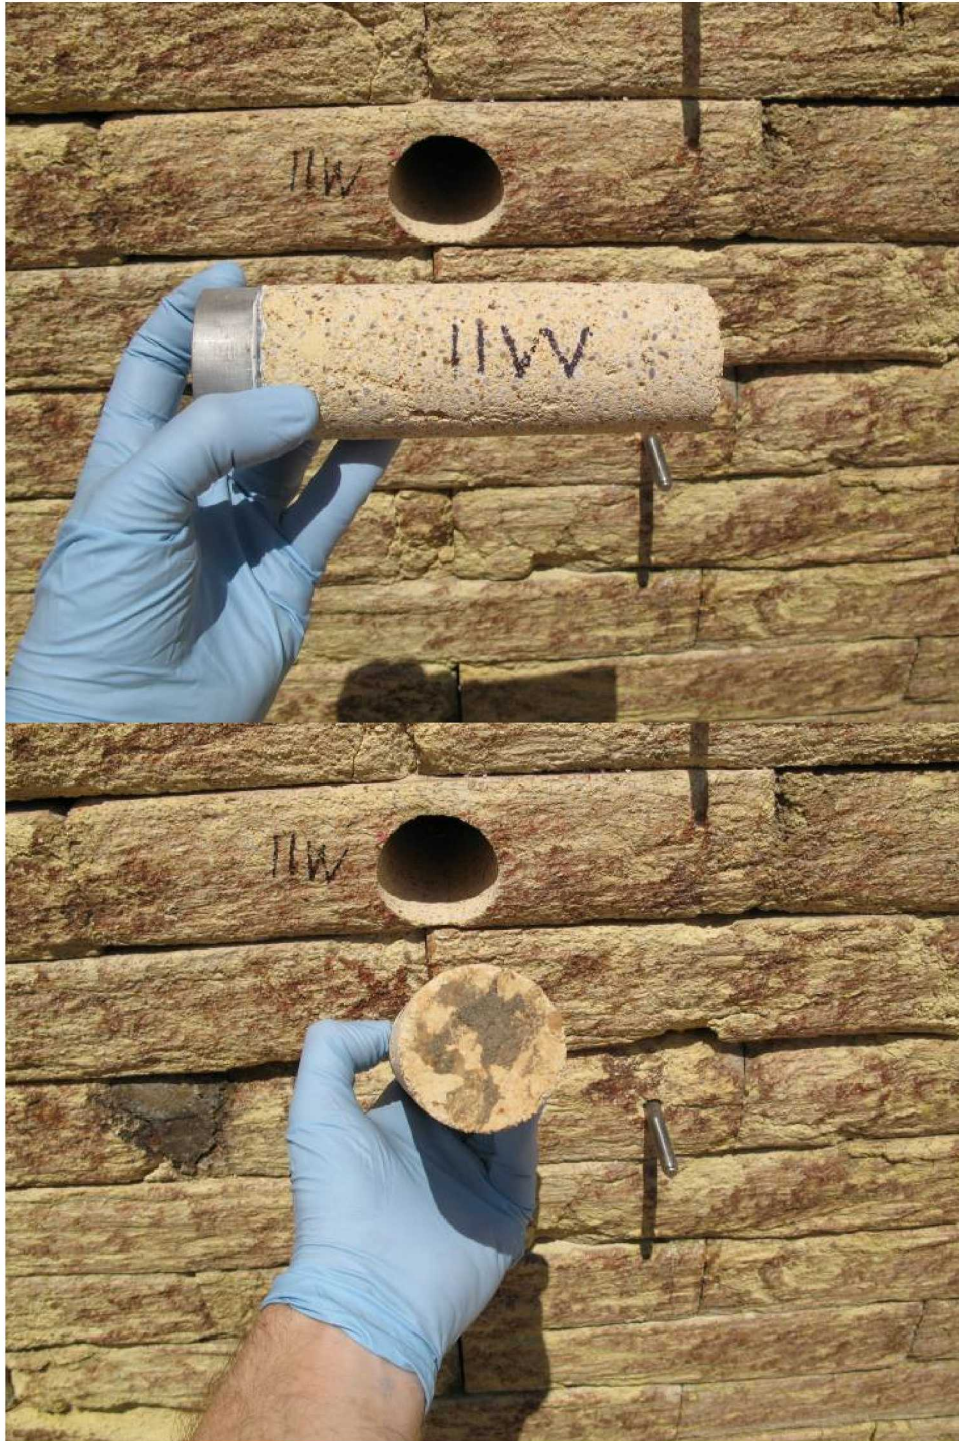
This core came out as adhesion testing began, so the pull stub was still attached. Some epoxy was found on the core.

Figure 40. Core 11W – side image of core and back end of core, closest to the concrete wall
