NASA/TP-2009-214769

A Summary of NASA and USAF Hypergolic Propellant Related Spills and Fires

B. M. Nufer
Kennedy Space Center, Florida

June 2009

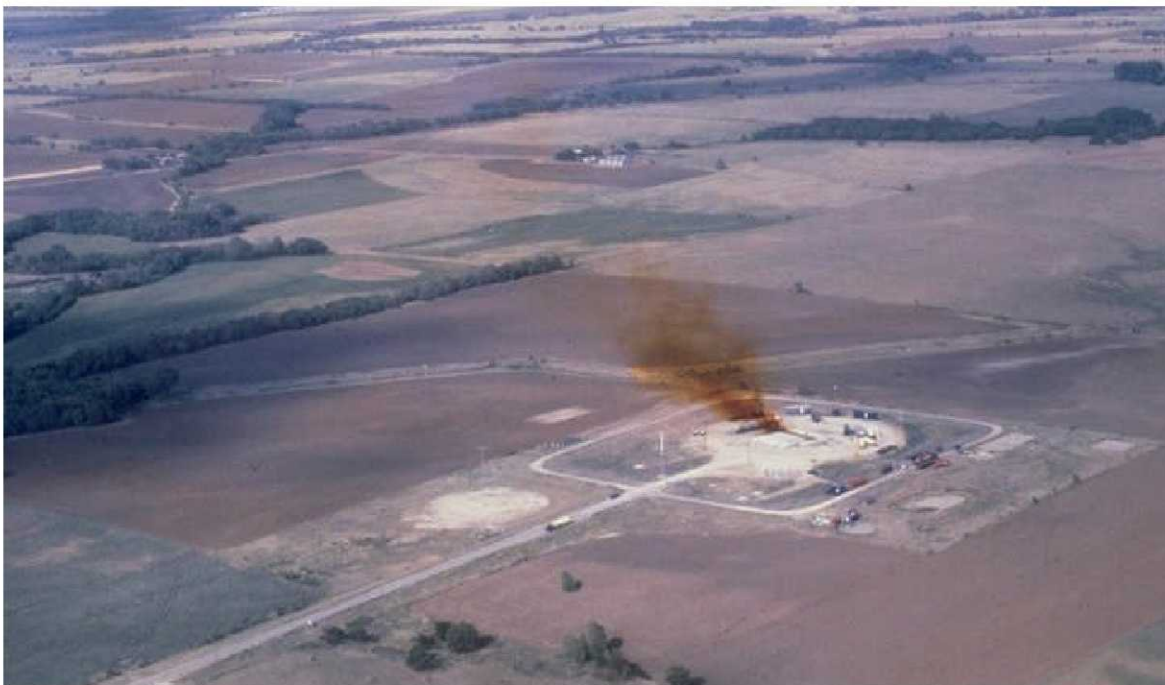
Figure 5-2: Aerial View of N₂O₄ Vapor Cloud Coming from Missile Silo 533-7

It was later discovered that the suit of the supervisor had failed, introducing him to dangerous levels of N₂O₄ (NO₂) vapors, which was ultimately fatal to him within minutes of being exposed (see section 1.1 "Properties of Nitrogen Tetroxide (N₂O₄)" for a description of what N₂O₄ and NO₂ does to the body). Two other technicians had removed their suit hoods while in the vapor cloud. One died nine days later. The extent of the injuries of the other technician is uncertain; however, he did survive. Repairs to the damaged 533-7 silo were attempted, but later discontinued for budgetary reasons. The silo was never returned to alert status.

- Proper configuration control of GSE components, in this case the filter, is highly important in the handling of toxic chemicals, especially hypergols (root cause of the incident)
- Emergency procedures and safing must always be reviewed, practiced, and ingrained in the minds of personnel working with toxic chemicals
- Procedural oversight may have been beneficial
- Proper isolation of bulk propellant should be inherently designed into any rocket propulsion system and used accordingly during loading operations
- Personal protective equipment (PPE) should be inspected prior to every use

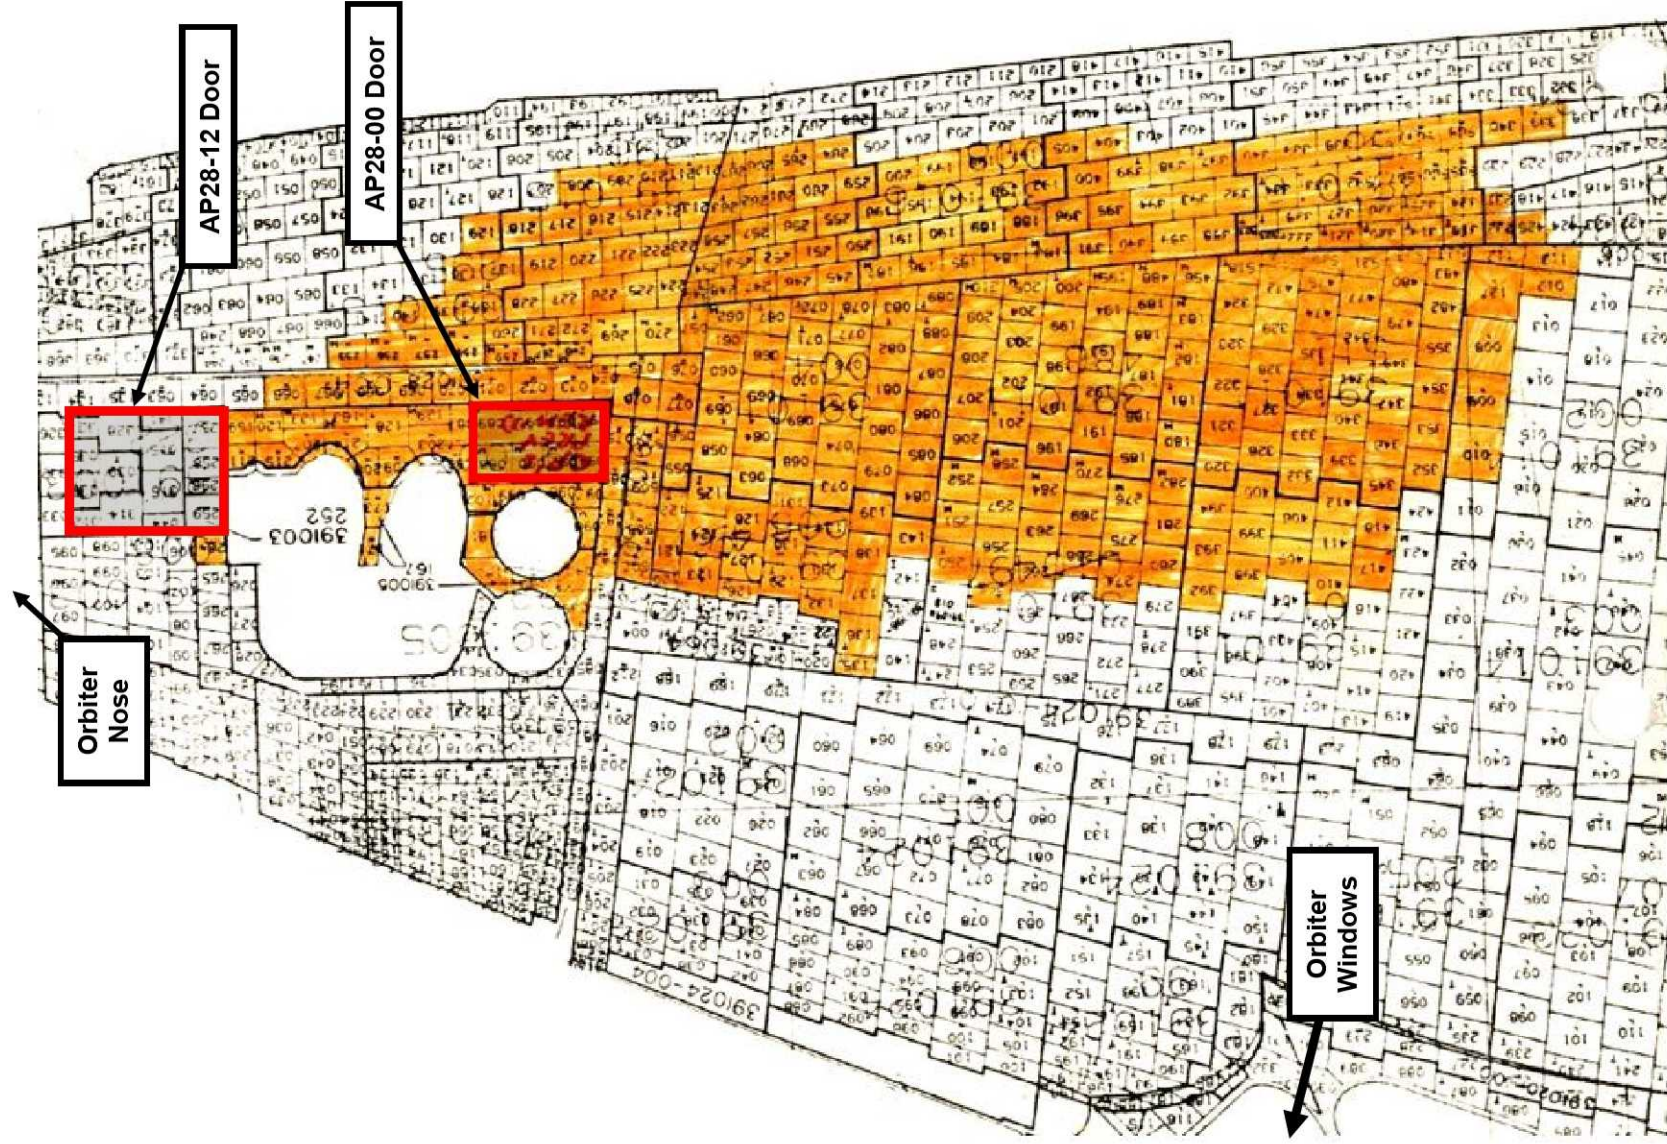
Figure 11-4: Removed Tile from OV-102 Following STS-2 N₂O₄ Spill

Corroded structural components that had been exposed to oxidizer vapors were later found in the internal portion of the FRCS module. It is believed that the vapors entered the forward module through small test ports located at the external doors. Many years later it was also found that the oxidizer vapor reacted with several electrical connector backshells within the FRCS.

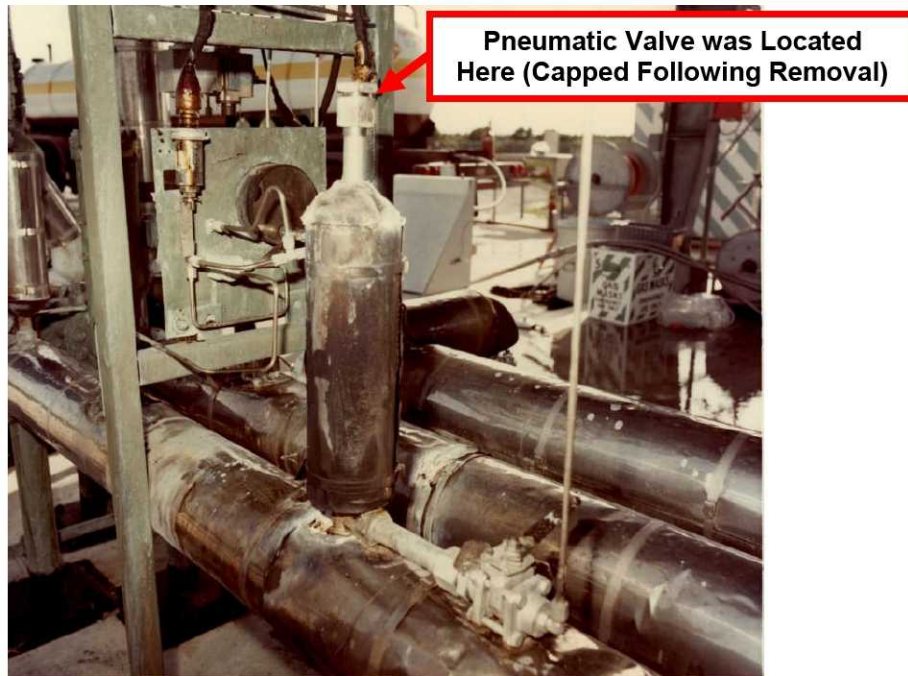
Figure 12-1: Photograph of Fuel Farm Following Fire

- The procedure was not written or reviewed by an experienced engineer prior to the task
- The engineer on console was making changes to the procedure real-time while monitoring another task in parallel
 - Improper adherence to the procedure and the procedure approval process are also root causes of this incident
- There was only one engineer on console supporting the hazardous operation
 - The engineer had to leave the communications channel to talk to the test conductor and in doing this missed some reports from the personnel at the fuel farm
- There was not a charged water line nearby when the fire occurred

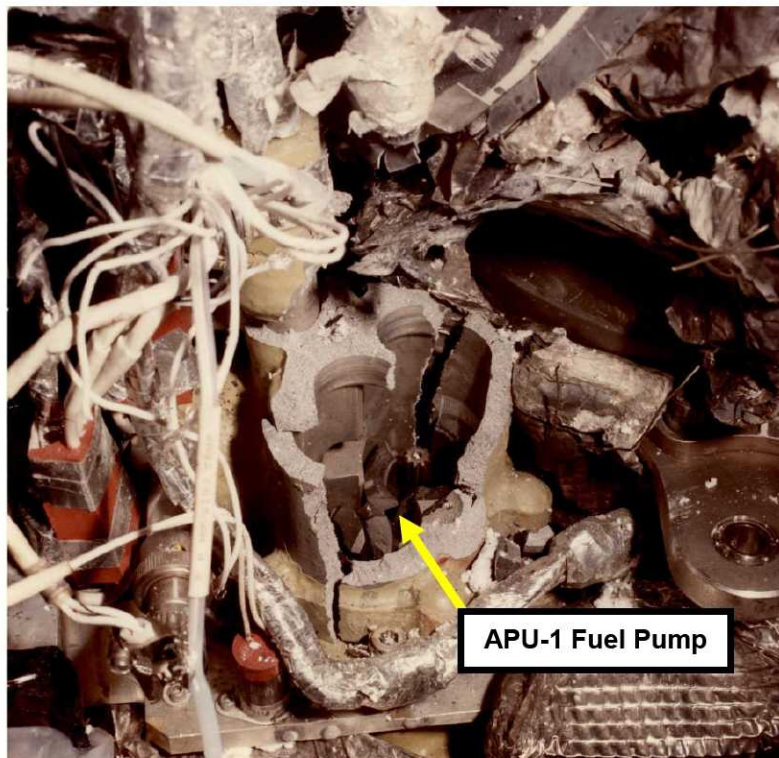
Figure 15-1: APU 1 Fuel Pump Explosion Following STS-9

The APU failures most probably resulted from a crack in the injector stem caused by corrosion of the sensitized inside diameter surface. The corrodant is probably carbazic acid or some similar substance which can be derived from air, moisture, CO₂, hydrazine and/or ammonia. The corrosion is time dependent and the crack progressed under sustained stress levels from the inner diameter surface toward the outer diameter surface until mechanical or thermal fatigue conditions could [complete] the crack rupture.”

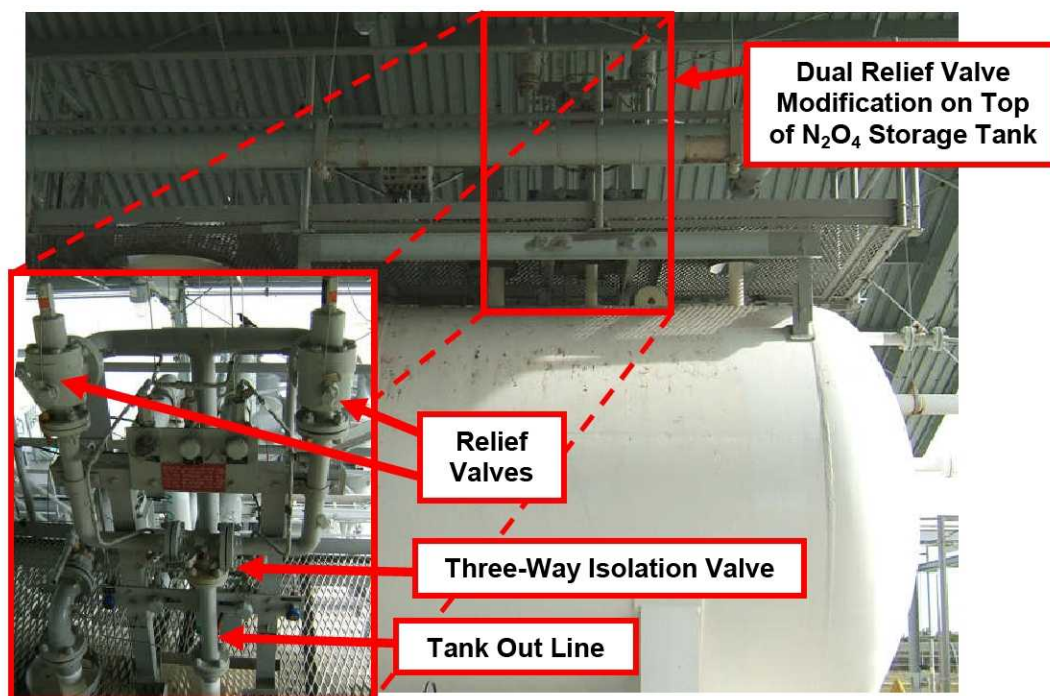
Figure 21-1: Dual Relief Valve Modification Location

An improper GSE design and operational human error were the root causes of this incident. About ten months prior to this relief valve removal and replacement operation, a formal request had been submitted by engineering to install a dual relief valve system onto the storage tank with a three-way isolation valve to prevent a vapor release during component removal. This request was denied. Following the large vapor release, the modification was implemented at both launch pads, greatly reducing the possibility of any future hazard. This dual relief valve modification allowed for isolation during the relief valve annual maintenance. The modification was also implemented on the fuel storage tanks at both launch pads. Figure 21-1 is a photograph of the relief valve locations on the top of the N_2O_4 storage tank with a close-up photograph of the relief valve three-way isolation valve modification.

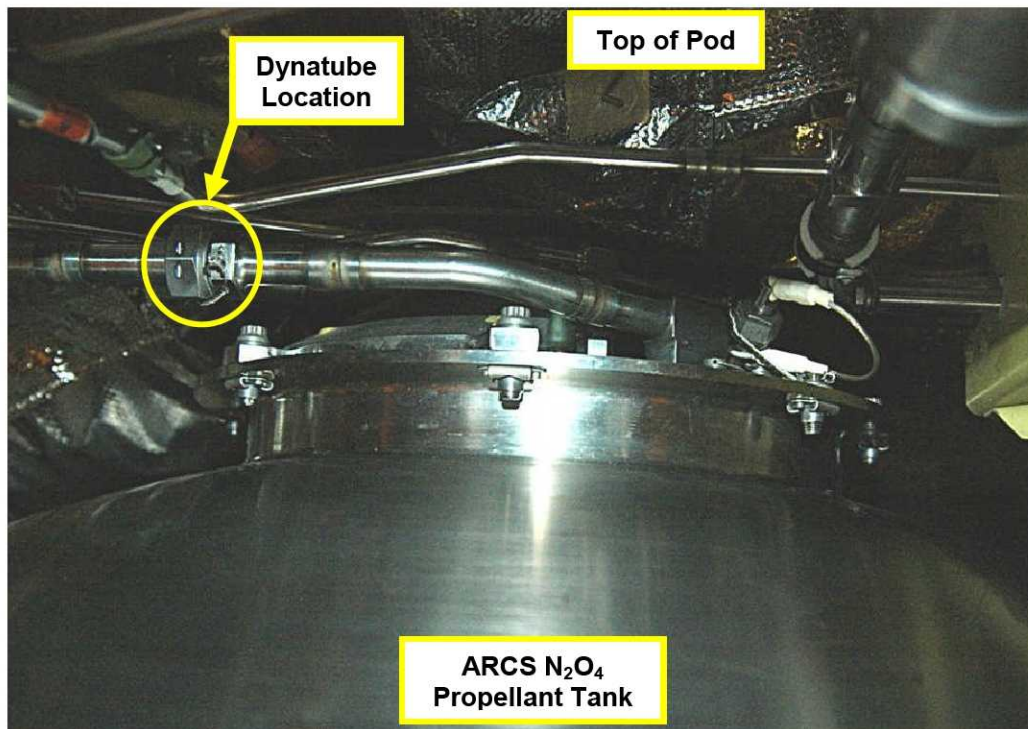
Figure 24-3: Dynatube Location on ARCS N₂O₄ Tank

First, the exact location of the leak within the pod had to be found (a cutaway view of the Space Shuttle OMS pod can be seen in Figure 24-1). This was difficult because the internals of the aft pods and forward module are not meant to be accessed while the vehicle is at the launch pad. The location of the leak had been isolated to the LRCS N_2O_4 system or the associated tubing through monitoring of the instrumentation in the LCC. The leak was measured to be 0.26 psi per hour (about 800 standard cubic centimeters per hour) and a TVC found the concentration of NO_2 vapor to be 15 ppm at the vehicle vent door. This later decreased to 3 ppm. An access door was removed on the pod's outer skin and several internal thermal blankets were removed. A long section of PVC pipe was then inserted into the pod to function as a guide for a borescope. Using a borescope, the leak was finally isolated (after a six hour search) to a 1/2-inch dynatube fitting on the MD224 leg (the N_2O_4 propellant tank ullage vent). A cross-section view of a dynatube is shown in Figure 24-2 and a photograph of the leak location can be seen in Figure 24-3.

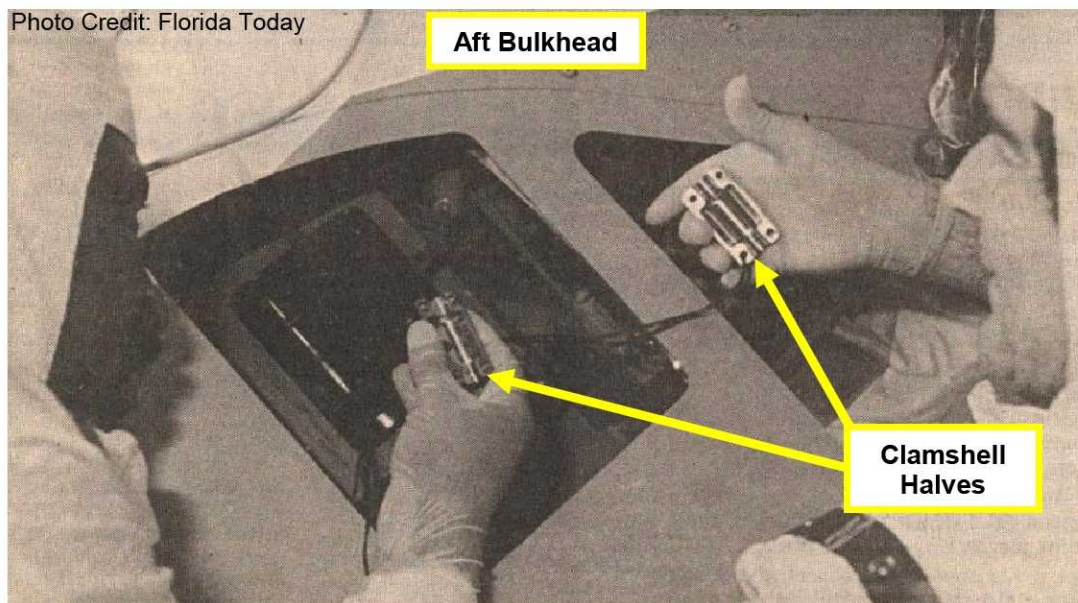
Figure 24-5: Technicians Repairing STS-26R Leak at the 1307 Bulkhead

After a week of deliberation, the “clamshell” was selected as it was the least invasive method to stop the leak prior to launch and it could be completed at the launch pad. Furmanite FSC-6B was used as the sealing compound as a result of it having the best compatibility characteristics with N_2O_4 . The FRF was finally completed on August 10, 1988 following a few hardware-related delays. The repair of the oxidizer vapor leak began on August 17, 1988 with the cutting of two holes in the aft 1307 bulkhead (the bottom of the payload bay with the orbiter in the vertical orientation) and the top of the pod beneath the bulkhead. The dynatube’s safety wire was removed and a “clamshell” (shown in Figure 24-5) was placed over the leak. The Furmanite sealing compound was then injected. The leak was eliminated; therefore, the Space Shuttle Program cleared Discovery for launch, which successfully occurred on September 29, 1988, a few weeks later than the original launch date of September 6, 1988. The delay was a result of multiple items including the FRF test delays, return to flight SRB testing delays in Utah, and the N_2O_4 leak on LP04.

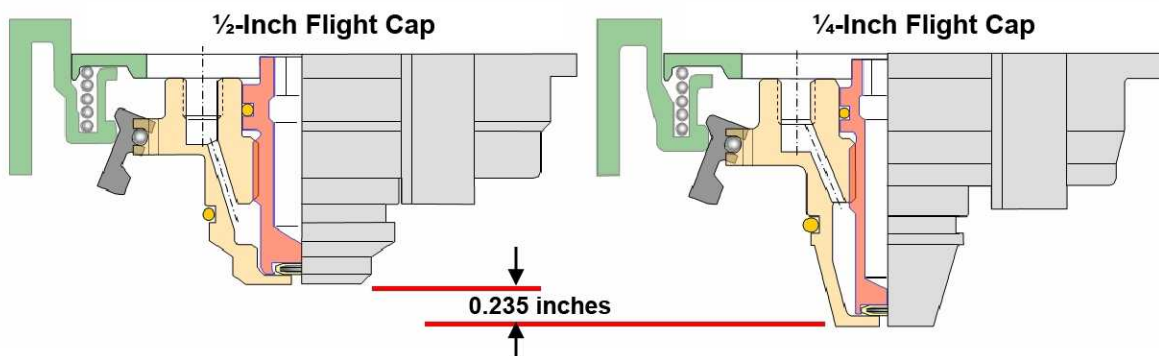
Figure 29-1: ¼-inch and ½-inch Hypergolic Flight Cap Cutaway View

- The appearance of a ¼-inch AHC cap is such that it could be mistaken for a ½-inch AHC cap to an untrained technician
 - The technician was undergoing on the job training under the direct supervision of an experienced technician, but the distinction between a ¼-inch cap and a ½-inch cap was not explained to him
- Age and wear made part number identification on the AHC cap difficult
- Work instructions should be written to include positive identification of interface equipment
- AHC cap mating should not be considered a benign activity; therefore, PPE should be used to protect the employees from credible releases of propellants
- Future designs should consider keying of AHC caps to preclude incorrect size/commodity installation

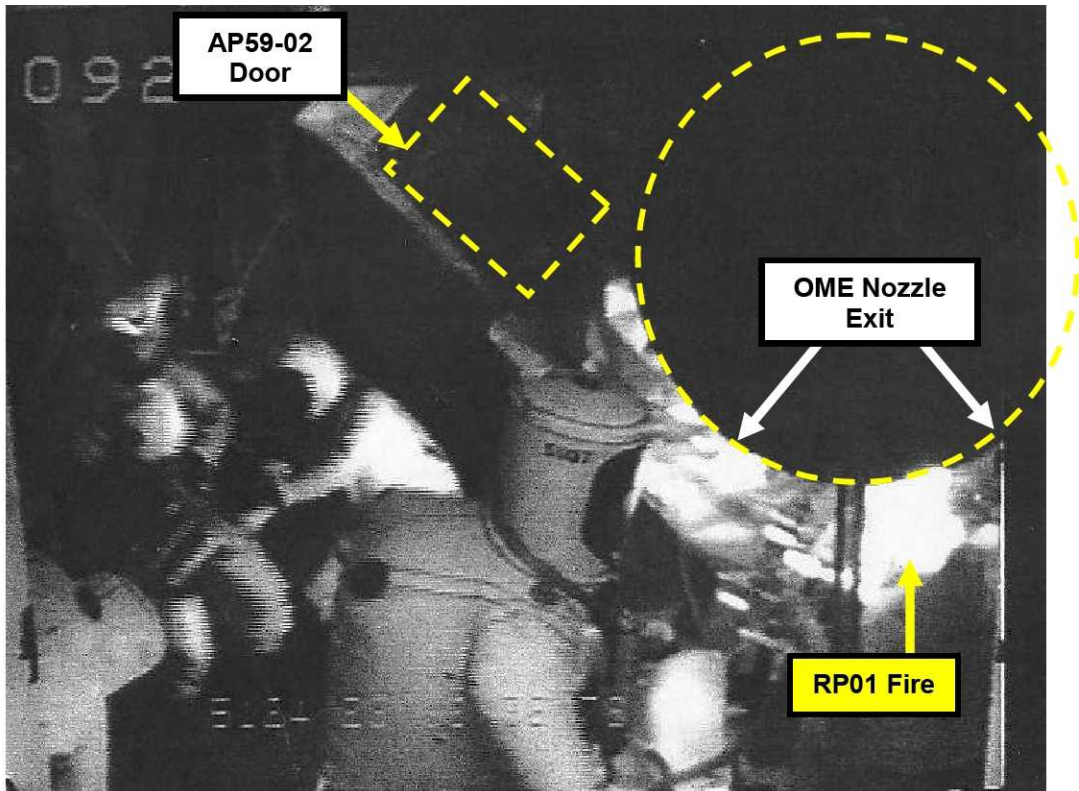
Figure 33-1: Still Photograph from Video of RP01 Fire

During the STS-69 OV-105 flow, while performing a thruster R1A removal and replacement, a fire broke out in the Space Shuttle right OMS pod stinger area. The fire burned strongly for about 30 seconds and a smaller flame burned for about one minute and 45 seconds. The size of the flame was estimated to be approximately 15 inches x 11 inches x 11 inches with a damage region of approximately 22 inches x 14 inches x 14 inches in the stinger. The materials that burned included several ounces of fuel, a shop light, and the Orcofilm spill protection (flame retardant covering films). Figure 32-1 is a still image from the video recording during the fire and Figure 33-2 is a clearer color photograph of the same area for reference.

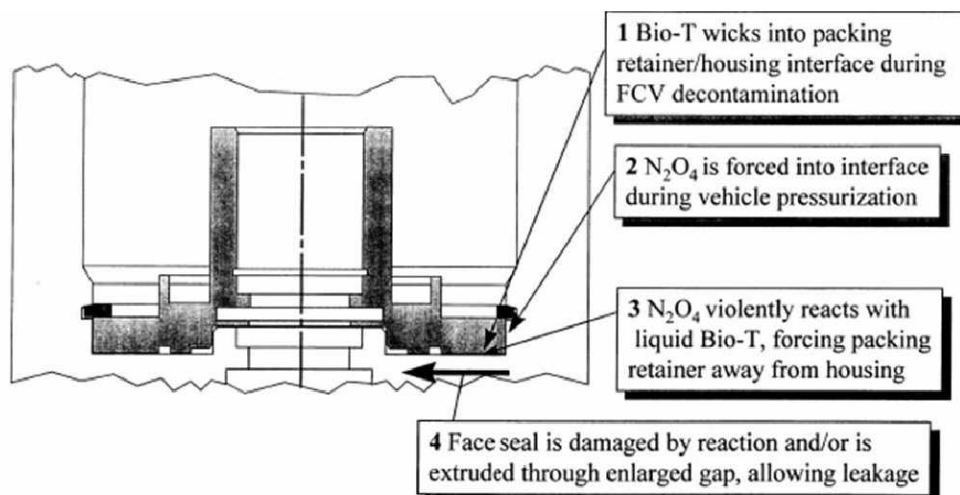
Figure 37-4: Titan IV A FCV Failure Description

1. By the completion of the TVC N_2O_4 propellant tank loading, the cavity adjacent to the packing retainer filled with liquid N_2O_4
2. The liquid N_2O_4 vaporized and migrated into the packing retainer crevice
3. During the tanks' pressurization, the trapped N_2O_4 vapor re-condensed into a liquid and reacted with the residual Bio T-200A in the packing retainer crevice (see Figure 37-4)
 - The energy of this reaction damaged the packing seal
 - The force of the increased system pressure overcame the remaining, compromised integrity of the seal components and thus flowed past the seals to atmosphere.

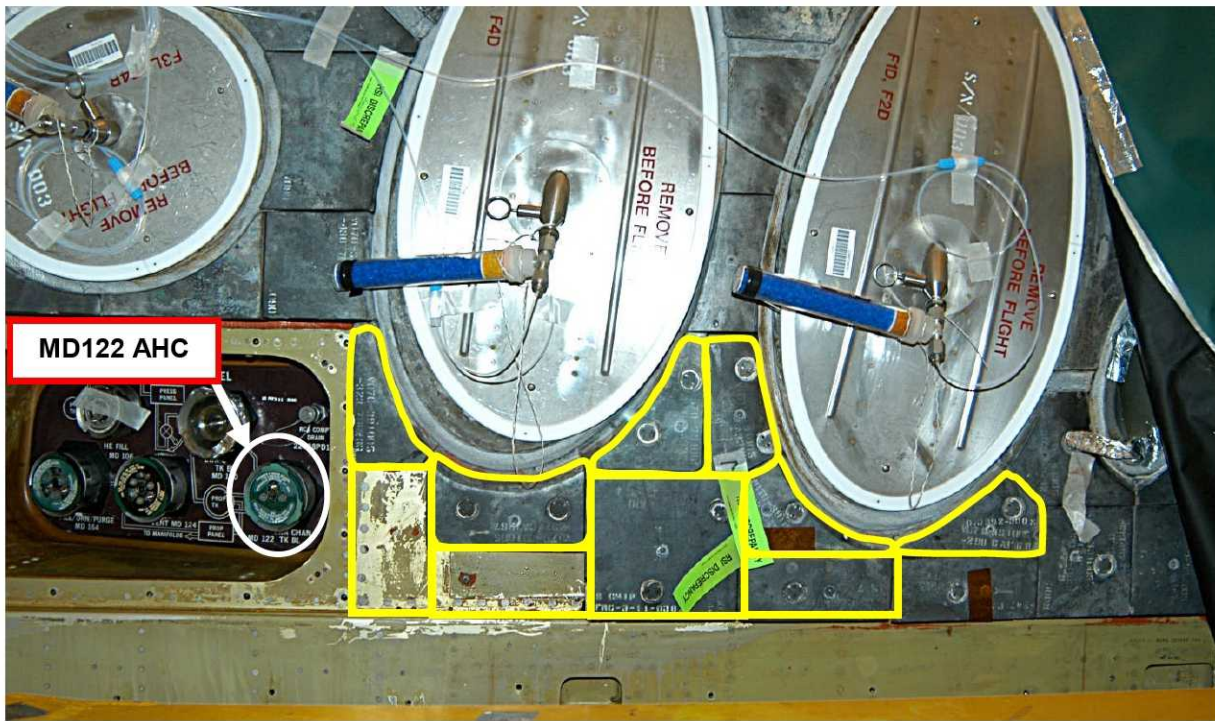
Figure 46-2: FRC3 Following Spill (Replaced Tiles Highlighted in Yellow)

tubing and are known to react with N_2O_4 (NO_2) vapors and cause corrosion on stainless steel tubing through chloride attack.
