Problems Encountered During the Recertification of the GLORY Solar Array Dual Axis Gimbal Drive Actuators

Marc Saltzman⁽¹⁾, Joseph P. Schepis⁽²⁾, Michael J. Bruckner⁽³⁾

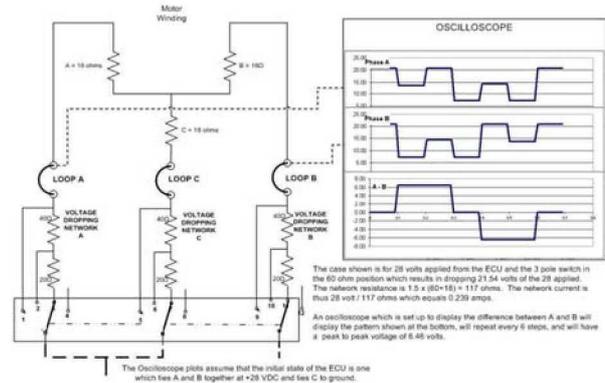
Figure 2 Threshold Voltage Testing

schematic were used to drop the output voltage across the windings. The fixturing for threshold voltage testing was such that both actuators were free to turn. Tab. 1 shows the threshold voltage test results. Inspection of these results shows that the new threshold voltage results were in-family with those recorded by Moog in 1999/2000. At this point it appeared testing would soon result in SADA re-certification for flight.

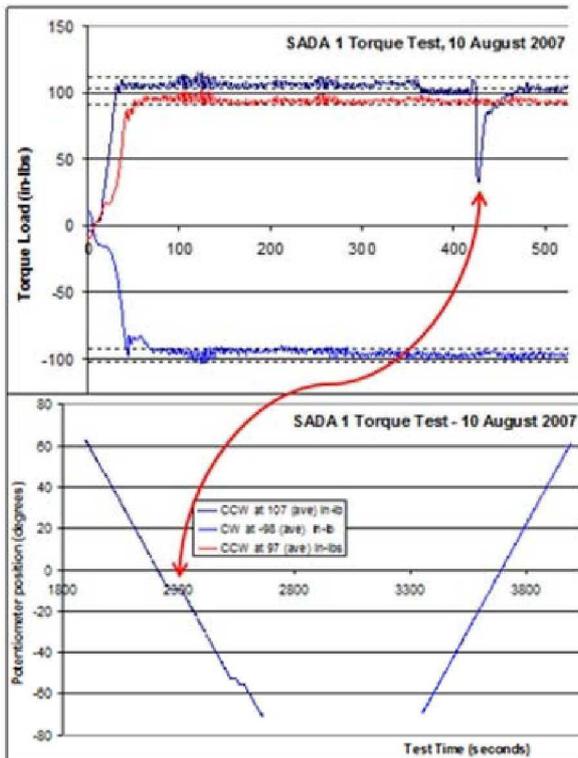
Figure 4 Torque Test Data

Torque capability in the 150 in-lb to 190 in-lb (16.9 N-m to 21.5 N-m) range was produced prior to shipment but, as demonstrated by the plots in Fig. 4, there was either 30% degradation in torque or a serious flaw existed in the test apparatus. At least two days were spent checking the calibration of the torque test setup. The final test results for both SADAs are shown in Tab. 2. In this table, “N/A” indicates the configuration could not be tested without disassembly.

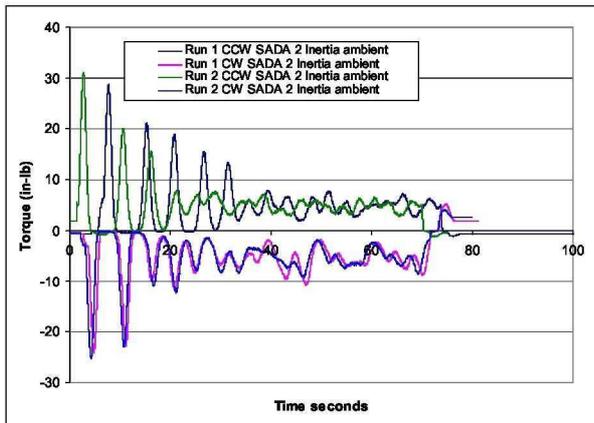
Figure 7 SADA 2 Inertia Test Record

To achieve a more conservative, test the actuator speed was increased to 4°/second and then 6°/second. In all cases the inertia was started without any lost steps. Additional test were conducted with the backlash

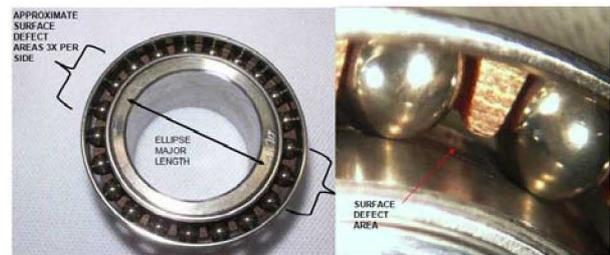
Figure 9 Harmonic Drive Wave Generator Bearing with Defect Areas

- The alpha drive showed no degradation from 1999.
- The beta drive showed the 30% to 40% degradation measured by Orbital.
- The SADA 1 motor stator housing was removed allowing the rotor/harmonic wave generator to remain installed. Moog observed that rotor rotation was ‘lumpy’ with repetitive cyclic torque peaks of approximately 6.5 inch-ounces (45.9 mN-m) versus the Moog

requirement for new hardware of 2 inch-ounces (14 mN-m).

- There remained a good quantity of grease/oil slurry present in the wave generator bearing.
- The amber colored lubricant inside the harmonic drive wave generator bearing was somewhat darker in places than the shade for new lubricant (50% Pennzane oil & 50% Pennzane grease).
- The cleaned wave generator bearing races had small patches of discoloration with a grainy appearance from either embedded material or a divot. These are shown in Fig. 9. Three such patches on each side were located on the inner race at the major diameter areas and coincided with the spacing of the balls. The remaining portions of the races were clean and smooth. An attempt was made to mechanically remove the discoloration using a pointed plastic stick but this was not successful.

SADA 2 was returned to Moog and retested on 1/30/2008. The beta drive showed 20% to 30% output torque degradation. The beta actuator was disassembled and showed the same discolored areas shown in Fig. 9, but not quite as prominently. Prior to disassembly the actuators were subjected to both threshold voltage and torque testing for comparison with the results recorded earlier by Orbital. These results also placed in question the validity of using threshold voltage testing as a conclusive verification that all is well with an actuator.

At this point the flow path led NASA, Orbital and Moog to the decision to disassemble the wave generator bearings from the beta actuators and subject the races and balls to laboratory testing. After two separate investigative sessions at Seal Laboratories, Moog’s assessment was that the discolored areas were, in fact, pitted areas most likely due to stress corrosion. Fig. 10 shows a visual summary of the typical findings. Except for a very minor amount of discoloration observed on the alpha actuator of S/N 1, the alpha

Based on the aforementioned findings, Orbital revised the Moog service agreement to include complete replacement of all harmonic drive bearings in both SADAs 1 & 2. While not contributing to the degradation the cotton phenolic wave generator bearing retainers were vacuum impregnated using an extended time of 3 days as recommended by the NASA

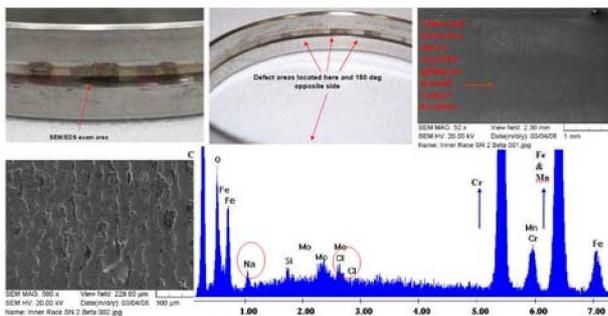
Figure 10 Laboratory Investigation Findings

Moog determined that the harmonic drive supplier had used a chlorinated solvent as part of the cleaning process. This practice has long since been prohibited but at the time the VCL SADA components were manufactured the process was still in use. It is thought that some small amount of this solvent had not been fully washed away. This in combination with the presence of sodium in the grease thickener provided the constituents for a salt solution only awaiting the arrival of small amounts of water vapor, the presence of oxygen, and, lastly, the availability of lots of time for the corrosion process to attack the bearing surfaces under most stress. The elliptical wave generator plug provided the stress. The evidence for the presence of chlorine and sodium is shown in the electron dispersion spectrographic (EDS) analysis portion of Fig. 10. Until 2004, the SADAs were stored with the VCL bus bagged and with an N2 cover gas but it was never confirmed that the cover gas had not dissipated, that the bag was entirely leak tight, or that trace amounts of moisture did not exist in the purge gas. In addition, after 2004, the SADAs were exposed to the atmosphere as they were required for integration and test purposes. There remains the mystery as to why the alpha actuators were not nearly as degraded as the beta actuators. Nevertheless, the root cause was concluded to be stress corrosion due to the incomplete cleaning of the harmonic drive components leading to the presence of small amounts of chlorine, sodium, water vapor, oxygen, and lots and lots of time.
