NASA/TM—2009-215802

Failure Analysis of Sapphire Refractive Secondary Concentrators

Jonathan A. Salem
Glenn Research Center, Cleveland, Ohio

George D. Quinn
National Institute of Standards and Testing, Gaithersburg, Maryland

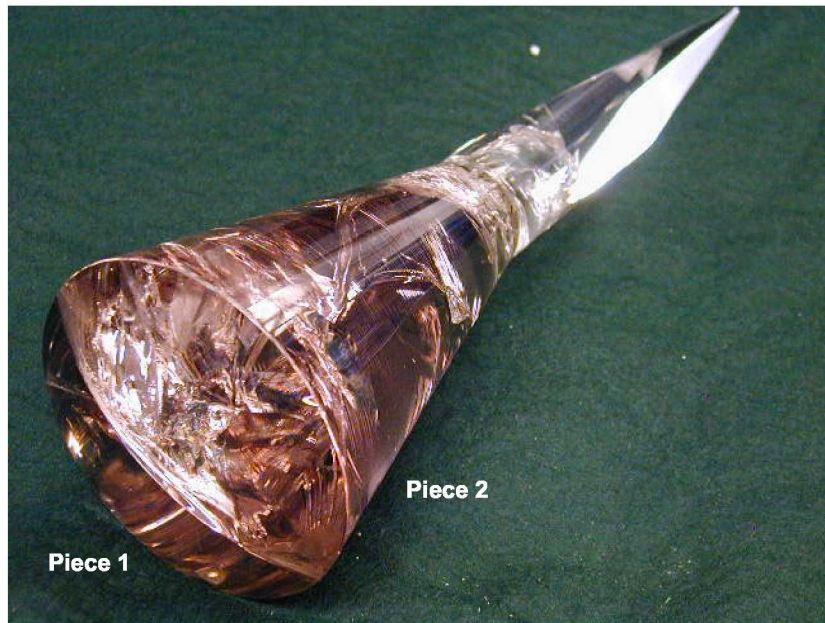
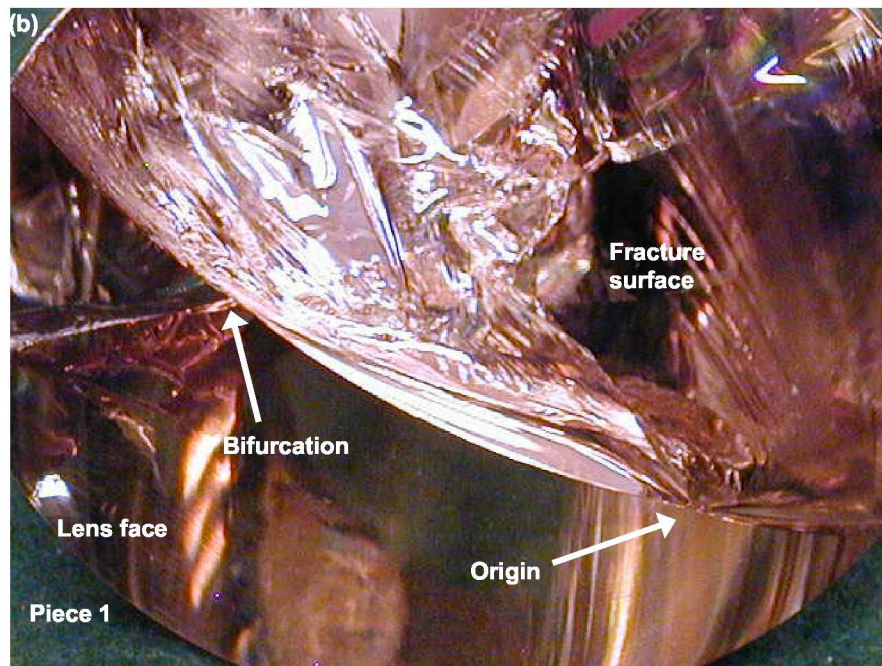
Figure 5.—(a) Overall view of RSC no. 1, the first solar concentrator, after testing. The lens diameter is 89 mm (3.5 in.) and the overall length is 284 mm (11.2 in.). (b) View of the fracture surface face of the bottom half (piece 1) showing the fracture origin and bifurcation that is located 44 mm away from the origin.

On August 30, 2001, two tests were run with the rigid primary concentrator—one at lower temperatures without the Re receiver and one at higher temperatures with the Re receiver. The high temperature test had an approximate maximum receiver temperature of 1300 °C (1573 °K) and an approximate front shoe temperature of 532 °C (805 °K), with a peak shoe temperature of 582 °C (855 °K) after shut down. The first indication of performance problems was an unexpected decrease in temperature as shown in the temperature—time profile in Figure 4. The test was shut down and cracks in the lens could be seen once the temperature cooled to ~982 °C. Upon inspection the crystal was observed to be cracked as shown in Figure 5.

As shown in Figure 5(a), the lens face and cone are fractured near the mid-plane of the lens face and downward into the body to the extractor. There is a mixture of cleavage and conchoidal fracture and some crack bifurcations. As will be shown later, fracture started on the face of the lens and propagated downward into the cone body and extractor.

Besides the severe cracking, Figure 5(a) also shows that the cone region of the lens exhibits a rose hue when viewed on the cone sides, with thicker regions appearing darker than thinner regions. When viewed down the lens axis, a light-brown hue is exhibited in the uncracked regions, and rose hues in the severely cracked regions, probably from side light being reflected out the lens face. The rod region and a heavily cracked region of the cone are still clear.

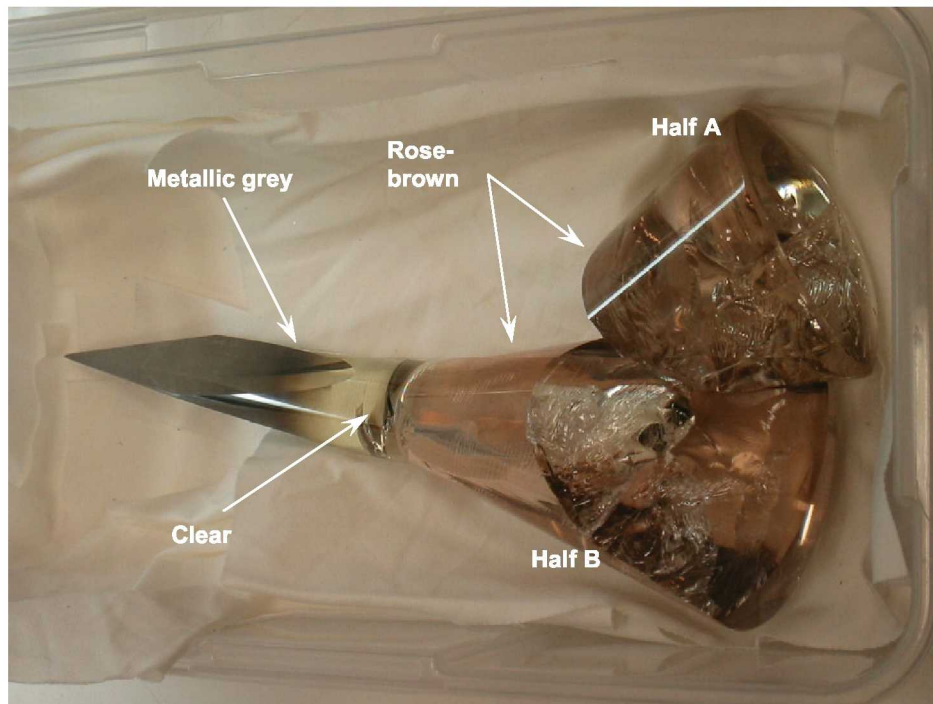
Figure 6.—RSC no. 2 after removal from the test rig. It has broken into two pieces. Cracks at the neck are also visible. The cracks in the neck and extractor are extensions of the main fracture in the cone body. The lens diameter is 89 mm (3.5 in.) and the overall length is 284 mm (11.2 in.).

As shown in Figure 6, the fracture started on the face of the lens and propagated downward into the cone body and extractor. The primary crack split the lens face and cone body near the mid-plane down to the extractor. Several *r*-plane bifurcations branch from the cone sides. The main crack rotated onto the *c*-plane after traveling ~15 mm into the extractor.

Besides being severely cracked, the cone region of the lens exhibits a translucent, lighter rose-grey hue as compared to the first RSC, with thicker regions appearing darker than thinner regions. The lighter color is likely a result of the lower temperature (and power) level. The end of the cone and the rod region just after the cone are clear whereas the remaining portion of the rod is an opaque dark gray.

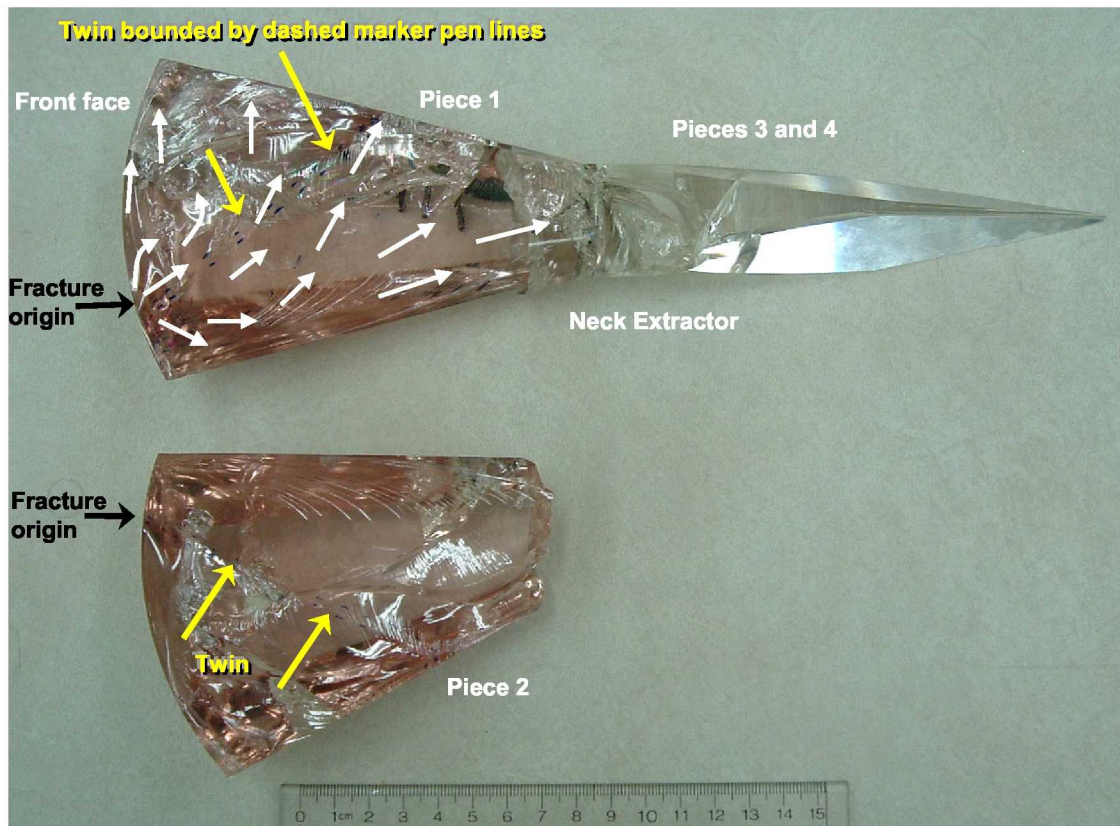
Figure 7 shows the four main pieces that concentrator no. 1 broke into after removal and some subsequent handling for the fractographic analysis. The origin is on the curved front face, about 20 mm away from the rim. There also is a large twin that extends diagonally all the way through piece 1 and which penetrates partially through piece 2. This twin was incidental and did not cause fracture.

Figure 7.—Concentrator RSC no. 1 fractographic analysis. Fracture started from the fracture origin on the front face and propagated (white arrows) into the cone body and onwards to the neck and extractor. The initial main fracture was almost perfectly radial and close to the m -plane in orientation. All the cracking in the neck and cone body can be backtracked to the one fracture origin. An incidental twin ran entirely through piece 1 from the lens front face through to the cone side and out the back of the cone. One end was close to but not exactly at the fracture origin site (2.3 mm away). There were minor perturbations in the main crack when it reached the twin plane indicating that the twin was in the RSC before the crack ran through it. The twin was very shallow in piece 2. It ran from the lens face right through the side of the cone, but did not extend very far below the fractured surface. The insert shows how subsequent handling caused the extractor to split into two pieces that separated from the cone body.

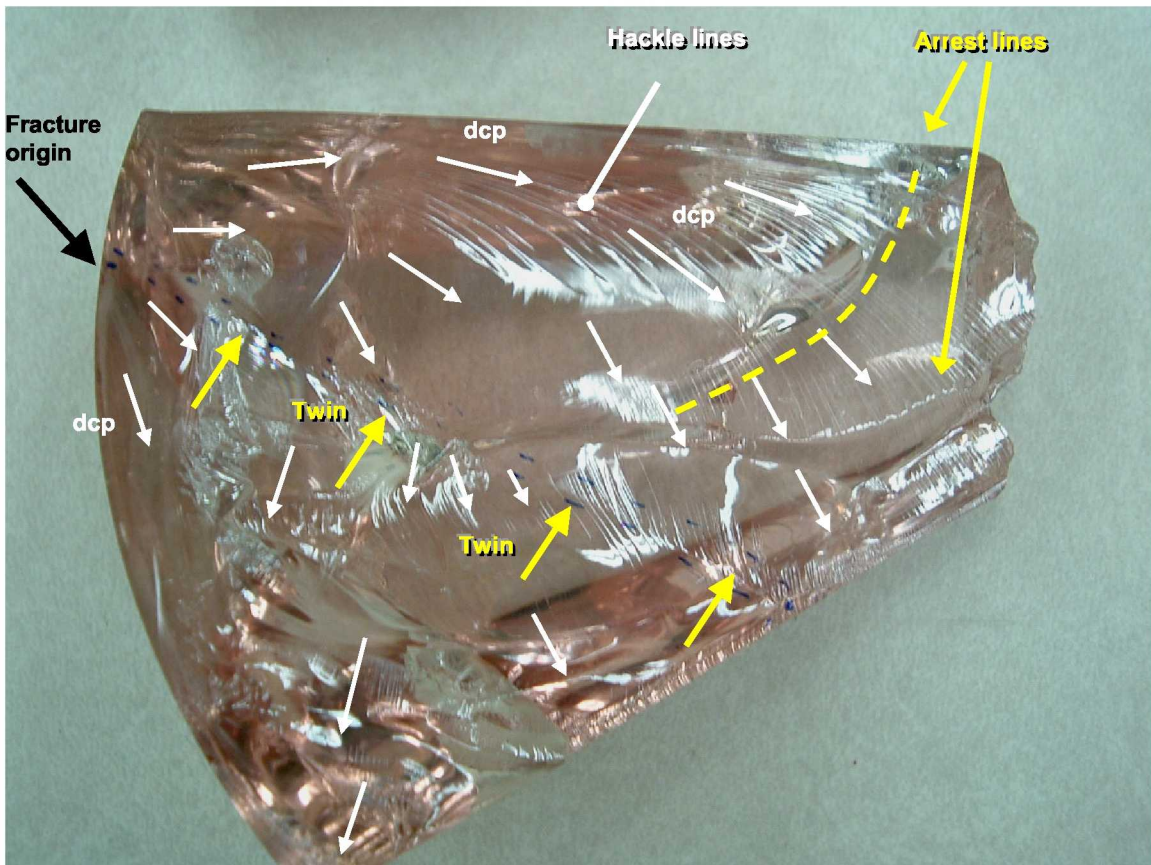
Figure 8 shows a close-up of piece 2 revealing some of the classic fracture surface markings such as twist hackle, cleavage step hackle, Wallner and arrest lines. The fractographic analysis of single crystals is covered in detail in Reference (Ref. 7). It should be borne in mind when viewing this and the following figures that reflections and translucency make photographing single crystals difficult. In the examples below, some regions are shown with several views with different lighting to bring out various details. Failure occurred from the fracture origin site and extended parallel to the *m*-plane. The main crack plane emanating from the origin contains hackle lines that extend from the lens face to the extractor on one side. This is a distance of ~5 in., and the crack nearly cleaves the cone into two segments that attached at the extractor rod. On the other side of the origin, the crack cleaved the lens cone only to a depth of ~2 mm along the lens before splitting, moving off the *m*-plane and forming a confluence of cracks at a variety of angles.

Figure 8.—Piece 2 of RSC no. 1. The small white arrows show the local direction of crack propagation (dcp) as identified by hackle lines, Wallner lines (not labeled), and arrest lines. These facilitate the determination of the crack propagation direction and the fracture origin. The twin runs diagonally across this view as marked by yellow arrows. Its left end comes very close to but is not coincident with the fracture origin. The main crack was perturbed slightly when it traversed across the preexisting twin.

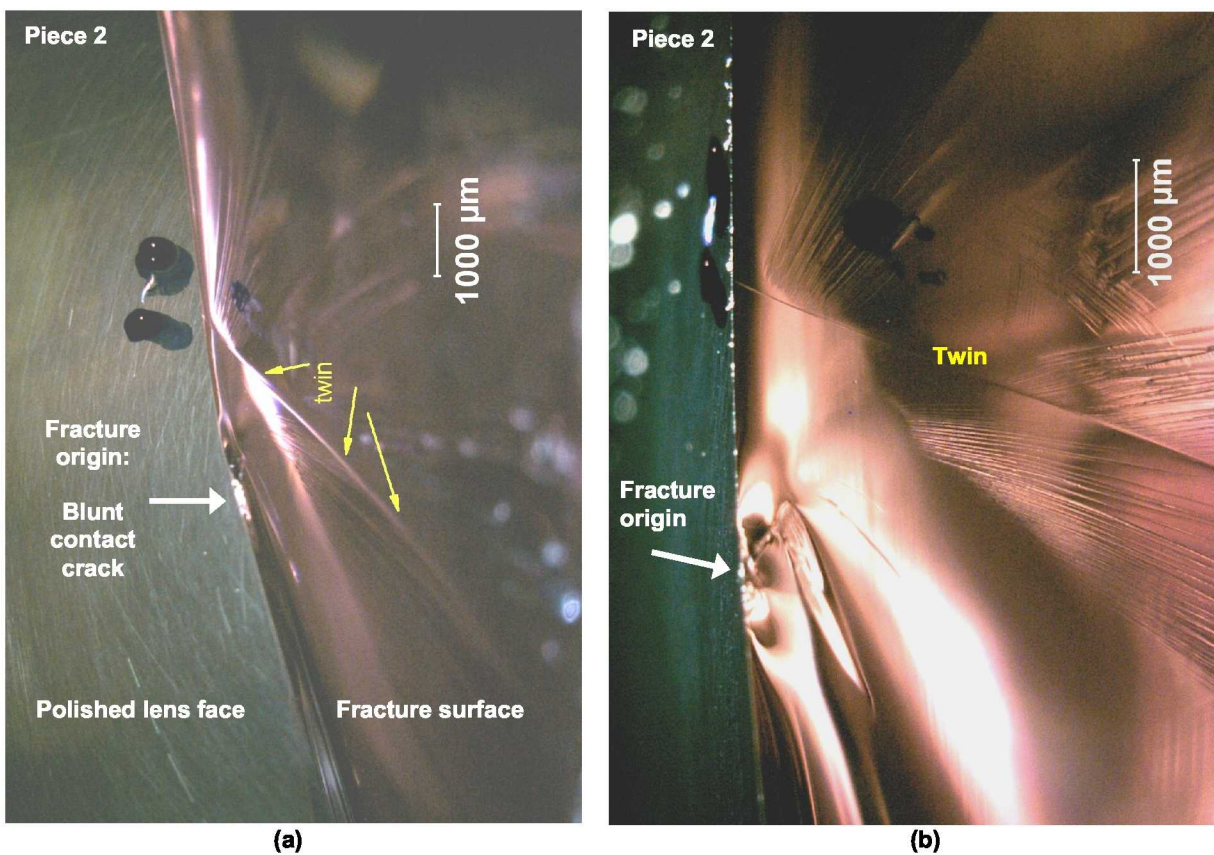
Figures 9 to 12 show that the failure origin is on the lens face, about 20 mm away from the rim. These views were taken with different lighting at different angles. The origin is a large, partially formed Hertzian cone crack, that extended from one of two partially polished impact divots or “bruises” measuring ~ 0.1 and ~ 0.2 mm in diameter, as shown in Figure 12. The cracks associated with the bruises are quite large, ~ 0.5 mm, and the damaged region can be seen with the unaided eye. Contact damage usually has two forms depending upon the sharpness or bluntness of the offending impactor (Ref. 7). Sharp impactor contact damage usually has a small concentrated damage crater with a star like array of cracks radiating outwards. Blunt impactor damage has a conical or ring shape. Often it may be a partial ring shape such as shown in Figures 10 and 11. From the size of the ring crack, it may be deduced that the impact object had a diameter greater than 0.5 mm.

Figure 9.—Close-up views of piece no. 2 of RSC no. 1 with about the same orientation as in Figures 7 and 8. Minor polishing scratches are revealed by the lighting in (a). (b) is a close up of (a).

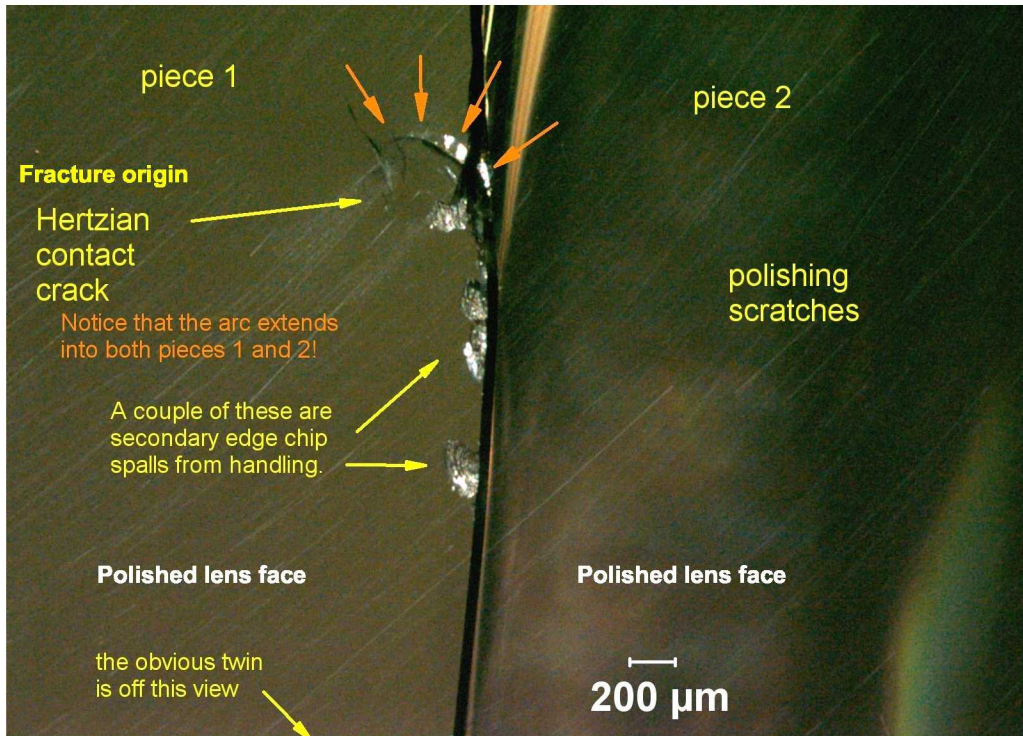
The Hertzian crack likely formed due to impact with a hard blunt object during the grinding or early polishing steps. As Figure 12 shows, final polishing created some microscratches around the bruises. These would not have been present if the impact had occurred *after* the final polishing phase. Better care would have eliminated this failure source.

Figure 10.—This view shows the curved polished face of pieces 1 and 2 of RSC no. 1 held together at the origin site. The orange arrows highlight the Hertzian (blunt impactor) contact crack.

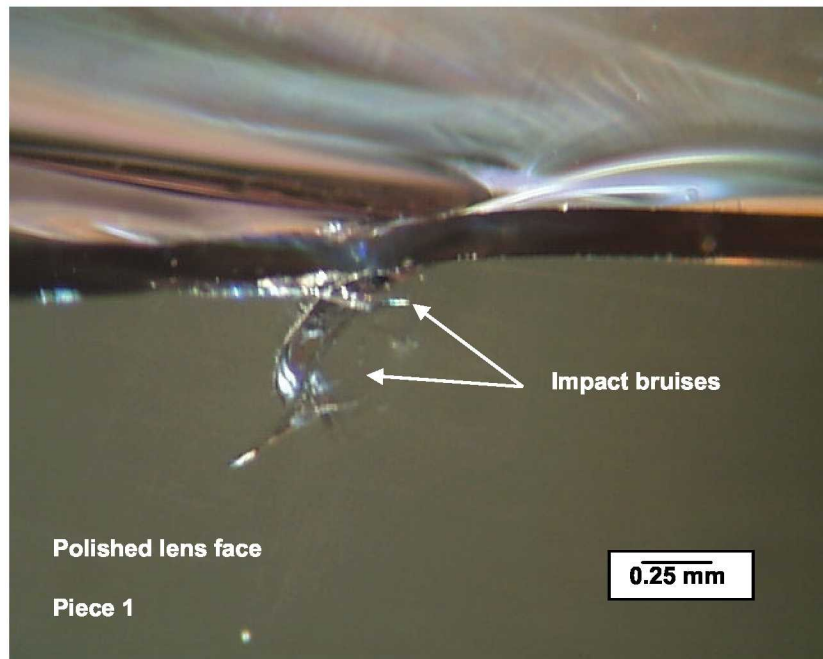
In addition to the bruises, large remnant scratches from the rough machining were noted on the lens faces, Figures 10 and 11, but also on the shaft, Figure 13. Another scratch approximately 2.3 mm from the rim on the lens face extends along nearly $\frac{3}{4}$ of the perimeter and can easily be seen with the unaided eye, Figure 14. Also apparent are some semi-polished chips on the edge between the lens face and the cone, as shown in Figure 15. Ideally, better machining and polishing should be performed. Poor polishing, such as that observed, is referred to as a “short finish” and generally results in a very large variation in the measured strength (Ref. 8).

Figure 11.—View of piece 1 of RSC no. 1 showing cracks extending from bruises on the lens face. The sites of the impact bruises are marked in this view, but they are more obvious in the next figure which has different lighting.

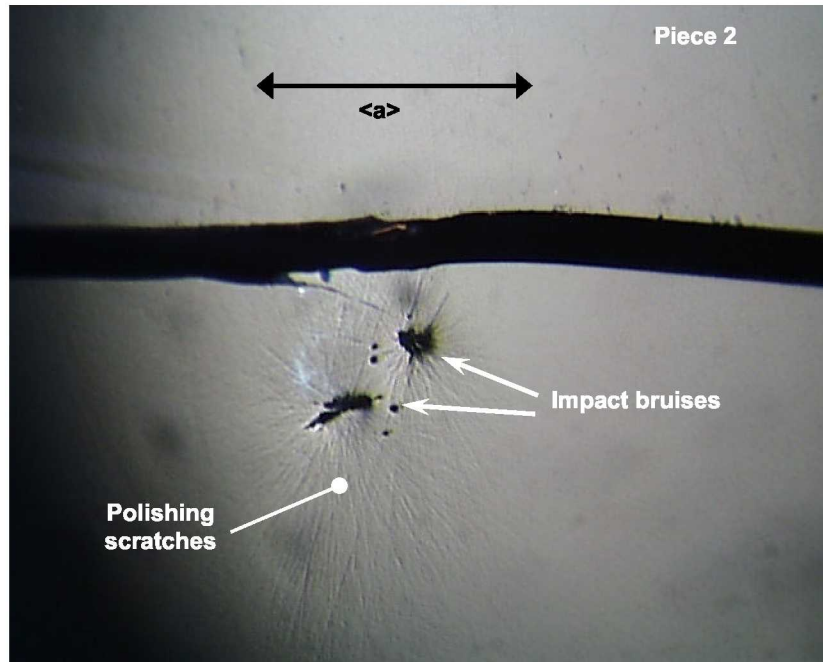
Figure 12.—Surface lighting of the bruises revealing polish scratches in the polished face of RSC no. 1. The residual scratches that radiate from the contact sites imply that the impacts occurred prior to the final polishing of the face. Final polishing caused micro scratches to radiate outward from the damage sites.

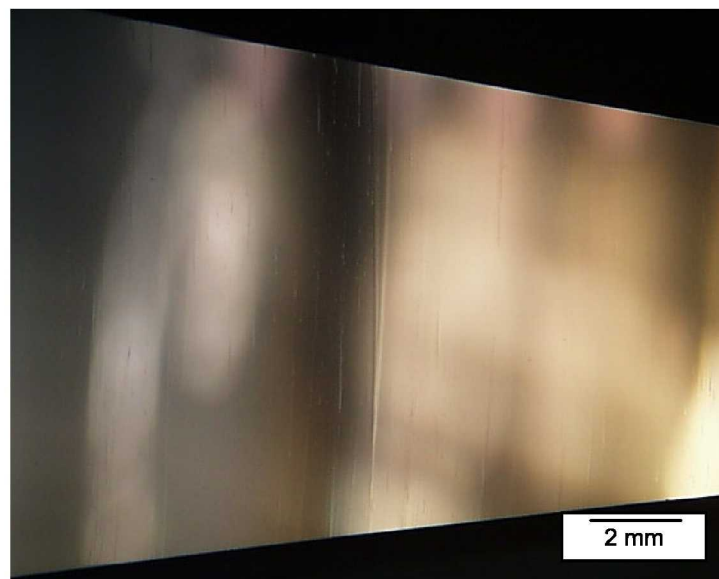
Figure 13.—Grinding marks along extractor shaft of RSC no. 1.

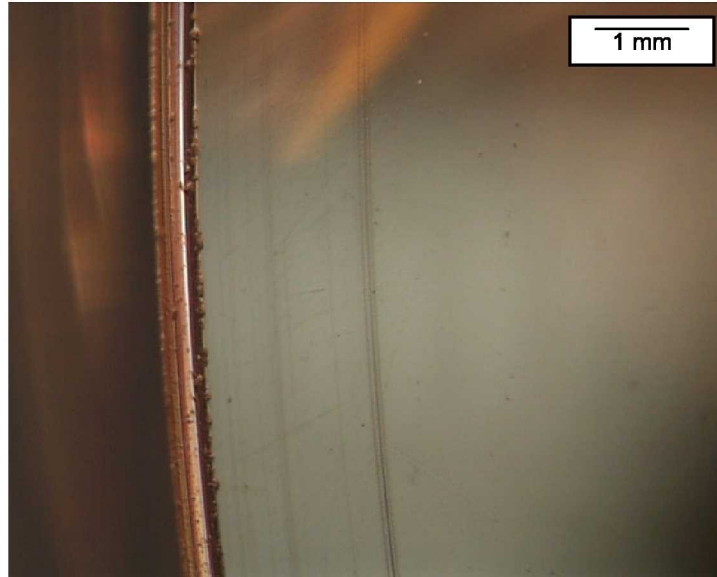
Figure 14.—Grinding damage and scratches on the lens face near the rim of RSC no. 1.

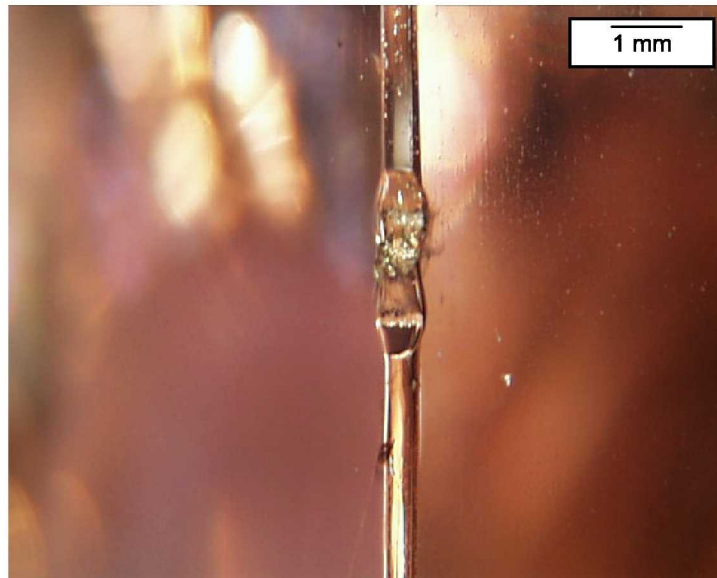
Figure 15.—Chips on the rim of the lens of RSC no. 1.

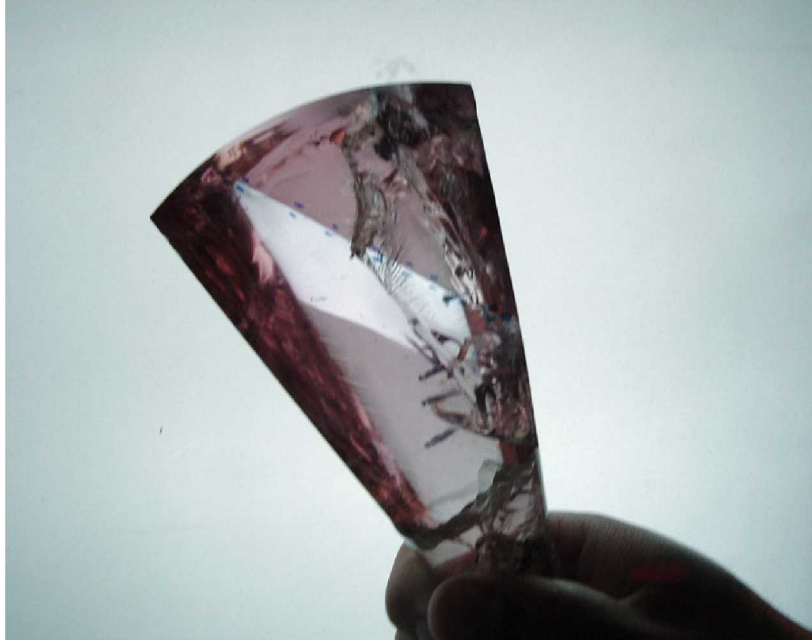
The twin that was observed running through RSC no. 1 is shown in Figures 7, 8 and 16, but it appeared to have been incidental. It could not be determined where it initiated. It was more obvious in piece 1 and it penetrated completely through the piece. It was seen over all surfaces with the naked eye. It extends only partially into piece 2. It is also visible on piece 2 primarily by how it affected the main crack propagation. Additional twins that were detected in the front face of piece no. 1 are shown in the Appendix.

Figure 16.—A prominent twin (the light colored band) ran through the body of piece 1 of RSC no. 1. This is a view of the piece through crossed polarizers.

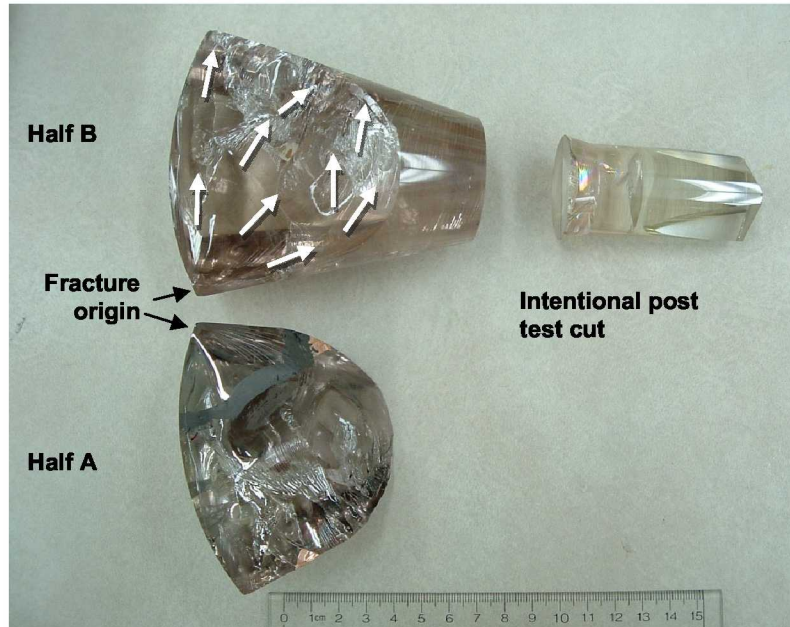
Figure 17 shows fractured RSC no. 2, which was intentionally sliced after the test in order to facilitate chemical analysis and fractographic examination. Hereafter the two halves of the conical body are referred to as half A or half B as shown in the figure. The main crack plane emanating from the origin contains twist hackle and cleavage step hackle that extend from the lens face to the rod neck and extractor. Once entering the rod extractor, the crack turned onto the c -plane, nearly cleaving the rod.

The crack path down the cone is parallel to the m -plane on one side and ill-defined on the other, and separates the cone into two halves. At ~17 mm from the origin along the side, the crack bifurcated once onto the r -plane. This bifurcation was followed by several others, one of which exited the cone, causing a portion of the lens to separate diagonally from the rest of the cone. Along the lens face, the crack extended along the r -plane until the middle of the lens, where it propagated in a conchoidal fashion. The first bifurcation occurred onto an m -plane at ~17 mm along the face. This was followed by second and third bifurcations at ~22 and ~30 mm (shown later in Figure 22(a)). The third bifurcation extended to edge of the lens, whereas the first two stopped within the concentrator.

Figure 17.—Concentrator 2. The white arrows show the direction of crack propagation.

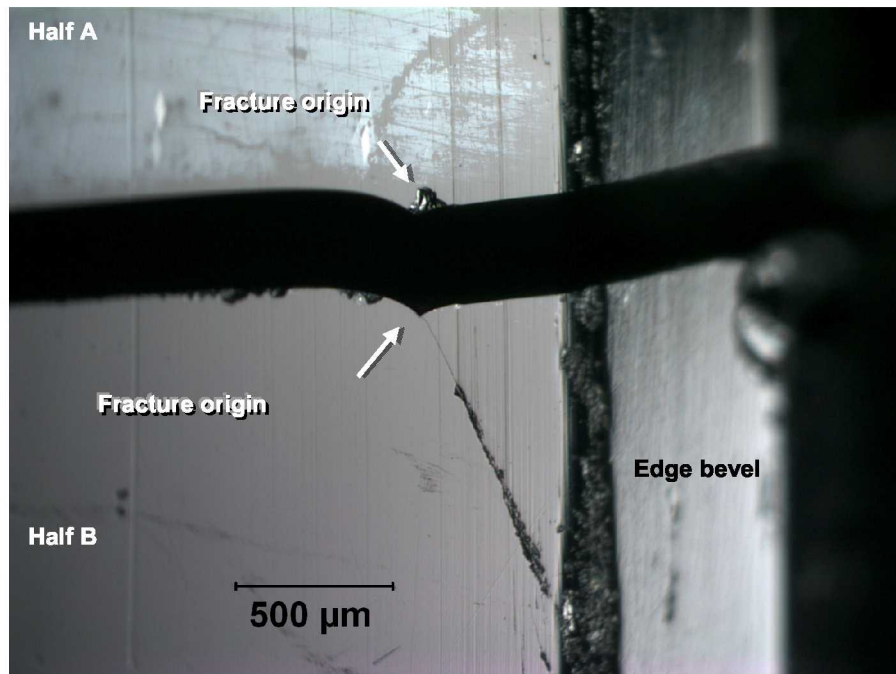
There was a single fracture origin on the lens face that was located only 0.5 mm away from the rim bevel and 1.3 mm away from the cone side wall as shown in Figures 17 and 18. It is not known whether this site was coincident with a shoe contact site as shown in Figures 2 and 3. On half B the origin is clearly identified as a large curved scratch. Close up views of half B are in Figures 19 and 20 which show the curved scratch in more detail.

Figure 18.—View of curved forward face of RSC no. 2. Fracture started from a curved scratch best seen on half B on the bottom. Note the secondary chipping on both halves along the main fracture plane.

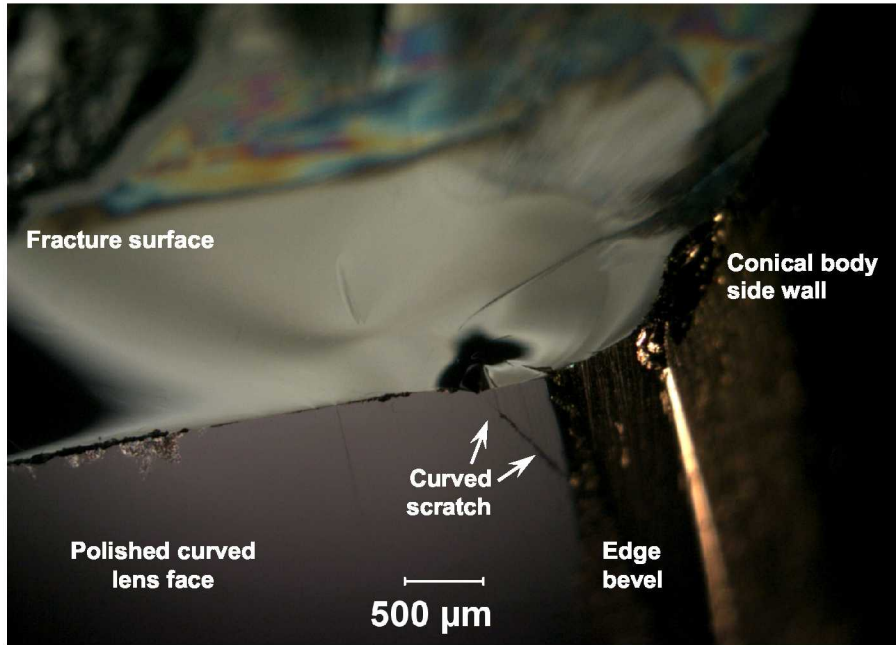
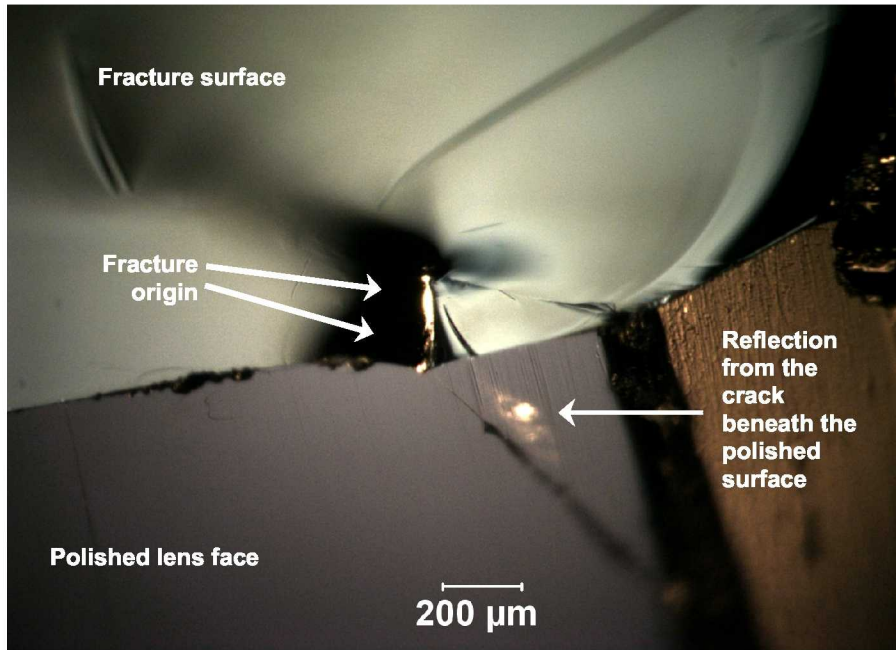
Figure 19.—Stereo optical microscope views of half B of RSC no. 2. The piece has been tilted so that both the fracture surface and the polished curved lens face can be seen. (b) is a close up of (a).

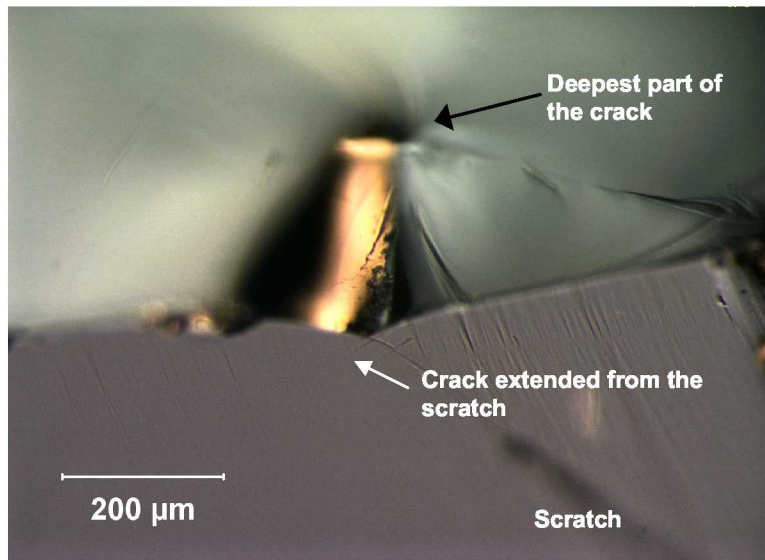
Figure 20.—Detail of the fracture origin of RSC no. 2, in half B. A crack extends from the scratch region (out of focus in this view) which is characterized by tell tale short lateral spall cracks. The crack created underneath the scratch extended upwards and curved to the left in this view (small arrow). The crack penetrates at least 250 μm deep beneath the polished surface into the lens body. Lens fracture started from the deepest point of the crack indicated by the black arrow. In this view, light reflections from the subsurface curved crack face cause shadows and bright reflections.

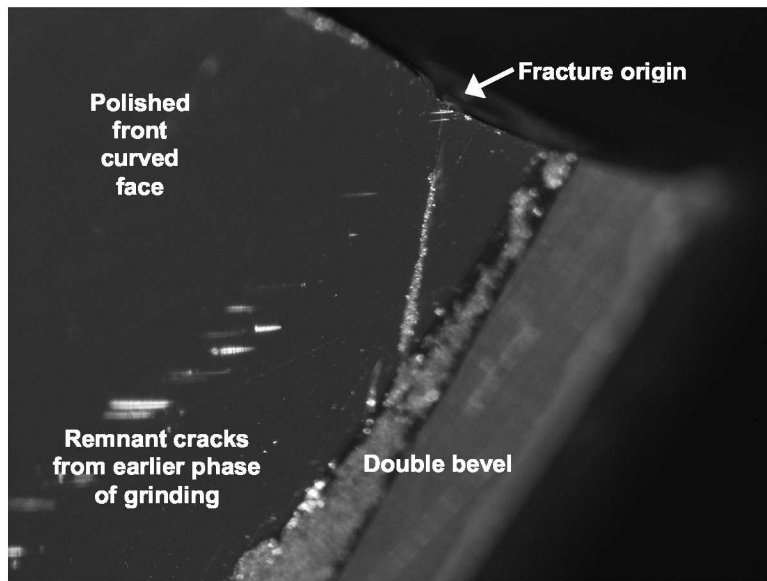
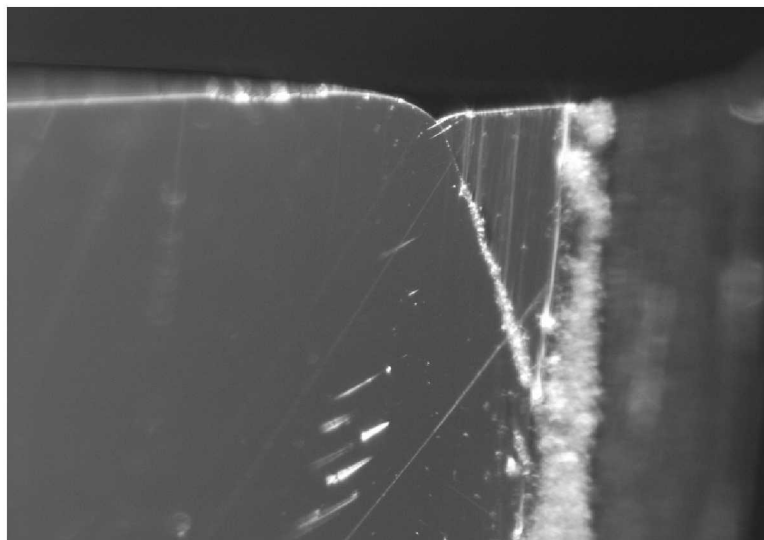
Figure 21.—Two views of the same area of the polished face and edge bevel of half B of RSC no. 2 revealing additional irregularities besides the curved scratch. Notice how adjusting the lighting in (b) can bring out some scratches that are not visible in (a).

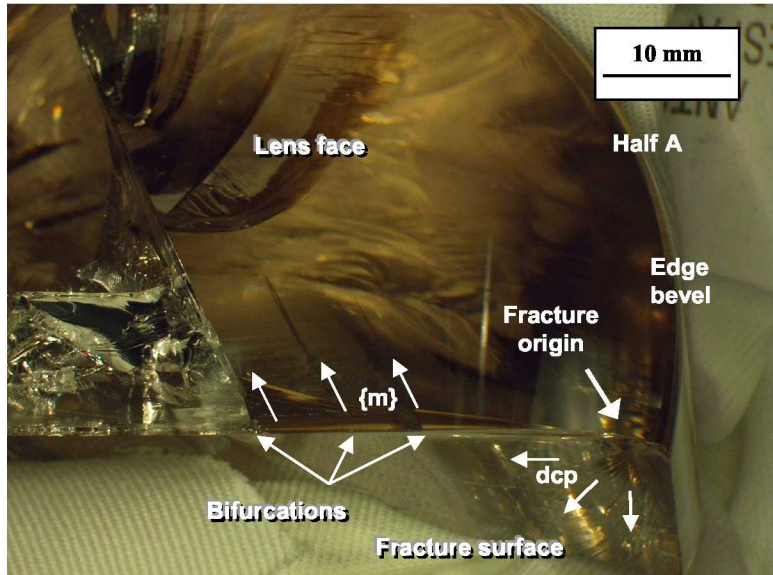
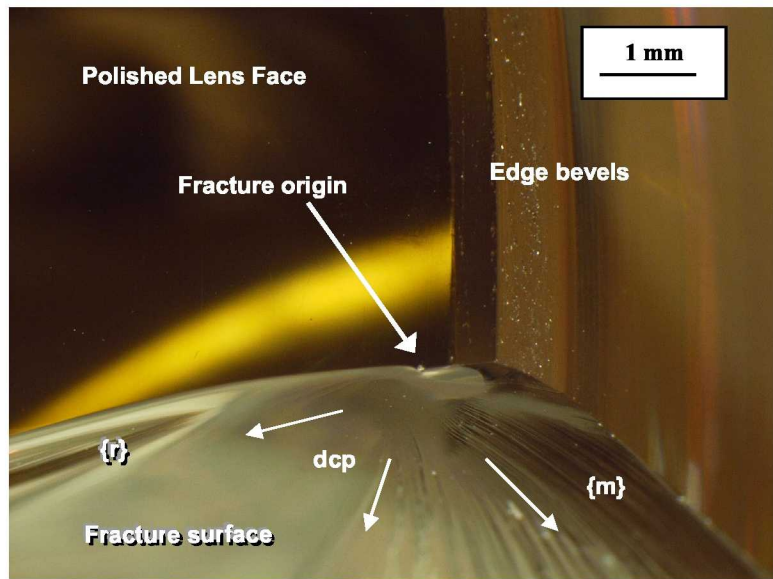
The matching half A of concentrator 2 is shown in Figures 22 to 25. The crack from the scratch is less clearly evident and attention is drawn to what appears to be a pit at the origin site. No trace of the apparent pit existed on half B. The “pit” is probably secondary chipping after the main fracture occurred or it may have been a small initial pit that was enlarged by secondary chipping. The scratch is the primary flaw.

Figure 22.—Views of the fracture origin area in half A of RSC no. 2 showing both the fracture surface and the polished front surfaces. Bifurcations onto the $\{m\}$ plane are evident in (a). The first two do not extend very far into the body, but the third causes a main crack to form all the way through the body. (b) shows radiating hackle lines on the fracture surface that point back to the origin site. “dcp” is direction of crack propagation.

Both of the crack fronts running along the *m*-plane (Fig. 22(b)) and *r*-plane (Fig. 22(a)) bifurcate at ~17 mm. Figure 22(a) shows several short bifurcations that are in a row, but these all arrested after a short propagation into the cone. The first significant bifurcation occurred at 30 mm from the origin. The bifurcation distance of ~17 mm combined with $A_b = 7.0 \text{ MPa}\sqrt{\text{m}}$ and equation 3 implies a fracture stress of ~65 MPa. The larger distance (30 mm) gives a stress estimate of 51 MPa using equation 3. This also is a very low stress, but again, these estimates are supported by the observation that the flaw at the fracture origin was rather large and deep.

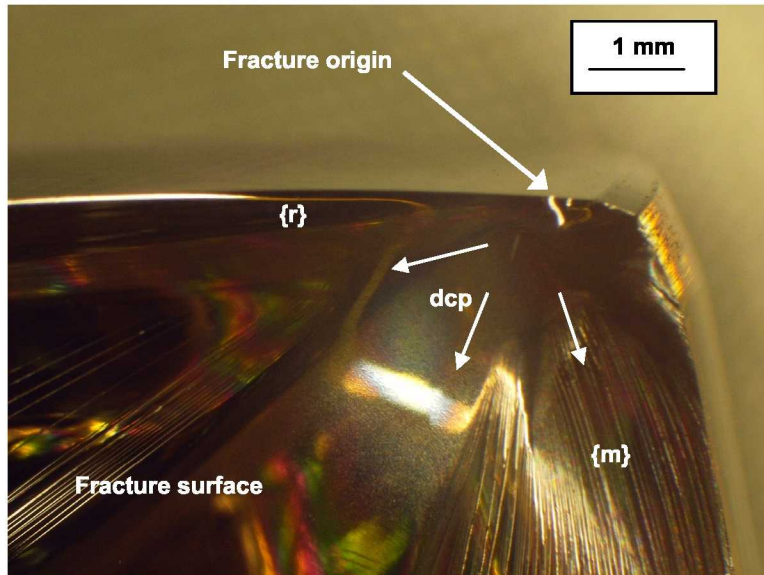
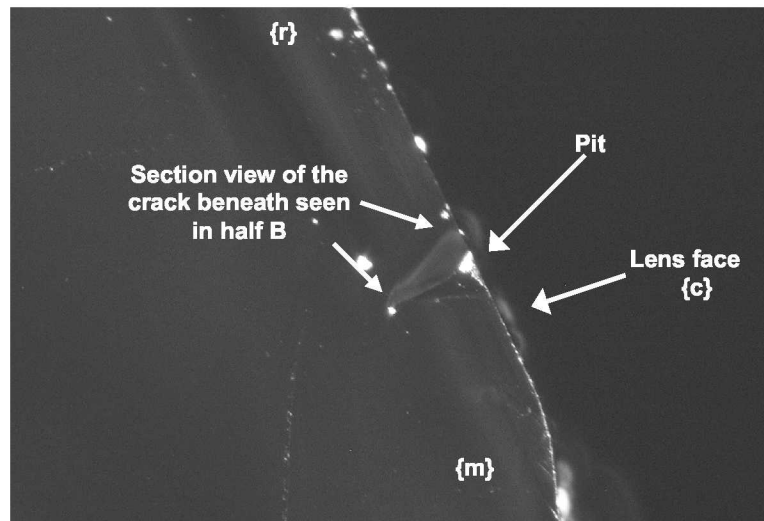
Figure 23.—View of fracture surface of half A of RSC no. 2 showing hackle lines that formed on $\{r\}$ and $\{m\}$ planes on either side of the origin.

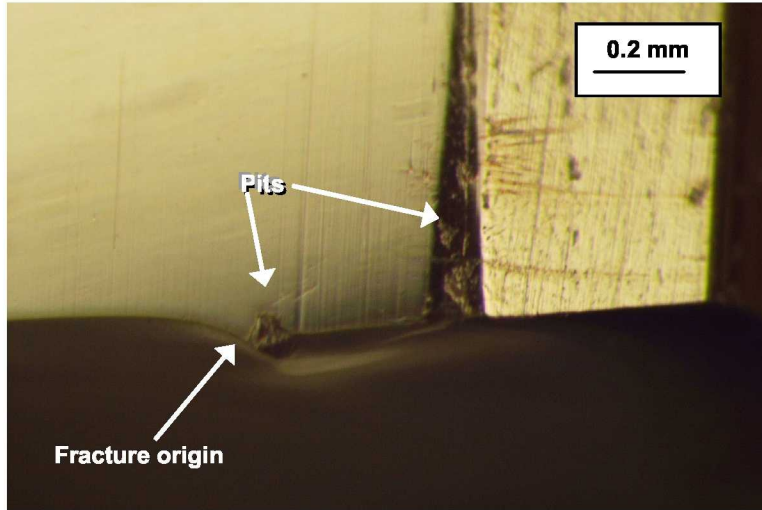
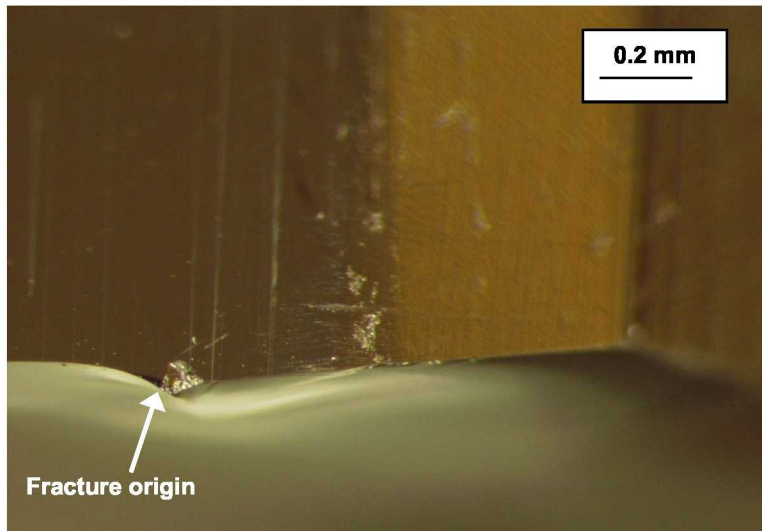
Figure 24.—Two views with different illuminations of lens face of half A of RSC no. 2 showing surface scratches, pits, and the fracture origin site.

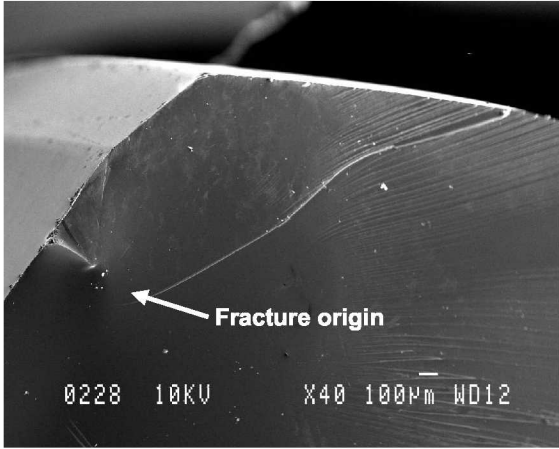
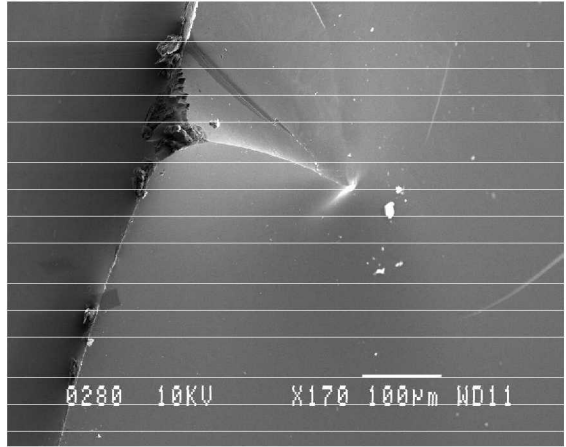
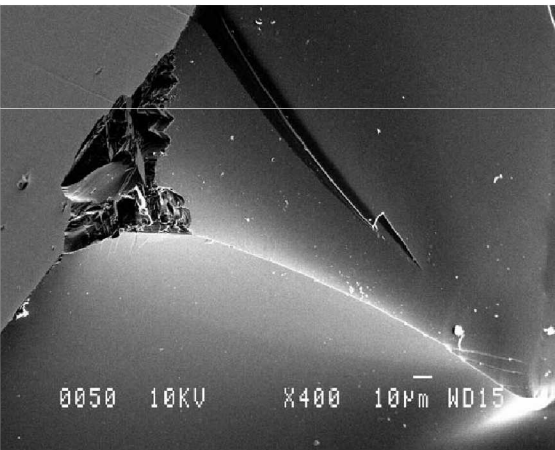
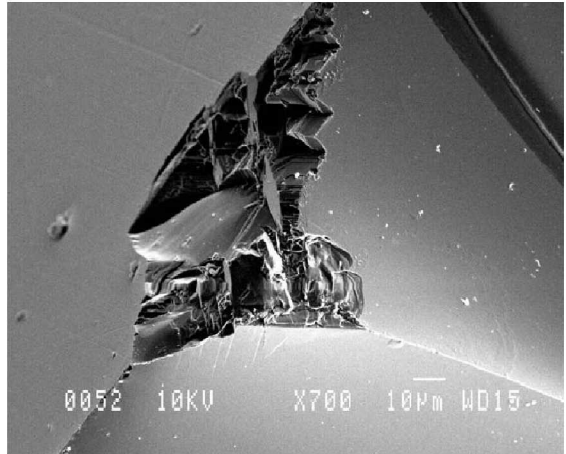
Figure 25—SEM close-up views of the origin in half A of RSC no. 2. (b) to (d) are close up views. The origin is the crack that penetrated beneath the polished surface. The "pit" is probably secondary chipping although genuine pits were noted elsewhere in the vicinity.

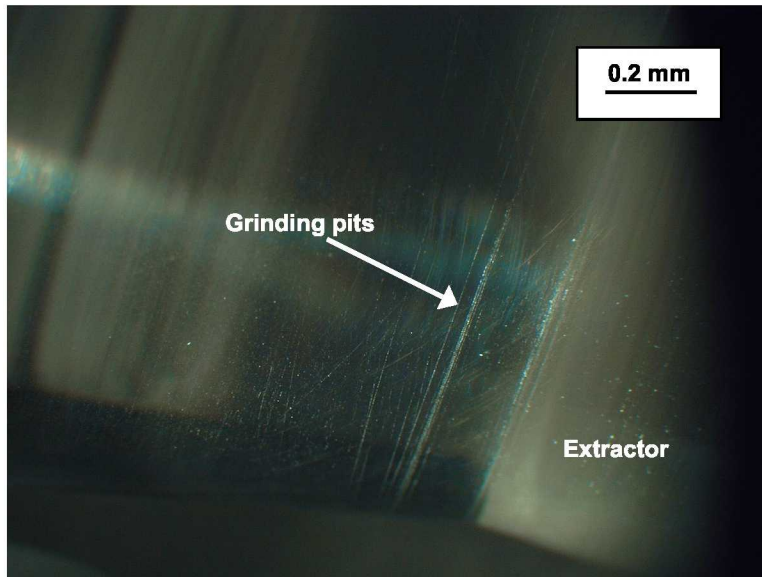
In addition, occasional, large remnant scratches from the initial rough machining stages can be noted on the lens, rod and cone, as shown in Figures 26 and 27. Several other features in the vicinity of the origin were also detected as shown in Figure 28, but they appeared to be incidental micro twins.

Figure 26.—View of lens cone and rod of RSC no. 2 showing surface scratches (grinding damage) prior to testing.

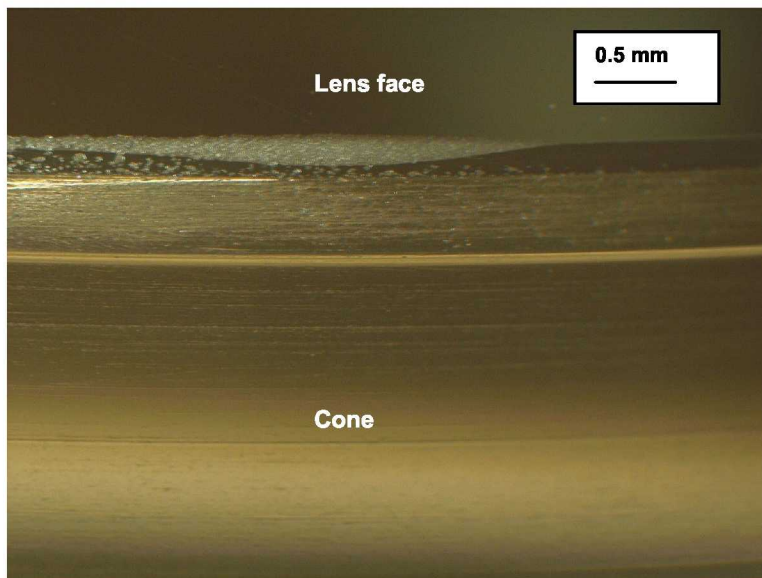
Figure 27.—View of RSC no. 2 cone and bevel showing heavy pitting and surface scratches (grinding damage) prior to testing. Notice the two step uneven bevel.

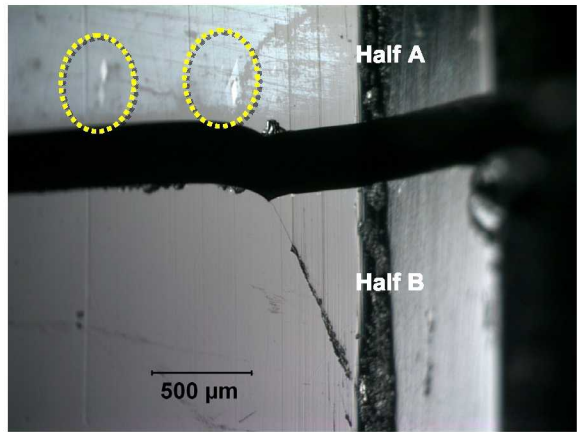
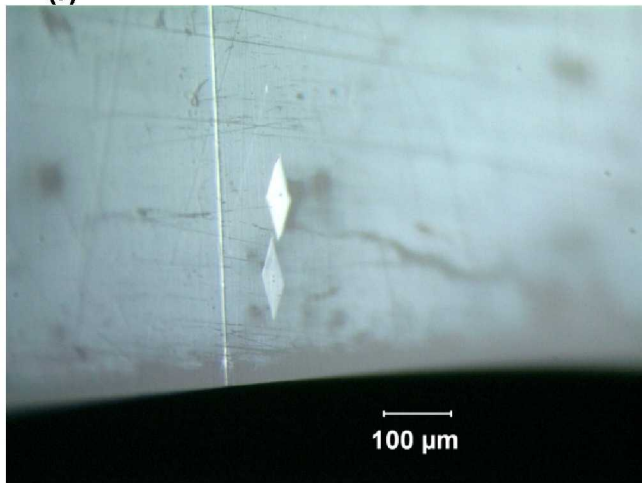
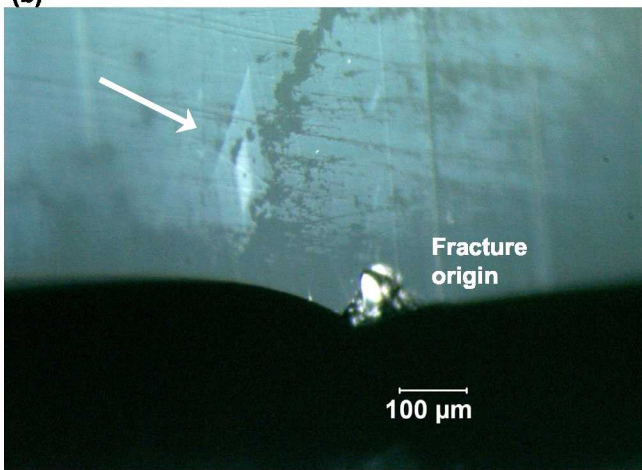
Figure 28.—Odd features detected on or just underneath the surface in half A of RSC no. 2 near but not actually at the fracture origin site. (a) shows the overall origin area with arrows marking the strange features. (b) and (c) are close up views.

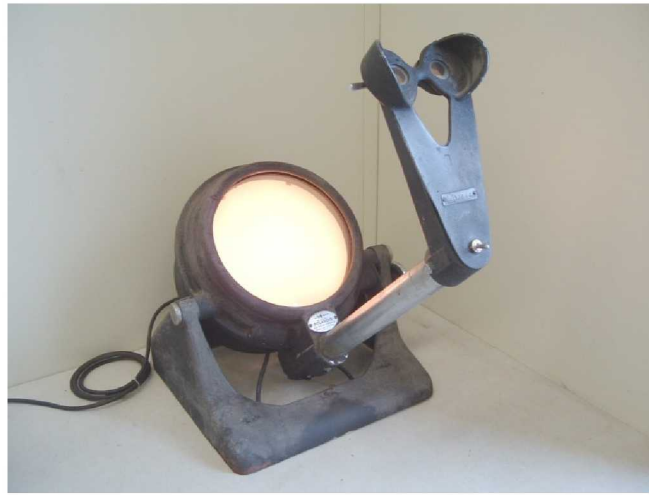
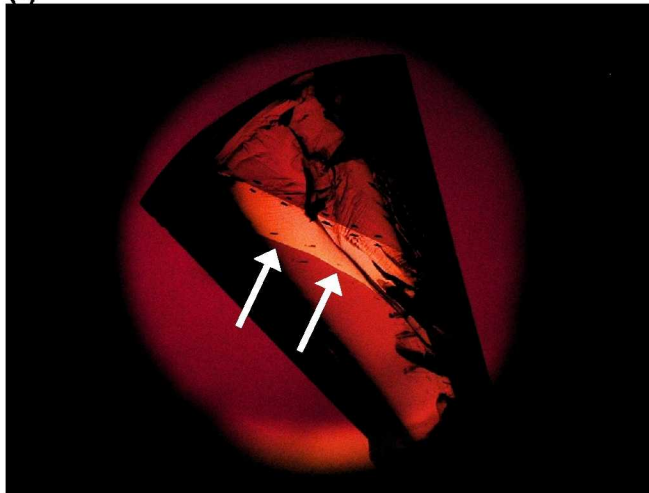
Figure A1.—Classic style Polariscope. (a) The component is placed between the polarizer eyepieces and the illuminated polarizing screen. (b) is a picture of piece 1 of concentrator 1. The photo was taken by a digital camera focused through one eyepiece. The very large twin appears as a light colored band running diagonally through the piece (white arrows). It is not a fracture plane.
