NASA/TM—2009-215802

Failure Analysis of Sapphire Refractive Secondary Concentrators

Jonathan A. Salem
Glenn Research Center, Cleveland, Ohio

George D. Quinn
National Institute of Standards and Testing, Gaithersburg, Maryland

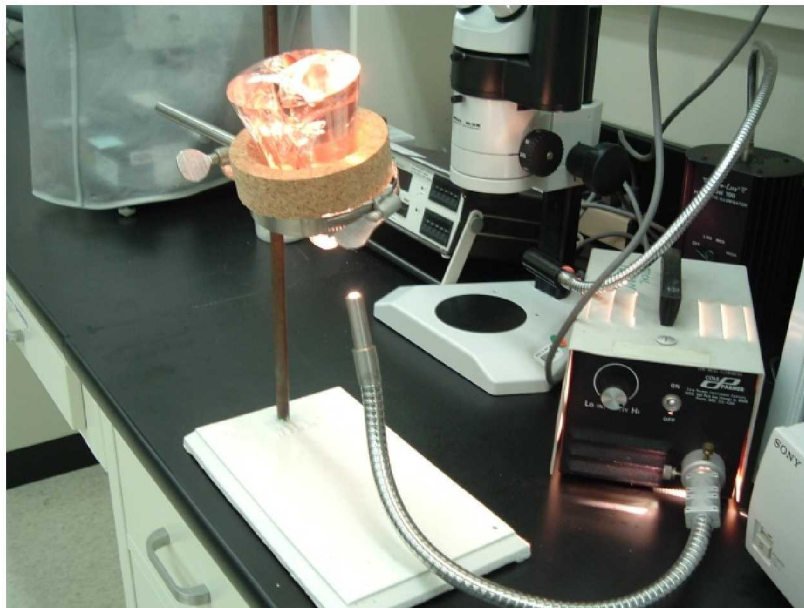
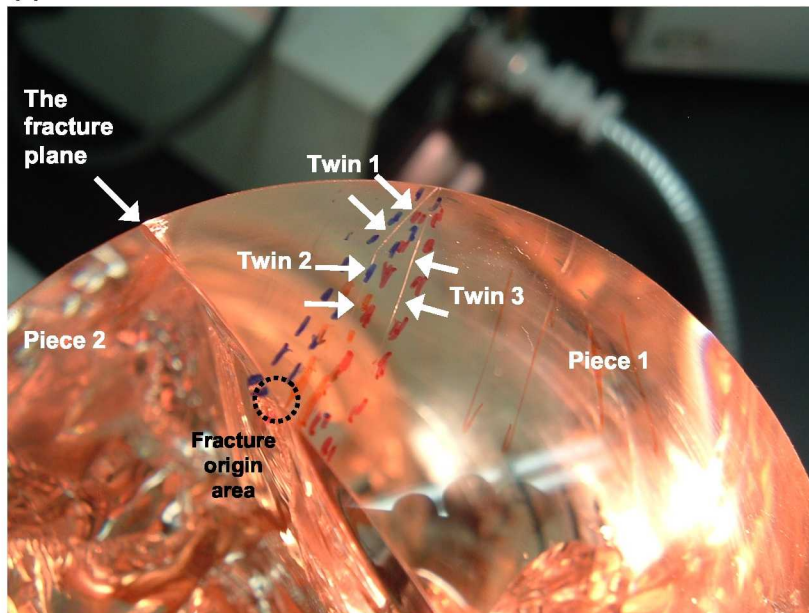
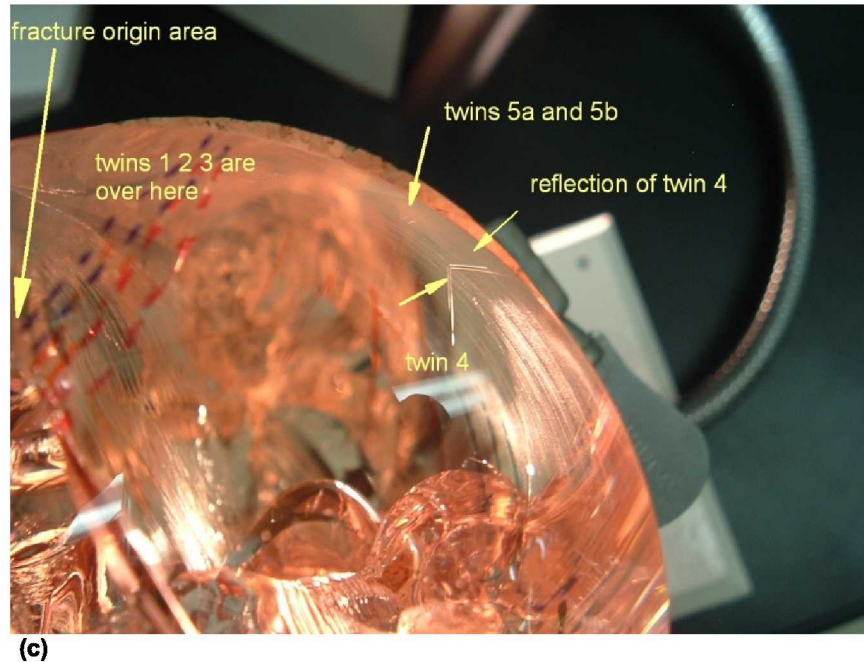
(a) shows the two pieces of concentrator 1 mounted in a soft cork ring on a common ring stand. A fiber optic light source was directed up through the body. (b) shows a digital camera photograph of the front face of RSC no. 1. Color felt tip dashed marker lines were marked on the surface to bracket two twins, which are the very thin white lines marked by the white arrows. (c) shows other twins on the same surface. The lighting and component orientation has to be changed to accentuate each twin set since it is difficult to get all twins visible at the same time. Twins 5a and b are tiny short segments. Twin 4 is longer.
