International Space Station Powered Bolt Nut Anomaly and Failure Analysis Summary

Daniel E. Sievers* and Harry K. Warden**

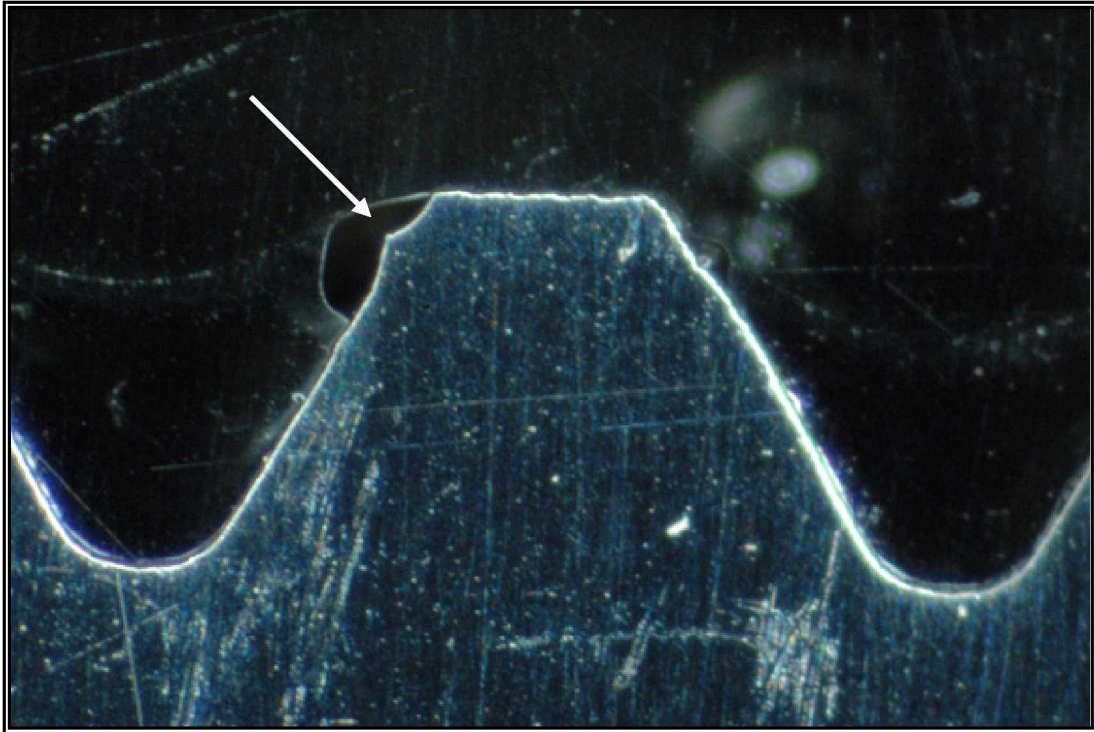
The machinist must ensure adequate and uniform lapping over all the internal threads with a hand tool specially made for the PBN thread dimensions to ensure burrs are removed and the required 16 micro-inch finish is obtained. The lapping process for the 2009 PBNs consists of machining a bolt to proper dimensions and covering it with lapping compound. When choosing a hand tool to lap the nuts and remove burrs left from machining, the hand tool material must be softer than the nut base material. This is to ensure the burrs will be removed and the base metal will not be damaged by galling with the hand tool. The best way to ensure an adequate finish is to fully engage the softer material tool with lapping compound multiple times to wear down any burrs left from machining. This process was implemented for the 2009 PBNs to smooth out burrs and meet required finishing while opening the nut pitch diameter before the application of lubricant. Figure 2, shown in the Appendix, is a surface finish error (burr) that occurred due to inadequate machining and lapping of the 2007 PBNs. This error may seem minuscule, but when requiring the Powered Bolt to autonomously attach two pressurized elements of the ISS together, a small burr will quickly break through the thin dry film lubricant and cause galling of the Powered Bolt Assembly.

Figure 2: Surface Finish error, burr; 500x magnification

- When lapping a surface, a method which is capable of obtaining the desired surface finish in every thread, groove, etc... must be determined and controlled. In this case, manual thread lapping with a "softer" tool and lapping compound, lapped multiple times worked well to wear down any burrs left from machining.
- Polishing with a lathe and sponge method was eliminated.
- Use of a go/no-go gauge before lubrication to check for correct thread dimensions was implemented.

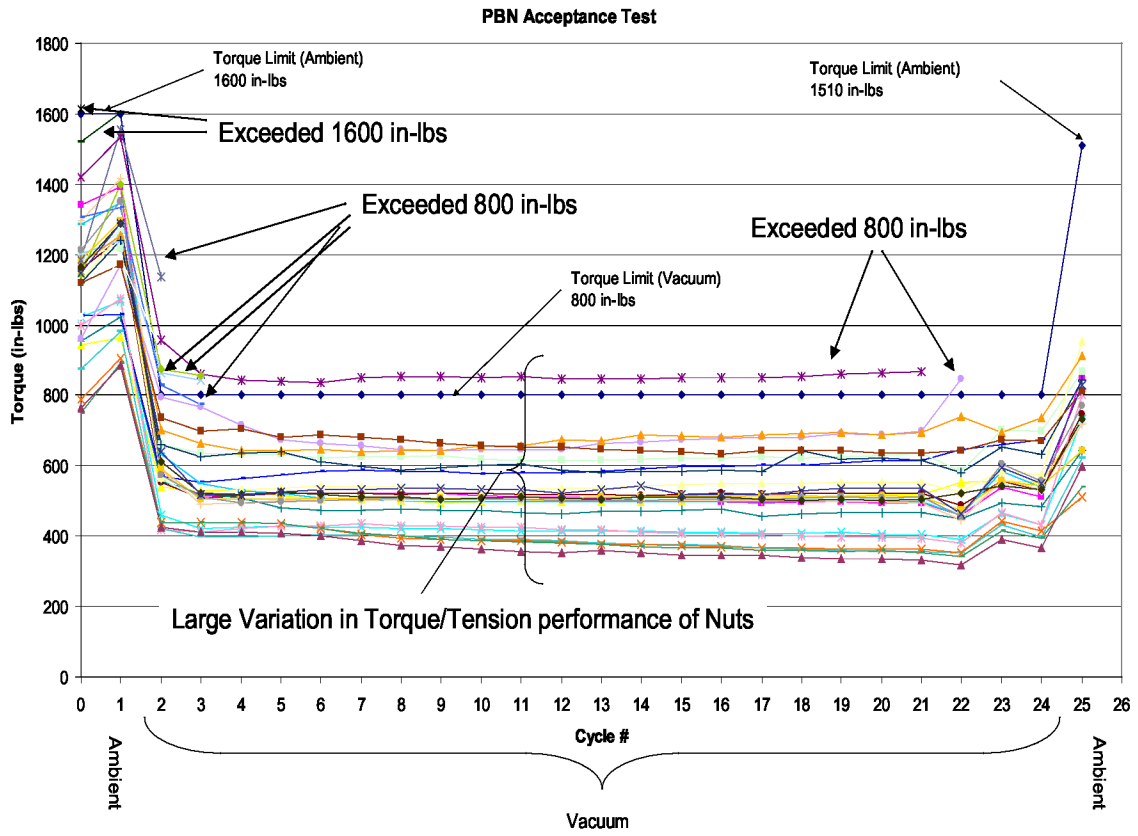
Dry film lubricants are used in space applications and specifically with the Powered Bolt Nuts for their thermal stability, low abrasivity and low shear strength. Dry Film Lubrication of the PBNs is another important aspect of manufacturing which ensures a smooth running system with no galling issues and consistent torque-tension characteristics of the mechanism. Each PBN should have values above 800 inch-pounds throughout cycles 2 through 24 of acceptance testing. Unacceptable test data from the PBNs manufactured in 2007 can be seen in Figure 3 of the Appendix. If the PBNs are not fabricated or lubricated correctly, testing torque limits above 800 inch pounds will be seen during cycles 2 through 24 of acceptance testing resulting in a failed acceptance test. The Acceptance test for the PBNs is a very rigorous test. A Powered Bolt (PB) is cycled into a PBN 28 times under a normal operating load. Cycles 0 and 1 are at ambient pressure and temperature. Cycles 2 through 21 are under vacuum at ambient temperature. Cycle 22 is under vacuum and at cryogenic temperatures. Cycle 23 is under vacuum and at hot temperatures. Cycle 24 is at vacuum at ambient temperatures. To finish the test, Cycles 25 through 28 are at ambient temperature and pressure. Figure 4 of the Appendix shows complete acceptance test data of all of the 2009 PBNs. The 2009 Acceptance test data shows more consistent torque-tension behavior of the correctly fabricated PBNs compared to the failed 2007 PBNs.

Figure 3: Acceptance test data from failed PBN lot of 2007

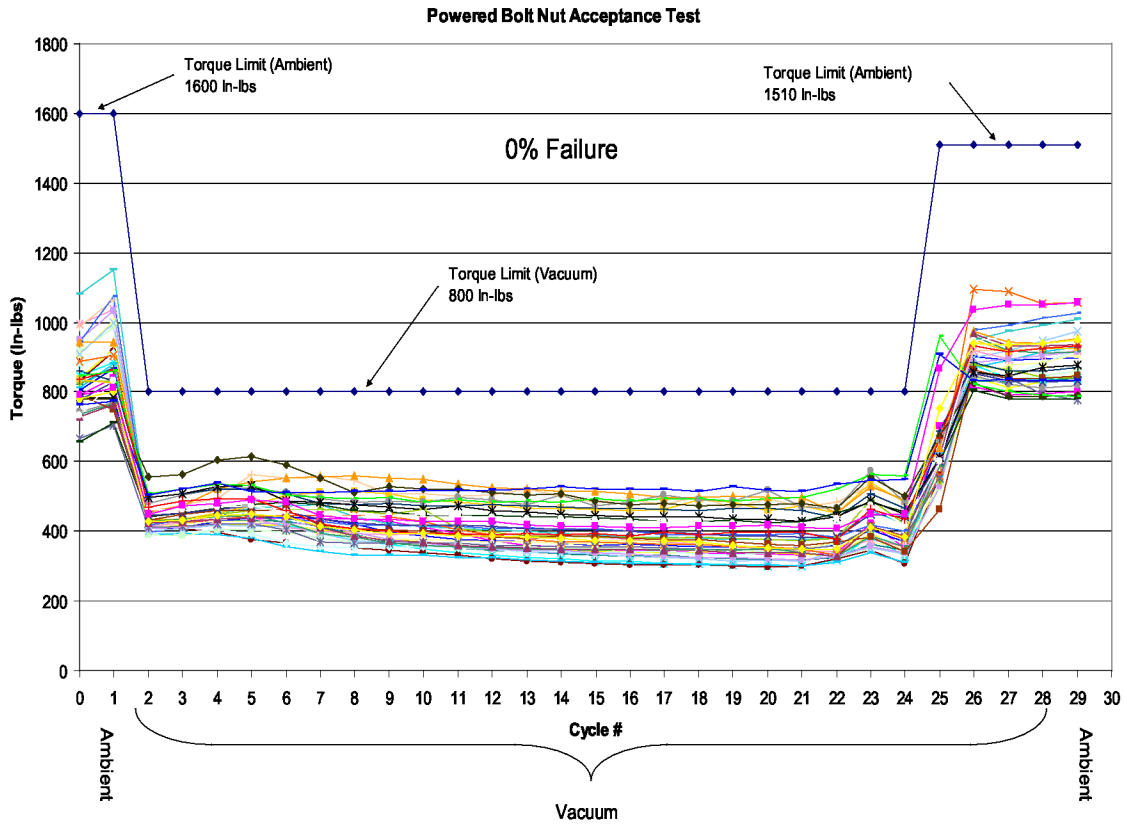
Figure 4: Acceptance test data from passed PBN lot of 2009

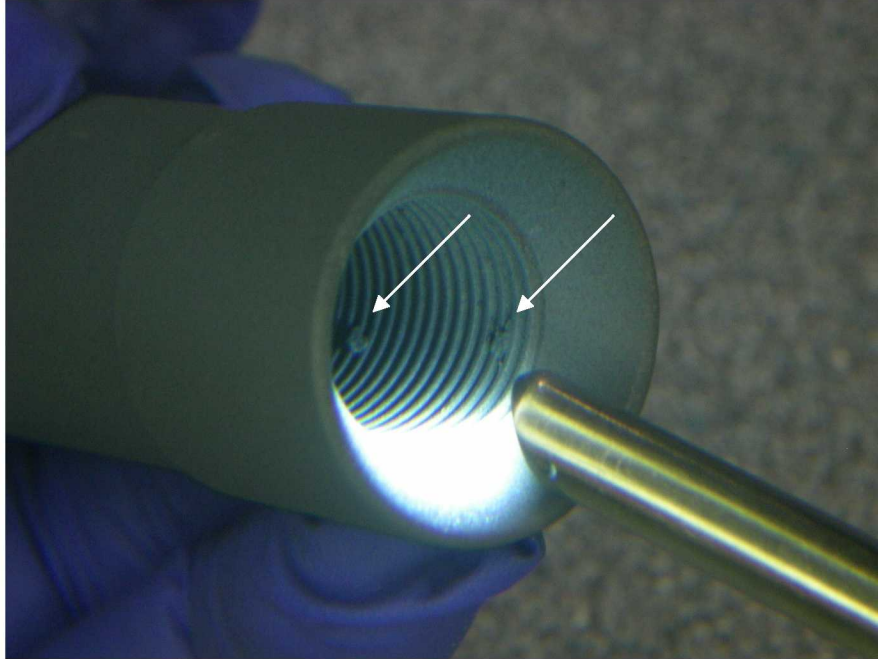
Figure 5: Agglomerations of base coat ceramic of Dry Film Lubricant

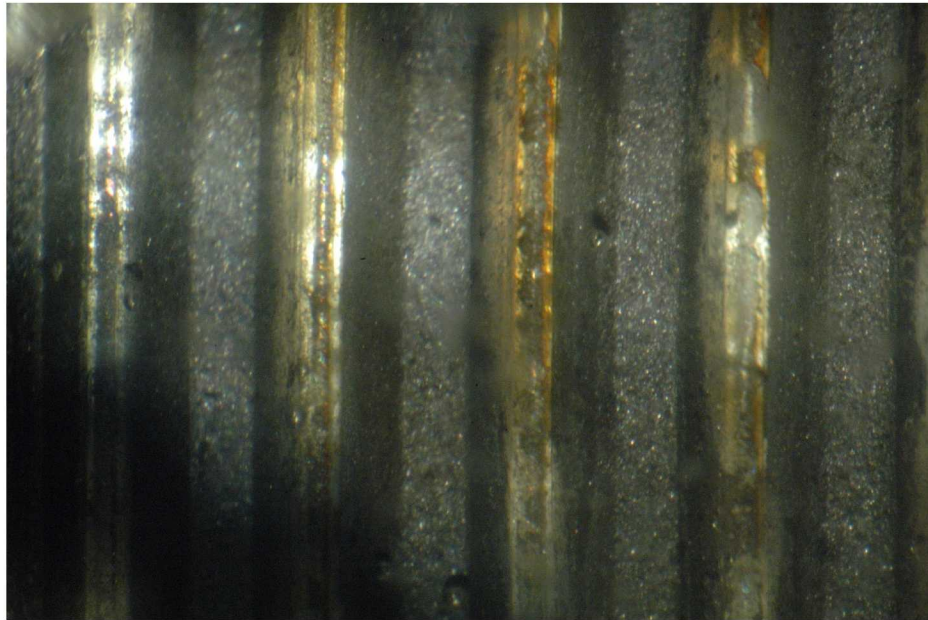
Figure 6: Amber coloration of resin binder; 50x magnification

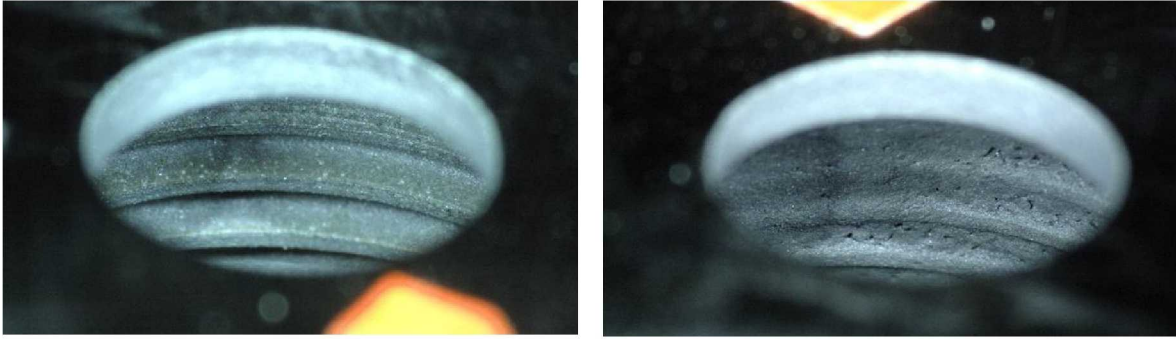
Figure 7: 2 180° views of a failed PBN; 50x magnification

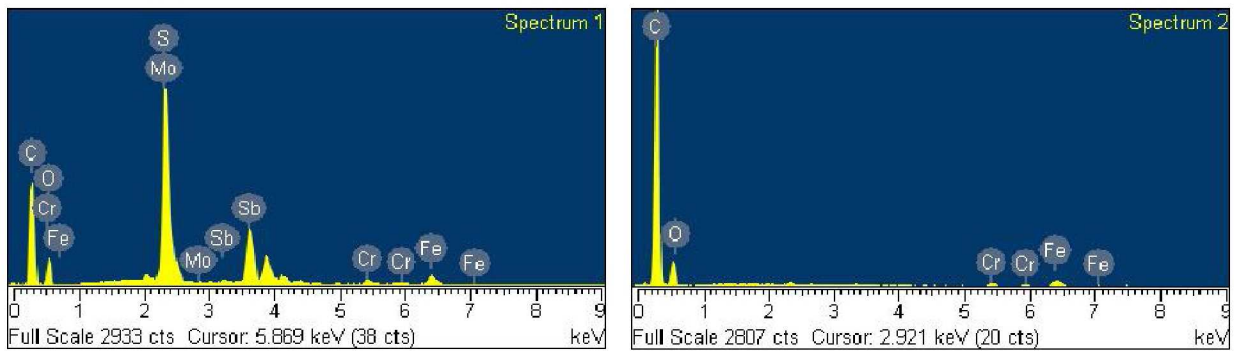
A way of analyzing lubricant for composition is using an Energy Dispersive Spectrometer (EDS). This equipment will show if lubricant is missing from the threads. The EDS indicated that the ceramic base coat was applied to the threads before the resin top coat. Figure 8, located in the Appendix, shows EDS images of a PBN which failed acceptance testing. Spectrum 1 is of a non-amber colored area and Spectrum 2 is of an amber colored area. The chemistry shows the absence of the Molybdenum disulfide (MoS_2) and Antimony (Sb) which make up the ceramic base coat of Vitro-lube NPI-1220C. This absence of ceramic base coat is a direct cause of not preheating the PBNs before lubrication.

Figure 8: Differences in coating chemistry of PBN

- To maintain consistent lubrication thickness a thread cutting technique was implemented over a thread rolling tap. Consideration of final lubricant dimensions is a key aspect of choosing a cutting tap.
- A preheating process was implemented to obtain proper flash temperature. Due to the migrating capabilities of dry film lubricants that are applied on to substrates as liquids, it is beneficial to preheat all mechanisms to defer and risk of lubricant pooling or lack of lubricant in less energy potential areas.
- Imposing an out of oven time limit during the lubrication process to keep the mechanisms at flash temperature.
