Investigation of Cracks Found in Helicopter Longerons

Abstract: Four cracked longerons, containing a total of eight cracks, were provided for study. Cracked regions were cut from the longerons. Load was applied to open the cracks, enabling crack surface examination. Examination revealed that crack propagation was driven by fatigue loading in all eight cases. Fatigue crack initiation appears to have occurred on the top edge of the longerons near geometric changes that affect component bending stiffness. Additionally, metallurgical analysis has revealed a local depletion in alloying elements in the crack initiation regions that may be a contributing factor. Fatigue crack propagation appeared to be initially driven by opening-mode loading, but at a crack length of approximately 0.5 inches (12.7 mm), there is evidence of mixed-mode crack loading. For the longest cracks studied, shear-mode displacements destroyed crack-surface features of interest over significant portions of the crack surfaces.

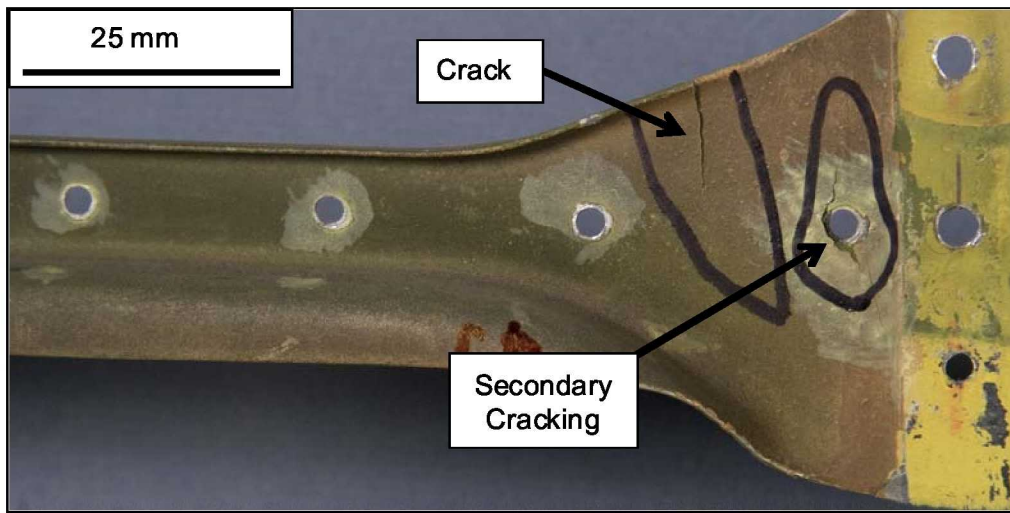
(a) Photograph of typical longeron crack with secondary cracking (Longeron #2, Crack #2).

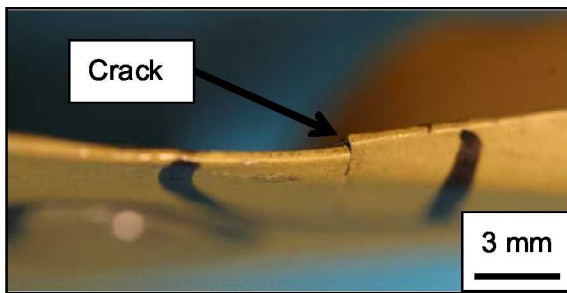
(b) Photograph of crack with residual shear displacement (Longeron #4, Crack #1).

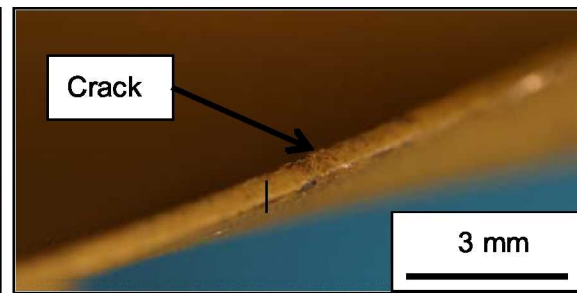
Finally, it is possible that residual shear displacements were not a product of service loading, but were imparted on the structure during component removal. The two smallest cracks (Longeron #1, Crack #3 and Longeron #4, Crack #2) were only discovered during examination at NASA (not found during Army inspections), and these cracks were considered to be “tight,” meaning that these cracks appeared as a fine linear indication without obvious residual shear deformation. Therefore, it seems likely that the visual inspection performed as routine maintenance, was only able to detect highly-visible cracks with significant shear displacements. Specifically, cracks with significant residual shear displacements expose a portion of the crack face, providing visual contrast with the painted (green) longeron surface, enhancing crack detection.

(c) Photograph of crack without residual shear displacement (Longeron #4, Crack #2).

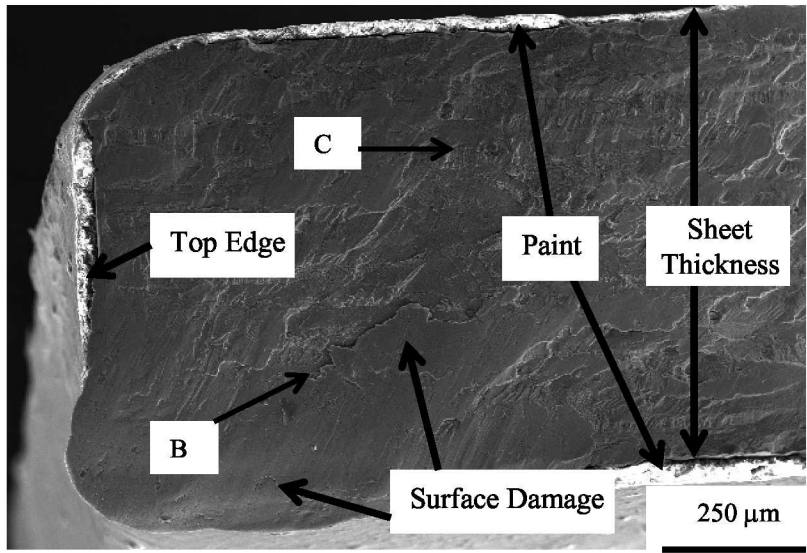
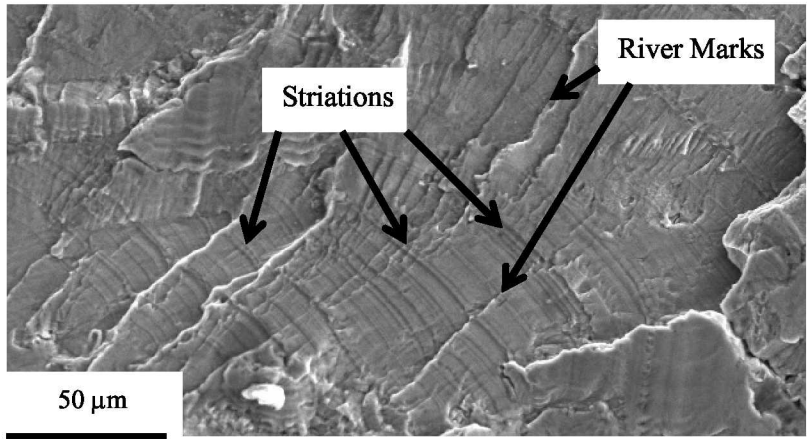
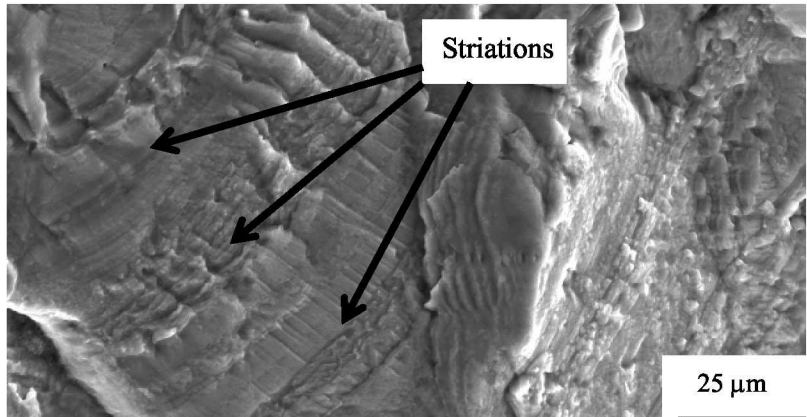
Figure 4. SEM crack-surface micrographs for Longeron #1, Crack #1.

SEM crack-surface micrographs for Longeron #1, Crack #1 (a crack approximately 0.85 inches long (21.59 mm) that initiated at Station 164.87) are shown in Figure 4. In Figure 4a, the sheet thickness direction is oriented vertically with the top edge of the longeron on the left side of the figure. Bright white regions seen on the outer surfaces of the sheet are paint. Large portions of the crack surface appear to be damaged or smeared, likely a result of the crack surfaces coming into contact with each other. Crack-surface features that may have been in these damaged regions have been destroyed; however, there are undamaged regions of the crack surface where striations have been found, and are shown at higher magnification in Figures 4b and 4c. These striations are compelling evidence that crack growth was driven by fatigue loading (ref. 1). Additionally, river marks (fatigue crack surface features that are typically perpendicular to striations, oriented parallel to the direction of crack growth) are labeled in Figure 4b.

(a) Lower-magnification image showing the entire sheet thickness.

(b) Higher-magnification image of fatigue striations, region B.

(c) Higher-magnification image of fatigue striations, region C.

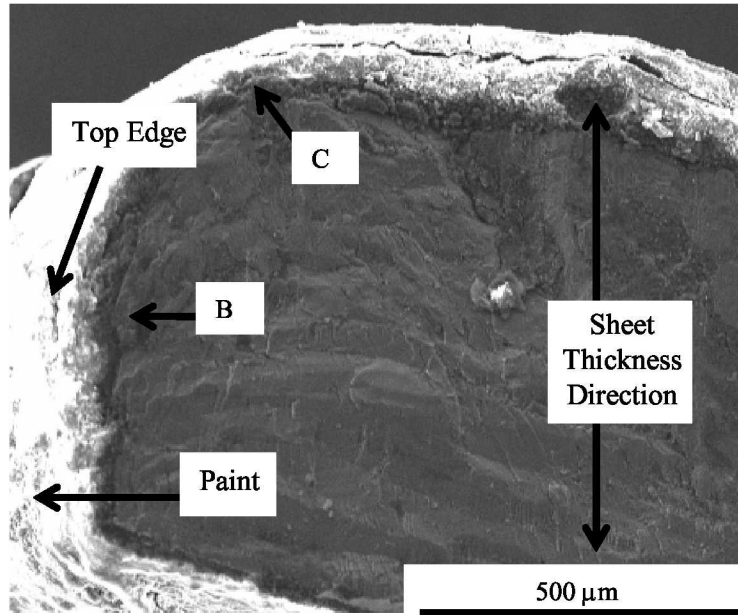
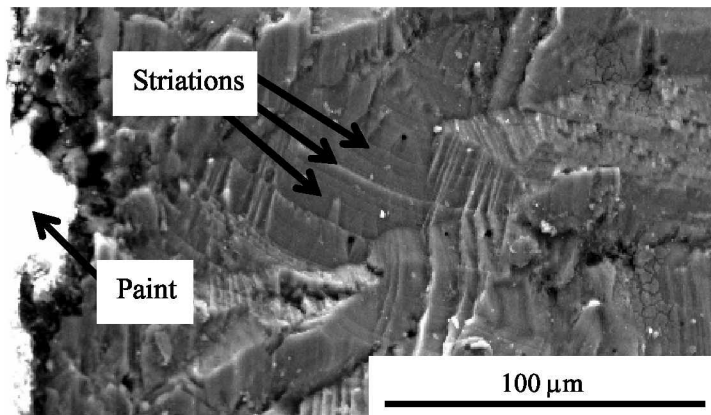
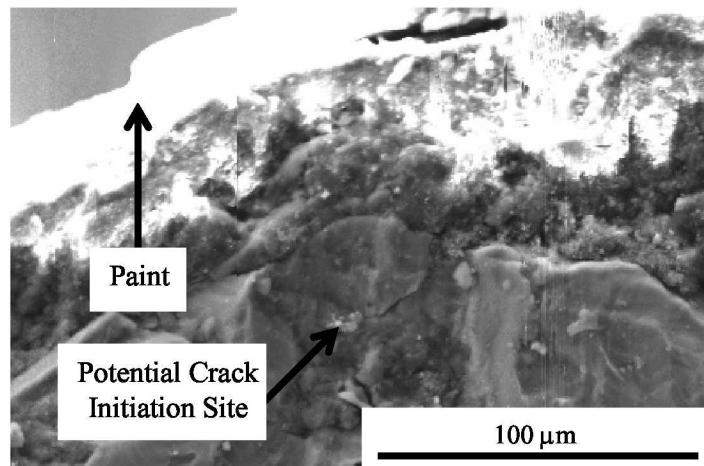
Figure 5. SEM crack-surface micrographs for Longeron #1, Crack #2.

Crack-surface examinations of Longeron #1, Crack #2 (a crack approximately 0.38 inches long (9.65 mm) occurring at Station 155.75), reveals the presence of fatigue striations, microscopic features consistent with fatigue crack growth (see Figure 5). A lower-magnification image of the crack surface is shown in Figure 5a corresponding to the top side of the longeron in the region where crack initiation appears to occur. The sheet thickness (0.025-inch-thick) direction is oriented vertically in this image. Two regions of interest are denoted, which are shown at higher-magnification in Figures 5b and 5c. Fatigue striations are easily identified in Figure 5b and at multiple other locations on the crack surface (ref. 1). The slight curvature of these striations (indications of the crack front at some previous point in time) can be traced back to determine the crack initiation site, which is shown at higher-magnification in

Figure 5c. Crack-surface features suggest that the location of crack initiation was near the surface of the sheet material. No obvious defect in the region of crack initiation was noted (e.g., corrosion pit, scratch, tool mark, etc.). The bright region near the outer surface of the sheet (extreme right side of Figure 5c) is a result of the paint covering the longeron.

(b) Higher-magnification image of fatigue striations, region B.

(c) Higher-magnification image of apparent crack initiation site, region C.

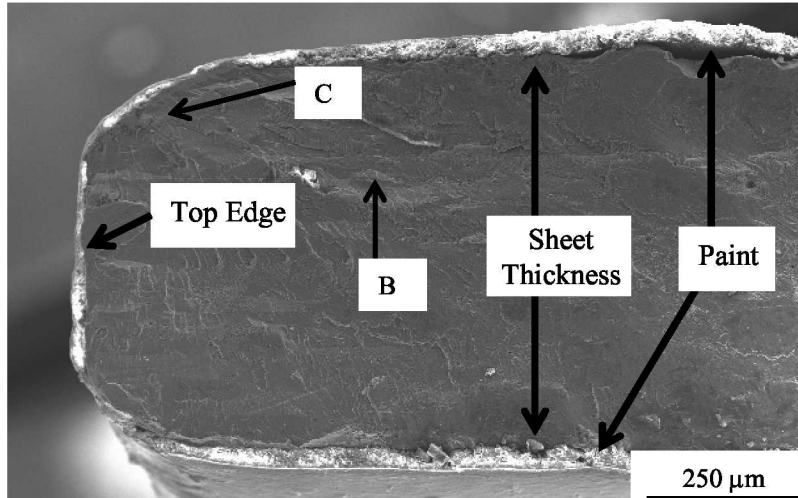
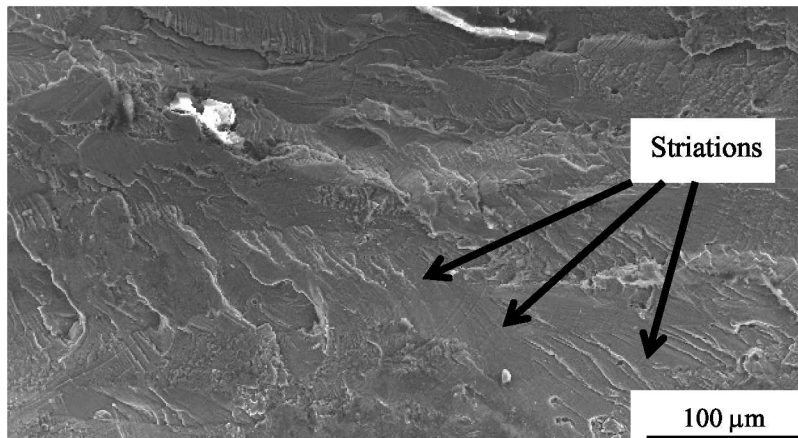
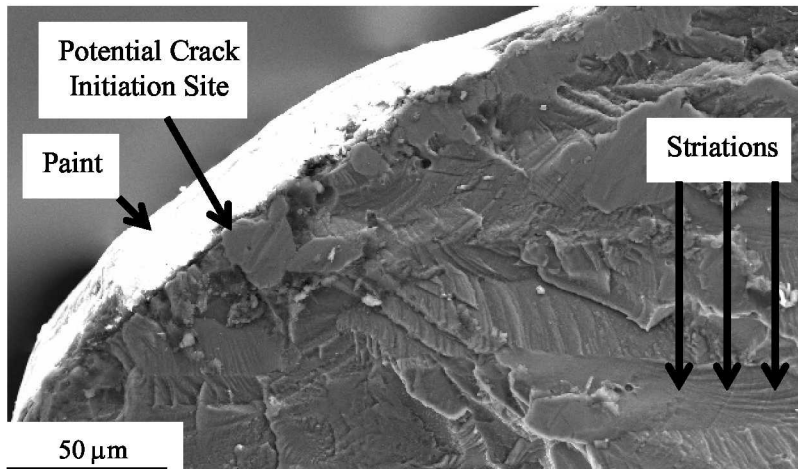
Figure 6. SEM crack-surface micrographs for Longeron #1, Crack #3.

SEM crack-surface micrographs for Longeron #1, Crack #3 (a crack approximately 0.15 inches long (3.81 mm) that initiated at Station 185.89) are shown in Figure 6. The crack surface corresponding to the top edge of the longeron is shown in Figure 6a, where the top edge of the longeron is on the left side of the figure and the sheet thickness direction is vertical. Paint on the surface of the longeron is seen as the bright white regions near the top and bottom of the figure. The crack surface is nearly free of mechanical contact damage and striations can be readily observed over nearly the entire surface (ref. 1). A typical striated region is shown in Figure 6b. Striations can be traced back to an apparent origin, which is located near the top left corner of the sheet, with respect to the orientation presented in Figure 6a, and is shown at higher magnification in Figure 6c.

(b) Higher-magnification image of fatigue striations, region B.

(c) Higher-magnification image of apparent crack initiation site, region C.

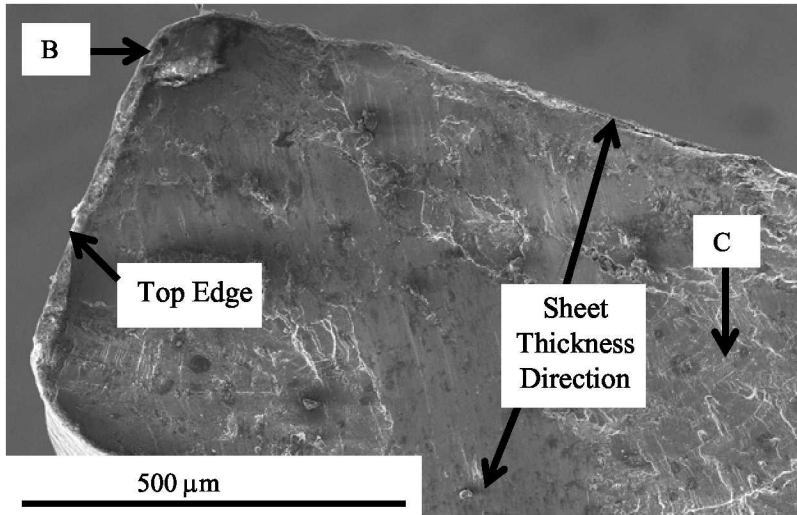
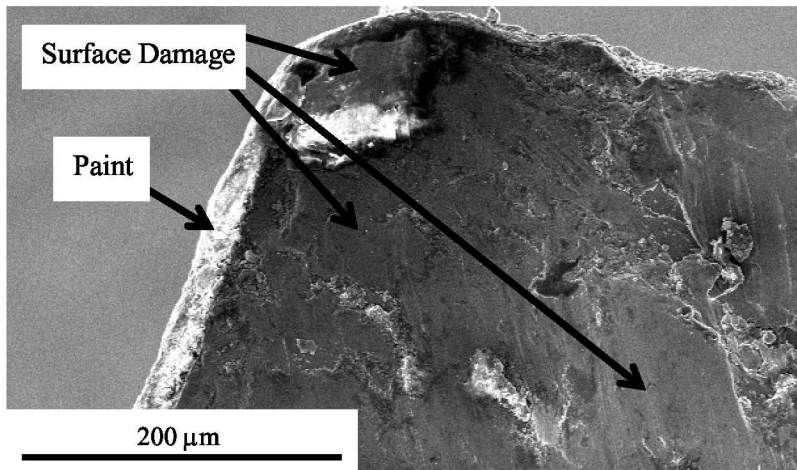
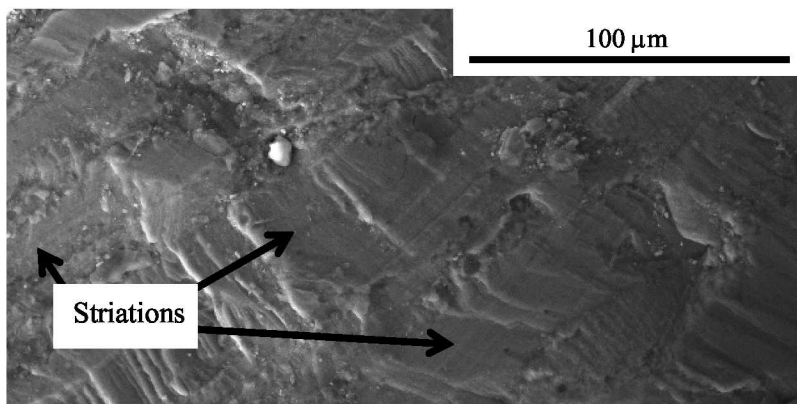
Figure 7. SEM crack-surface micrographs for Longeron #2, Crack #1.

SEM crack-surface micrographs for Longeron #2, Crack #1 (a crack approximately 0.62 inches long (15.75 mm) that initiated at Station 146.62) are shown in Figure 7. A lower-magnification image of the crack surface corresponding to the top edge of the longeron (apparent crack initiation region) is shown in Figure 7a. A higher-magnification image of the crack surface, corresponding to the upper left corner of Figure 7a, is shown in Figure 7b. Here, the crack surface appears to be smeared (contact damage) such that most of the crack-surface features (e.g., fatigue striations) have been destroyed. However, further from the top edge of the longeron (crack surface regions corresponding to the left side of Figure 7a), fatigue striations are observed (ref. 1). A typical region of fatigue striations is shown at high magnification in Figure 7c.

(b) Higher-magnification image of crack-surface damage, region B.

(c) Higher-magnification image of fatigue striations, region C.

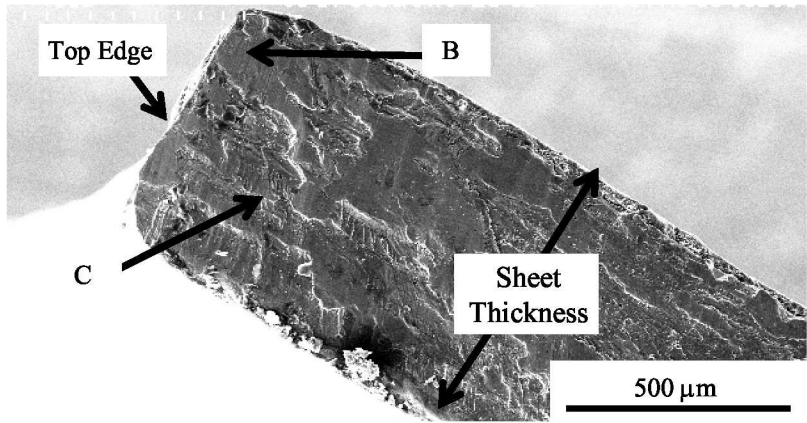
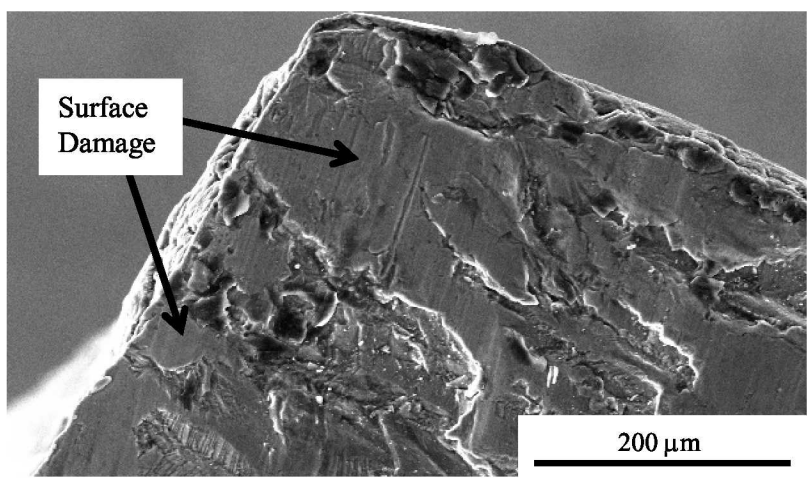
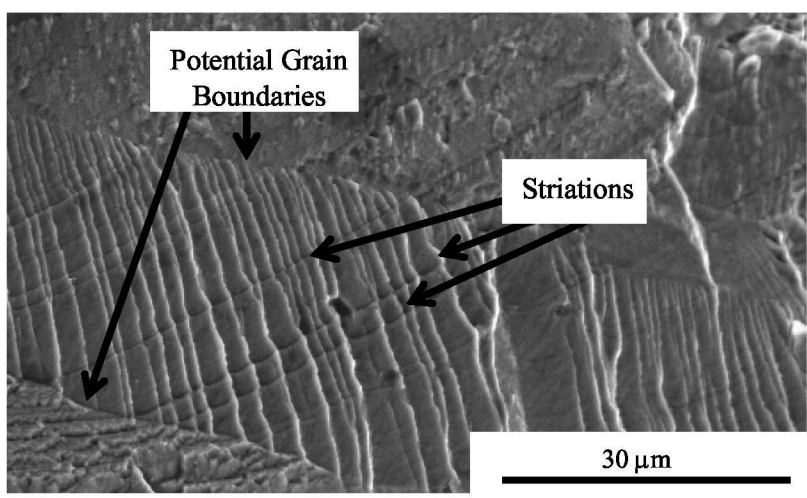
Figure 8. SEM crack-surface micrographs for Longeron #2, Crack #2.

SEM crack-surface micrographs for Longeron #2, Crack #2 (a crack approximately 0.44 inches long (11.18 mm) that initiated at Station 164.87) are shown in Figure 8. The crack surface near the top edge of the longeron is shown at lower-magnification in Figure 8a. A higher-magnification image of the crack surface, corresponding to the upper left corner of Figure 8a, is shown as Figure 8b. Similar to the results previously shown in Figure 7 (Longeron #2, Crack #1), the crack surface appears to be smeared (contact

damage) such that most of the crack-surface features, like fatigue striations (if they did exist), have been destroyed. However, there are a few islands of undamaged crack surface that contain striations (ref. 1). An example of these striations is shown in Figure 8c. Here, “river marks” (fatigue crack surface features that are typically perpendicular to striations, oriented parallel to the direction of crack growth) can be seen oriented vertically and striations are seen arcing across the image, as the crack appeared to grow from the upper left corner of the figure to the lower right. In this image, a third set of interesting linear features can be seen that are believed to be grain boundaries (ref. 1). Here, it is believed that the region containing the clear striations is within a grain oriented in a manner to promote striations while the regions above and below are grains having different orientations such that striations are less pronounced. If these features are indeed grain boundaries, the grains in this sheet product are elongated in the sheet directions and thin in the direction of the sheet thickness. Further work is needed to characterize the microstructure of this sheet product.

(b) Higher-magnification image surface damage, region B.

(c) Higher-magnification of fatigue crack striations, region C.

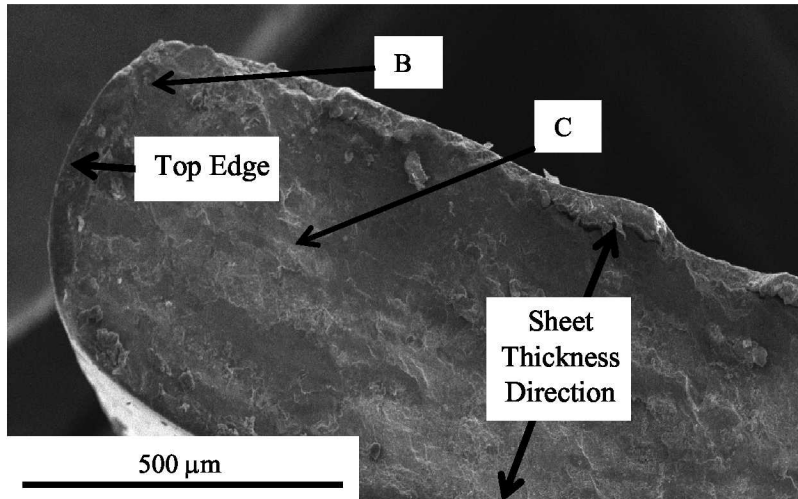
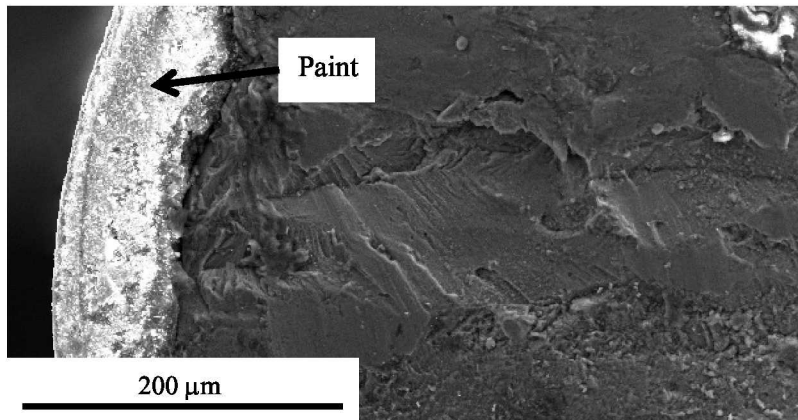
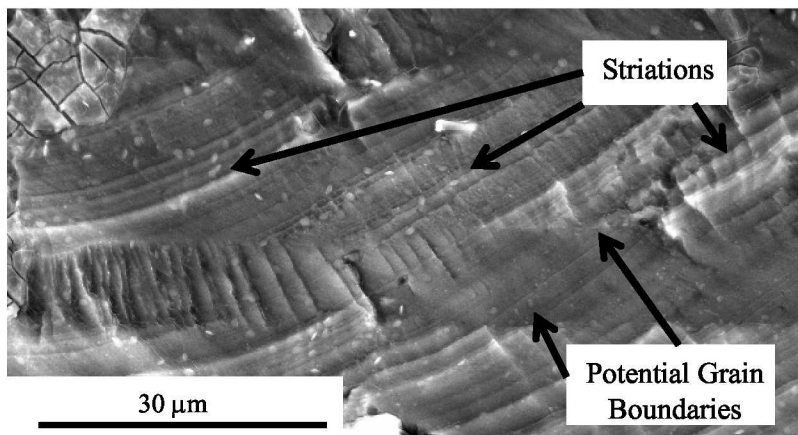
Figure 9. SEM crack-surface micrographs for Longeron #3, Crack #1.

SEM crack-surface micrographs for Longeron #3, Crack #1 (a crack approximately 0.31 inches long (7.87 mm) that initiated at Station 164.87) are shown in Figure 9. The crack surface region near the top edge of the longeron is shown at lower-magnification in Figure 9a. A higher-magnification image of the surface near the edge is shown in Figure 9b. Here, the top edge of the longeron sheet is on the left side of Figure 9b; the bright area corresponds to the paint on the outer surface. Similar to the results for the cracks found in Longeron #2, portions of the crack surface appear to be smeared or damaged. However, islands of undamaged surface can be seen near the center of Figure 9b. Some of these undamaged regions are striated, as shown in Figure 9c, indicating that the crack propagation was driven by cyclic loading (ref. 1).

(b) Higher-magnification image of surface damage, region B.

(c) Higher-magnification image of fatigue striations, region C.

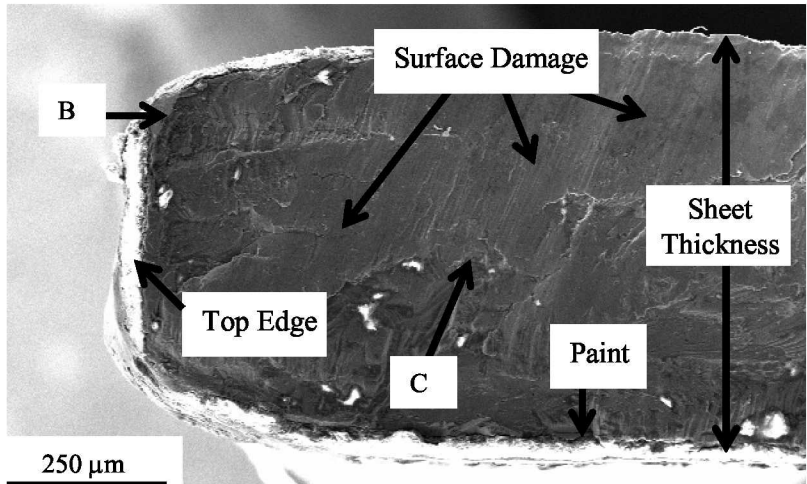
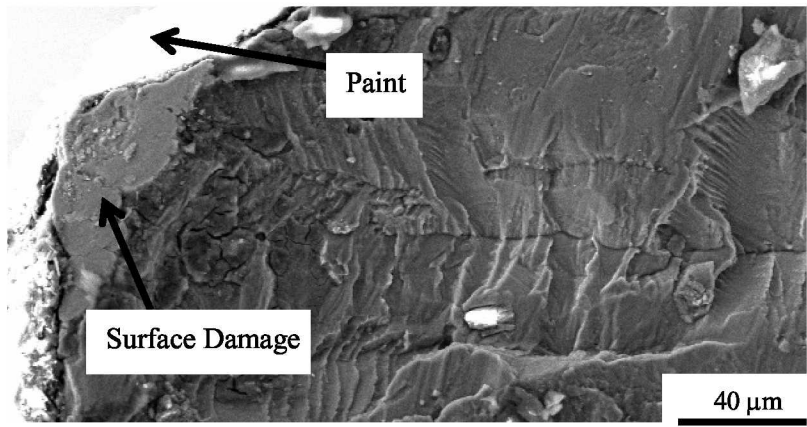
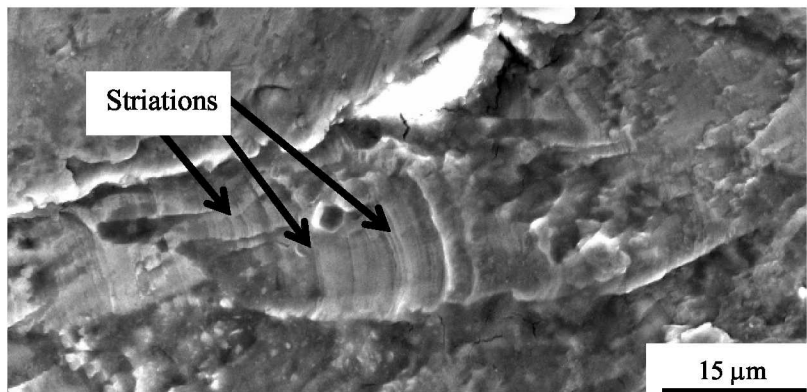
Figure 10. SEM crack-surface micrographs for Longeron #4, Crack #1.

SEM crack-surface micrographs for Longeron #4, Crack #1 (a crack approximately 0.49 inches long (12.45 mm) that initiated at Station 155.75) are shown in Figure 10. A relatively low-magnification image of the entire sheet thickness is shown as Figure 10a; here, the top edge of the longeron corresponds to the left side of the figure. Large portions of the crack surface appear to be damaged, presumably smeared as crack faces came into sliding contact, as observed in Figure 3b. In these damaged regions, crack-surface features of interest have been destroyed. A higher-magnification image of the damaged corner region is shown as Figure 10b. However, there are crack-surface regions that escaped mechanical

damage and in these regions fatigue striations were observed (ref. 1). A typical example of striations in these undamaged regions is shown as Figure 10c.

(b) Higher-magnification image of surface damage, region B.

(c) Higher-magnification image of fatigue striations, region C.

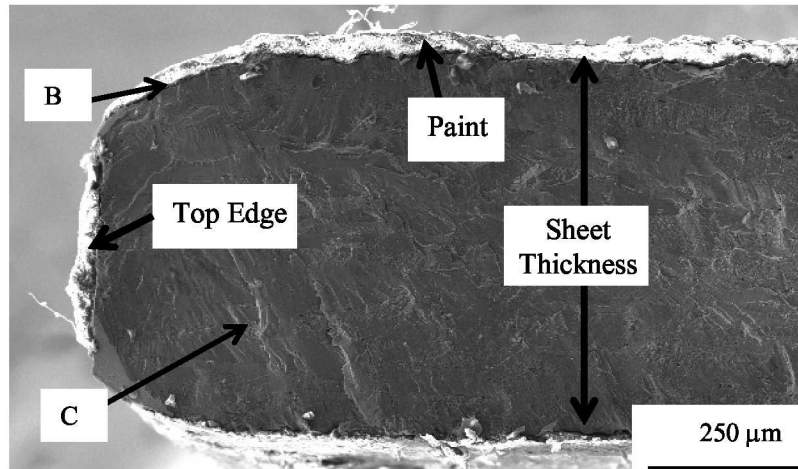
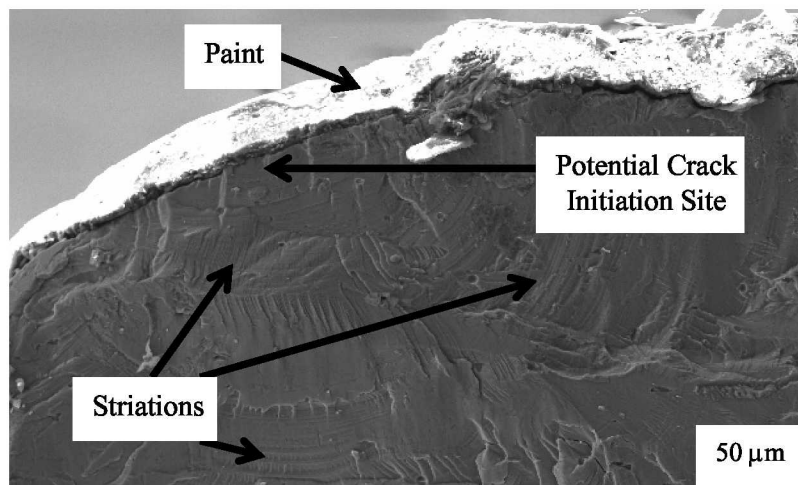
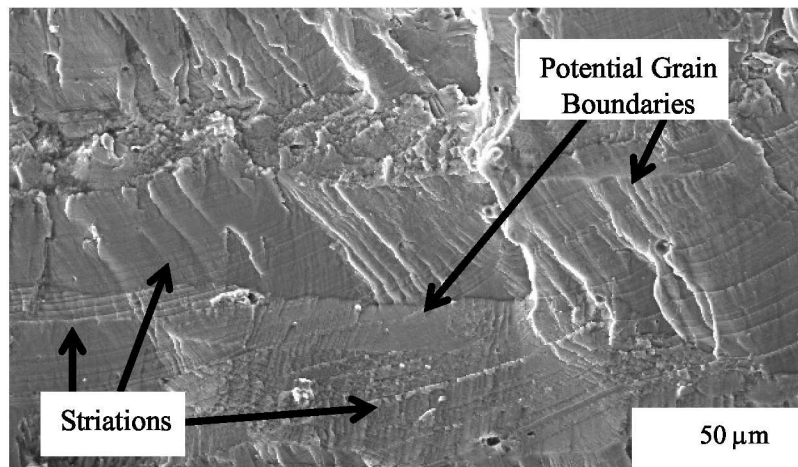
Figure 11. SEM crack-surface micrographs for Longeron #4, Crack #2.

SEM crack-surface micrographs for Longeron #4, Crack #2 (a crack approximately 0.18 inches long (4.57 mm) that initiated at Station 164.87) are shown in Figure 11. A relatively low-magnification image of the entire sheet thickness is shown as Figure 11a; here, the top edge of the longeron corresponds to the right side of the figure. Recall from Figure 3b that this relatively short crack exhibited no residual shear displacement. It is likely not coincidental that these crack surfaces are nearly free of contact or smearing damage. Nearly the entire crack surface contains fatigue striations (ref. 1). These fatigue striations can be traced back to an apparent crack initiation site, which is shown at higher magnification as Figure 11b. No obvious crack initiation feature (e.g., scratch, pit, or other defect) was observed near the crack initiation site, which suggests that surface defects were not a contributing factor in crack initiation. Fatigue striations are shown at high magnification in Figure 11c. In this image, the crack surface appears similar to that of Longeron #2, Crack #2 (Figure 8c) and Longeron #3, Crack #1 (Figure 9c), where features that are believed to be grain boundaries can be identified in the image.

(b) Higher-magnification image of apparent crack initiation site, region B.

(c) Higher-magnification image of fatigue striations, region C.

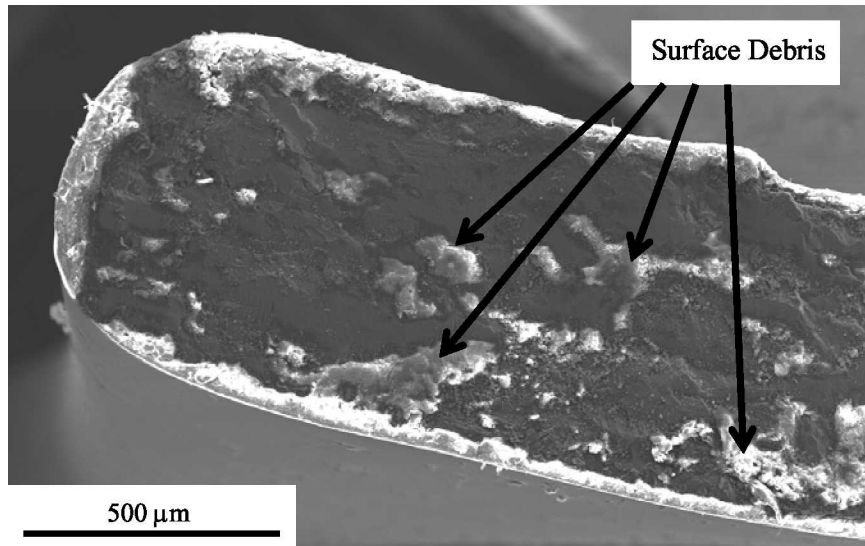
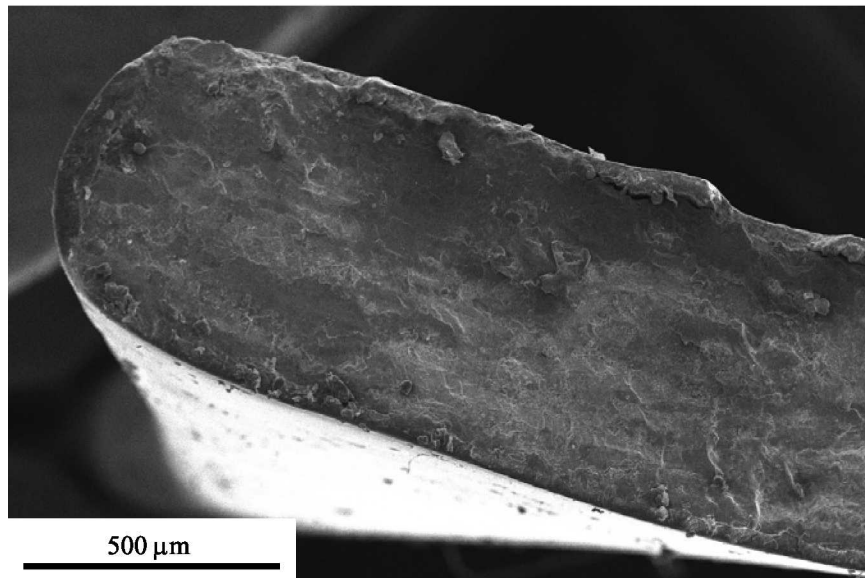
Figure 12. Images of typical crack surface (Longeron #3, Crack #1).

Typically, the crack surfaces were covered with debris that obscured the microscopic features of interest. To examine these features, the crack surfaces were ultrasonically cleaned in acetone, which successfully removed most of the debris without damaging the crack surfaces or the paint on the external surfaces of the longerons. The SEM images shown in Figures 4-11 were taken from clean surfaces. However, before cleaning, the dirty surfaces were examined in the SEM and chemically analyzed using Energy Dispersive X-ray (EDX) Spectroscopy (ref. 2). Crack surfaces of Longeron #3, Crack #1 are shown in Figure 12 both before cleaning the crack surfaces (Figure 12a) and after cleaning (Figure 12b). The crack surface debris is readily seen as the bright white regions in Figure 12a (absent in Figure 12b), a result of surface charging in the electron beam of the SEM. An EDX analysis taken of the debris (white regions in Figure 12a) indicates the presence of chlorine (25.3% weight), oxygen (16.6%), silicon (15.7%), sulfur (11.3%), sodium (9.0%), potassium (7.4%), phosphorus (6.0%), calcium (5.4%), and aluminum (3.3%). Similar chemical signatures have been obtained from other crack surfaces.

Crack-surface debris originally obstructed portions of the crack surface, especially the portions of the crack surface where crack initiation is presumed to have occurred. Cleaning of the crack surface was necessary to observe crack surface features of interest. As a precautionary measure, crack-surface debris was chemically analyzed before removal in case this substance was later found to contribute to crack initiation or propagation. No evidence was found to suggest that the crack-surface debris influenced crack initiation or propagation.

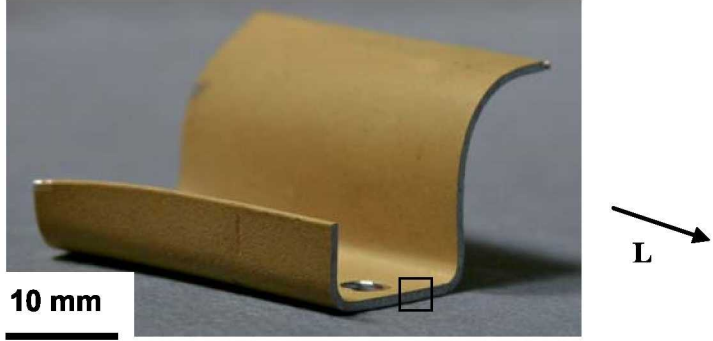
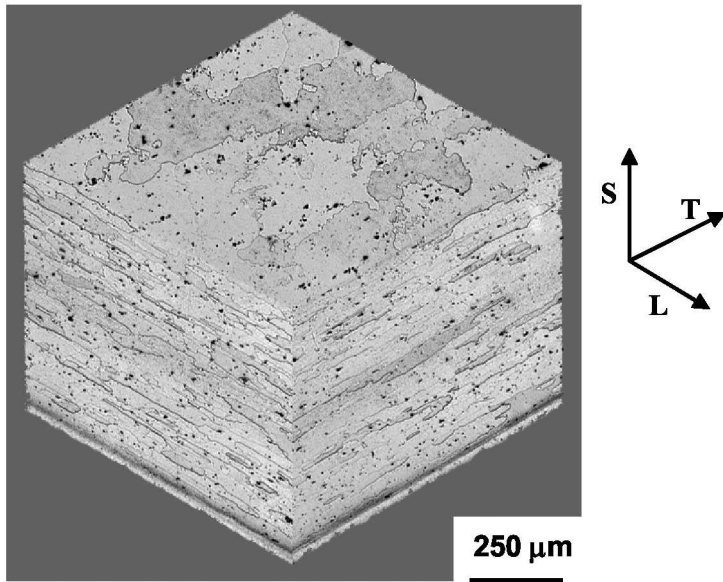
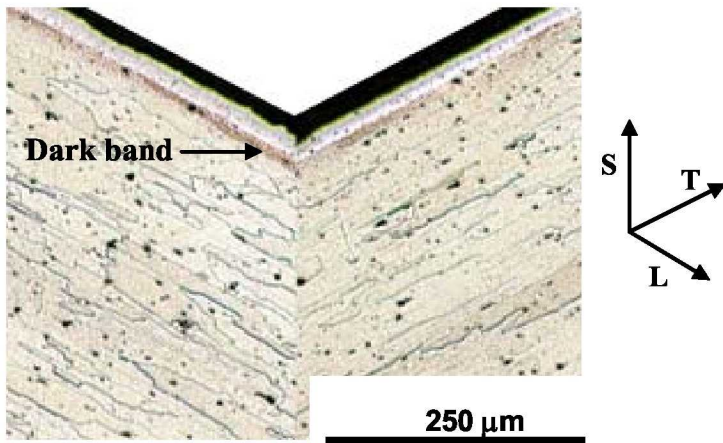
Figure 13. Results of metallurgical analysis of aluminum alloy 7075 longeron sheet material.

The microstructure of the aluminum alloy 7075 sheet is shown in Figure 13. For this microstructural analysis, a sample of material was cut from Longeron #1, immediately aft of Station 155.75. As indicated by the boxed region in Figure 13a, the material analyzed corresponded to the portion of the longeron that was fastened to the tail-boom fairing skin. Surfaces normal to the sheet directions were cut, mounted, etched[†] and polished for metallurgical analysis, and the corresponding images were arranged to appear as a three-dimensional cube of the material, herein termed “orthogonal metallurgical cube.” See Figure 13b for an orthogonal metallurgical cube of the longeron sheet material; here, the bottom edge of Figure 13b corresponds to the outer edge of the longeron sheet. The orthogonal surfaces used were termed “L” (perpendicular to the length of the longeron), “T” (perpendicular to the vertical longeron direction as described in Figure 1), and “S” (perpendicular to the 0.025-inch sheet thickness direction). Examination of the dark lines in Figure 13b (presumably grain boundaries) indicates large grain areas on the S-surface with long and flat grain areas along both the L-surfaces and T-surfaces. These observations are typical of aluminum sheet material and a flattened pancake-shape grain structure. A portion of Figure 13b is shown at higher magnification in Figure 13c to better show microstructural boundaries. Here, the typical spacing between linear indications on both the L-surfaces and T-surfaces is nearly 20 μm , consistent with the hypothesis that the features observed in Figures 8c and 9c are grain boundaries

Examination of the orthogonal metallurgical cube of Figure 13b reveals the presence of what appears to be a dark band near the outer surface of the sheet material (see bottom of Figure 13b). This discoloration occurred in the same near-surface region where small grain sizes were observed (recall Figure 14). A chemical analysis (EDX) was performed on near-surface and interior regions of the polished surfaces. SEM images of regions examined are shown in Figure 15. In these images, the sheet material is seen at the bottom with the paint layer near the top. The near surface region selected for analysis is shown with a box in Figure 15a and the interior region (approximately 60 μm from the surface) is indicated by a box in Figure 15b. The chemical analysis results, which are summarized in Table 2, indicate that the near surface region contains less alloying elements (zinc, copper, and magnesium) than the interior region, which has a composition typical of aluminum alloy 7075 (ref. 4). This depletion of alloying elements at the surface may result in a degradation of mechanical properties, such as poor resistance to crack initiation. In all cases where crack surface observations permitted (recall Figures 5, 6, and 11), crack initiation sites were always located on the corner of the longeron cross-section near the intersection of sheet surface (where a depletion of alloying elements was observed) and the top edge of the longeron where bending stresses are likely greatest. Further study is needed to determine if the chemical depletion contributed to the cracking.

During metallurgical analysis of the longeron sheet material, an unusual feature was observed on polished surfaces of near-surface samples. (Recall, this layer appeared as a dark band near the bottom of Figure 13b.) Chemical analysis of near-surface region (Figure 14a) revealed that, in comparison to both the interior chemistry and typical aluminum alloy 7075 chemistry (ref. 4), it was relatively poor in the alloying elements copper, zinc, and magnesium, and appeared to contain traces of iron. This alloying element depletion may result in a local degradation in mechanical performance, including resistance to cracking. In the examples where crack-surface features were used to determine an apparent crack initiation site (Longeron #1, Crack #2; Longeron #1, Crack #3), these crack initiation sites occurred near the longeron sheet surface (where alloying element depletion was observed). EBSD results (Figure 15) revealed that the typical grain sizes within this near-surface alloying-element-depletion region were significantly finer than those within the longeron sheet interior. Additionally, the absence of corrosion pits, scratches, dents, or tool marks, suggests that corrosion and handling (e.g., installation and maintenance) were not contributing factors on crack initiation.

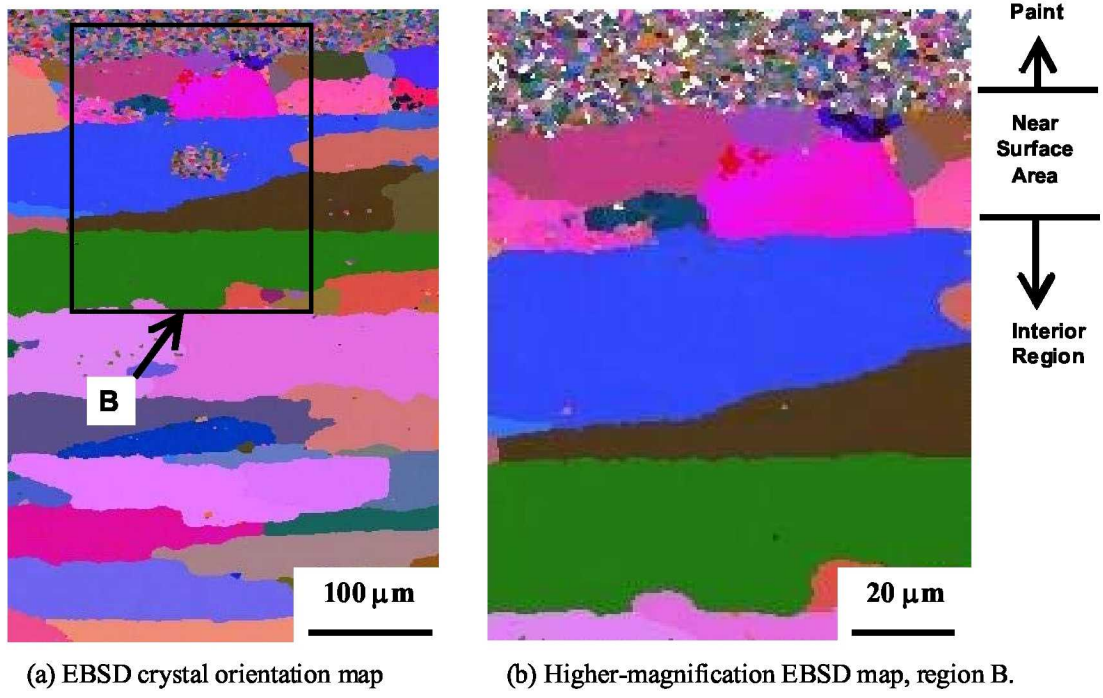
Figure 14. Near-surface crystal orientation maps generated by EBSD.

orientation as the crack faces. The sample was mounted in an epoxy material to preserve the integrity of the edges (prevent rounding during polishing) and polishing was performed with care to eliminate surface residual stresses. EBSD data were collected across the sample, and then analyzed to produce crystal orientation maps of the near-sheet-surface material, which are presented in Figure 14. Figure 14b is a higher-magnification crystal orientation map of region B, which is indicated in Figure 14a. The paint, near surface area, and interior regions are indicated in Figure 14b. The crystal orientation map consists of thousands of points, each assigned a color based on its crystal orientation. In this image, grains appear as continuous regions having the same color. The grains seen in the interior region appear to be elongated and approximately 25 μm thick (in the sheet thickness direction, seen in Figure 14 as the vertical direction), which is consistent with the grain size estimates obtained from SEM observations of Figures 8c, 9c, and 11c. The grains within 25 μm of the sheet surface have a significantly smaller grain size compared with the interior region.
