# International Space Station USOS Potable Water Dispenser On-Orbit Functionality vs. Design

The International Space Station (ISS) currently provides potable water dispensing for rehydrating crewmember food and drinking packages. There is one system located in the United States On-orbit Segment (USOS) and one system in the Russian Segment. Shuttle mission STS-126 delivered the USOS Potable Water Dispenser (PWD) to ISS on ULF2; subsequent activation occurred on November 2008. The PWD is capable of supporting an ISS crew of six, but nominally supplies only half this crew size. The PWD design provides incremental quantities of hot and ambient temperature potable water to US food and beverage packages. PWD receives iodinated water from the US Water Recovery System (WRS) Fuel Cell Water Bus, which feeds from the Water Processing Assembly (WPA). The PWD removes the biocidal iodine to make the water potable prior to dispensing. A heater assembly contained within the unit supplies up to 2.0 L of hot water (65 to 93 °C) every 30 min. During a single meal, this quantity of water supports three to four crewmembers' food rehydration and beverages. The unit design has a functional life expecta

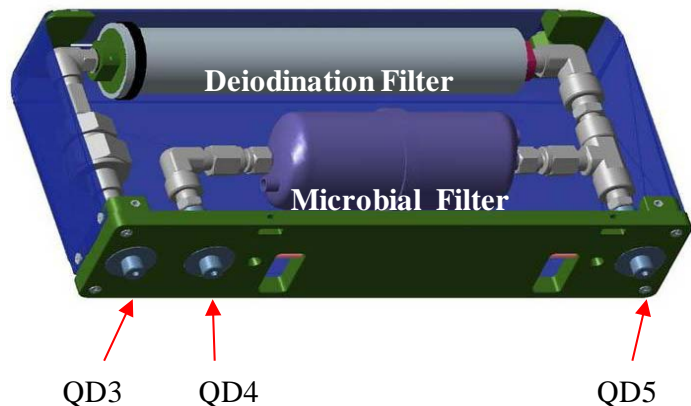
Figure 3. PWD Filter ORU

Although the disinfection process appeared thorough at the time, the PWD project team determined some possible flaws with the disinfection process of the PWD Filter ORU and the PWD unit itself. Specifically, the dwell times used in both disinfection procedures for the PWD and the PWD Filter ORU was only 5 minutes. The PWD was disinfected with iodine, and the Filter ORU was disinfected with H<sub>2</sub>O<sub>2</sub>. During PWD troubleshooting for possible causes for microbial contamination, the JSC Microbiology Lab determined that the dwell times were

insufficient for both pieces of hardware, The Microbiology Lab recommended a minimum of 1 hr dwell disinfection time to achieve a successful disinfection. Since the PWD flight unit will not be reprocessed, this realization was too late. However, the team modified the applicable PWD Filter ORU process procedures to correct this issue for future flights. The PWD Filter ORU is delivered roughly every 8 months due to life time expiration.

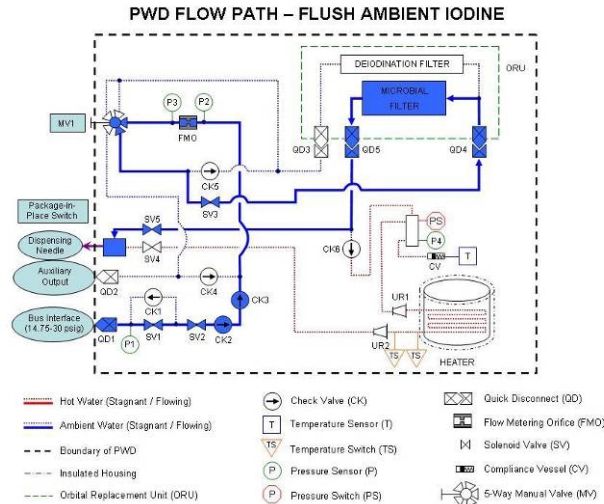
**Figure 4. PWD Flush Iodine Mode, Ambient**

While these theories explained the root cause of the microbial contamination within the PWD, the crewmembers still required immediate remediation, as ISS only had one of two potable water sources available. With the PWD unfit for crew consumption, they relied upon the Russian potable water source. The PWD team suggested a variety of remediation options to swiftly accommodate the crew and ISS Program's needs. The quickest and most affordable solution was to flush iodinated water from the WRS Fuel Cell Water Bus into the PWD, using the PWD Flush Iodine Mode, on January 7, 2009 (see Fig. 5). The PWD design included this mode in order to have the capability to flush biocidal, iodinated water (1 to 4 ppm  $I_2$ ) into the PWD, bypassing the PWD Filter ORU Deiodination Filter by going in through QD4. The flush continues through the Microbial Filter and downstream of the ambient leg of the PWD. Nominally, the ambient leg does not show residual biocide in the water (see Fig. 4); it does in this mode, due to the Deiodination Filter bypass.

Although this solution provides hope for remediation of the ambient leg of the PWD, the PWD team recognized potential issues prior to success. The first known issue was the JSC Microbiology Lab determination that the low amount of  $I_2$  (1 to 4 ppm) from the Bus was not capable of remediating a known contaminated system. This low concentration of  $I_2$  was only sufficient to maintain an already clean system. Additionally, the team knew prior to delivery of the PWD that  $I_2$  was not compatible with the Microbial Filter

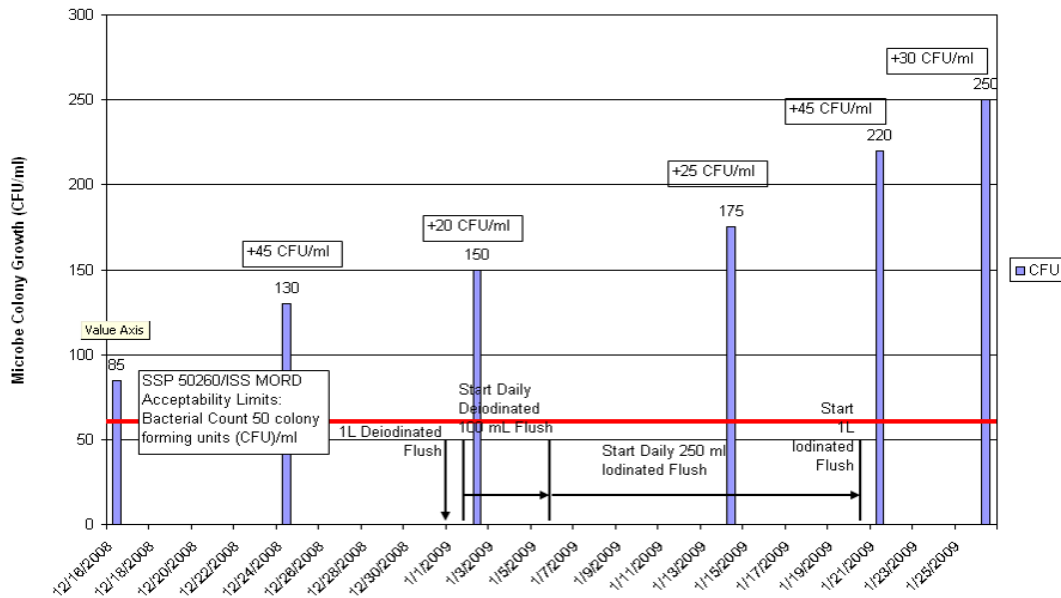
**Figure 5. PWD Flush Iodine Mode, Ambient**

**PWD - Test results from Ambient Leg water measurements**

Despite the known issues, the Mission Operations Directorate (MOD) and the PWD team tried the flush option, as it was the quickest and most cost-effective solution to the PWD contamination issue. After the Flush Iodine Mode took place, the crew ran another MCD microbial test, which revealed yet another increase in microbial growth. The Flush Iodine Mode did nothing to help remediate the PWD contamination issue (see Fig. 5). This method of remediation failed because of a low concentration of iodine, in addition to the possibility of a iodine-resistant bacterium contamination.

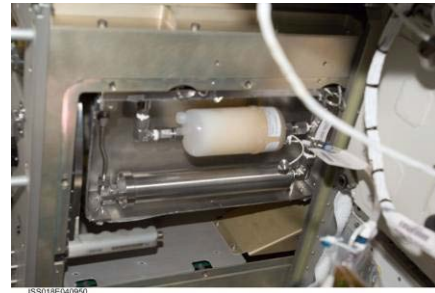
**Figure 10. On-orbit Use of Iodine Shock Kit**

The PWD Disinfection Kit consisted of the Teflon bag of 40 ppm I<sub>2</sub> solution; the PWD Filter Flush Assembly; the PWD Filter Tube Assembly; and three extra QD sterile caps for the PWD Filter ORU QDs. The QDs caps were delivered to place on the PWD Filter ORU QDs in case the Filter was removed from the PWD unit. The PWD Disinfection Kit launched on STS-119/15A in March 2009. The crew used the PWD Disinfection Kit (excluding the PWD Filter Tube Assembly) as planned during 15A docked operations in March 2009 (see Fig. 10). The initiative was a success and the microbial counts from the ambient leg of the PWD dropped from 250 CFU/mL to 0 CFU/mL, after the 10 L flush of water. Additionally, the PWD desorbed all of the I<sub>2</sub> and I from the microbial filter, making the effort a complete success. Since the use of the Disinfection Kit, the PWD continues to sustain low bacteria counts.

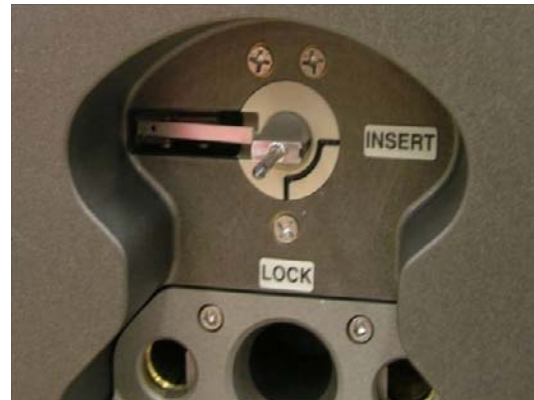
**Figure 12. Behind the Beverage Adapter, PIP Switch**

On June 6, 2009, the crew reported to Houston Mission Control Center (MCC) that the PWD stopped dispensing. One possible cause for a no dispense scenario includes a not fully active Package In Place (PIP) Switch. The PIP Switch resides behind the Beverage Adapter (see Fig. 11 and 12). The PIP Switch is a safety feature for the PWD, designed to prevent inadvertent dispense. The PIP Switch ensures that a food or drink package is in place before a dispense can occur (see Fig. 12). The PIP Switch activates via a plunger on the back of the Beverage Adapter, which fully extends when a food or drink package is in place, signaling the switch to allow a dispense to occur (see Fig. 13).

To validate the cause for the PWD malfunction, the team recommended that a crewmember use their finger to lightly press the PIP Switch, which would confirm that a dispense could occur with switch activation. The crewmember reported back that when they manually pressed the PIP Switch, the PWD began to dispense nominally. This verified why the PWD stopped dispensing, but did not establish a root cause for the Beverage Adapter Plunger failure to fully extend and actuate the PIP Switch. While the team continued to investigate the anomaly, the Operational Support Officer (OSO) recommended a temporary resolution to the problem. The OSO requested the crew add a small layer of tape on top of the PIP Switch to increase the area between the Beverage Adapter Plunger and PIP Switch. This would allow the plunger to make contact with the switch and actuate a dispense (see Fig. 14). This temporary workaround allowed the crewmembers to continue to use the Beverage Adapter nominally, while troubleshooting continued on the ground.

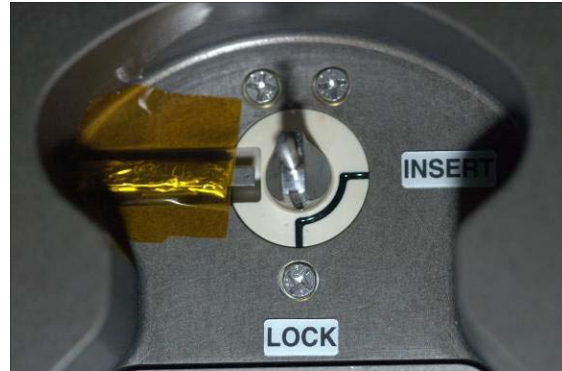
**Figure 14. Behind the Beverage Adapter (PIP Switch with Tape)**

Although the temporary workaround was a good short-term fix, team concerns remained regarding the untested and unknown stresses induced on the PIP Switch, due to the off-nominal configuration of the layer of tape on the switch. The team requested a stress analysis to verify that the tape configuration on the switch was safe for continued use. The stress analysis found that the life of the PIP Switch potentially reduced from 1,000,000 cycles to less than 5000, if the switch continued in this off-nominal configuration. The PWD team created instructions for tape removal and a return to nominal switch configuration, while continuing to research the length of the Beverage Adapter plunger more closely.

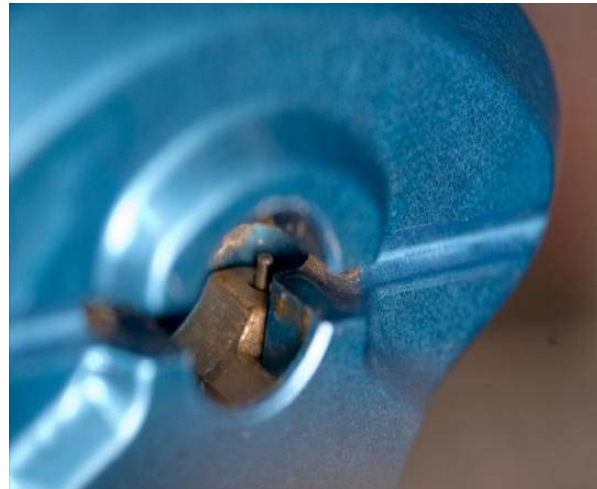
On July 3, 2009, during the Beverage Adapter Plunger investigation, the crew reported to Houston MCC that the PWD Package Insert Port appeared rusty (see Fig. 15) and that the Beverage Adapter Slide Assembly was sticking (see Fig. 16). The crew took apart the Beverage Adapter Assembly on July 4, 2009, finding a water leak within the adapter. The crew also found apparent food debris or possible corrosion around the capture pins on top of the Slide Assembly within the Beverage Adapter Assembly (see Fig. 17). The PWD team instructed the crew to wipe down that area of the assembly with Povidone Iodine wipes to remove as much residual debris as possible.

**Figure 15. On-orbit photo of PWD Package Insert Port with Food Residue/Corrosion within the Beverage Adapter the PIP Switch with Tape**

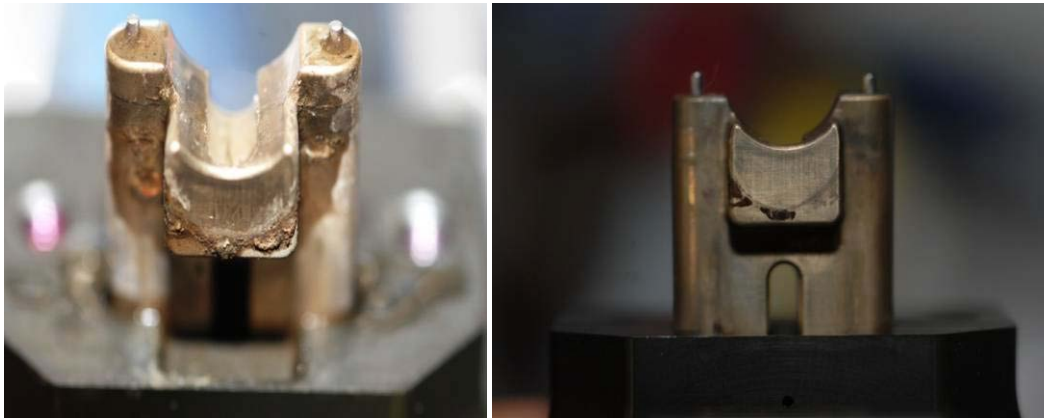
**Figure 17. Precleaning (left) Postcleaning (right): On-orbit Photos of the Food Residue/Corrosion on the Slide Assembly Internal to the Beverage Adapter**

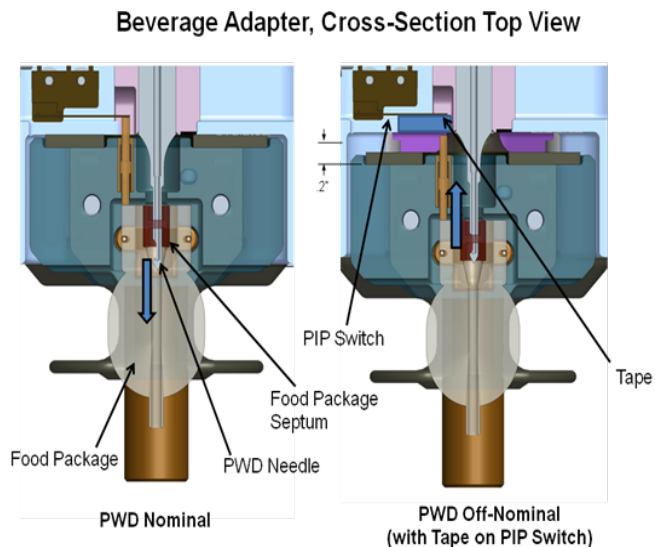
**Figure 18. Beverage Adapter Cross Sectional View, Leakage Path (blue arrow)**

The PWD team determined that a water leak from the dispense point of the Needle was back-flowing into the interior of the Beverage Adapter (see Fig. 18). The off-nominal configuration of the tape on the PIP Switch like exacerbated this scenario. The tape on the switch did not allow the PWD food and/or drink packages to seat properly within the Beverage Adapter, leaving a small gap where the Needle did not fully insert into the food or beverage package (see Fig. 18). With this understanding of the water leak within the Beverage Adapter, the team finalized the procedure to return the PWD to the nominal configuration. The procedure tasked the crew to lubricate the Beverage Adapter Plunger with Braycote 601 and remove the tape from the switch. Lubricating the plunger allowed it to loosen enough to fully extend and actuate the PIP Switch to activate a dispense. The crew performed the tasks successfully. The root cause for the plunger not fully extending, however, remained undetermined.

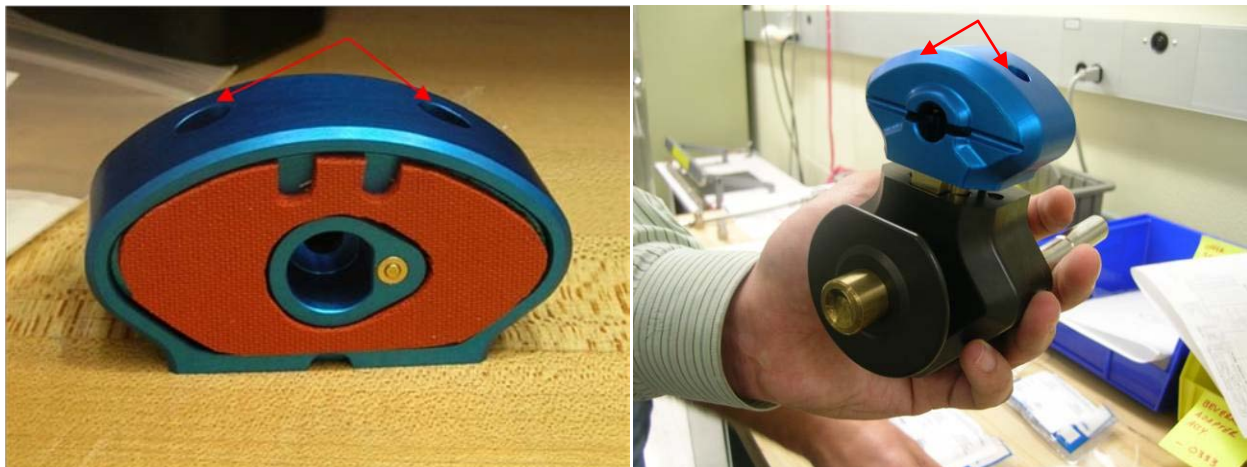
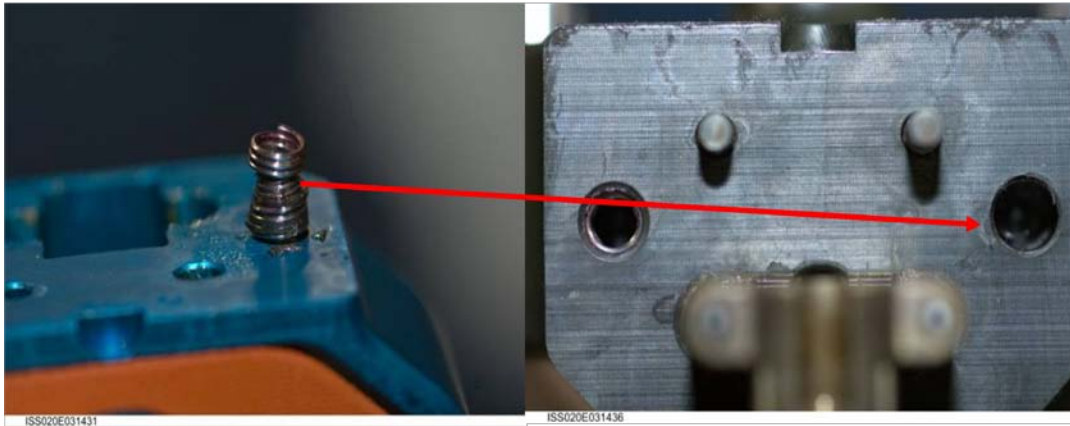
**Figure 20. Stripped Helical Insert from the Beverage Adapter**

disassembly for cleaning, as it was not foreseen that a leak would occur in this area. On August 24, 2009, due to repetitive off-nominal cleaning of the Beverage Adapter, one of the two locking inserts failed on orbit (see Fig. 19 and 20). Over-torque during Beverage Adapter reassembly stripped out the helical insert. The Beverage Adapter can function with one fastener. If the crew damaged the other insert, however, nothing would hold the two pieces of the Beverage Adapter together. The PWD team quickly engineered short- and long-term solutions to address the problem. The short-term solution recommended the crew to wrap Kapton tape around the parameter of the Beverage Adapter. The recommended long term solution was for the PWD team to redesign and deliver a new Beverage Adapter capable of withstanding repetitive cleaning. Within 3 months of the initial request, the redesigned Beverage Adapter was delivered to the ISS on ULF3.

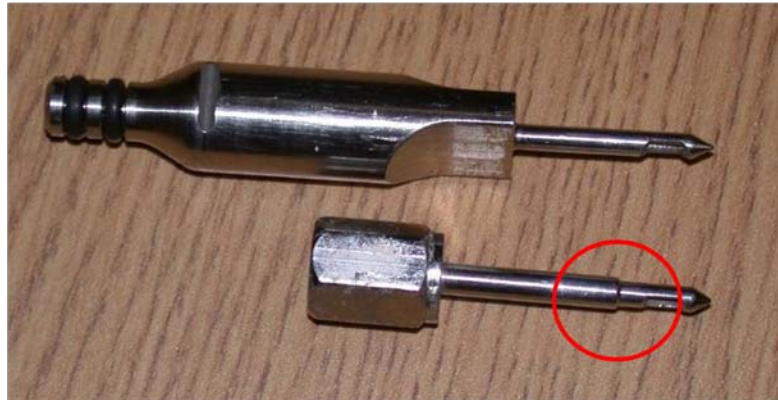
**Figure 21. (Top) PWD Needle, (Bottom) Shuttle Galley Needle**

The leak issue is still undergoing investigation by the team. The team's inability to duplicate the leak may stem from the zero gravity atmosphere in which the leak occurred. The PWD Needle design is one of the possible causes for the leak. The team found that the Shuttle Galley Needle design differed from the PWD Needle design by a small shoulder feature found on the Shuttle Galley Needle. (see Fig. 21). It is believed that the shoulder on the Shuttle Galley Needle provides an additional sealing surface at the septum interface on the food/drink package, which prevents potential water backflow. Since the team could not replicate the leakage found on orbit, the PWD team could only replicate the Shuttle Galley's Needle design, but could not verify that the new Needle design fixed the leakage problem. The newly designed PWD Needle, matching the Shuttle Galley Needle, was delivered to ISS on 20A, February 2010. Once the redesigned PWD Needle is on orbit, the team will assess whether the theory of the shoulder resolves the leak issue with the Beverage Adapter.

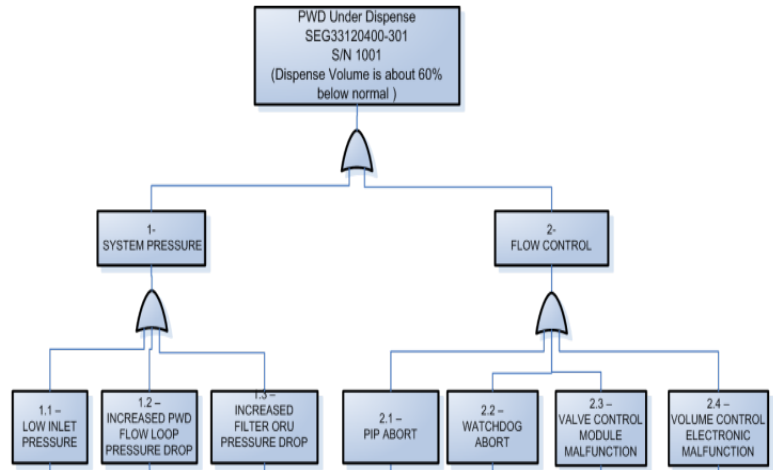
Figure 22. Root Cause Under Dispense Fault Tree

Root cause analysis indicated that a low dispense volume is a function of one of two scenarios (see Fig. 22). Possible causes follow: 1) The system pressure is lower than expected at the inlet or there is an internal pressure drop to the PWD; and/or 2) there is a malfunction within the flow control of the PWD System electronics. The low system pressure could come from the inlet and/or the increased pressure drop within the PWD Flow Loop or the

The most likely root cause for the increase in pressure drop is due to an obstruction within the Filter ORU Assembly. The under dispensing occurred after approximately 8 months of filter use. This was the same Filter ORU that the crew used the Disinfection Kit on in March 2009. The 0.2 micron microbial filter can trap debris and even air, which means the PWD may become obstructed over time, causing blocked water flow and an under-dispense scenario.

The PWD team gave the crew several troubleshooting courses of action as solutions to the under-dispense issue: 1) Check the PWD System for obvious visual obstructions, including a pinched water hose; 2) check, clean, or replace the needle; and 3) replace the PWD Filter ORU. Although the under-dispense is a nuisance to the ISS crew, it is not a safety issue to date. The need to continue to dispense additional times to achieve the desired hydration is acceptable.

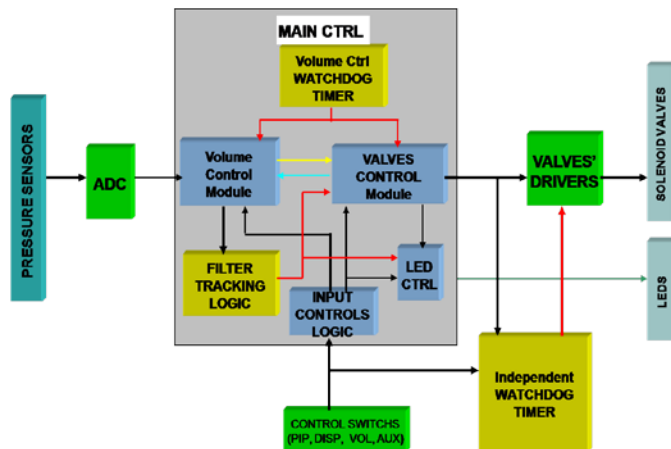
Figure 23. PWD Flow Control Electronics

A fault tree analysis of the PWD Flow Control electronics (see Fig. 23) shows an early termination of the water flow cycle and a reduced dispense volume. Dr. Barrett’s video recording of the experiment allowed the PWD team on the ground to observe the behavior of the PWD LED lights. Through this observance of how the PWD LED lights responded during dispense, the engineers determined the probable/improbable failures within the Flow Control electronics.

The final leg of the fault tree analysis to be considered was the volume control module (VCM), a part of the Flow Control components. If the VCM fails, either the internal pressure sensor, the ADC, or the internal flow calculation logic failed. Failure of these components would result in one of the following: a low delta-pressure reading or a high delta-pressure reading. A low delta-pressure reading would result in a calculated flow rate lower than actual with a longer dispense time. The watchdog timer would abort the cycle with a higher than selected dispensed volume. A high-delta-pressure reading would result in a calculated flow rate larger than the actual rate, with a reduced dispense time. The dispensed volume would be lower, but the watchdog would not activate. Neither of these events occurred, pointing to the improbability of VCM failure.

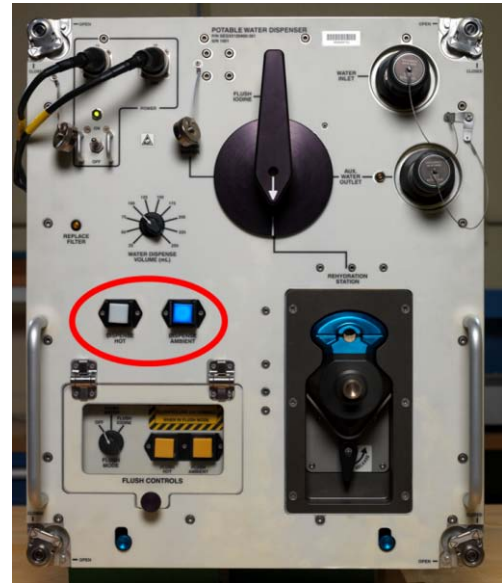
Figure 24. Front Panel of the PWD, LEDs (RED)

Engineers noticed at the end of every dispense cycle, both of the PWD LEDs (see Fig. 24) stopped blinking and went to steady-state prior to the PIP Switch release. This showed a watchdog timer override, a clear indication that the problem was not an early release of the PIP Switch. Observing the start and stop of the blinking LEDs during Dr. Barrett’s 250 mL dispense, the lapse time was approximately 30 seconds. The PWD watchdog timer is set at a fixed rate of 500 mL/min, which corresponds to the behavior of the LED lights going to steady state at the end of a dispense. The LED observation eliminated the volume control watchdog early timeout event as a root cause failure. The same manner of PWD LED observation indicated the improbability of an independent watchdog early timeout as a root cause, because the controls would not have functioned. (I get it, but this is a lot to digest. You may want to add clarification for other readers.)
