Status of the Regenerative ECLS Water Recovery System

Layne Carter¹

NASA Marshall Space Flight Center, Huntsville, AL 35812

The regenerative Water Recovery System (WRS) has completed its first full year of operation on the *International Space Station (ISS)*. The major assemblies included in this system are the Water Processor Assembly (WPA) and Urine Processor Assembly (UPA). This paper summarizes the on-orbit status as of May 2010, and describes the technical challenges encountered and lessons learned over the past year.

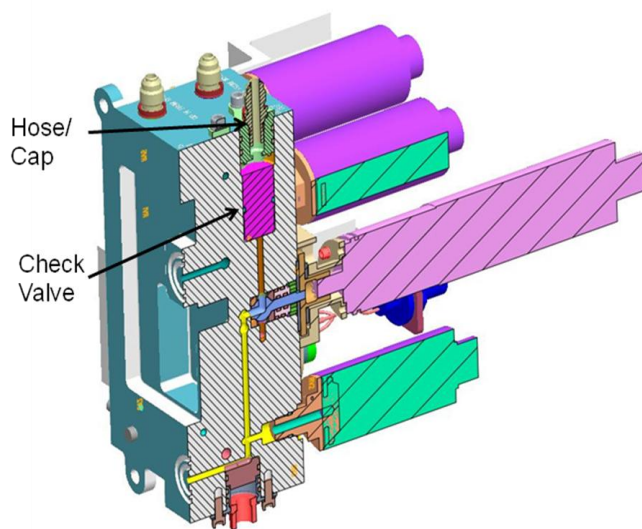
Figure 4. FCPA Manifold

A separate anomaly also discussed in the previous paper (1) was the failure of the FCPA check valve. The purpose of this check valve is to prevent backflow from the WPA waste tank into the DA. On April 23 2009, the check valve failed closed during normal operation of the fluids pump, and repeated attempts to open it by operating the pump were unsuccessful. Since this check valve is a redundant control against backflow (and not required as a safety control), engineering personnel determined that it should be removed from the hardware on ISS. This allowed for the first intermediate-level (I-level) activity on UPA. I-level refers to on-orbit maintenance of hardware internal to an ORU, which avoids the costly effort to return and resupply an entire ORU on ISS that has failed due to a single component. The check valve is an inline component in the FPCA manifold (see Figure 4). Due to this design, the valve could be removed by first removing the inlet flex hose/cap to the manifold, then the check valve, and finally replacing the flex hose. Implementation of this procedure was challenging because the required tools were not available on ISS, requiring creative solutions by the ISS engineering/operations personnel. The flex hose/cap (hose not shown in Figure 4) is held in place with two fasteners. After the fasteners were removed, the cap was removed by gently pulling on the base of the hose with a pair of pliers to overcome the resistance of the two radial o-rings. The inline check valve is held in place by a separate radial o-ring. Threads at the inlet to the check valve are provided for removal, but require a bolt with the mating threads (not present on ISS). Instead, operations personnel identified a plastic nozzle from a foam applicator available on ISS with threads slightly smaller than the required bolt. These threads were then wrapped with Kapton tape to better match the threads in the check valve (see Figure 5). Despite the use of the modified hardware as tools, the crew was successfully able to remove the check valve and therefore return the UPA to operation.

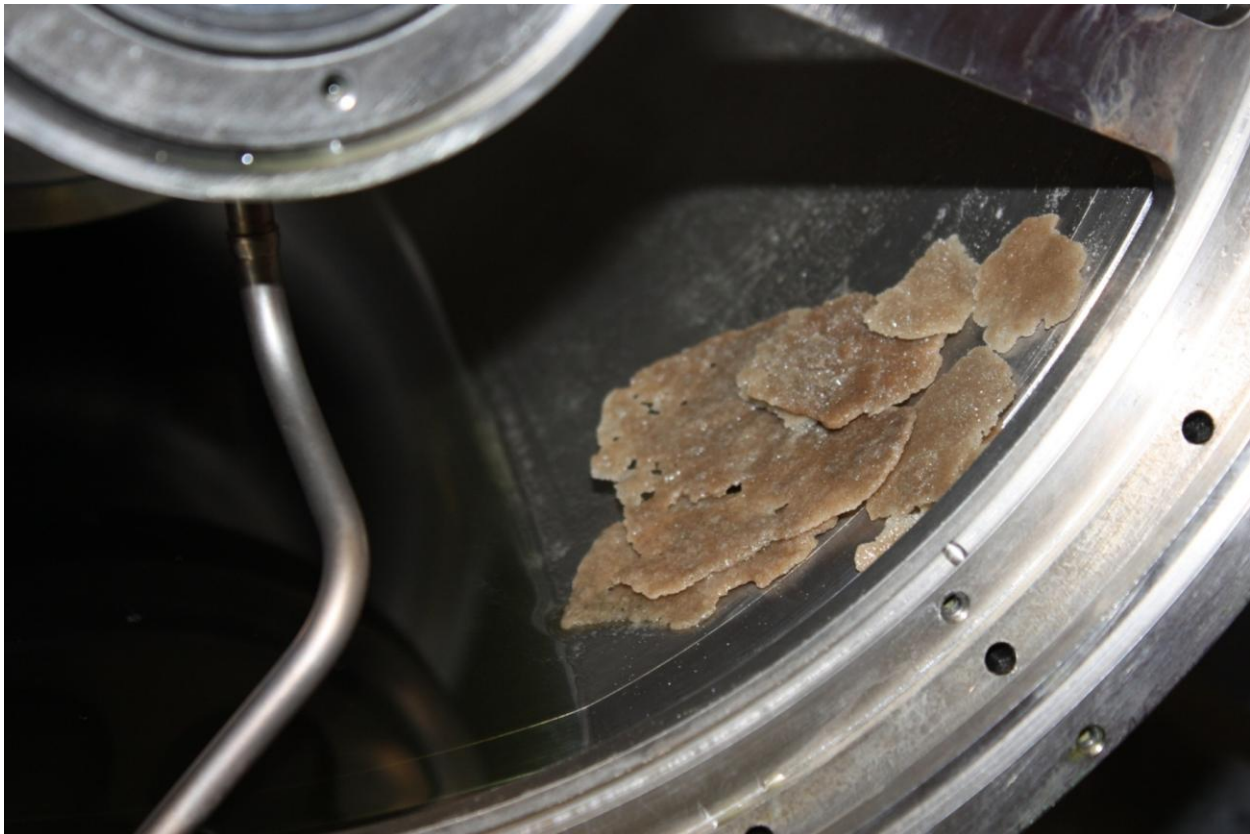
Figure 6. Precipitation in the Distillation Assembly Evaporator

After return to the Marshall Space Flight Center in December 2009, the DA was disassembled. The root cause of the anomaly was found in the evaporator, which contained a significant quantity of solids (see Figure 6). These solids had blocked the brine pitot tube, resulting in flooding the DA. In addition, the urine brine had passed through the demister and the compressor lobes, and was found in the DA's condenser and the stationary bowl.

Subsequent analysis of the solids determined that they were primarily comprised of calcium sulfate. Calcium is present in the urine primarily due to bone loss from the crew, whereas sulfate is present primarily due to the use of sulfuric acid in the urine pretreatment. Calcium levels on ISS are elevated compared to ground urine due to the absence of gravity. During ground testing, the UPA was proven to have no issues with recovering 85% of the water from pretreated urine. However, at 85% recovery on ISS, the higher concentration of calcium resulted in calcium sulfate exceeding its solubility limit. Since calcium sulfate solubility is lower at elevated temperature, it precipitated in the DA where the fluid is at the maximum temperature in the recycle loop.

In addition to the elevated calcium concentration, data from pretreated urine and brine has shown an elevated pH level. During ground tests, the urine pH was typically 1.5 to 1.8, and the brine pH would drop to approximately 1.1 to 1.4. However, the pH of the urine and brine on ISS has ranged from 1.7 to 2.5. This elevated pH is an issue because lower pH levels inhibit precipitation of the calcium sulfate. In addition, elevated pH levels can result in a loss of microbial control in the brine loop, though fortunately no microbial content was detected in analysis of urine and brine that has been returned to the ground. The reason for the elevated pH level is not specifically known, but it does appear to correlate with elevated phosphate levels in the urine.

Based on these observations, engineering personnel agreed that 85% recovery of water from the pretreated urine was not viable. A rigorous statistical analysis of urine chemistry was performed by personnel at the Johnson Space Center (JSC) and MSFC using analysis of samples taken on ISS. This analysis defined a 90% upper confidence limit on the calcium concentration as 283 mg/L. Given this concentration, a 70% recovery has been specified for future operation of the UPA, which accepts an 8% risk of reaching the calcium solubility limit over a given crew increment. Though this approach has some risk, 70% recovery was deemed necessary to meet logistics requirements for RFTA refurbishment and water resupply. In parallel with this modification to on-orbit operations, NASA personnel will investigate options for either removing calcium from the urine prior to introduction to the UPA, or introducing chelating agents into the pretreated urine that will inhibit precipitation of the calcium sulfate.

In addition, the rebuild of the DA S/N 02 will incorporate modifications to the demister. Water vapor generated by the evaporator flows through the demister before entering the compressor. The function of the demister is to collect liquid droplets in the vapor stream and sling them back into the evaporator. The investigation of the failed DA determined that the demister was not effective in removing liquid from the vapor stream, resulting in precipitation of solids on an inlet screen to the compressor. This ultimately caused elevated compressor temperature when the DA flooded and the inlet screen was almost completely blocked with precipitation. The demister redesign will address deficiencies in the demister functions to insure liquid droplets are effectively collected and returned to the evaporator, thus protecting the compressor from ingesting liquid.

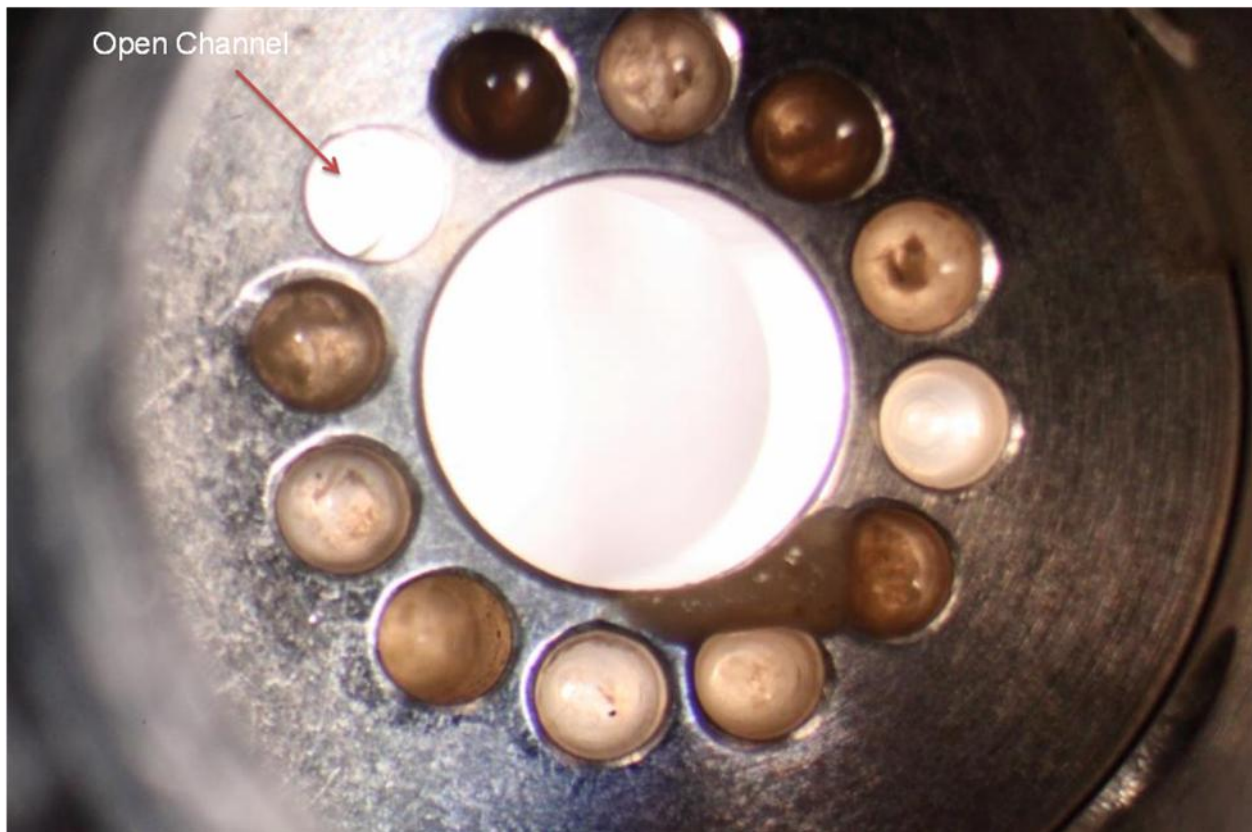
Figure 7. Biomass Present in MLS Inlet Solenoid Valve

The failed ORU was disassembled at Hamilton Sundstrand the week of February 22, 2010. Though the plumbing internal to the ORU exhibited no significant indication of biofouling, the MLS inlet solenoid valve was found to be significantly occluded with biomass. This biomass had accumulated in the valve between the poppet and the valve seat, obstructing the clearance in this region and causing the excessive pressure drop. Figure 7 provides a view of section of the valve that feeds the poppet, illustrating the accumulation of biomass in all but one channel.

Based on this investigation, engineering personnel are pursuing multiple efforts to insure the continued operation of the WPA on ISS. First, additional filters have been shipped to ISS as spares for the filter currently installed upstream of the MLS. Filter life is being tracked to determine if this approach is viable for long term WPA operation. Currently, after two months of operation on ISS, no significant increase in pressure drop has been

observed. If the current filter life is deemed unacceptable, a modified filter design will be delivered to ISS that provides additional filter surface area. Also, an additional solenoid valve may be built and delivered to ISS to be replaced by the crew if the failure occurs again.

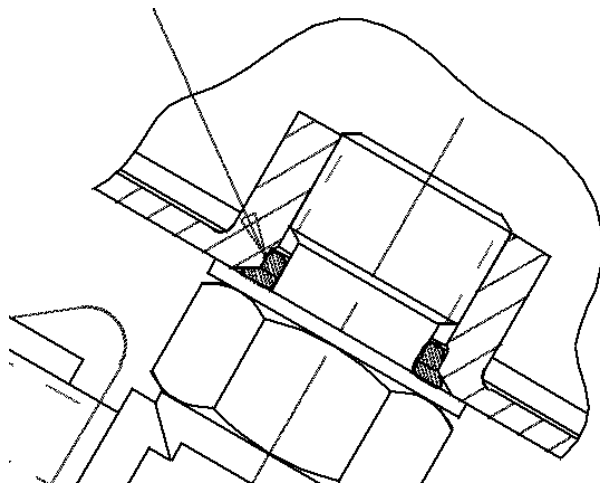
Figure 8. Standard MS Boss Fitting

The spare Catalytic Reactor ORU S/N 02 was delivered to ISS on Shuttle Discovery in April 2010 and installed in the WPA on April 11, 2010. The failed Catalytic Reactor ORU S/N 01 was returned on the same Shuttle for a subsequent failure investigation. After initially completing a Computerized Tomography (CT) scan at MSFC to confirm the configuration of the seals in the reactor tube fittings, the hardware investigation was completed at Hamilton Sundstrand. An initial leak test of the reactor confirmed the location of the leaks identified on ISS, and also identified an additional leak at the other end of the reactor tube. All leaks occurred through a standard MS Boss fitting, a cross section of which can be found in Figure 8. This fitting uses an o-ring made of ethylene propylene diene monomer (EPDM), which is the optimum rubber to be used in aqueous applications at temperatures above 65 C (Catalytic Reactor operating temperature is 130 C). In an ideal application, the o-ring is pushed by the jam nut and washer into the annulus between the female bore and the male gland as shown in Figure 8. Figure 9 shows an o-ring from an ambient temperature application in the Catalytic Reactor ORU after 8 years in place. As expected, the o-ring has slightly deformed to fill the annulus and thus provide the seal against external leakage.

EPDM o-ring

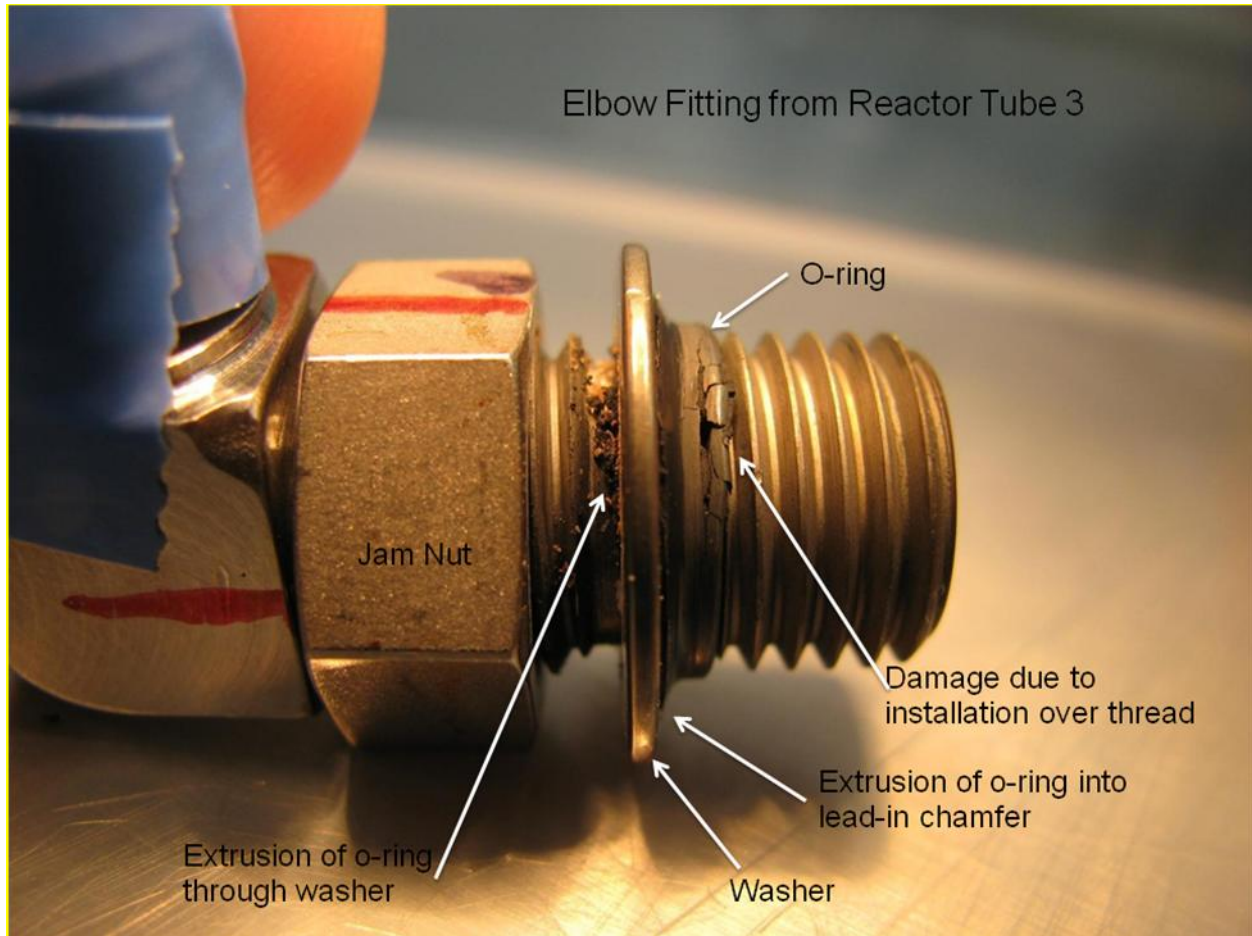
Figure 10. View of Damaged O-ring

However, the o-ring selected for this application did not take into account expansion of the o-ring due to swell (water absorption) or thermal expansion at the elevated temperature application. Therefore, the o-ring volume exceeded the available gland volume at elevated temperature, ultimately resulting in compression set. Figure 10 shows the fitting from the 3rd reactor tube, which was the location for the highest leak rate. In addition to the compression set (note the o-ring was deformed to the available gland volume), this o-ring had also been installed over the bottom thread. Also, the o-ring had even extruded through the inside diameter of the washer because of the fact that it exceeded the available gland volume at the elevated temperature.

To support refurbishment of Catalytic Reactor ORU S/N 01, the hardware is being redesigned to eliminate the overfill condition of the o-ring in the gland at the elevated temperature. This is accomplished with some combination of modifications, including an alternate EPDM o-ring with less swell, a custom o-ring with a smaller

cross section, and/or a machined fitting with a smaller diameter. The objective for the refurbishment of this ORU is to return it to ISS on Shuttle Endeavor in October 2010 if the schedule permits.
