Failure Analysis in Space: International Space Station (ISS) Starboard Solar Alpha Rotary Joint (SARJ) Debris Analysis

¹ *National Aeronautics and Space Administration, Kennedy Space Center, USA;*

Failure Analysis in Space

International Space Station (ISS) Starboard Solar Alpha
Rotary Joint (SARJ) Debris Analysis

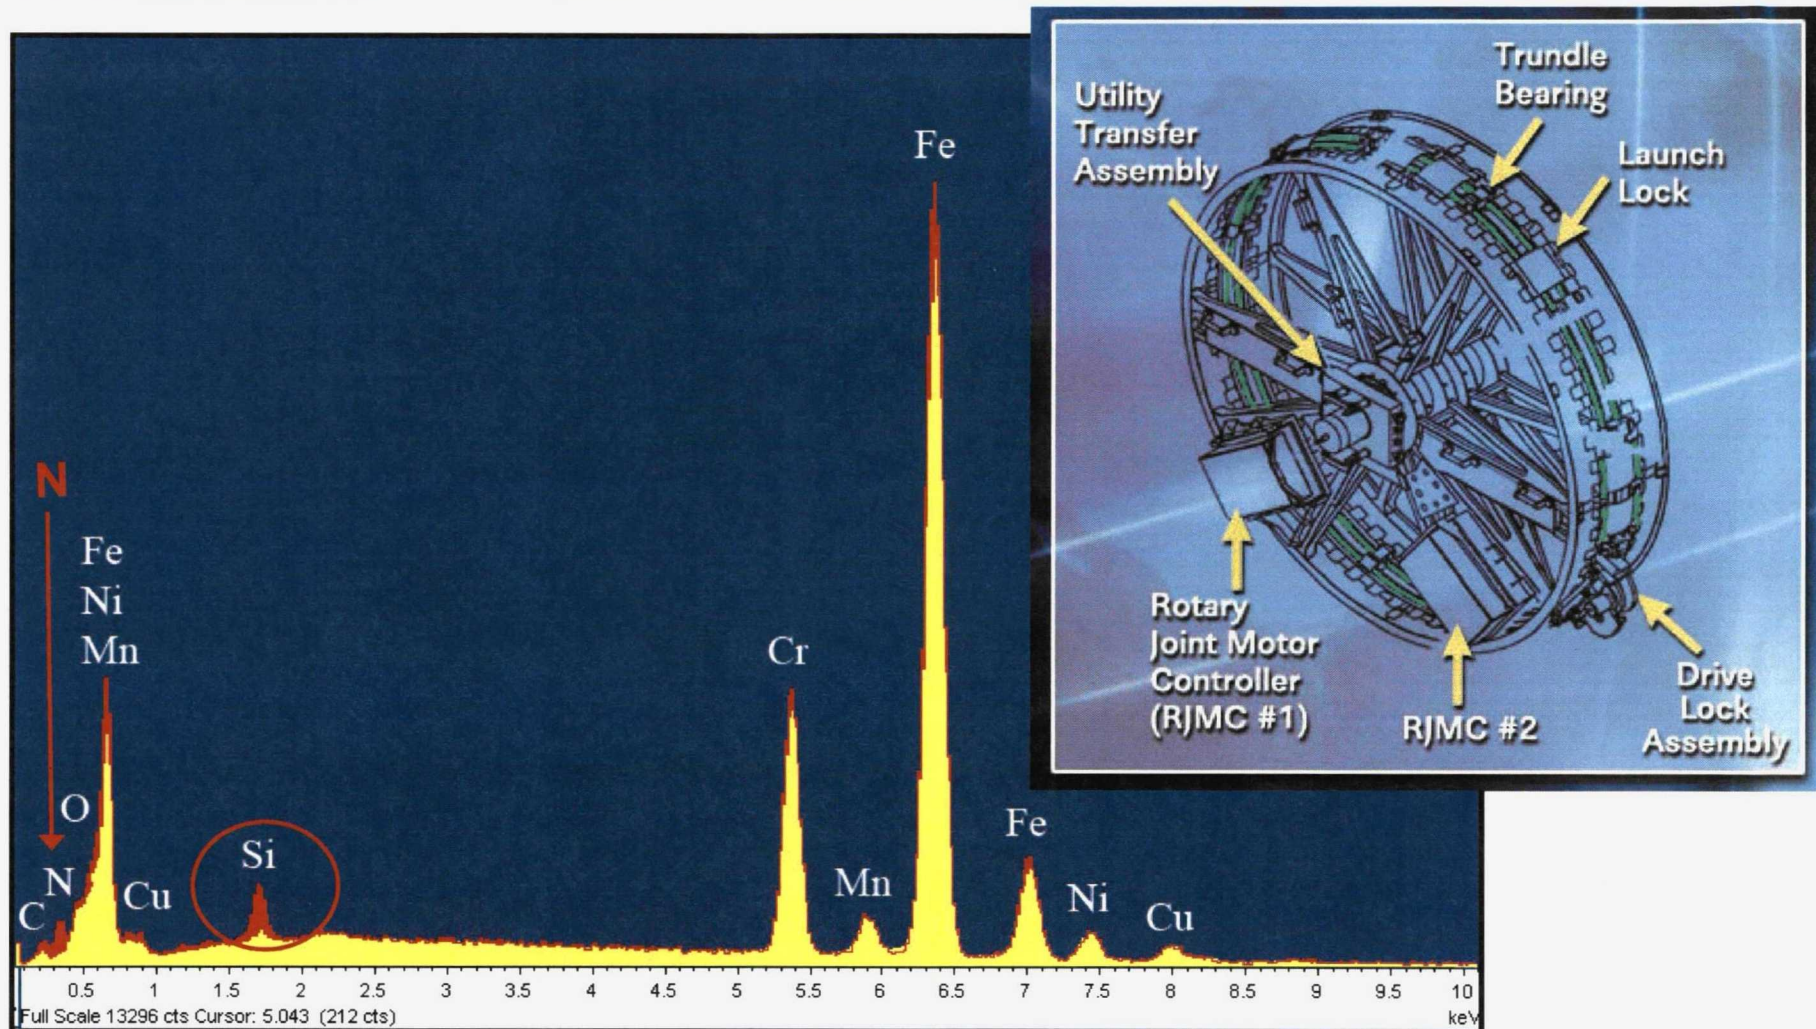
Overlay of representative spectrum from debris (red) on the baseline 15-5 PH spectrum. Nitrogen peak indicates that the debris is from the nitrated layer. The silicon peak is from the silicone adhesive used on the sampling tape.

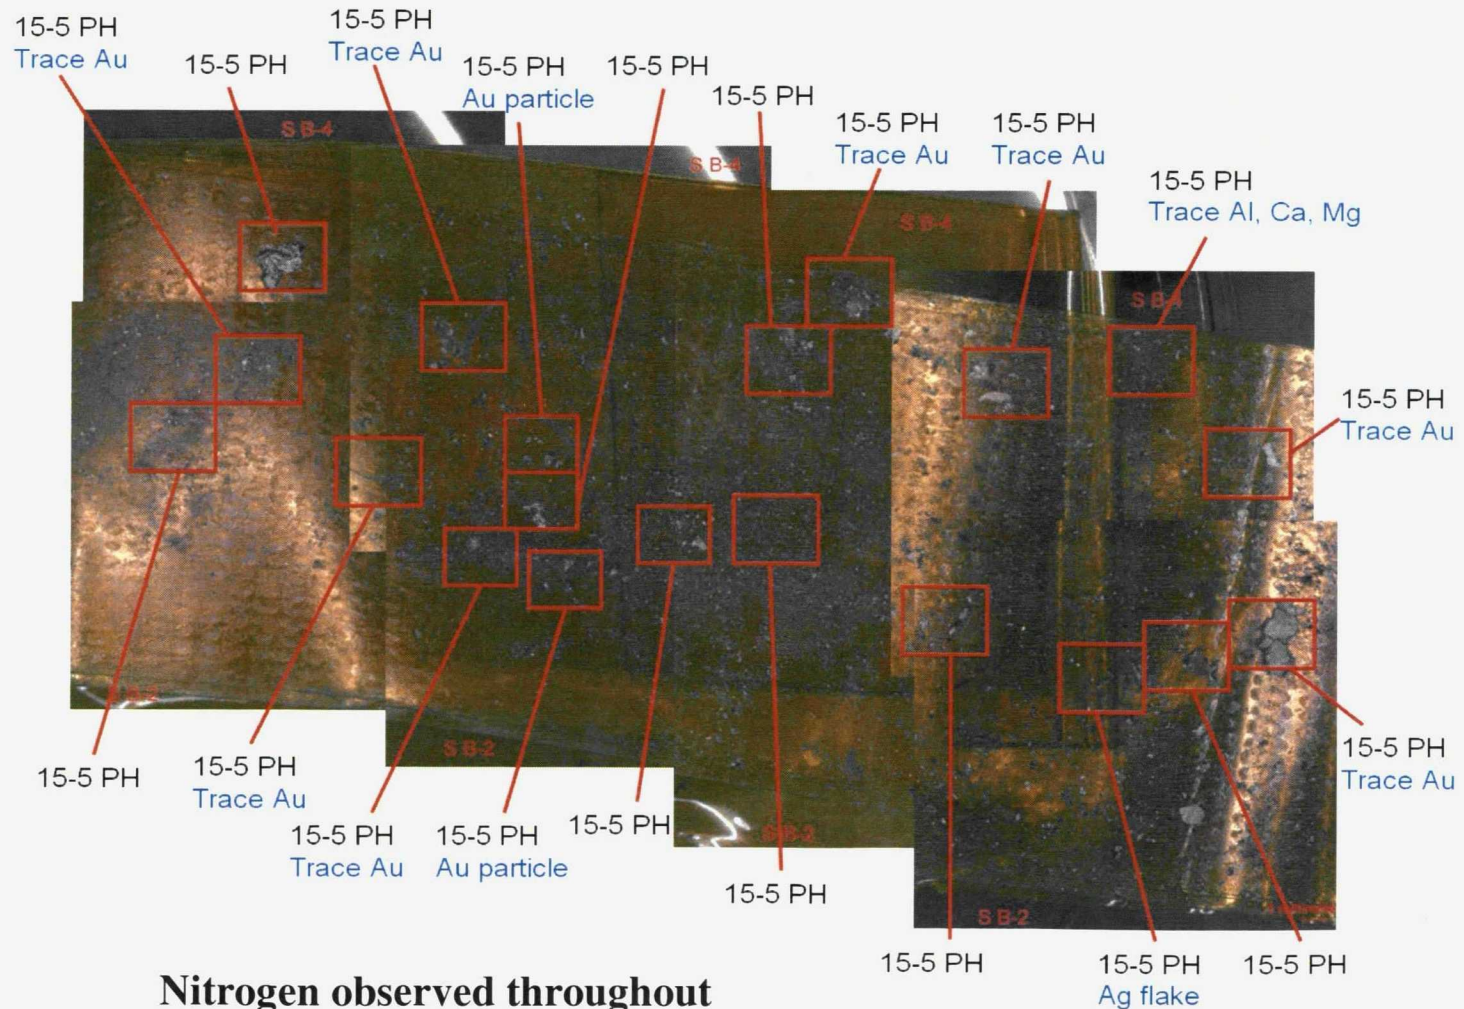
Representative tape showing the analysis locations. The majority of the particles were nitrated 15-5 PH stainless steel.

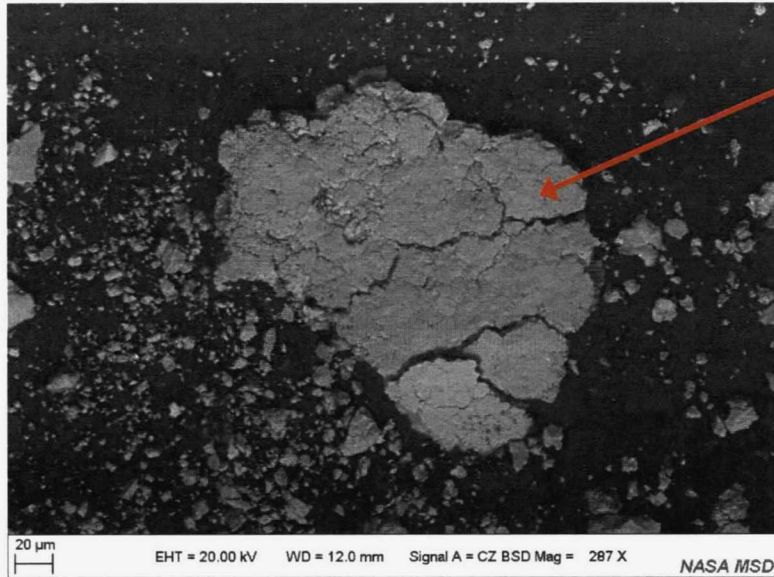
“Extrusion-like”
damage;
possible
agglomeration.

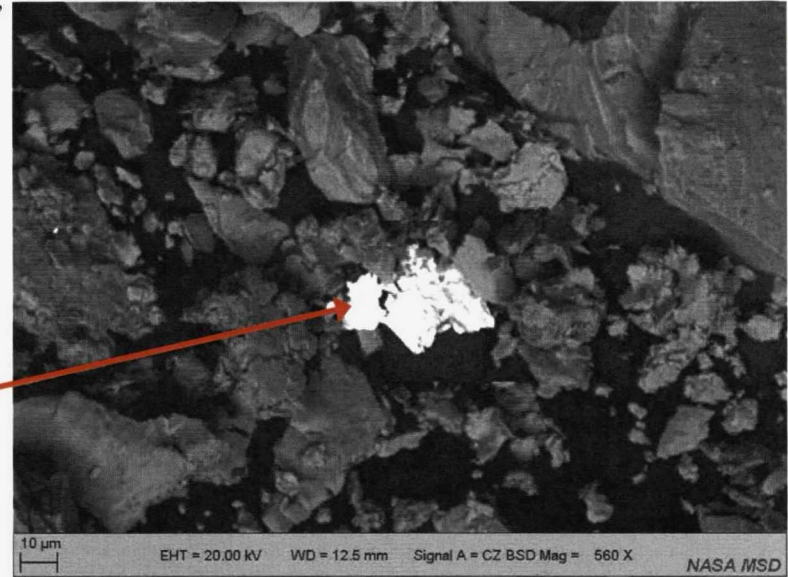
Gold particle
showing
atomic
contrast.

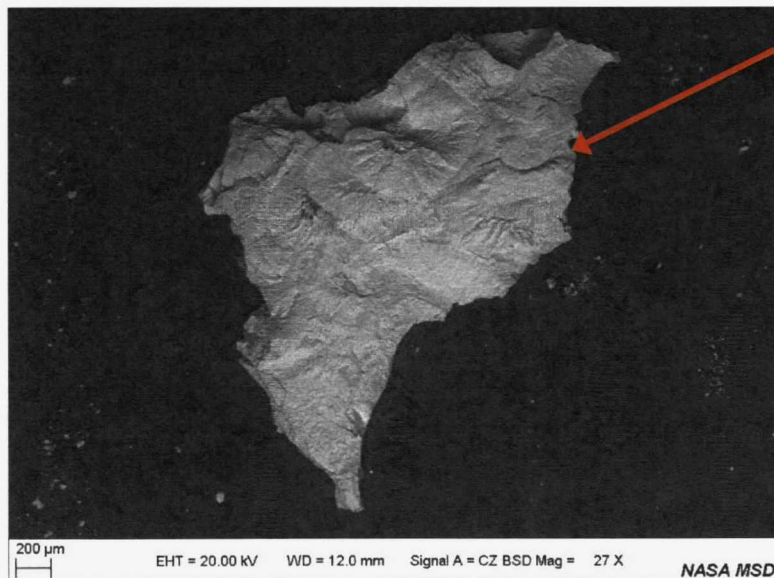
Evidence of
possible
cleavage.

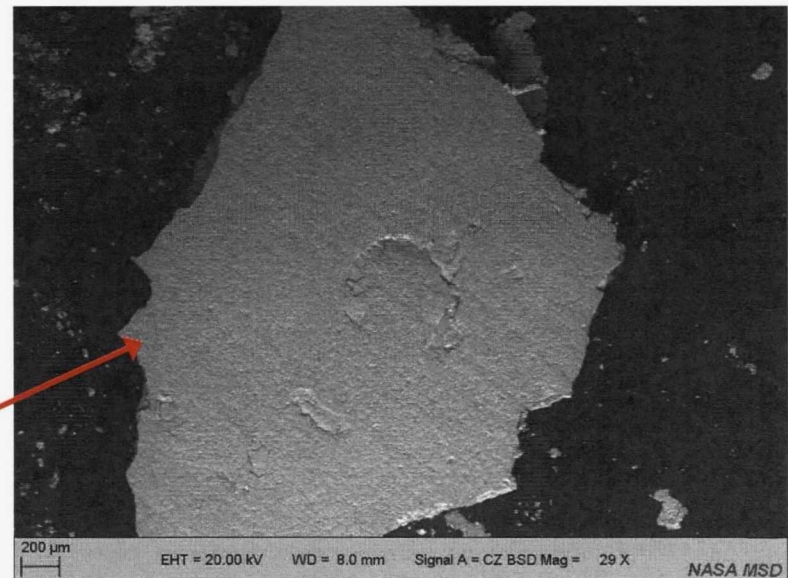
Original 15-5
PH nitrided
surface with
machine
markings.

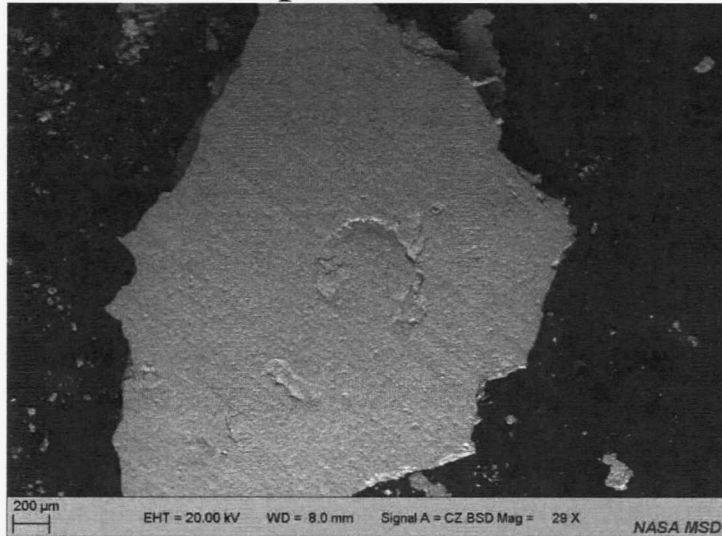
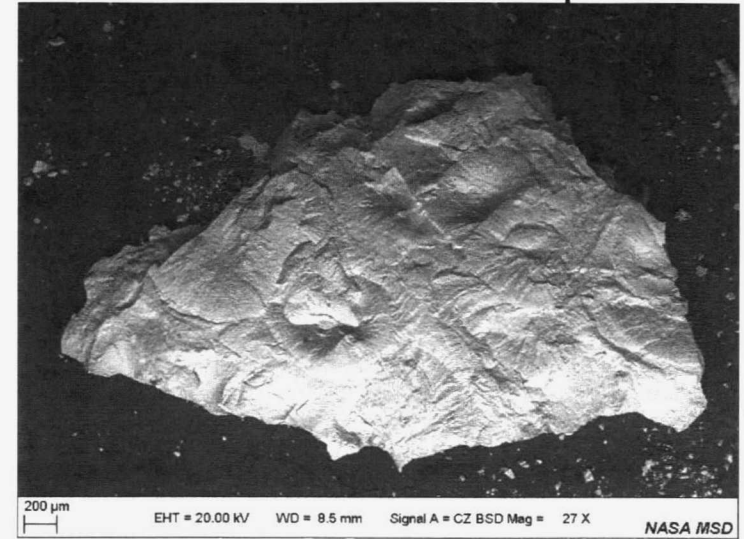
Nitrided 15-5 PH
surface with
machine markings
on obverse (L)
and flipped over
revealing
scalloped reverse
(R).

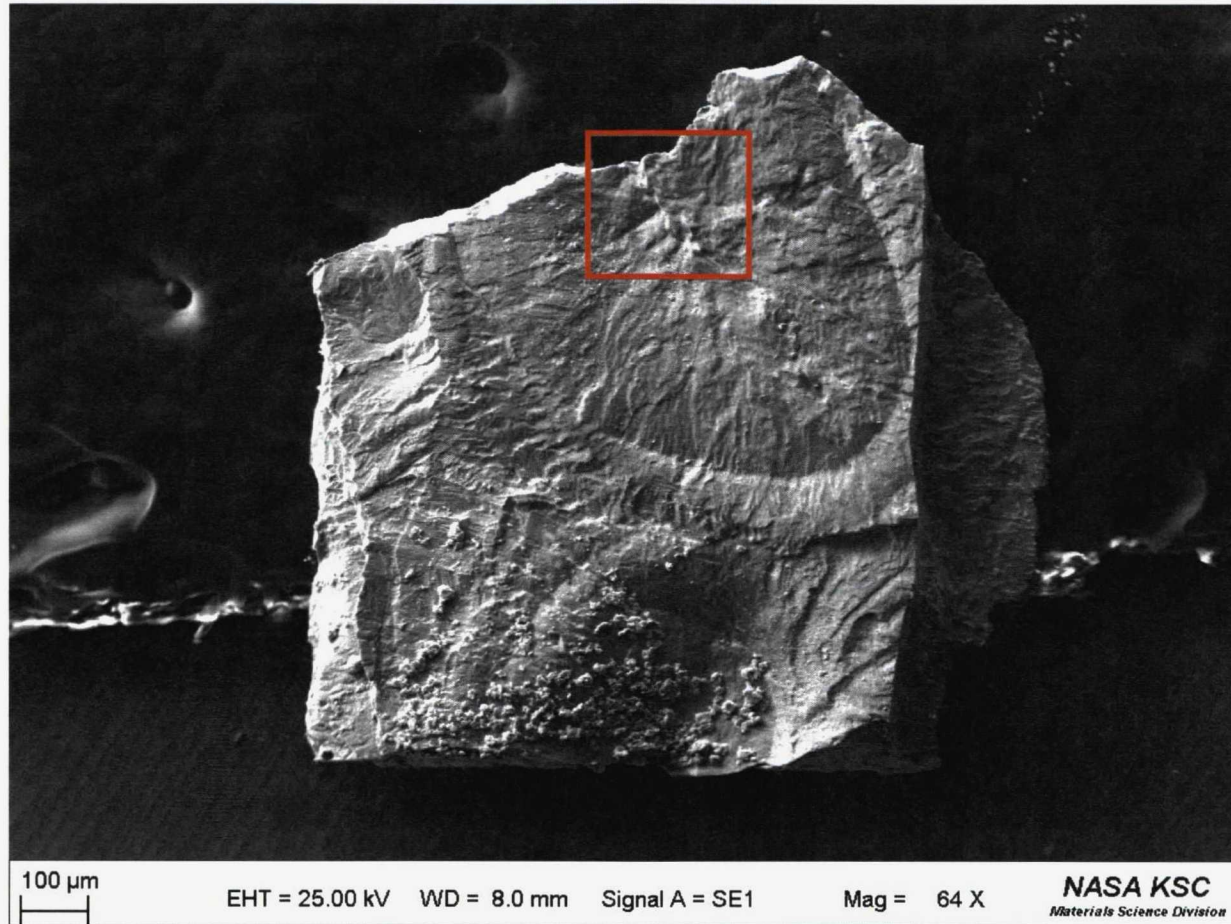
Secondary electron (SE) SEM image of a fragment removed from tape and imaged under high vacuum.

Area in red box appears to be a fracture initiation site and elliptical region suggests crack arresting. Features typical of spalled fragments.

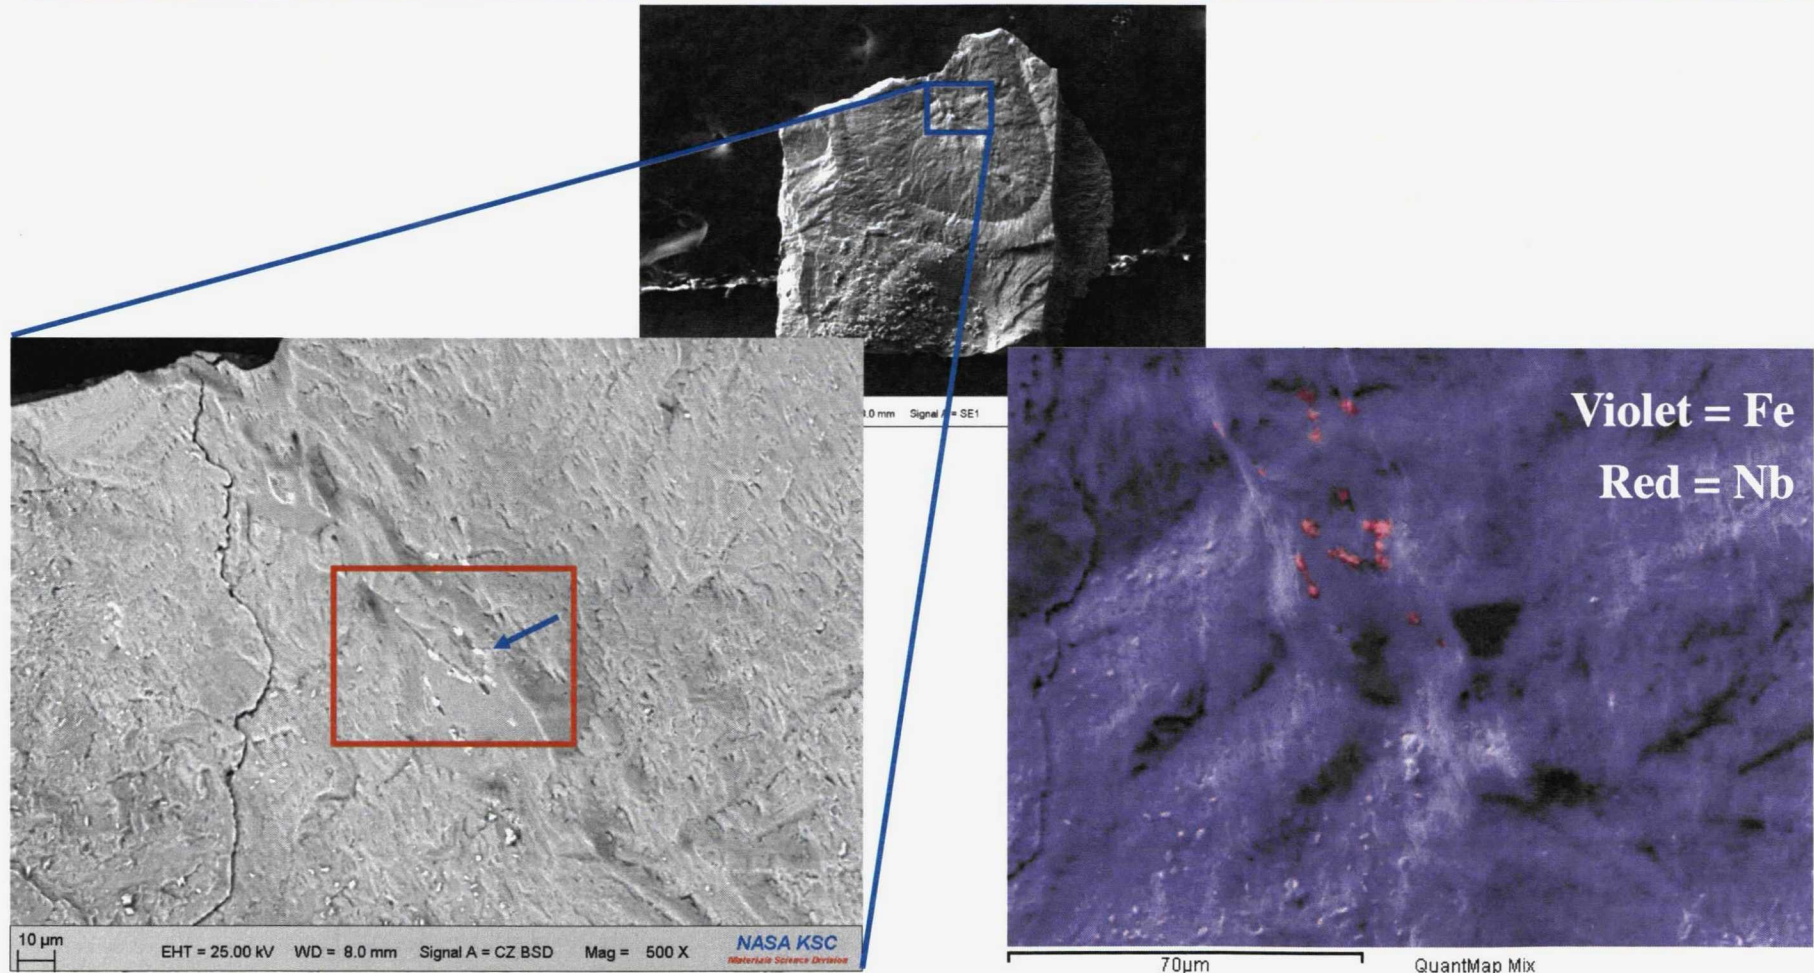
Backscattered electron image of outlined area in red box from previous slide showing atomic contrast.

X-ray elemental dot map of the boxed area, showing niobium-rich precipitates in an iron-rich matrix.

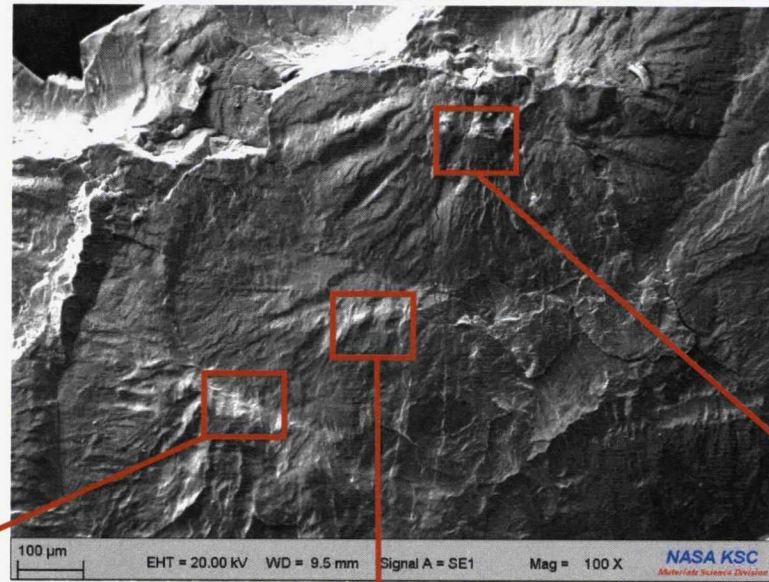
Backscattered electron image showing atomic contrast of the niobium-rich precipitates at typical subsurface fracture initiation sites.

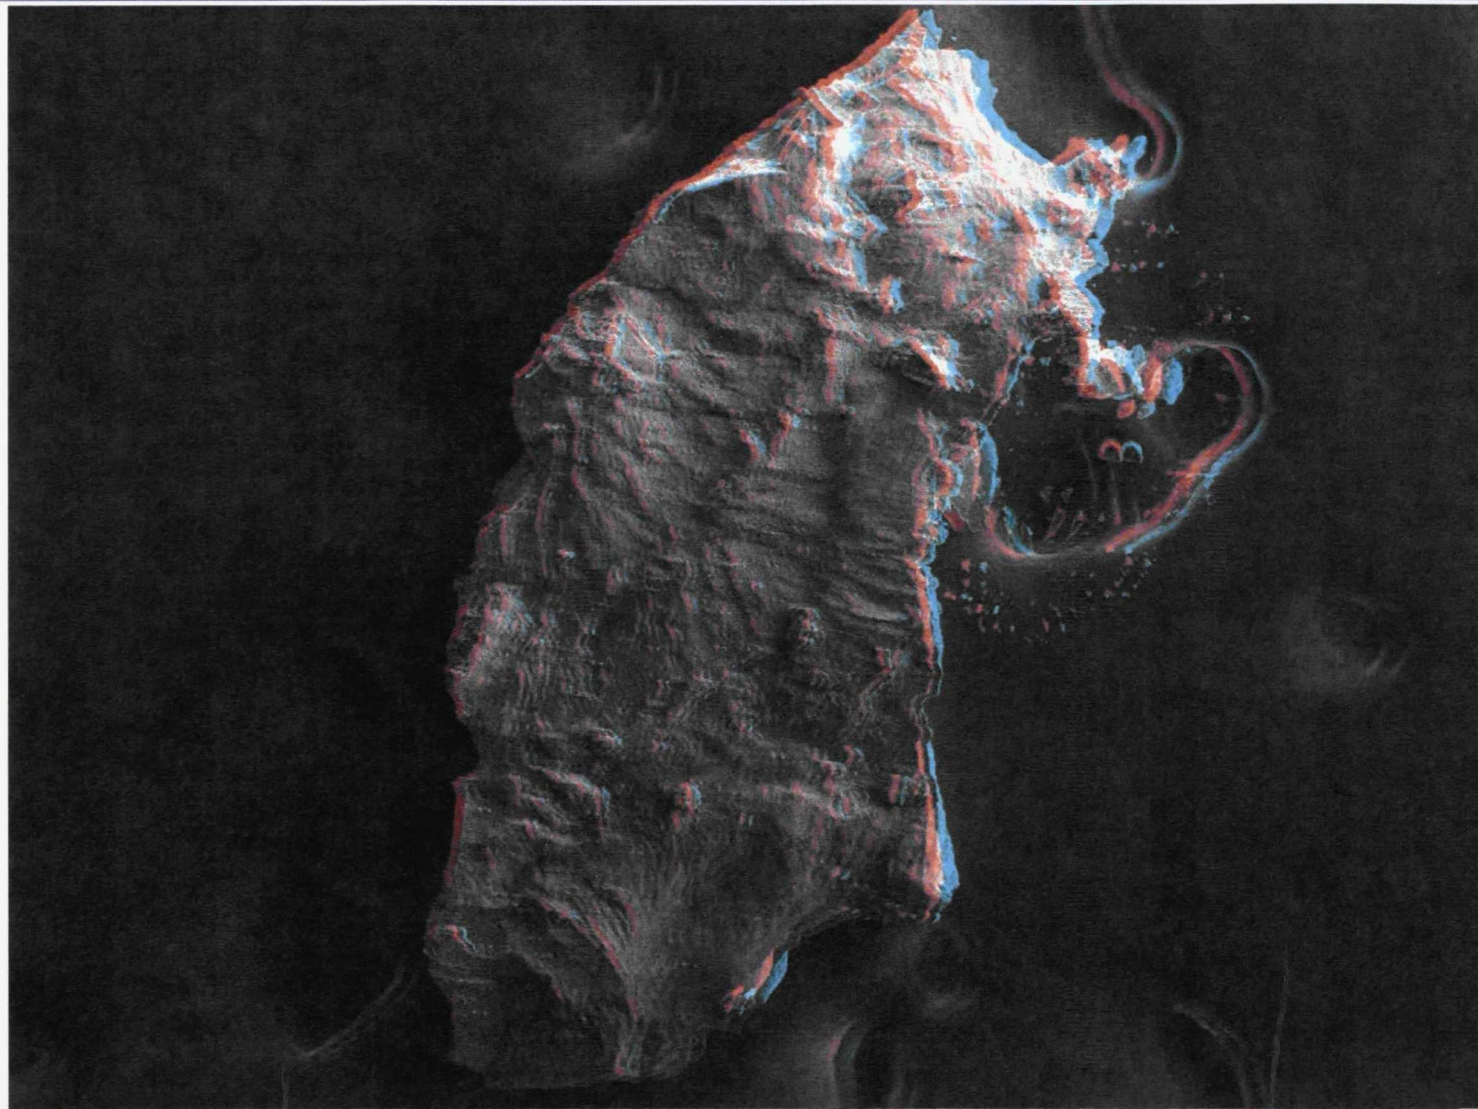
SEM images showing the 3-dimensional topography of the SARJ fragments. Note the relatively flat fracture path and the sharp, perpendicular edges.

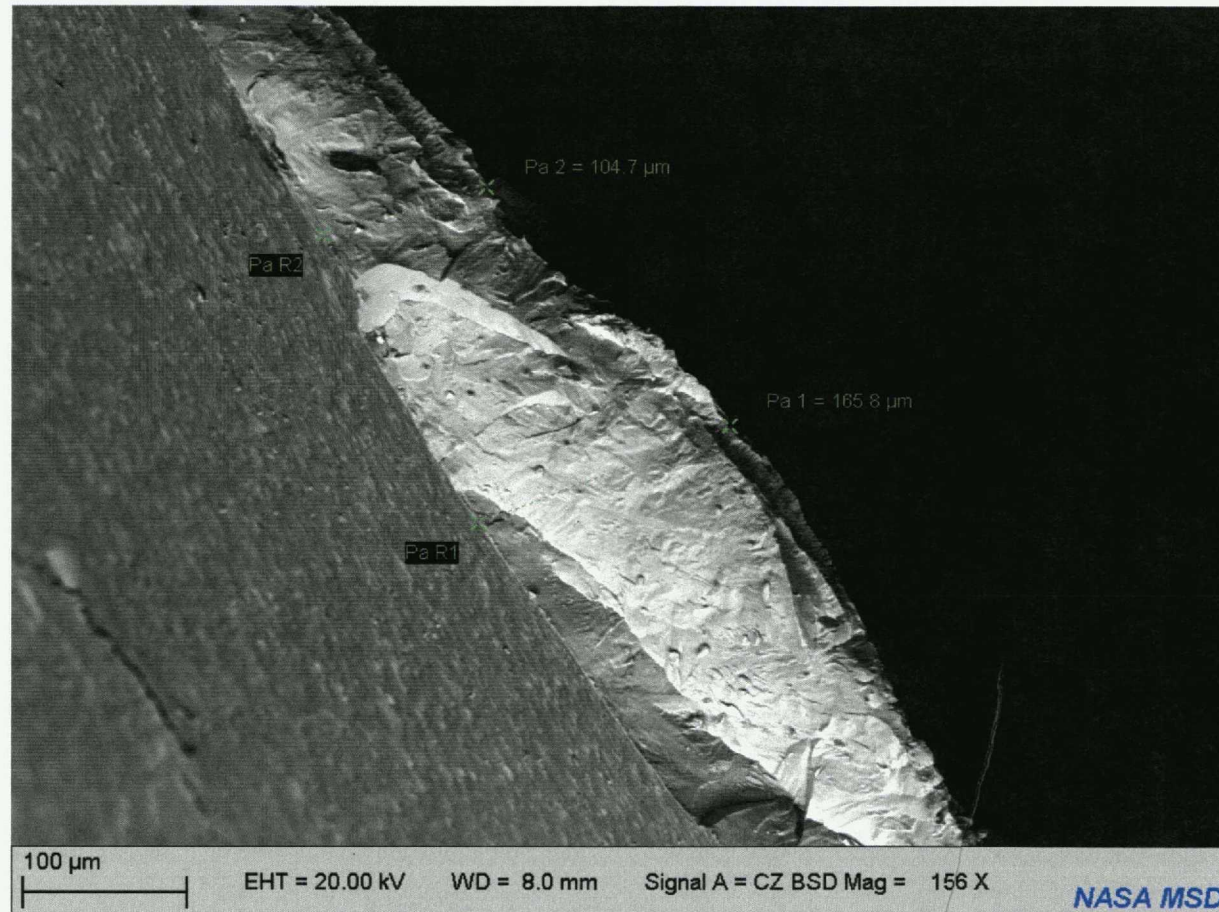
Particle thickness measurements of a large particle in the SEM correlated with measurements taken using laser confocal microscopy, which were 100 to 165 μm for this particle.

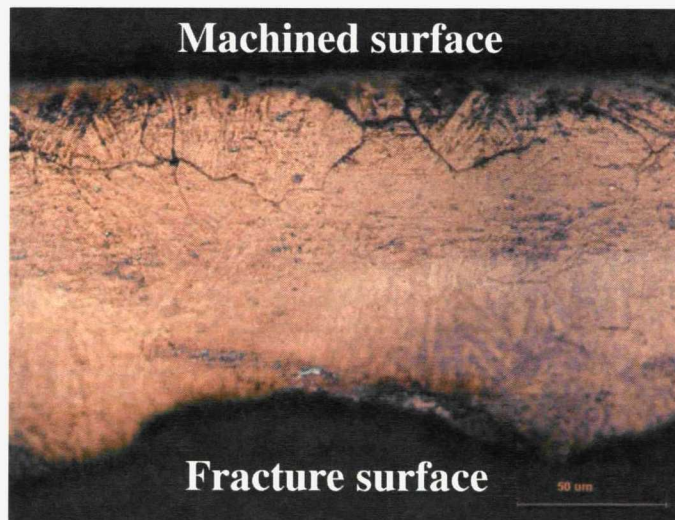
SARJ fragment cross section.

No martensitic core was observed in SARJ fragment.

Microhardness of the mounted cross section was converted to approximately 71 Rockwell C (HRC).

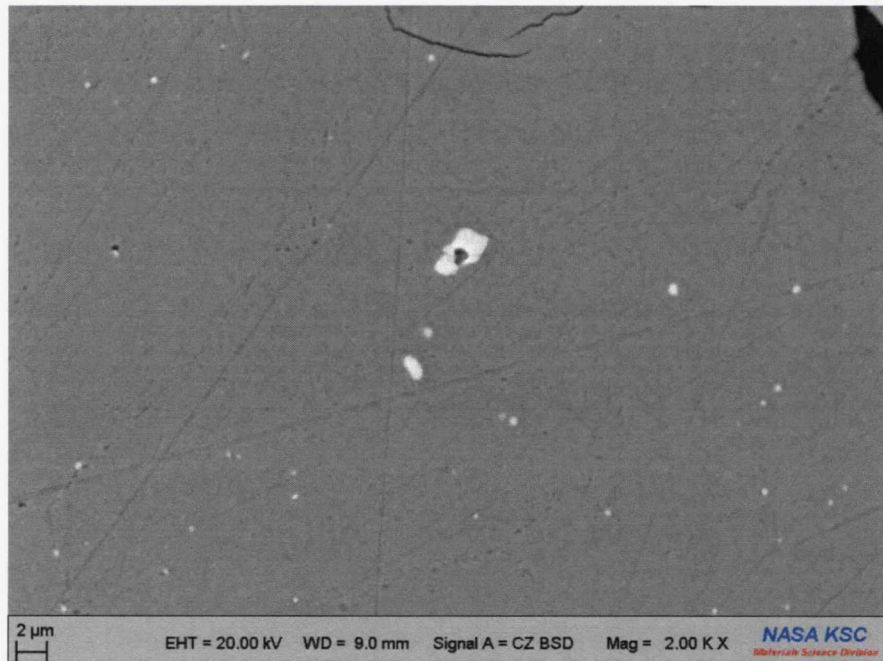
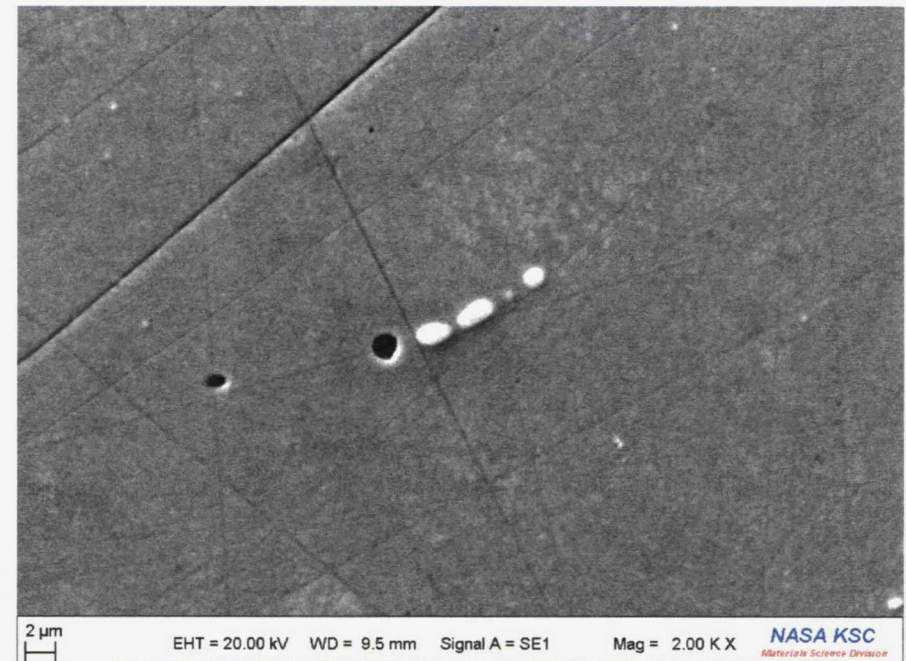
The precipitates in the SARJ fragment were similar in size and distribution to stock 15-5 PH stainless steel.

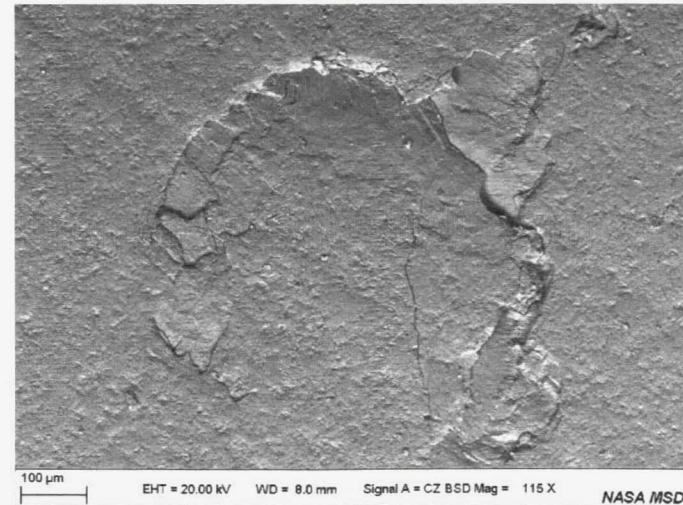
- Contact stress fatigue, i.e. spalling, with subsurface initiation:
 - Location of origin – “Short distance below surface, usually at a nonmetallic inclusion”
 - Initial size – “Small”
 - Initial shape – “Irregular”
 - Crack angle with respect to surface – “Roughly parallel at bottom, perpendicular at sides”
 - Apparent occurrence – “Sudden”

Incipient spall on the SARJ fragment
