Document No. TR-692-001  
Date September 24, 1991

## Test Report

# Demonstration of Hazardous Hypervelocity Test Capability

Issued By  
National Aeronautics and Space Administration  
Johnson Space Center  
White Sands Test Facility  
Laboratories Office

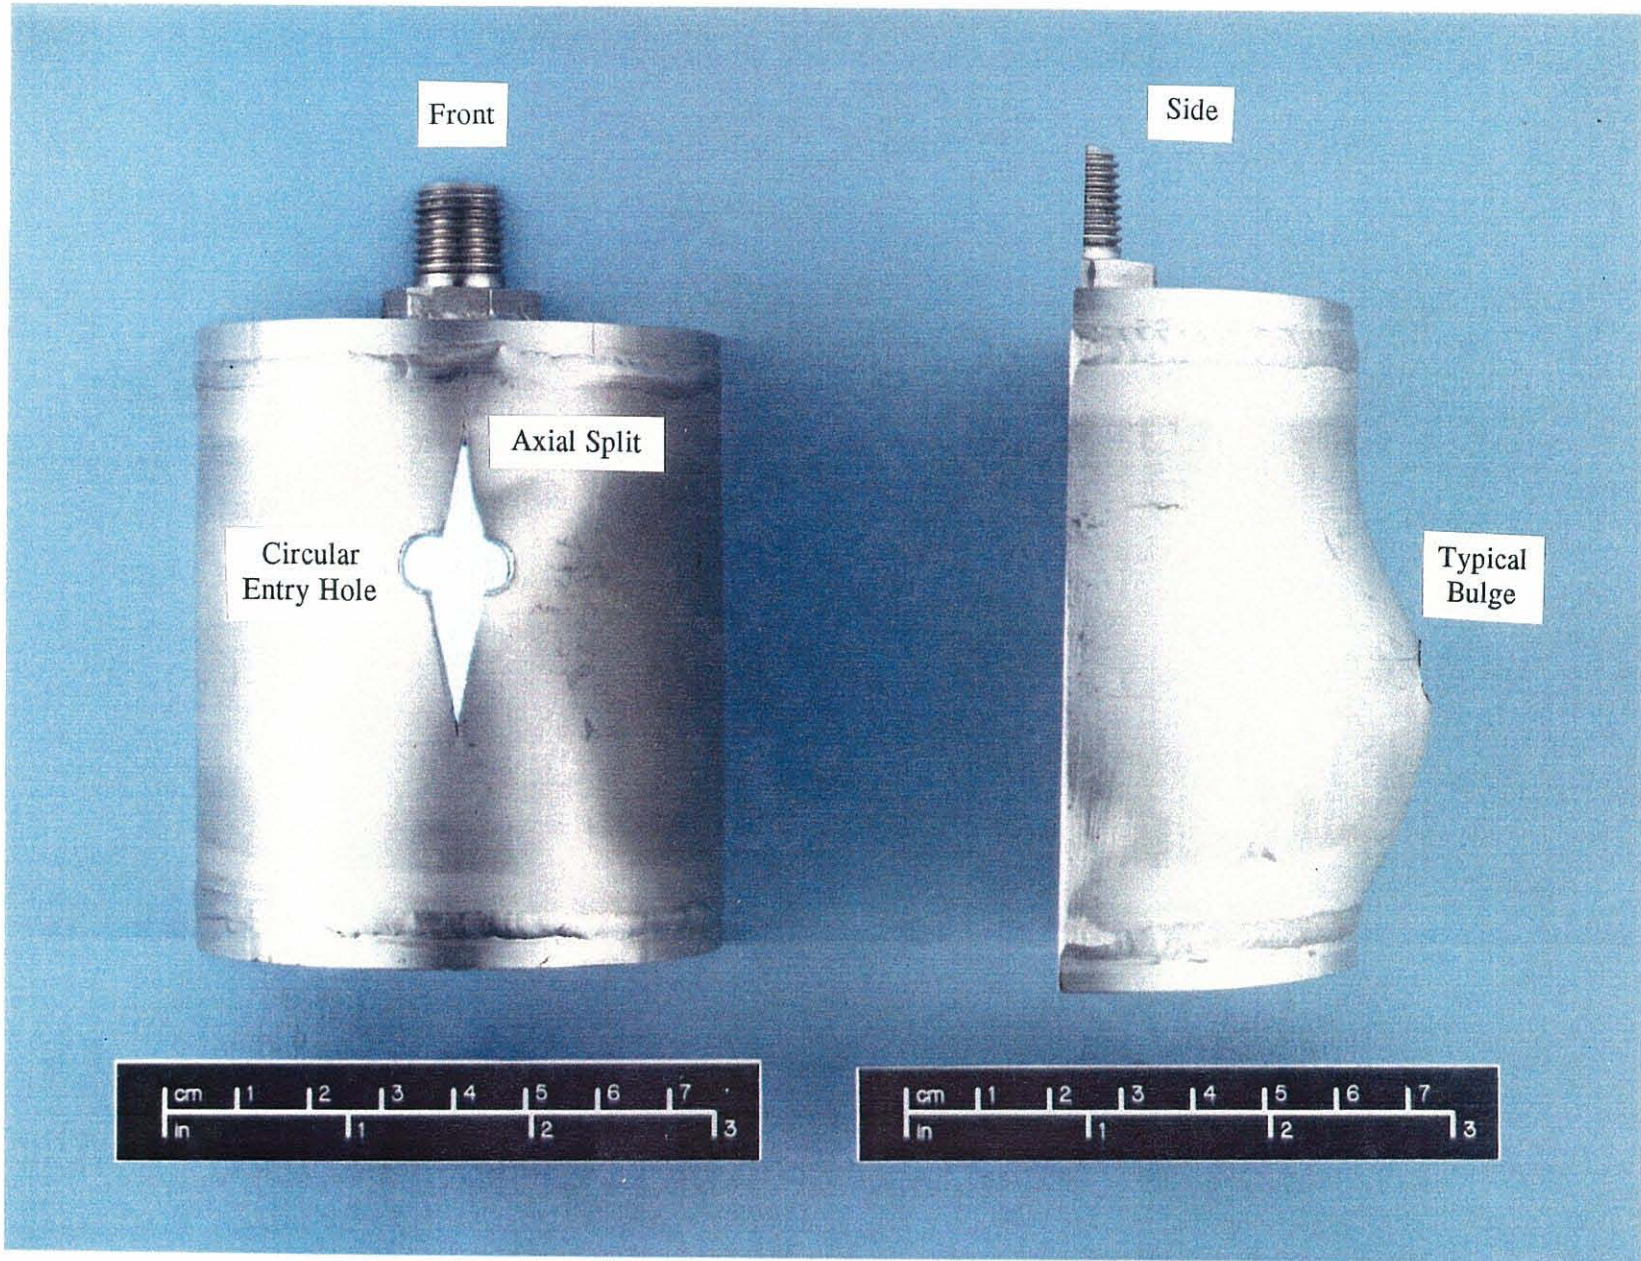
Two of the three water-filled test vessels had the same failure mode: a circular entry hole, a split along the cylinder axis, and an outward bulge from the vessel face. Figure 6 shows front and side views of typical entry damage. Posttest measurements of test article HYP-1 show that the entry area was bulged outward a maximum of 0.86 cm (0.34 in) with a 4.3-cm (1.7-in) long axial split. The circular entry hole appeared to be approximately 0.71-cm (0.28-in) diameter, but was bisected by a maximum of 0.71 cm (0.28 in) by the split. Test article HYP-8, which was placed 7.6 cm (3.0 in) behind a 0.25-cm (0.01-in) thick aluminum shield, bulged only 0.46 cm (0.18 in). A 3.2-cm (1.26-in) long split terminated at the weld heat-affected zone boundary. The circular entry hole was smaller than the circular entry hole for test article HYP-1, measuring only 0.63-cm (0.25-in) diameter and separated by a maximum of 0.38 cm (0.15 in).

**Figure 6**  
Bulged Entry Damage to Liquid-Filled Vessels

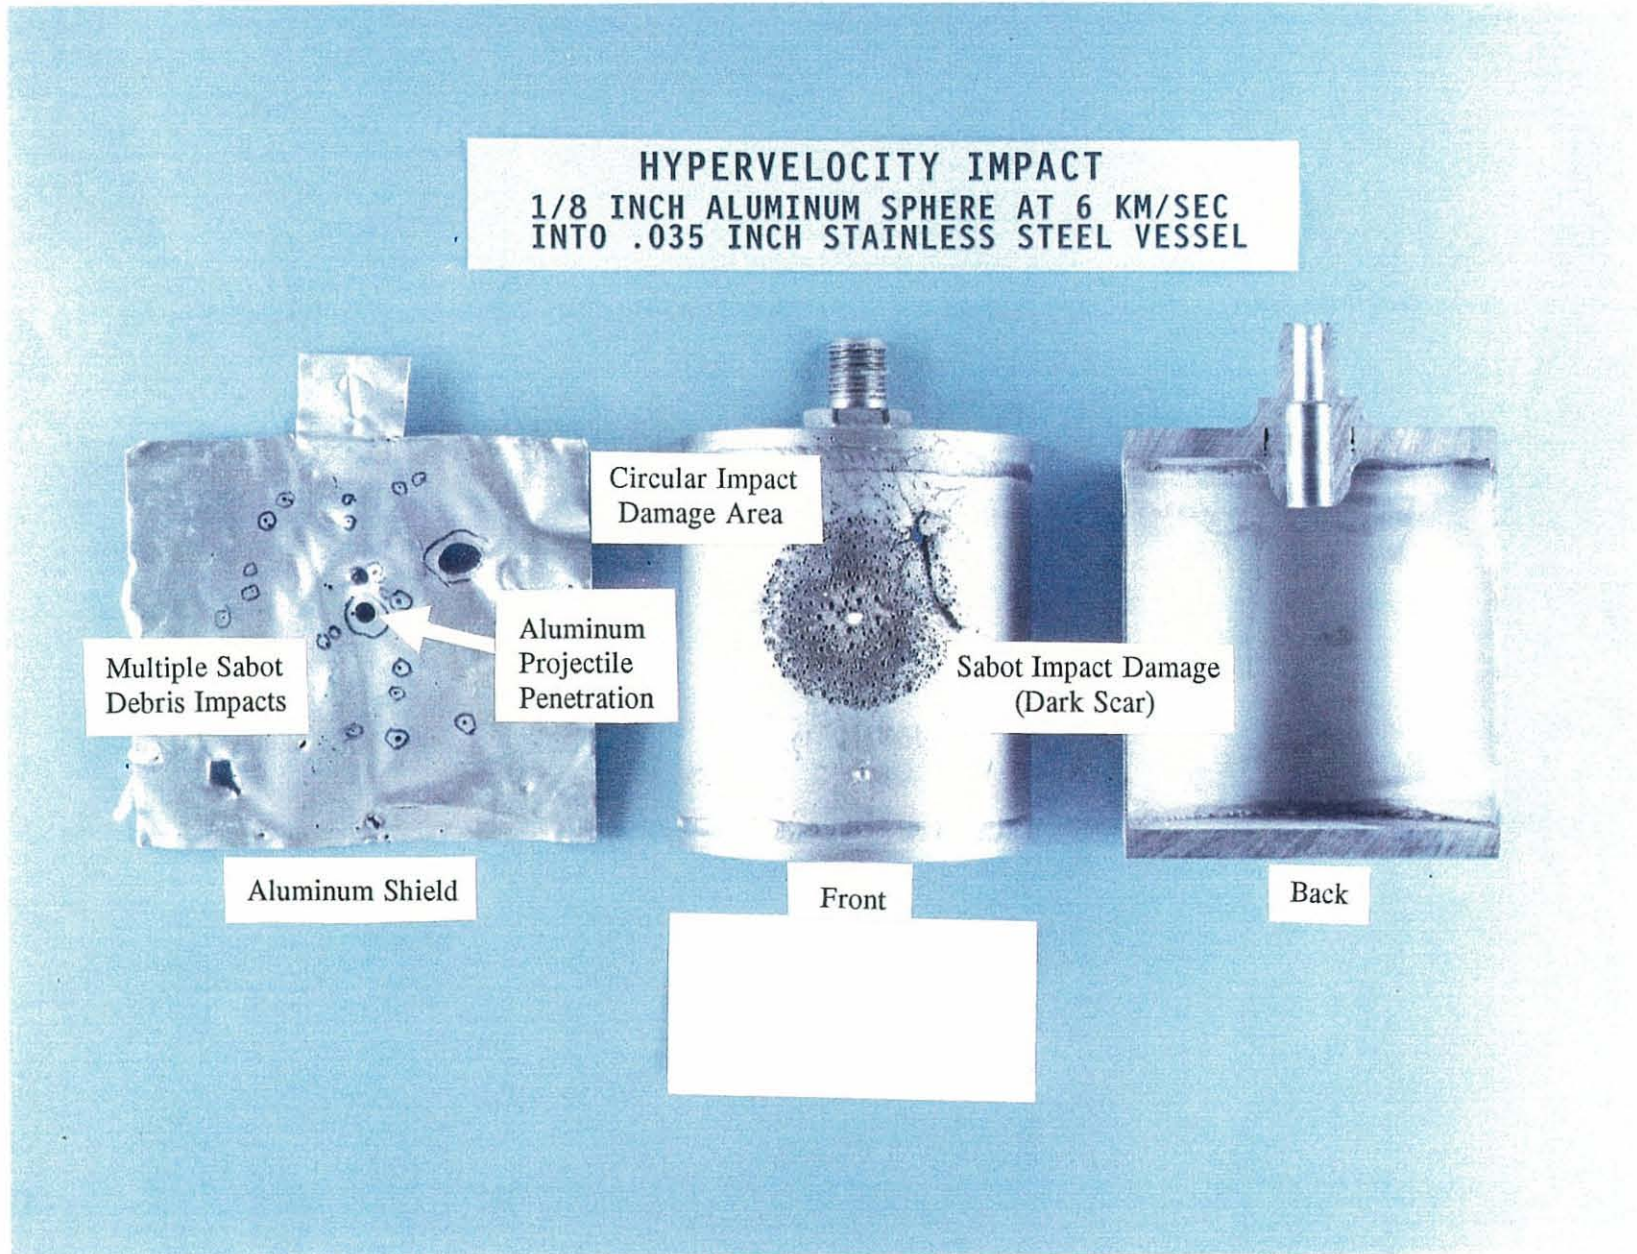
Test article HYP-6, placed 10.1 cm (4.0 in) behind a 0.25-cm (0.01-in) thick aluminum shield, displayed a different failure mode: damage to the vessel face resembled a shotgun blast, rather than the bulge and split evident in previous tests. Impacts, including several full penetrations, were concentrated in a circular, blackened area (Figure 7 ). The internal vessel wall, opposite the entry damage, was scarred with shallow impacts and scratches, but was not penetrated. Test article HYP-6 was not available for posttest measurement.

**Figure 7**  
Posttest of Sectioned 2.07 MPa (300 psig)  
Shielded Water Test Vessel

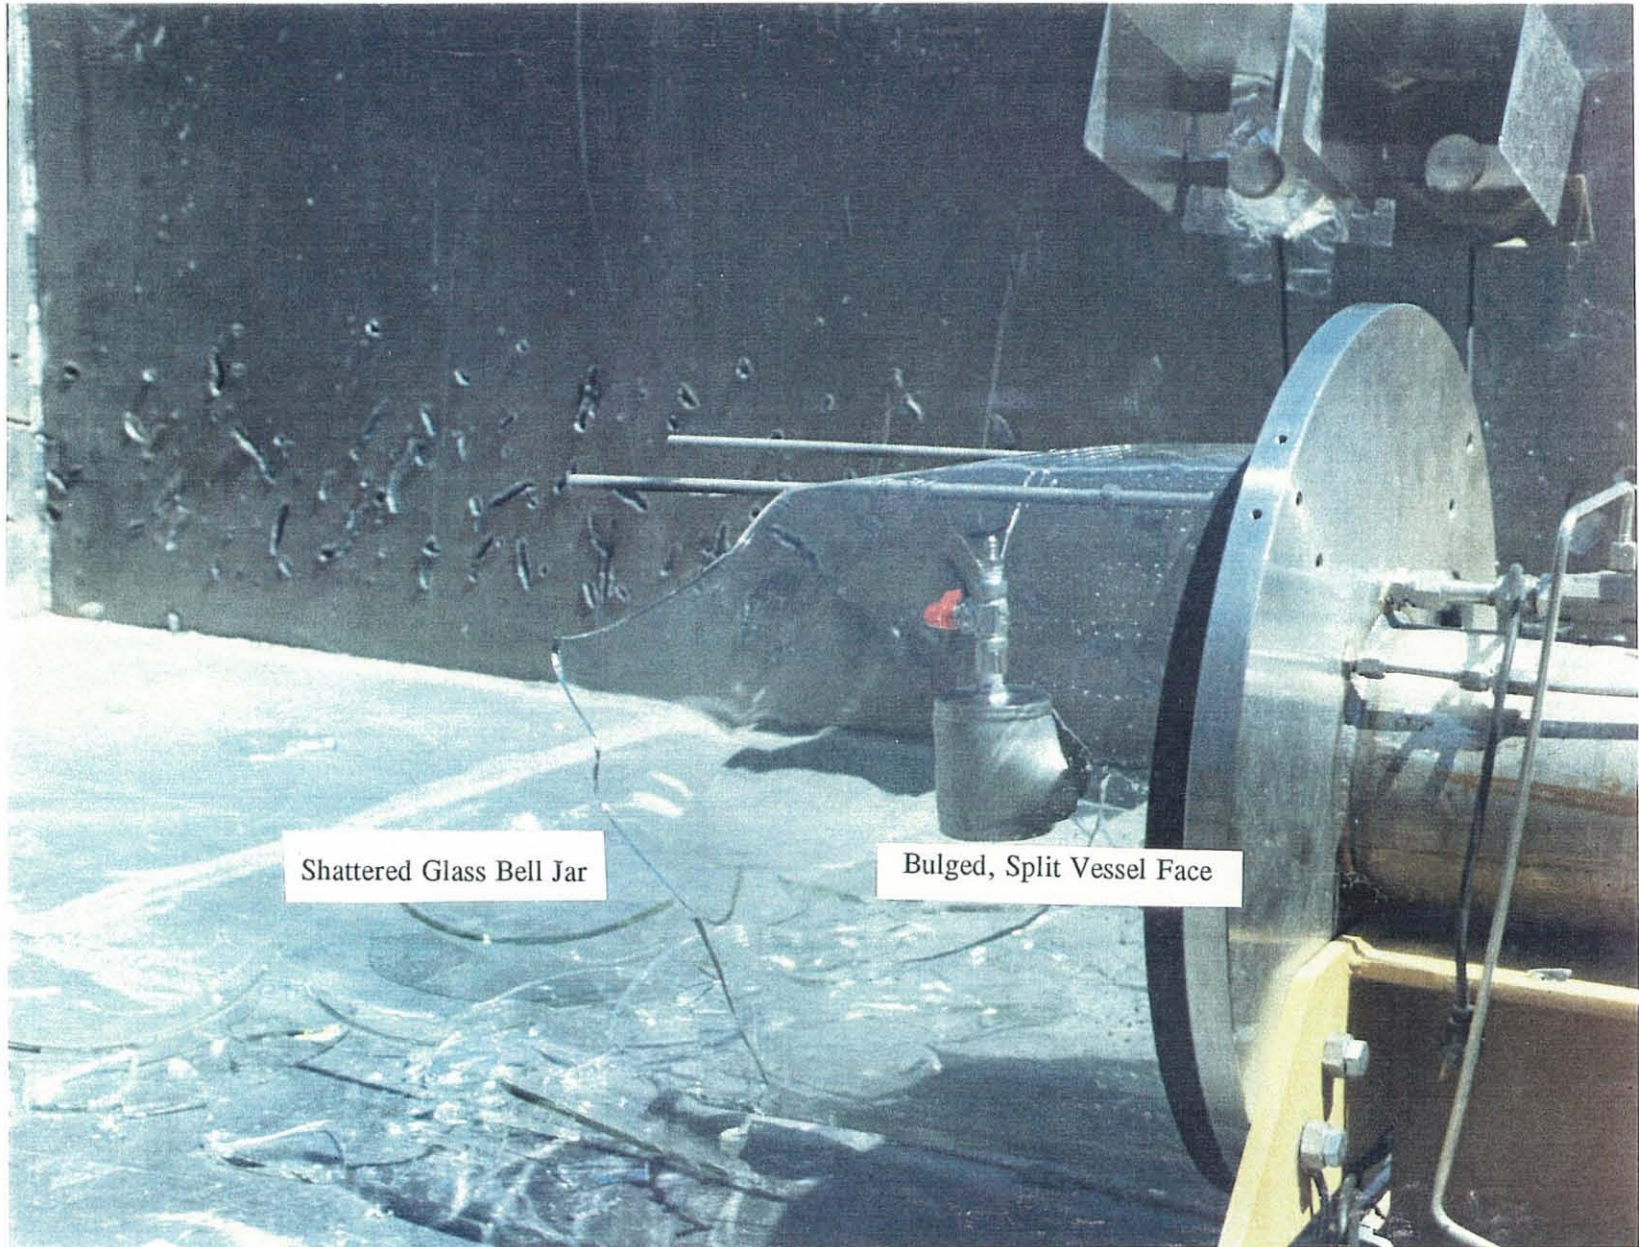
Test article HYP-10 sustained two impacts, one from the aluminum projectile and one from a piece of nylon sabot. The vessel face was split from end to end (Figure 8) with some shearing at the welds. Although there was no visible impact damage to internal vessel surfaces or end plates, wall expansion was evident throughout the vessel circumference. In addition, the glass bell jar was shattered (Figure 8). Following impact, the high-pressure nitromethane squirted out the entry hole causing the test article to swing upward toward the glass bell jar, shattering the glass bell jar. The nitromethane did not detonate, although high-speed film records\* revealed an enhanced flash, possibly the result of ignition of some of the nitromethane. The test article was unavailable for posttest measurements.

Shattered Glass Bell Jar

Bulged, Split Vessel Face

**Figure 8**  
Posttest 0.85 MPa (12.3 psig)  
Nitromethane Test Vessel

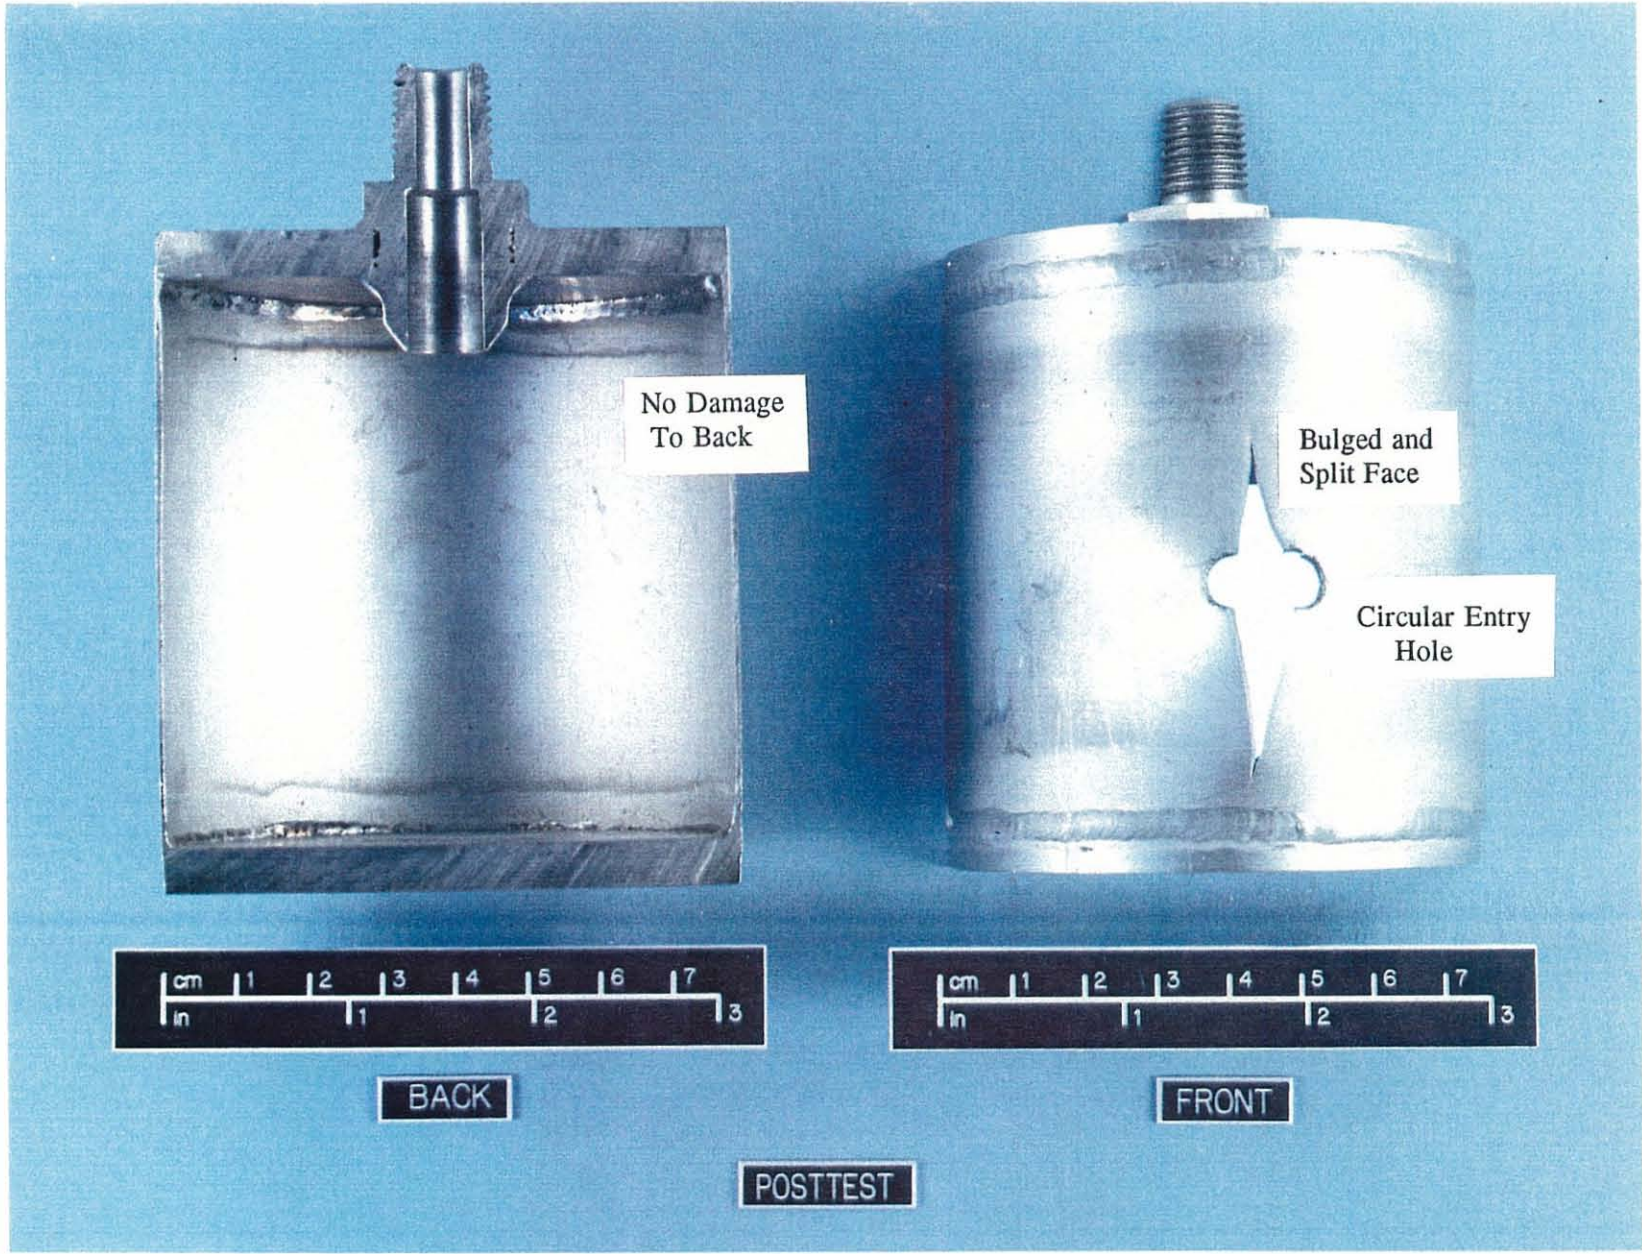
Test article HYP-2 contained hydrazine, pressurized to 2.07 MPa (300 psig) with gaseous nitrogen. Projectile impact of HYP-2 was just below the cylinder mid-point and in the liquid. The resulting circular entry hole, bulge, and split (Figure 9) were similar to that found on the water-filled vessels. Again, the 4.78-cm (1.88-in) split terminated on one end at a weld heat-affected zone boundary. The circular entry hole was approximately 0.69-cm (0.27-in) diameter, bulged 0.94 cm (0.37 in), and separated a maximum of 0.74 cm (0.29 in). Several scratches and very shallow pits were found opposite the entry damage, but both end plates were in pristine condition. As expected, based on the nitromethane test results, the hydrazine did not detonate.

**Figure 9**  
Sectioned 2.07 MPa (300 psig)  
Hydrazine Test Vessel

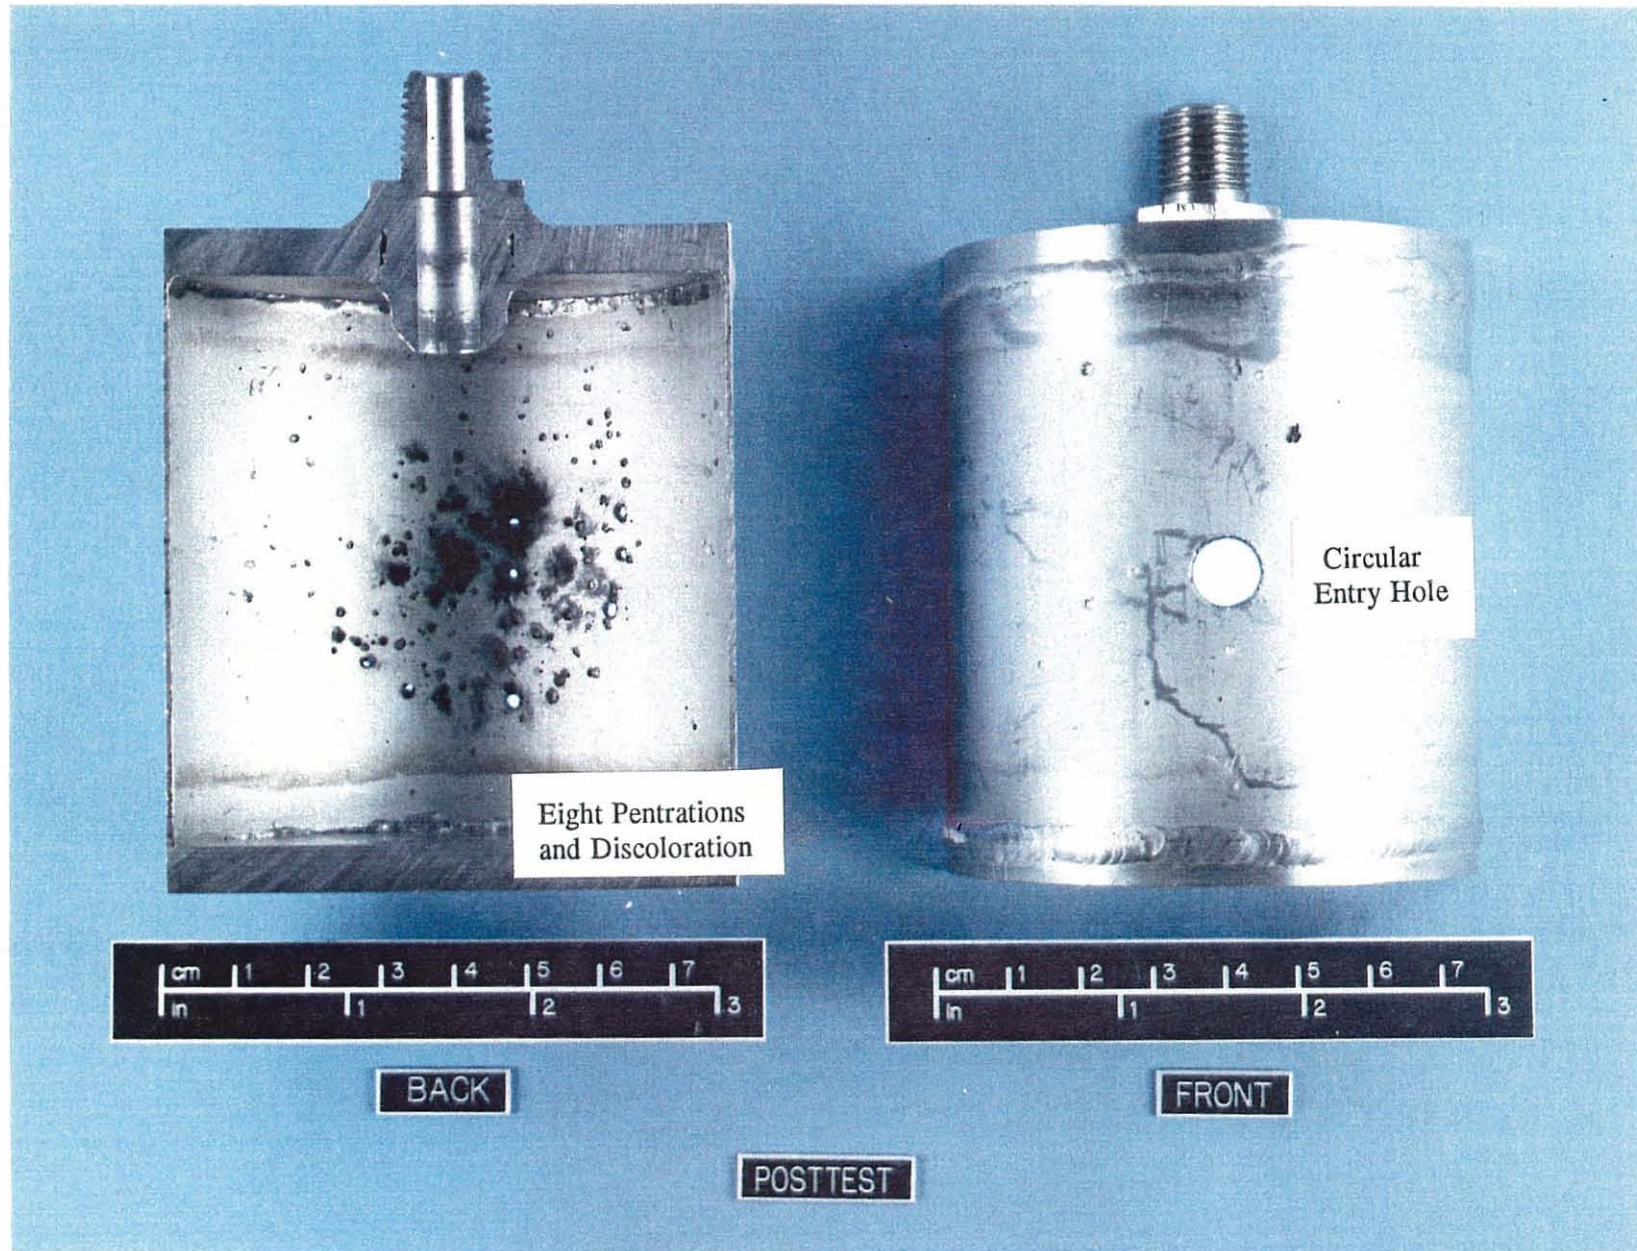
Entry damage to the gaseous nitrogen-filled vessel (HYP-5) was different than that found on any of the liquid-filled vessels. Impact damage was limited to a single, circular entry hole, but no bulge or split was evident (Figure 10). The vessel wall opposite the 0.89-cm (0.35-in) diameter entry hole was peppered with impacts, including eight full penetrations of up to 0.26-cm (0.10-in) diameter. The "shotgun" damage pattern on HYP-5 was similar in appearance to that found on the face of the shielded, water-filled HYP-6 (Section 7.2.1), but the damage radius of HYP-5 was larger. Several dozen more circular impacts dimpled the external vessel surface. Black discoloration was found around some of the penetrations, and both end plates were scarred with shallow circular impacts and scratches.

**Figure 10**  
Sectioned 2.07 MPa (300 psig)  
Nitrogen Test Vessel

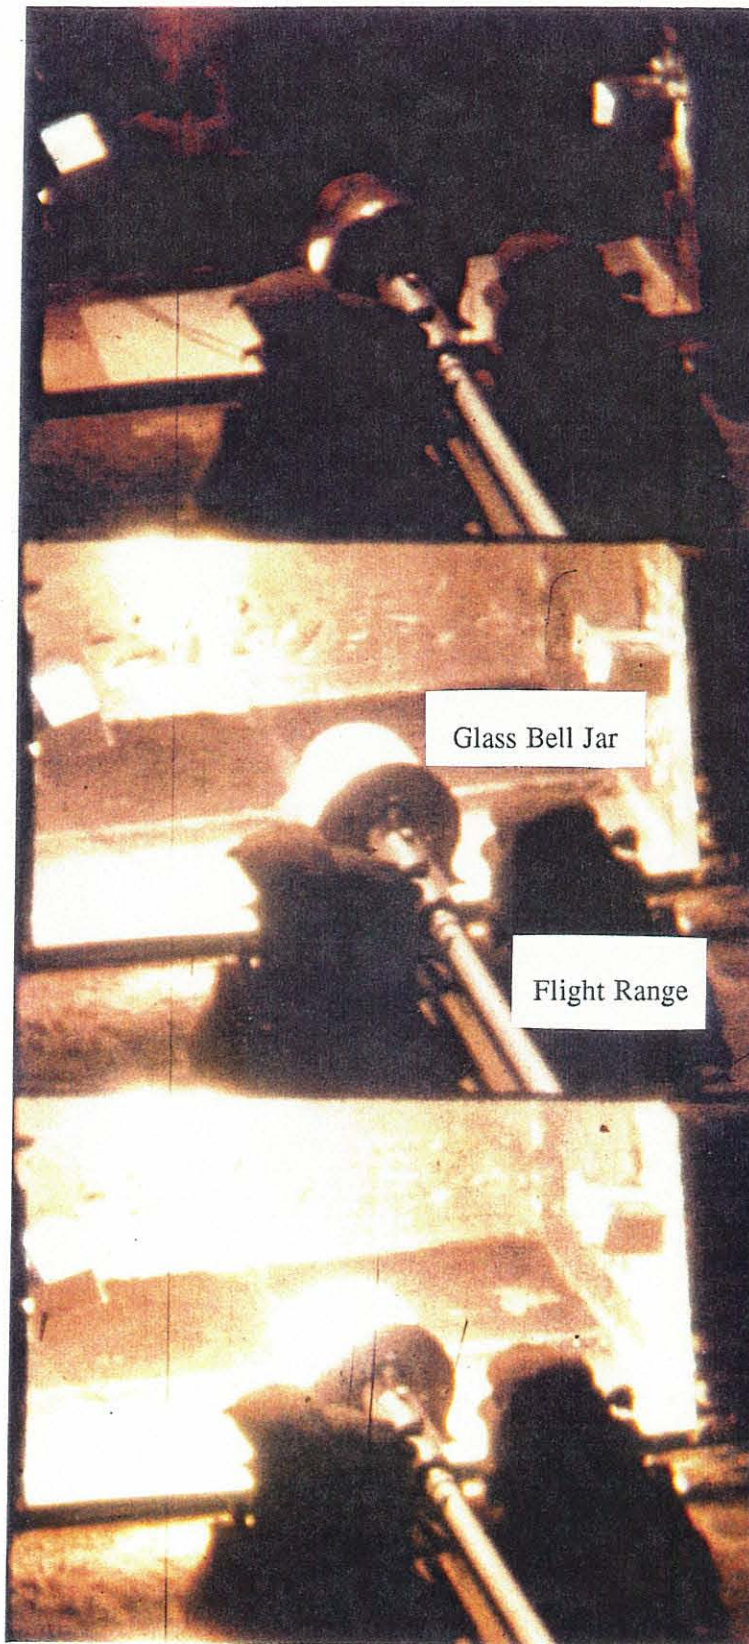
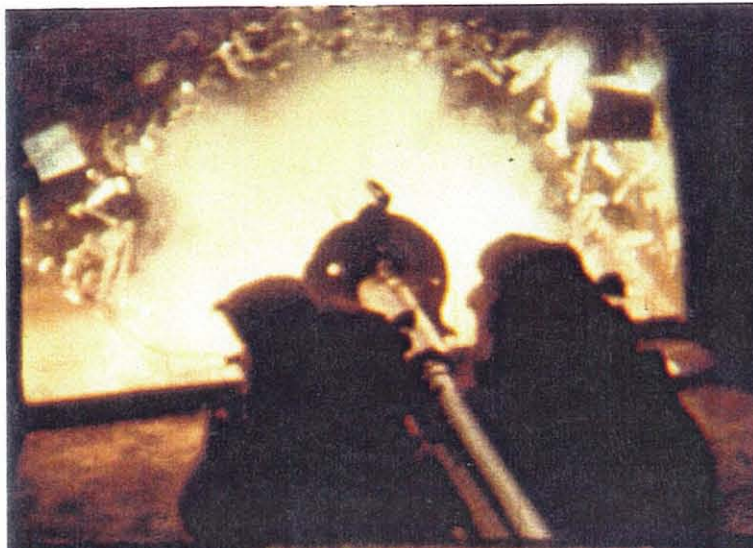
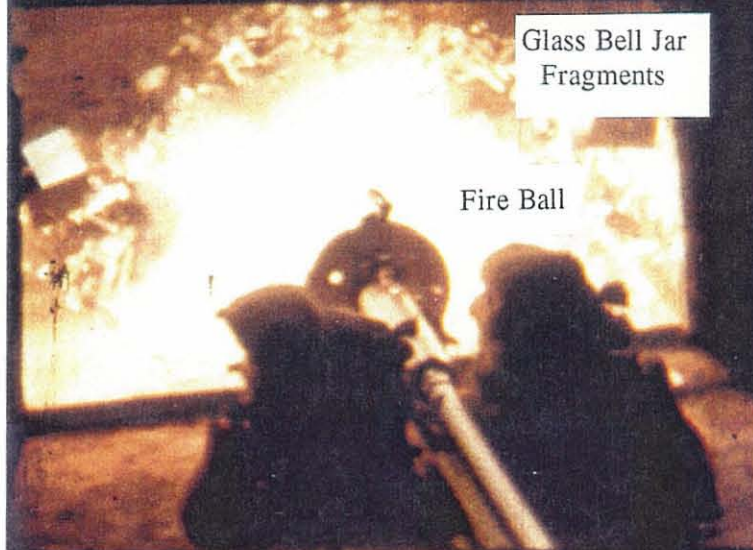
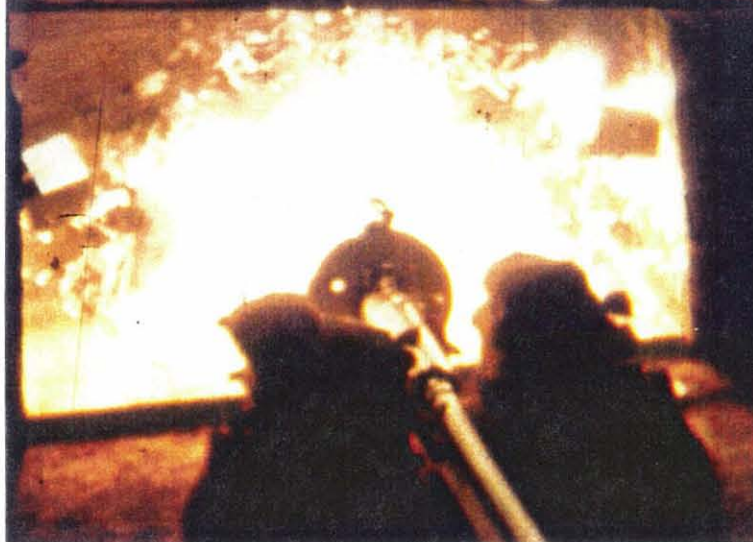
The oxygen test proved to be the most violent of all the tests. High-speed cinema film (Figures 11 and 12) show the glass bell jar following impact. Figure 12 shows glass bell jar

**Figure 11**  
Impact of 20.7 MPa (3000 psig)  
Oxygen Test Vessel

**Figure 11 (Continued)**  
Impact of 20.7 MPa (3000 psig)  
Oxygen Test Vessel

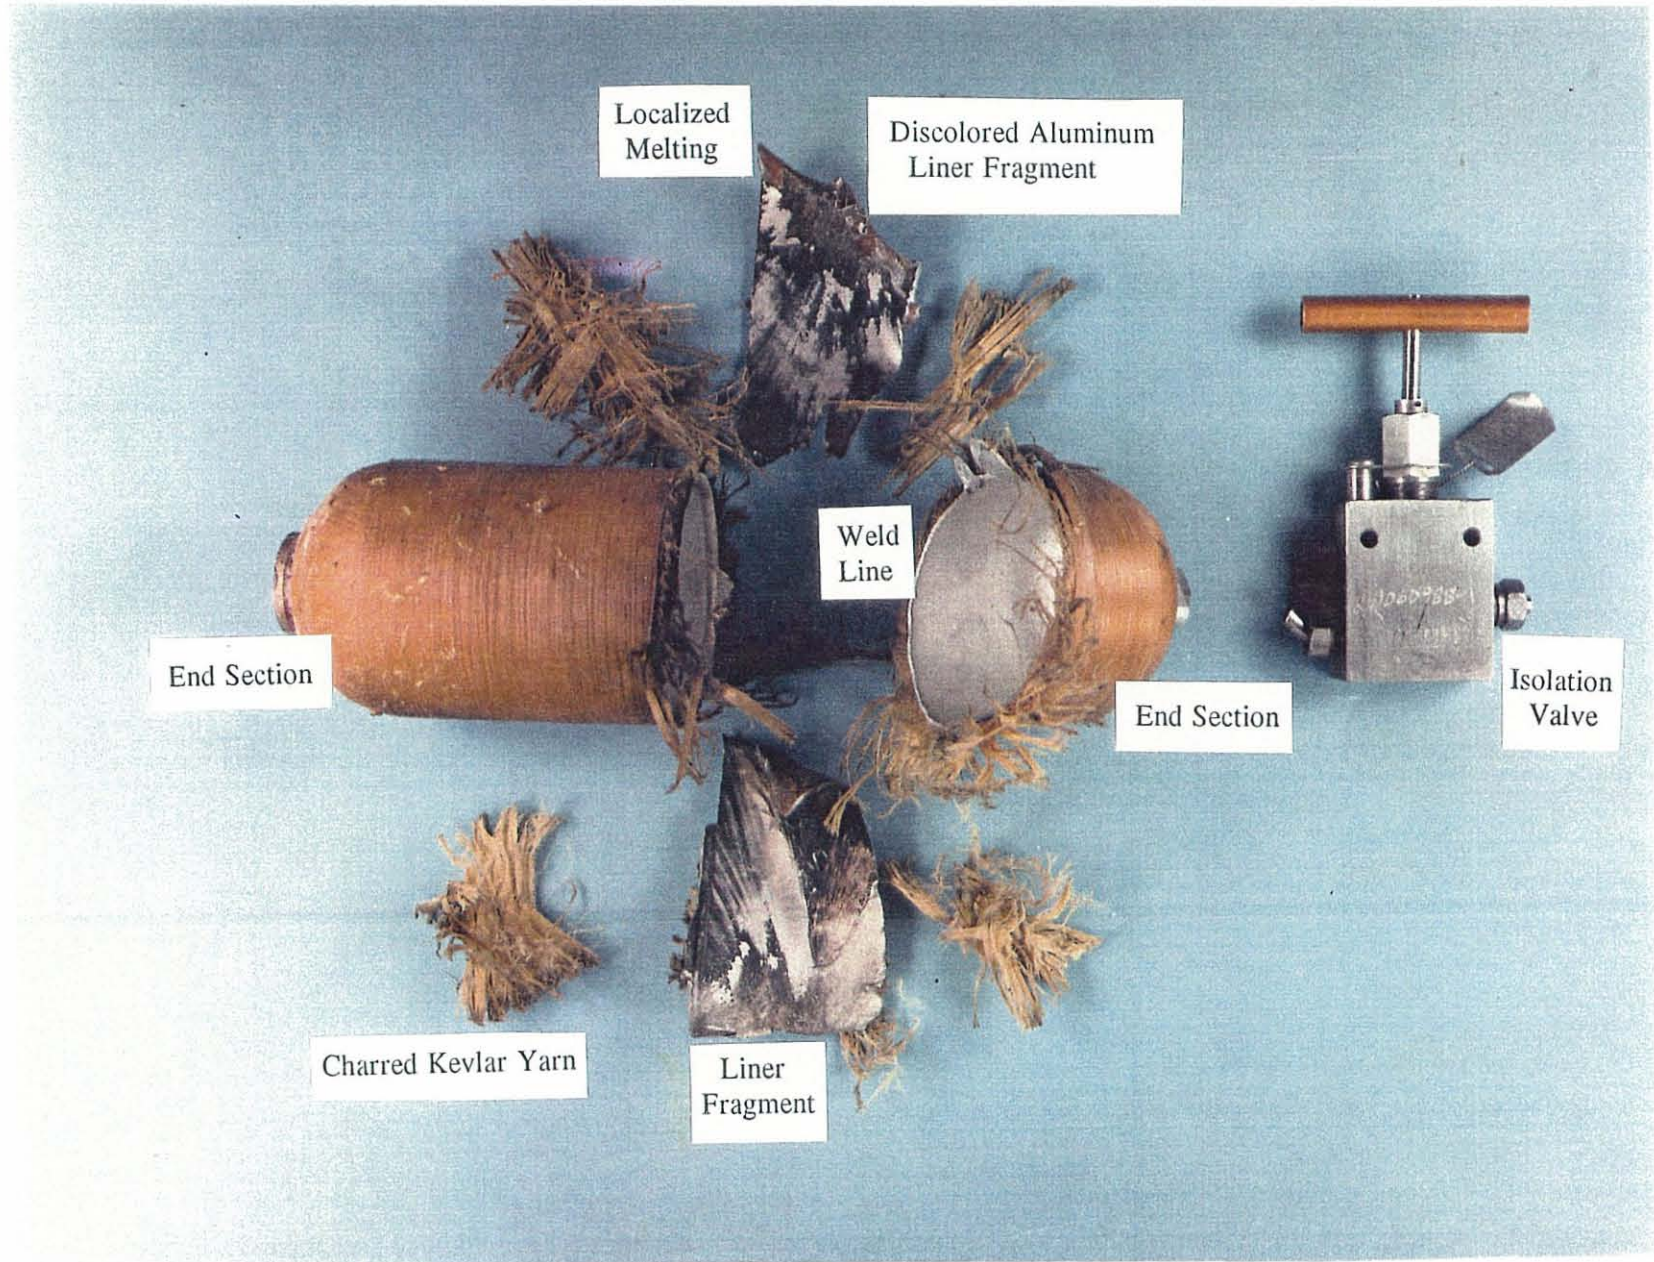
fragmentation as a fireball envelopes the target. Test article HYP-9 ruptured into five pieces: two end sections, two fragments of bare aluminum liner, and one isolation valve (Figure 12). The fracture terminated at the circumferential weld line (Figure 13). Pieces of unraveled Kevlar yarn were also found. The 737-gram (1.6-lb) isolation valve sheared off and was propelled up over the rear blast mats, 18.3 m (60 ft) into the desert; all other parts of the test article were contained within the blast cell, although shards of bell jar glass were found as much as 50 m (164 ft) away from the blast cell.

Discoloration, char, and localized melting of the aluminum liners, charred Kevlar fiber, film records, and aluminum oxide slag on the bell jar fragments gave conclusive evidence of an oxygen fire. Both aluminum liner fragments were flattened and charred, with melted and discolored edges. Although a metallic spray pattern was evident on both fragments, neither fragment exhibited the pinhole perforations found in the nitrogen vessel. The Kevlar overwrap on one end section was torn and charred, and the metal fitting had been flattened, presumably upon impact with the blast cell wall.

**Figure 12**  
Ruptured 20.7 MPa (3000 psig) Oxygen Test Vessel
