**HIGHER MAGNIFICATION IMAGING OF THE POLISHED ALUMINUM COLLECTOR RETURNED FROM THE GENESIS MISSION.** M. C. Rodriguez<sup>1</sup>, P. J. Burkett<sup>2</sup>, J. H. Allton<sup>3</sup>; <sup>1</sup>Geocontrol Systems- ESCG at NASA/Johnson Space Center, Houston, TX 77058; [melissa.rodriguez-1@nasa.gov](mailto:melissa.rodriguez-1@nasa.gov), <sup>2</sup> Jacobs- ESCG at NASA/Johnson Space Center, Houston, TX 77058, <sup>3</sup> NASA/Johnson Space Center, Houston, TX 77058.

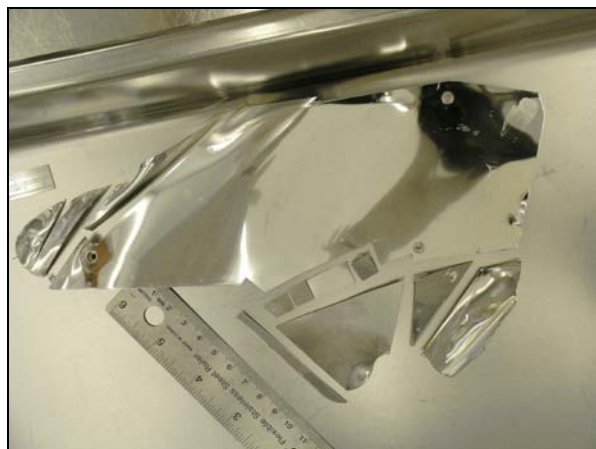
*Previous and current subdivision.* The collector (sample number 50684.0) has been subdivided by the use of a small handsaw in 2005 and further in 2010, resulting in 18 subsamples (Fig.1). Orientation of the cuts during subdivision of the collector was dictated by the desire to provide specific areas of flat surface for analysis by rastering techniques. The orientation was also controlled by the restrictions for securing the collector for the sawing process (attachment points). Two suspected hypervelocity impact craters (both approximately 30  $\mu\text{m}$  in diameter) were reported [3] and were specifically removed in the subdivision of 2010. Analysis of the craters is reported by [4]. To date, 36  $\text{cm}^2$  (14%) of the total area (245  $\text{cm}^2$ ) has been allocated for scientific study.

Fig. 1. Overview image of the remaining polished aluminum kidney after the most recent subdivision.

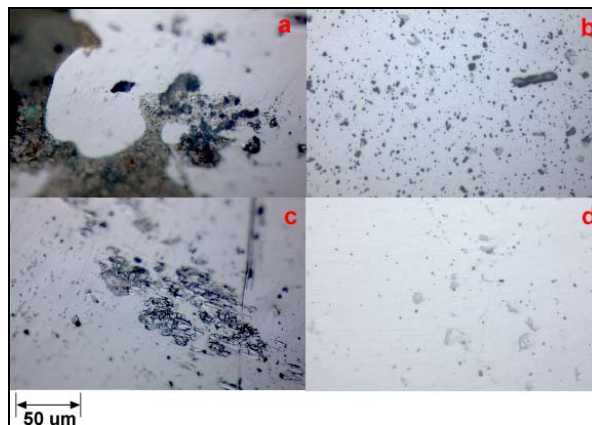
scanned at 5X magnification on a Leica DM6000M microscope using either Surveyor or Image Pro Plus software. Under higher magnification, the post-landing aluminum surface is very uneven, with many bumps and undulating ridges (Fig.2a). There are also several depressions that appear as microcraters on initial examination. Portions of these “pits” have angular walls and shallow, irregular depths; excluding them from consideration as hypervelocity impact craters. Much of the contamination observed under higher magnification is consistent with what is seen on the majority of the Genesis collector array materials: 1) dark carbon fibers and fragmented array collector fines, such as silicon dust, from the spacecraft and 2) Utahogenic particulate dispersion of salts and sediments, including dried droplets (Fig.2b). Several gouges and scratches are also seen (Fig.2c). There is one feature unique to the polished aluminum surfaces: the presence of small, transparent, irregularly shaped gray film-like specks seen at 50X. They are seen on each kidney subsample and are randomly distributed across the surface (Fig. 2d).

Fig. 2a-d. Examples of surface contamination on the polished aluminum pieces found at 50X magnification

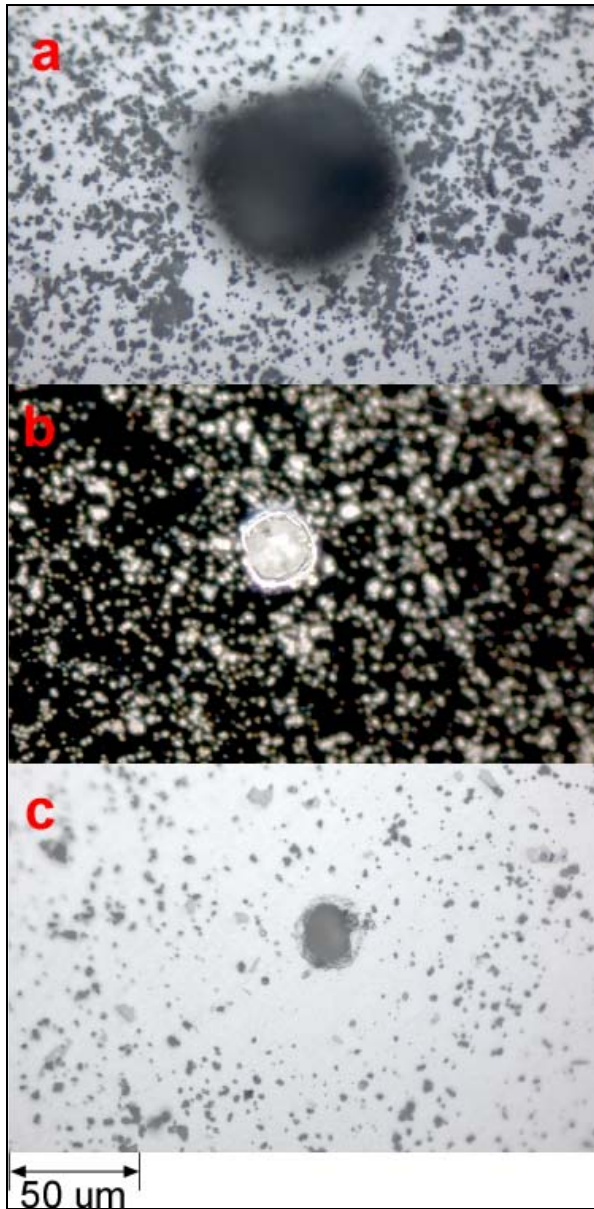
*Additional microcrater documentation.* Additional work has been done to identify three additional microcraters in two subsamples (50684.8 and 50684.11) of the polished aluminum kidney. All of the craters have similarly shaped round, raised walls with varying pit depths (measured from collector surface to pit bottom). Crater 1 was measured to have a depth of 49  $\mu\text{m}$  and outer rim dimensions of 74  $\mu\text{m}$  (Fig. 3a). Crater 2 was measured to have a depth of 11  $\mu\text{m}$  and outer rim di-

mensions of 32  $\mu\text{m}$  (Fig.3b). Crater 3 was measured to have a depth of 8  $\mu\text{m}$  and outer rim dimensions of 28  $\mu\text{m}$  (Fig.3c).

Fig.3. Microcrater features found in subsamples 50684.8 (a and b) and in 50684.11 (c).
