NASA/TM—2008–215411

# **The Repair and Return to Flight of Solid Rocket Booster Forward Skirt Serial Number 20022**

*T.W. Malone and C.S. Jones  
Marshall Space Flight Center, Marshall Space Flight Center, Alabama*

**June 2008**

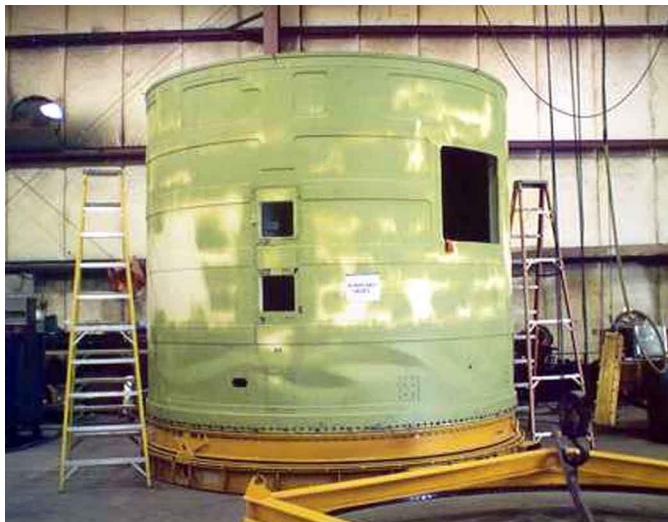
After the STS–37 launch, S/N 20022 suffered water impact loads in excess of its design strength. The structural alloy (Al 2219) sustained damage that included skin buckling in the aft skin bay area as shown in figure 1. Depressions were observed to a depth of 1.6 cm (0.64 in) in the lower bay.

Figure 1. S/N 20022 buckled forward skirt.

Using a hydraulic press, located at General Products in Huntsville, AL (fig. 2), buckling was removed within 0.5 cm (0.2 in). This operation restored the area contour within the experience base.

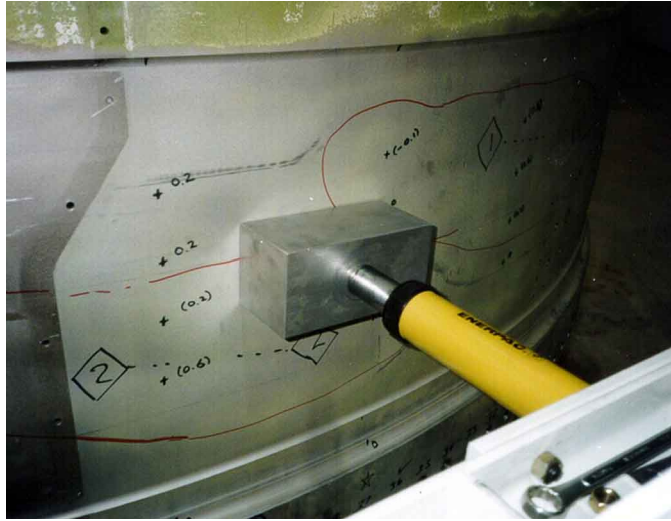
Figure 2. Hydraulic press debuckling S/N 20022.

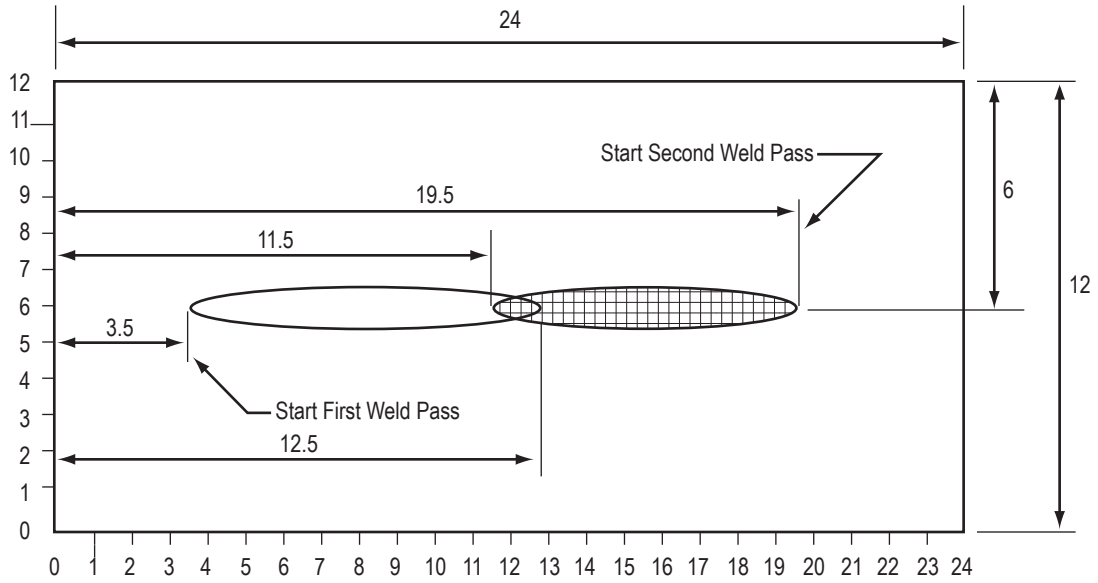
Tungsten inert gas (TIG) welding was used without filler wire at a current of  $\approx 185$  amps and a weld speed of  $\approx 15$  ipm in accordance with procedures defined in MSFC-SPEC-504C.<sup>1</sup> Two separate weld passes were made in the geometric center of the panel. Each weld pass was  $\approx 0.25$ -in wide. The first pass was  $\approx 9$ -in long. The second was  $\approx 8$ -in long and overlapped the first weld pass by  $\approx 1$  in.

Figure 3. MSFC demonstration panel weld locations/passes.

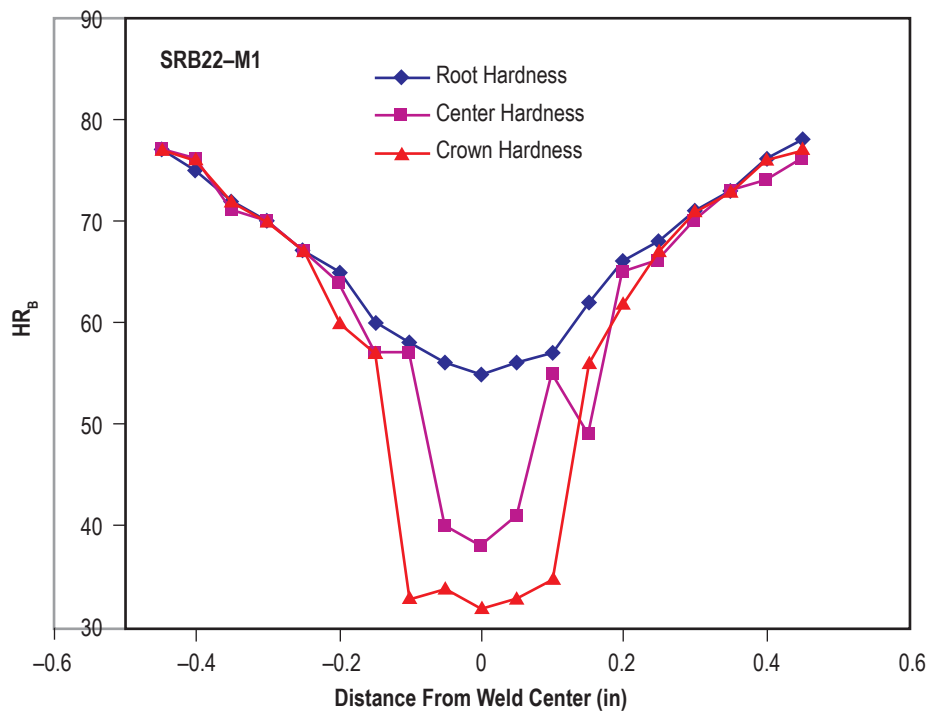
**2.2.1.1 Metallography** The degree of weld penetration was determined by measuring cross-sections of the weld nugget taken at three locations, with the average measurement indicating a penetration depth of  $\approx 50$  percent. Hardness surveys were taken transverse to the welding direction as shown in figure 4.

Figure 4. Typical microhardness curve for weld nugget on MSFC demonstration panel.

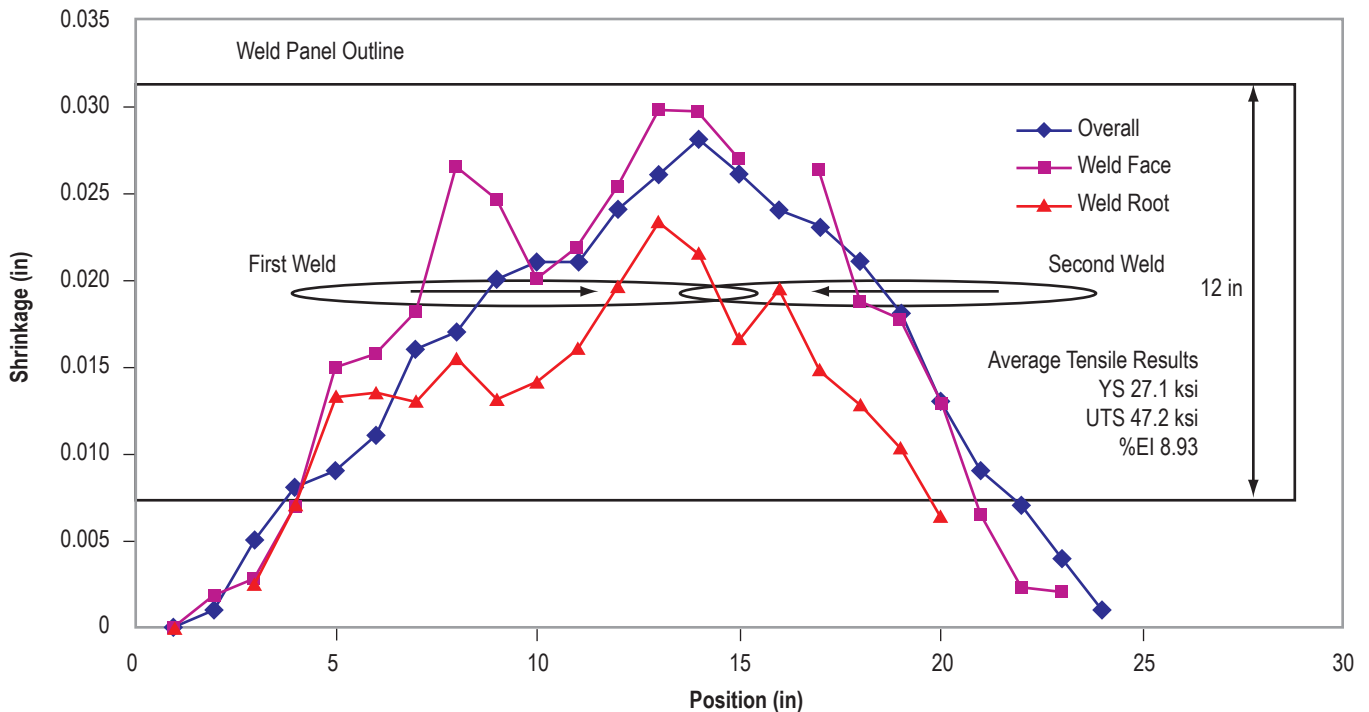
- In the transverse direction, maximum shrinkage (0.03 in) was observed at the midpoint of the panel. Minimum shrinkage (averaging 0.0025 in) occurred at the ends of the panel.
- In the longitudinal direction, maximum shrinkage (0.007 in) was observed at the two outer edges of the panel. Minimum shrinkage was zero at the midpoint of the panel (table 1). These shrinkage data are also presented graphically as curves in figure 5.

Figure 5. Data curve showing MSFC demonstration panel shrinkage.

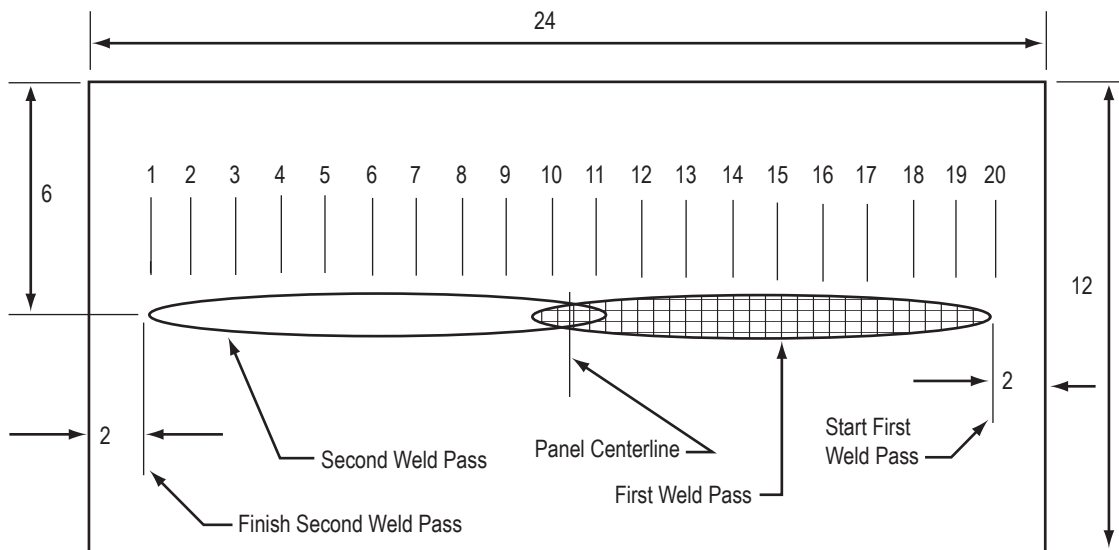
- Before and after measurements showed an average shrinkage of 0.028 in at locations 8–12 near the center of the weld side of the panel.
- Welds were evaluated for defects using visual, penetrant, and radiographic inspections. Technical Micronics Control (TMC), Inc. of Huntsville, AL conducted the radiographic inspections in accordance with MIL–STD–453.<sup>4</sup> No indications were observed.
- Average test data included UTS 44.5 ksi, YS (0.2 percent) 27.2 ksi, and %El (2 in) 5.2 percent.
- Weld nugget penetration averaged 46.9 percent, based upon 10 data points.

Figure 6. General Products test panel 1, specimen locations 1–20.

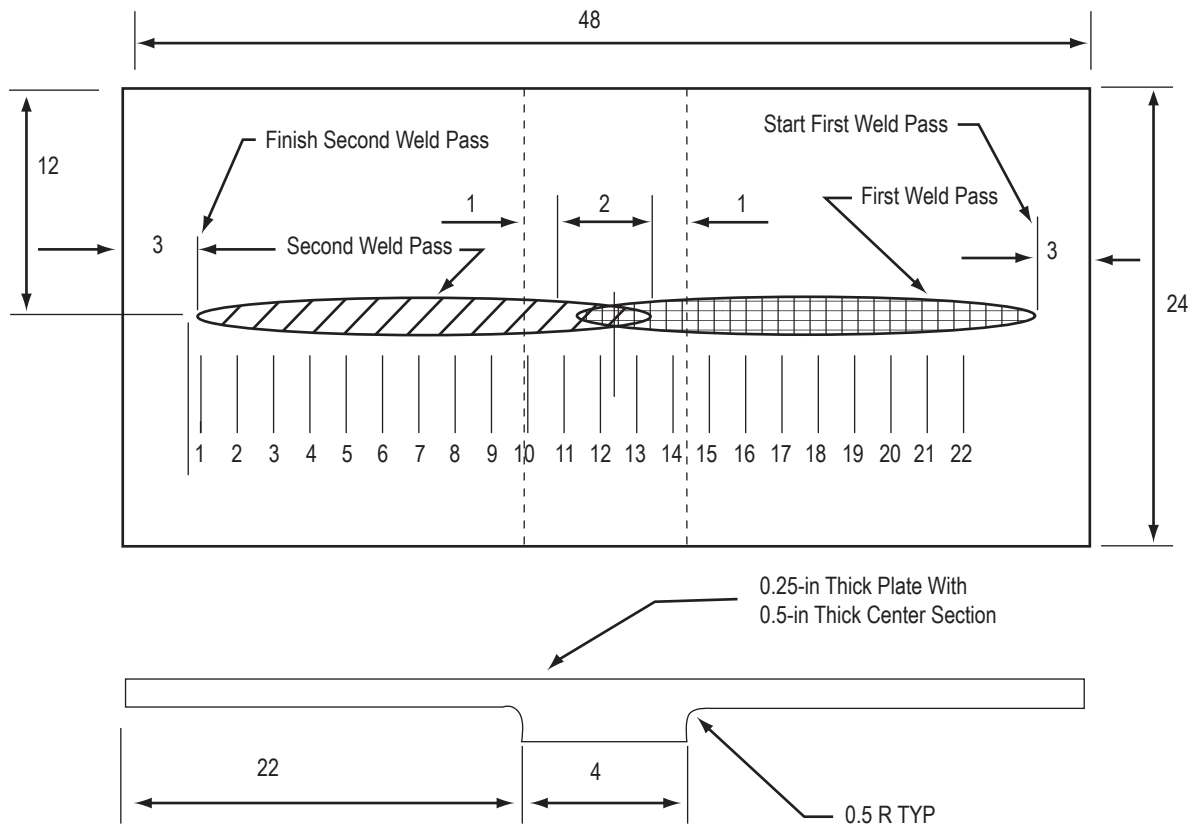
- Before and after measurements showed an average shrinkage of 0.017 in at locations 10–14 near the center of the weld side of the panel.
- Welds were evaluated for defects using visual, penetrant, and radiographic inspections conducted by TMC in accordance with MIL-STD-453.<sup>4</sup> No indications were observed.
- Average test data included UTS 48.8 ksi, YS (0.2 percent) 30.7 ksi, and %El (2 in) 5 percent.
- Weld nugget penetration averaged 39 percent, based upon 12 data points. The thick center section (0.5 in) had much lower penetration than the rest of the panel, causing a lower average than for test panel 1.

Figure 7. General Products test panel 2, specimen locations 1–22.

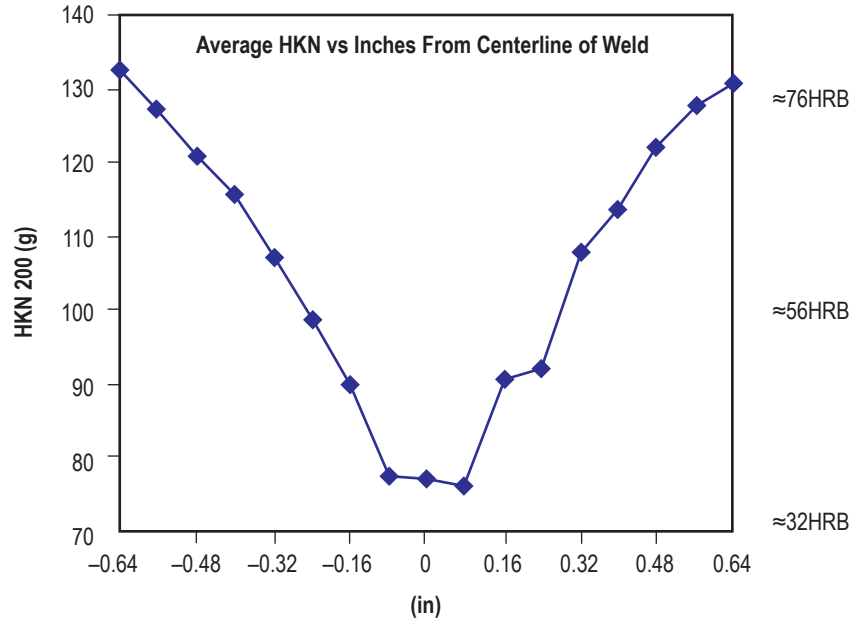
A microhardness evaluation was conducted for the weld area on both test panels to define the limit of thermal impact on the parent material, as depicted in figures 8 and 9. These data show a return to the T87 tempered condition (i.e.:  $\approx 76 \text{ HR}_B$ ) at 0.5–0.6 in from either side of the centerline of the weld nugget.

Figure 8. General Products test panel 1 hardness values, from weld centerline into parent material.

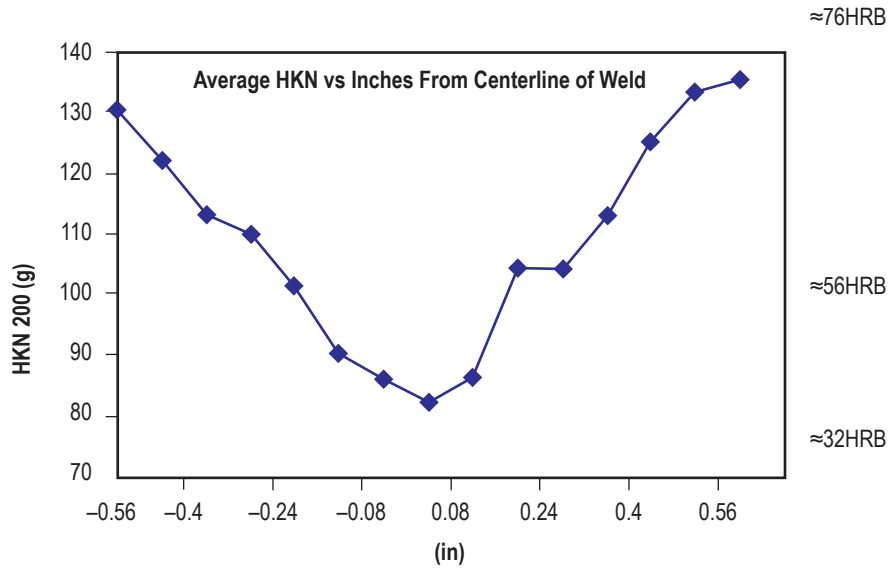
Figure 9. General Products test panel 2 hardness values, from weld centerline into parent material.

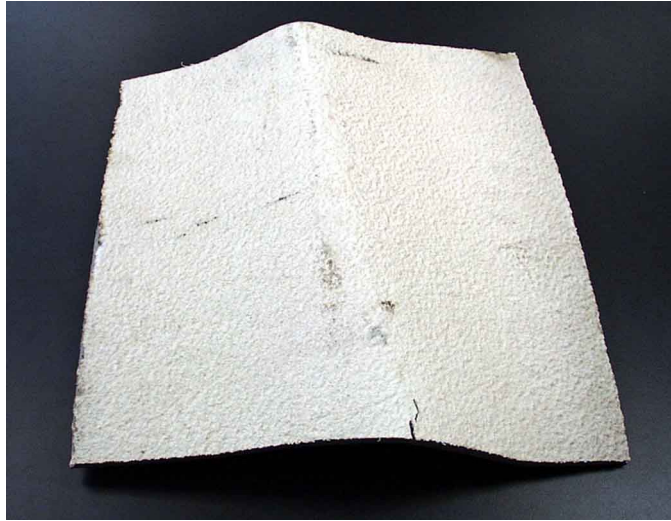
In May 2000, a section of similarly buckled material from another damaged forward skirt, S/N 007, was selected for testing. This section was the same material (Al 2219-T87) and thickness (0.63 cm or 0.25 in) as the area in question on S/N 20022, with a maximum deflection or buckle of  $\approx 7.1$  cm (2.8 in). The buckled panel was photographed as received (figs. 10 and 11). Following the removal of all coatings using a hydrolaser, radiographic and dye penetrant inspections were conducted. A  $1\frac{3}{4}$ -in long crack was found and trimmed away. No other anomalies were detected.

Figure 10. As-received, S/N 007 test section.

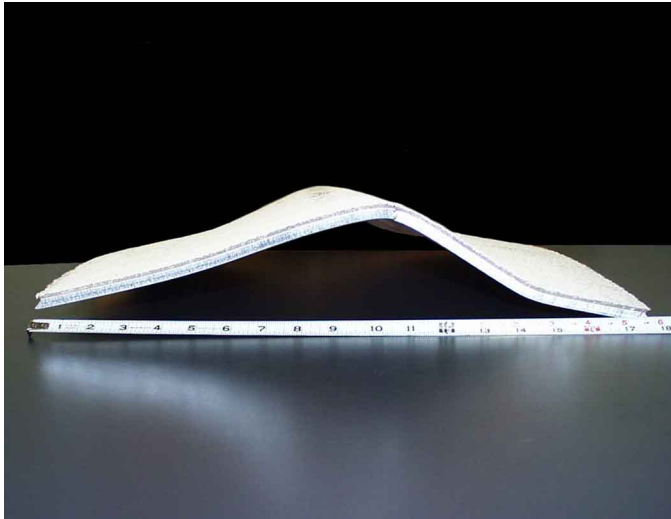
Figure 11. As-received, S/N 007 test section, side view.

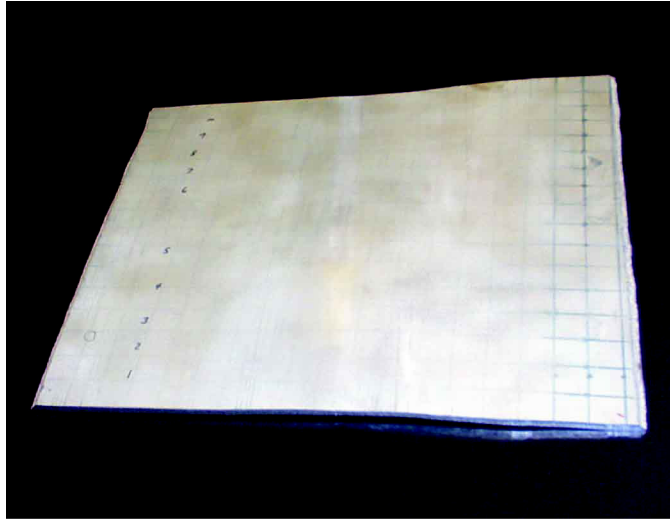
S/N 007 was debuckled and restored to within 0.5 cm (0.2 in) of the original surface by General Products, using the same tooling and expertise as for S/N 20022. Actual postdebuckling measurements indicated a flatness of 0.25–0.38 cm (0.1–0.15 in). The panel was photographed again after debuckling, as shown in figures 12 and 13. No indications were reported during another round of nondestructive evaluation. Tensile specimens were then fabricated from the repaired section, figure 14, per ASTM E 8, “Standard Test Method for Tension Testing of Metallic Materials.”<sup>6</sup>

Figure 12. S/N 007 debuckled test section.

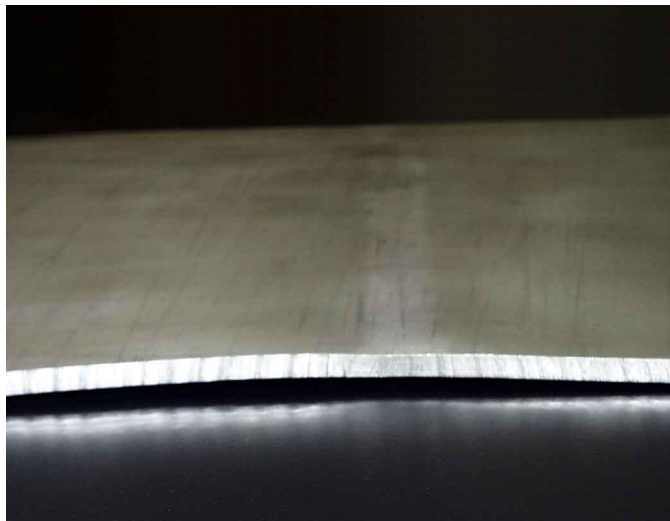
Figure 13. S/N 007 debuckled test section, side view.

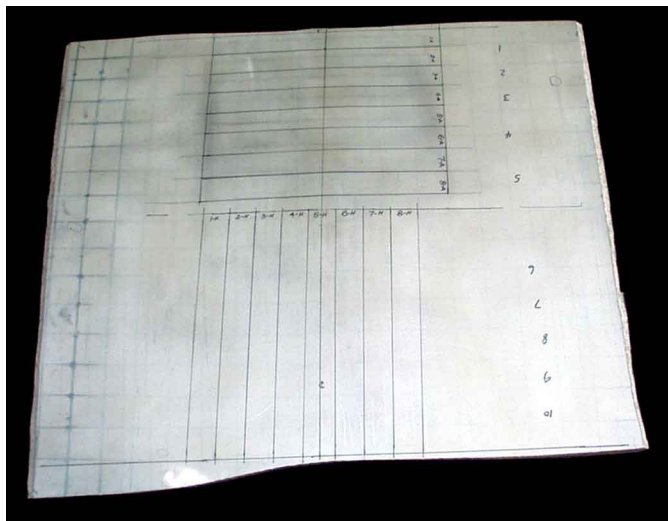
Figure 14. Specimen locations on S/N 007 debuckled test section.

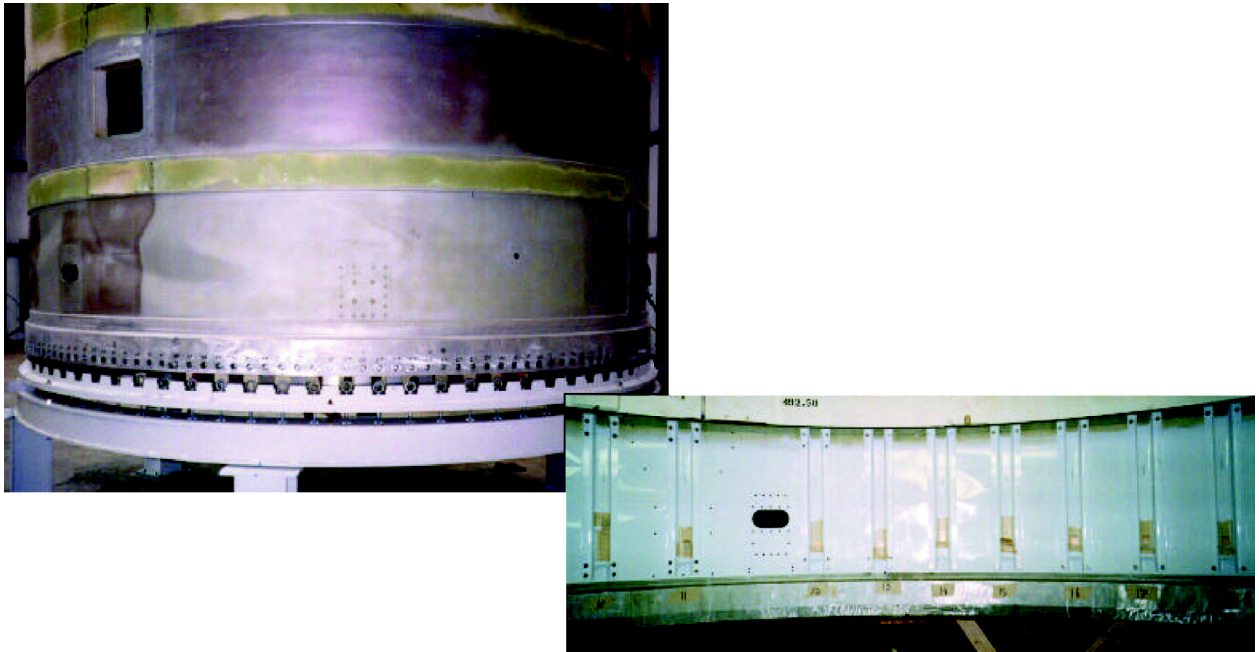
Figure 16. Exterior of S/N 20022 with callout of installed stringers.

As a result of these evaluations, stringers were fabricated and installed on S/N 20022 (fig. 16) in preparation for its return to flight.
