Pressure Testing of a Minimum Gauge PRSEUS Panel

Andrew E. Lovejoy¹ and Marshall Rouse²
NASA Langley Research Center, Hampton, VA 23681

Kim A. Linton³ and Victor P. Li⁴
The Boeing Company, Seal Beach, CA 90740

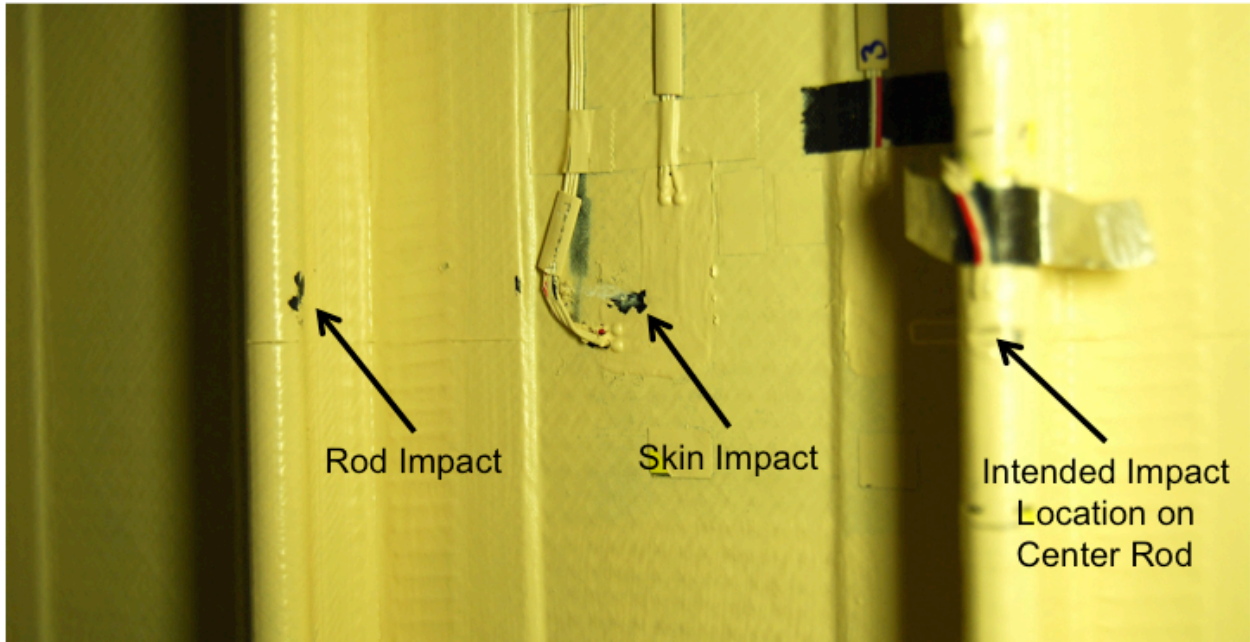
Prior to applying load level 3, the panel was impacted with barely visible impact damage (BVID) at an impact energy of 20 ft-lbs. This energy level is meant to represent the ultimate force that a tool drop or other such event would impart on the inside surface of an aircraft, and has been used on previous PRSEUS tests.¹⁴ A spring-loaded impactor was used with a 1-inch diameter impact tup. The impactor was positioned against the side of the center stringer to inflict an impact at an angle of approximately 40 degrees measured from the plane of the panel. However, during execution, the impact apparatus slipped, and the impactor had a glancing blow to the skin, and then impacted the side of the stringer adjacent to the center stringer. Figure 22 shows the impact locations. Since the angle of impact with the skin was very shallow, it is believed that the impact to the adjacent stringer was very close to the desired 20 ft-lb energy level. Previous testing has shown that little effect is seen to the response and failure load due to impacts at this energy level to either the top or side of the rod region.¹⁴ Also, since the strains in the stringers adjacent to the center stringer are almost the same as those in the center stringer, it was concluded that this impact was sufficient so no additional impact was imparted.

Fig. 22. Impact of panel skin and stringer.

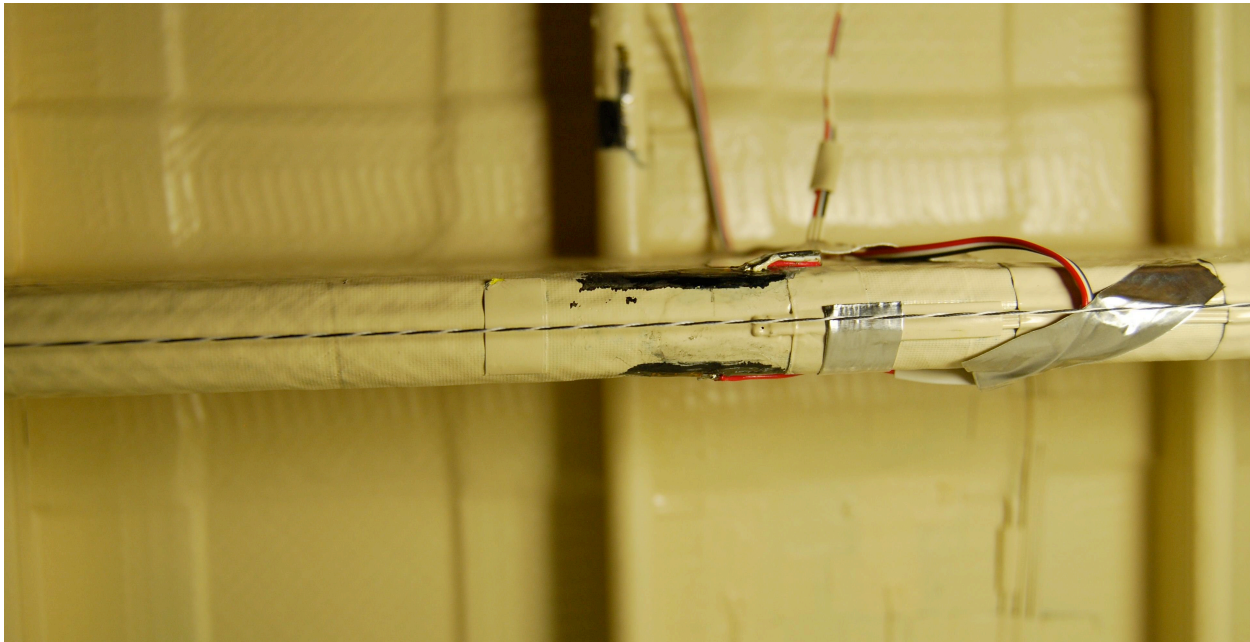
The VIC out-of-plane displacement plot from load level 2 (Fig. 15a) shows a slight offset in the displacement field. This offset suggested unsymmetric response of the frames during pressurization, and is a possible cause for the difference between analysis and load level 2 test response for some gages near the edge of the panel. Unsymmetric response of the frames could be due to initial geometric imperfections in the frames or boundary condition effects. Therefore, also prior to applying load level 3, the frames were checked for straightness using a twisted pair of white and black thread as shown in Fig. 23. This straightness check indicated that both frames appeared to be very straight, and therefore it is unlikely that initial imperfection of the frames caused this unexpected frame response. In order to monitor bending of the frames during load level 3, additional strain gages were added to either side of the frame tops at the center of the frame length, and were identified simply by numbers 42 – 45. Gages 42 and 43 are back-to-back on the frame top adjacent to the gages at the edge of the panel shown in Figs. 7 and 8, with gage 42 being located on the side of the frame toward the center of the panel. Gages 44 and 45 are back-to-back on the other frame top, with gage 44 being located on the side of the frame toward the center of the panel.

Fig. 23. Straightness of frame using twisted white and black thread.

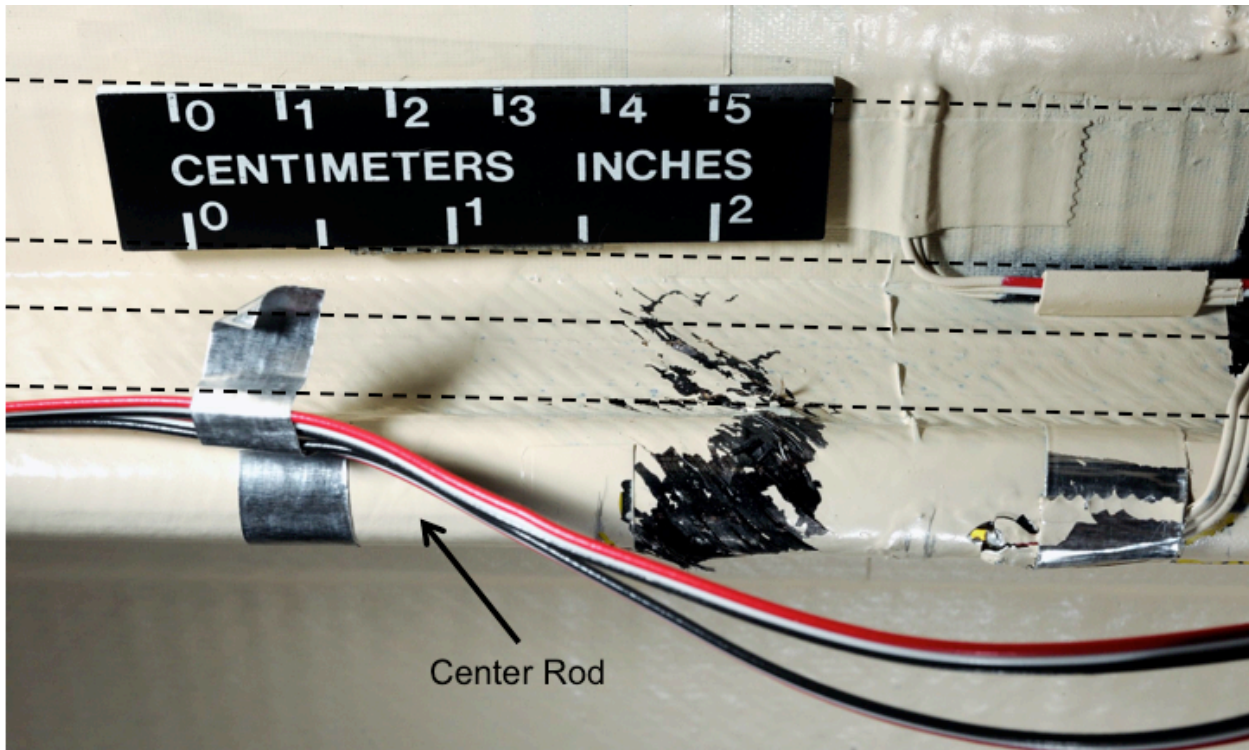
Post-test examination of the panel confirms that the load shift was associated with a failure of the center stringer. Figs. 31 and 32 show the two sides of the center stringer, where the locations of the stitching on the stringer web and flange are shown indicated by dashed lines. Failure is evident in the stringer wrap at the rod location, and damage progresses down the stringer web to the flange. The damage was arrested between the lower stringer web stitching and the stringer flange stitching while the panel was loaded beyond the 28.44 psi level. The pressure was increased to the maximum test pressure of 30 psi, and the damaged panel was able withstand this increased loading without any indication of further damage. The initial failure at 28.44 psi was 3.0% above the analytically predicted value of 27.6 psi for the pristine panel. As has been mentioned, previous testing has shown little effect to the load carrying capability of the PRSEUS rod when impacted with the level of energy used, so it is not unexpected that the analysis of the pristine panel accurately predicts the response of the panel with BVID on the stringer.

Fig. 31. Center rod damage, side 1. Stitch locations indicated by dashed lines.

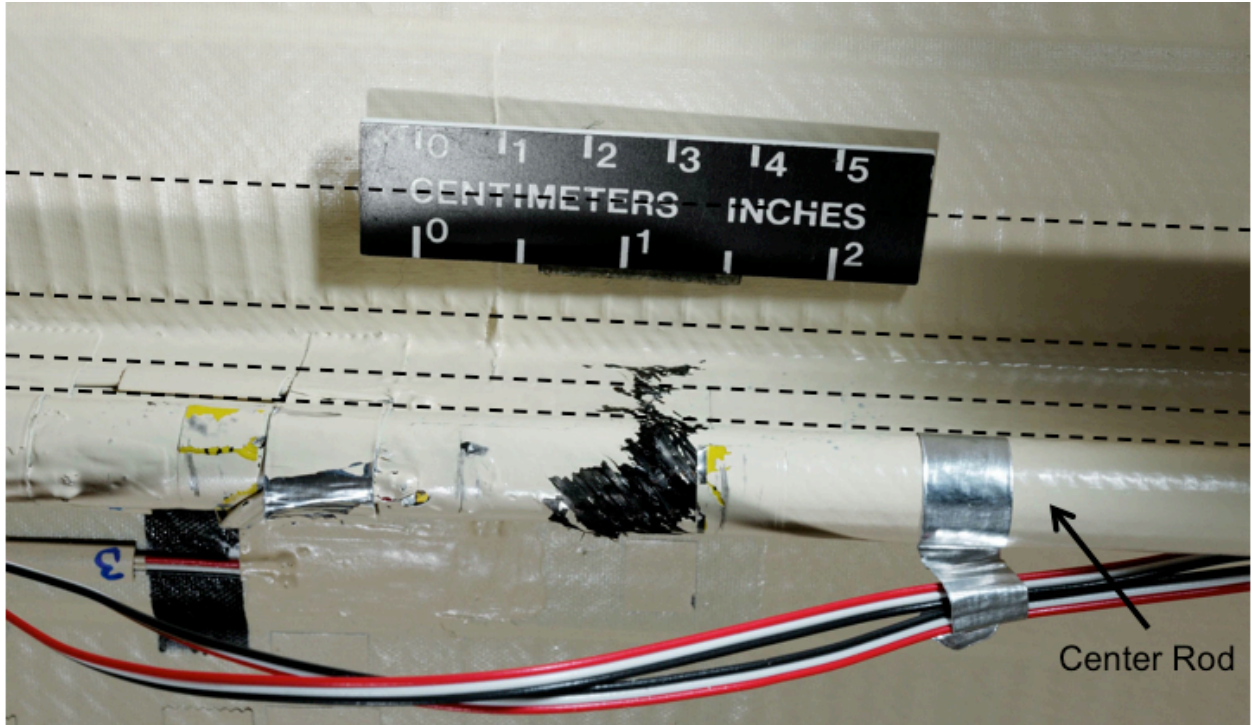
Fig. 32. Center rod damage, side 2. Stitch locations indicated by dashed lines.
