## 47th AIAA/ASME/SAE/ASEE Joint Propulsion Conference & Exhibit

### Lessons Learned from the Space Shuttle Engine Hydrogen Flow Control Valve Poppet Breakage

Abstract authored by Hugo E. Martinez, in collaboration with John Albright, Stephen Damico, and John Brewer of NASA's Johnson Space Center, Engineering (EP4)

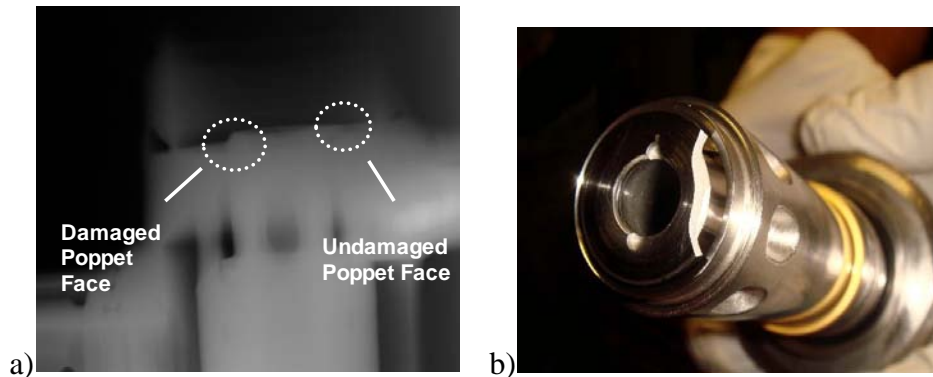
Figure 1: a) Initial X-Ray of STS-126 failed poppet, b) Broken poppet flange.

After STS-126 landing, an x-ray on the vehicle confirmed the cause as a broken poppet (Figure 1). The valve was removed from the system and sent to the vendor for teardown and evaluation, where a break of approximately 87 degrees of the poppet flange was documented (see Figure 1). The failure initiated in the flange radius (Figure X). The remainder of the valve's piece parts were inspected for clues as to the breakage, but no out of print condition, material non-conformance, or clear evidence of particle impact were found. In addition, vehicle inspections such as servicing of the upstream filter element and borescope inspections of the tubing, failed to uncover any evidence of particle impact as the cause. There was damage in the downstream 90-degree elbow, indicating that the particle had passed through on its way into the ET. Since the ET is not recovered post-launch, the broken piece was never found.

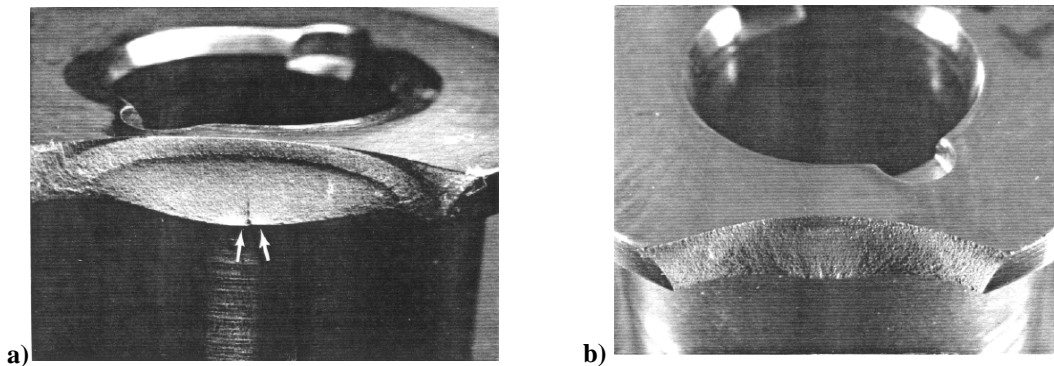
These new poppets were built from 440C, a very strong but brittle material. The drawing allows 440A or 440C, which have similar material properties, although 440C is slightly less ductile. Inspection of the poppets found no evidence of particle impact damage on any of the remaining surfaces. The first failure was originally blamed on particle impact due to facility contamination, although the morphology of the fracture surface showed some signs of fatigue. The test stand was inspected for the potential to generate contamination but no debris source was found. The upstream filter element was analyzed, the system was Freon flushed at a flow rate three times higher than the low flow rate, and 100A cleanliness was verified. The second failure, because it occurred after flushing and verification of the test stand, was blamed on fatigue entirely.

**Figure X. a) First ATP failure after 2 sec of stabilized GH2 flow time, ~72.5 deg crack. b) Second ATP Failure while pressure being brought up, ~58 deg crack**

Mitigation actions in response to the two ATP failures were minimal. A proposed change of material from 440C to Inconel 718 was disapproved by Configuration Control Board (CCB) due to cost. The program disallowed the use of 440C (replaced by 440A) for poppets because of the higher carbon content came at a cost of ductility. Additionally, all poppets made by that particular vendor were removed from inventory and post machining heat treatment was revised to improve material ductility and toughness. Dye pen inspections of poppet post manufacture and during refurbishment were implemented

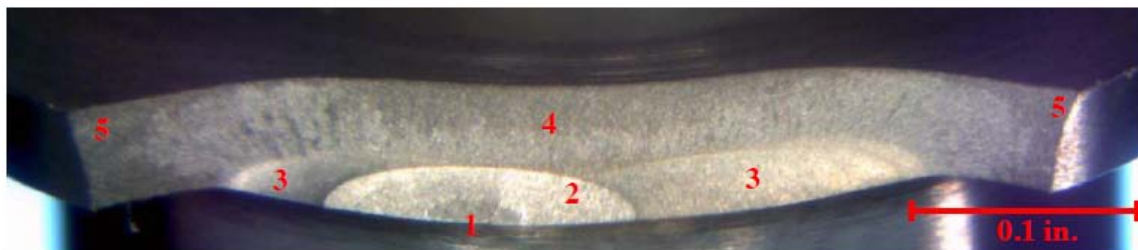
After STS-126 landing, the failed FCV was removed for inspection. Optical and Scanning Electron Microscope (SEM) fractography were conducted on the failed FCV poppet head. Preliminary results indicated the failure occurred by fatigue. The fracture exhibited several distinct “thumbnail” features, indicative of fatigue cracking, but the fracture morphology was not clear (e.g., no definite fatigue markings, striations, were present, and secondary cracking was considered “unusual”). Fracture by simple overload or impact was not evident. The crack was about 0.3 in. length before it went unstable and liberated material. Shown in Figure X, the five zones identified in the failed poppet head were 1) small initiation thumbnail crack (0.040” in length), 2) depth and circumferential expansion of zone 1 (0.138” in length), 3) asymmetric circumferential expansion of zone 2 (0.33” in length), 4) through-crack depth expansion of zones 2 and 3, and 5) final ligament at failure.

Figure X: STS-126 failed poppet fractography, detailed 5 zones of damage.

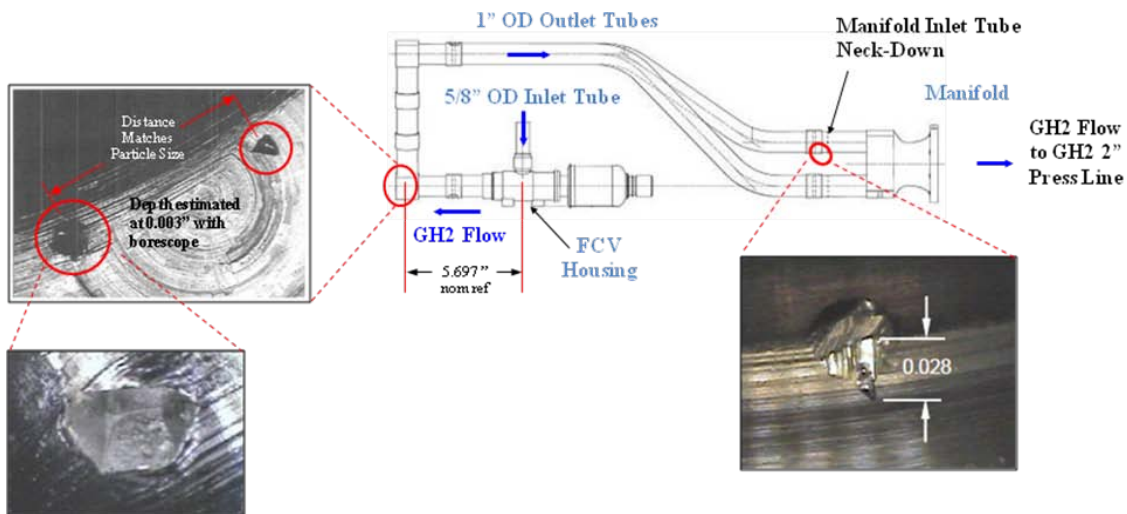
Borescope inspections were conducted of the OV-103 hardware post-landing after STS-126. In the first 90-deg elbow immediately downstream of the FCV, two dings were found, estimated to be 0.003 inches deep in the 304L stainless steel, with spacing that matched the approximate particle size missing from the failed poppet head. Further downstream, just prior to the 2 inch manifold, an additional mark was observed. Neither of these downstream indications revealed any data on the cause of the failure.

**Figure X:** Borescope inspection results of downstream GH2 pressurization system post-landing following the STS-126 failure.

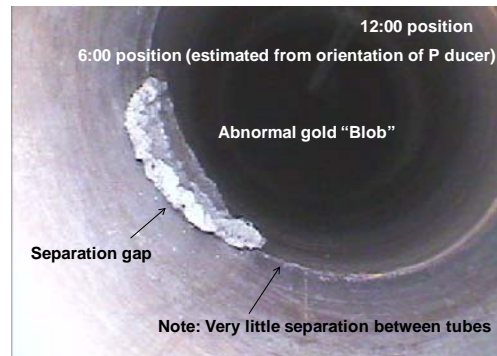
Borescope inspections were conducted upstream of the FCV also in an attempt to find possible cause for the failure. Inspections results found protruding gold braze slag in an upstream joint, but Materials and Processes (M&P) evaluation determined that the braze was intact (i.e., brazing material had not been released that could have impacted the FCV). It was concluded that the gold braze may have resulted from gold perform material run-out during line brazing during modification at the vendor, Palmdale, during OV-103 Flight 12 Orbiter Major Modification (OMM).

**Figure X:** Borescope inspection indication of gold brazing upstream of failed FCV.

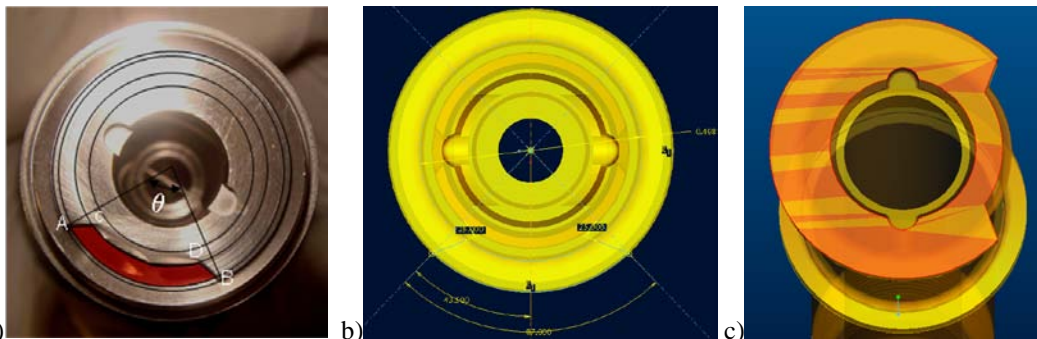
In order to support additional flight rationale questions for particle impact concerns, two different approaches were used to estimate the missing particle size and mass from the STS-126 failure: a CAD approach, and a “cloud map” inspection technique. In the latter approach, a Thermal Protection System (TPS) surface defect scanner was used to scan the surface of the failed poppet and generate the negative volume. A similar scan was made of the unbroken side of the poppet, and the negative volume was obtained by taking the difference and outputting to a CAD file. CAD results estimated a missing chip volume was 0.0013 cu. in., and mass was 0.141 gm. The resultant planar flow area exposed by the missing chip was calculated to be 0.031 sq. in.

**Figure X:** a) Failed STS-126 poppet, b) crack size geometry modeling, c) resultant CAD model of failed poppet for particle size, mass estimations

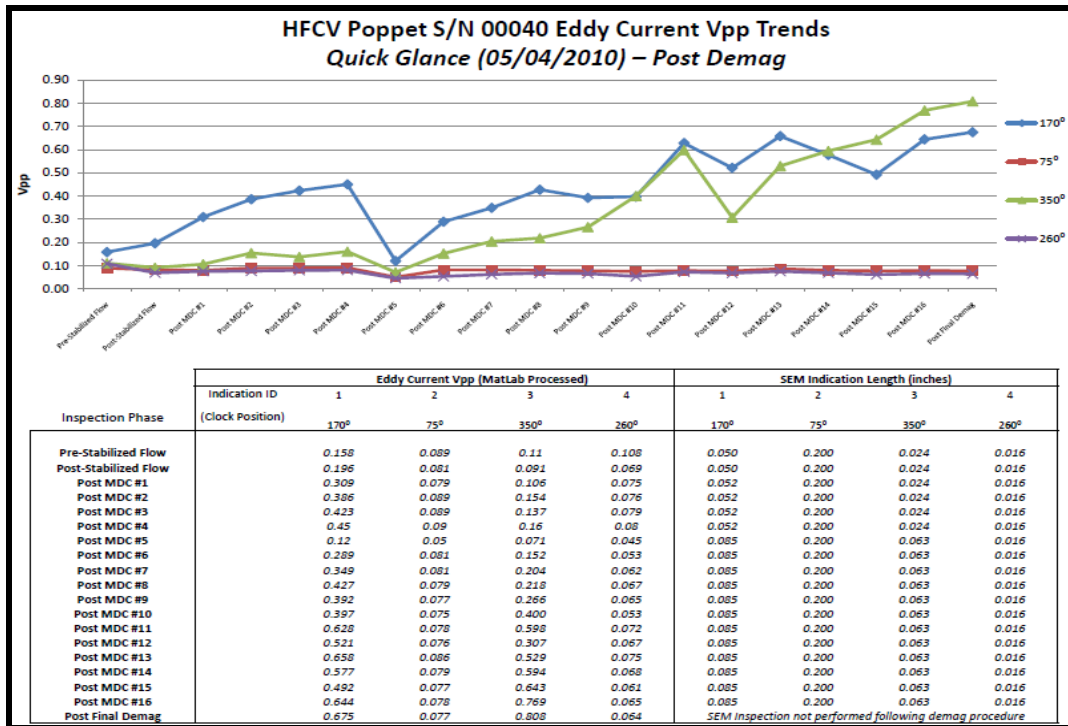
A similar drop in eddy current occurred on MDC #12, without a corresponding growth in crack size. This poppet completed 16 MDC without failure. This data did not indicate that a cracked poppet can fly safely. It did, however, did give insight to the NDE community on the limitations and abilities of the eddy current technique we were currently using.

Figure X- 16 Mission Duty Cycles performed on poppet S/N 0040. Note: The 75° and the 260° indications were determined to be scratches rather than cracks.

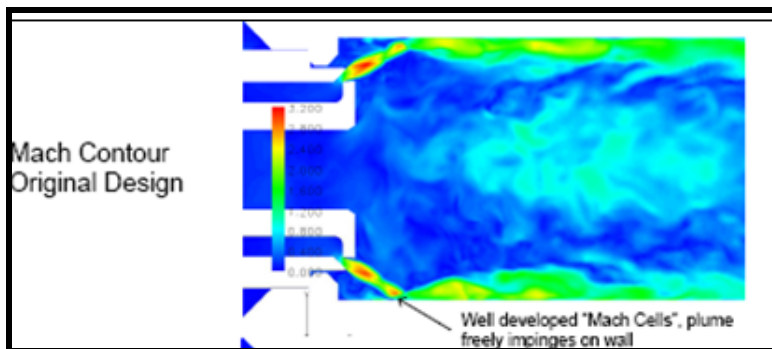
**Figure X**– Discharge from the poppet flange impinges directly on the outlet tube wall. The plume contacted the exact location of the installed high frequency pressure transducers.

The data for the first round of environmental testing revealed the environment just downstream of the poppet flange was so severe that the impinging GH2 flow damaged the high speed pressure transducers located there repeatedly (figure X). Testing showed that the pressure transducers further downstream captured clean usable data signatures. The acoustic emission sensors attached to the outside of the housing

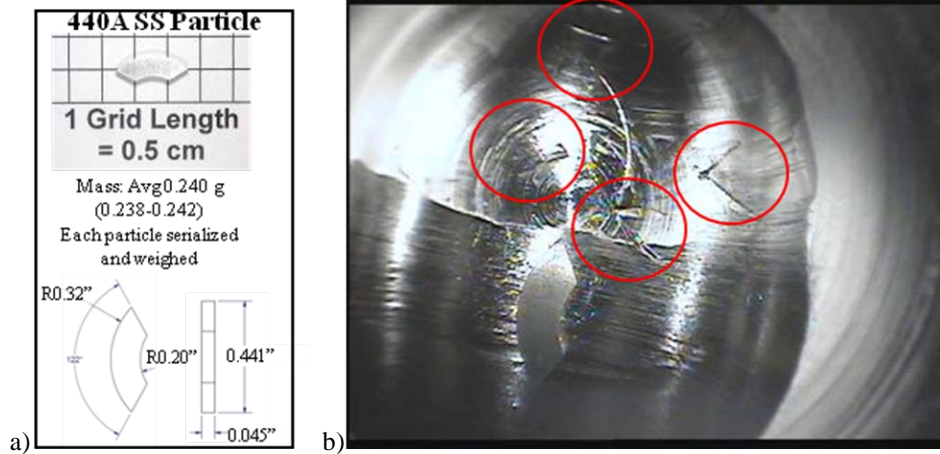
Figure X: a) WSTF Particle Injection test sample, b) WSTF Test results, First 90 deg elbow downstream of FCV. Impactor sample shown for comparison

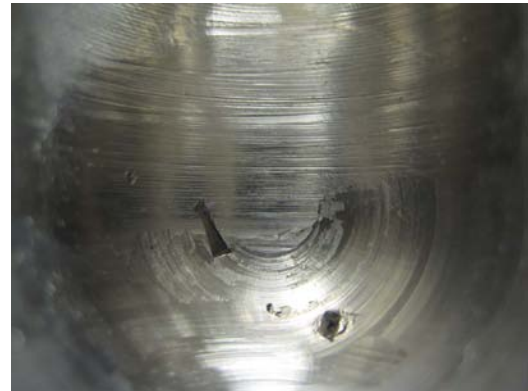
GRC testing at 493 ft/sec velocity on 304L elbow yielded similar damage to STS-126. The conclusion was that the STS-126 first 90 deg elbow impact occurred at 500 +/- 50 ft/sec. Impacts at speeds greater than theoretical ballistic limit of 900 ft/sec on the elbow resulted in perforation

**Figure X: GRC testing impact feature at 0.022” depth on first 90deg elbow downstream of FCV**

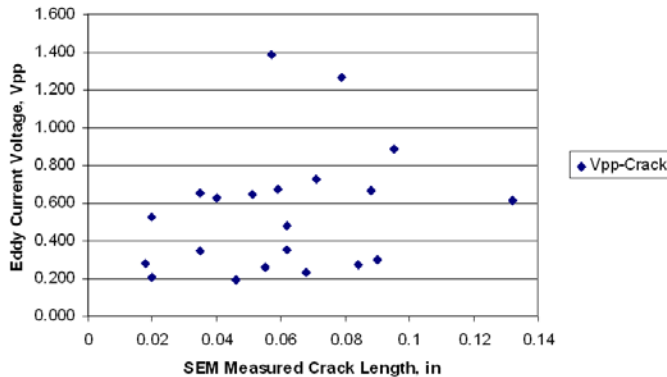
**Figure X: Eddy Current inspection results used for STS-119**
