Lessons Learned from the Space Shuttle Engine Cutoff System (ECO) Anomalies

The Space Shuttle Orbiter's main engine cutoff (ECO) system first failed ground checkout in April, 2005 during a first tanking test prior to Return-to-Flight. Despite significant troubleshooting and investigative efforts that followed, the root cause could not be found and intermittent anomalies continued to plague the Program. By implementing hardware upgrades, enhancing monitoring capability, and relaxing the launch rules, the Shuttle fleet was allowed to continue flying in spite of these unexplained failures. Root cause was finally determined following the launch attempts of STS-122 in December, 2007 when the anomalies repeated, which allowed drag-on instrumentation to pinpoint the fault (the ET feedthrough connector). The suspect hardware was removed and provided additional evidence towards root cause determination. Corrective action was implemented and the system has performed successfully since then.

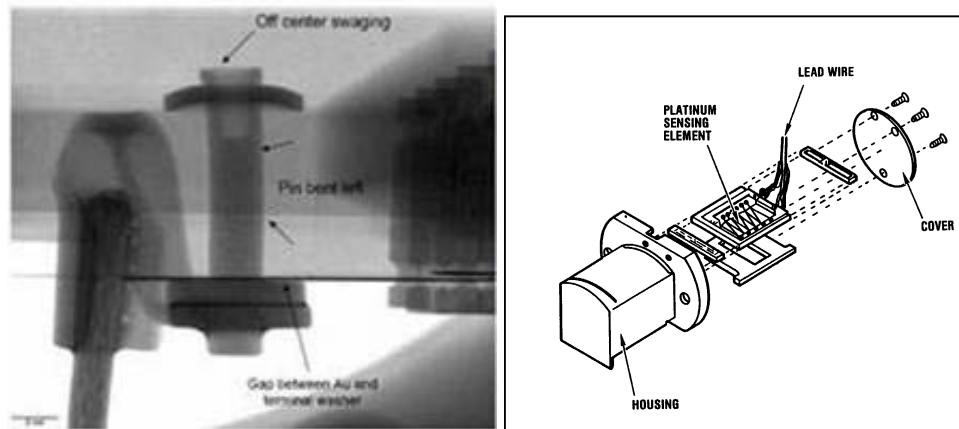
The sensor design uses a very fine platinum sensing element tensioned within a ceramic housing and brazed to gold plated contacts. To connect the sensor lead wires, the lead wires are brazed to terminal posts that are connected to the ceramic housing at the gold plating with swaged joints. Swaging of these tiny parts is a manual operation and subject to some variability. Loss of preload at this swaged connection was considered a potential cause of the intermittent open circuits observed, and will be discussed in more detail later. Figure 4 shows a highly magnified nanofocus X-ray image of a terminal post and swaged joint.

Figure 4. LH2 ECO Sensor in nano-focus view (left) and exploded view (right)

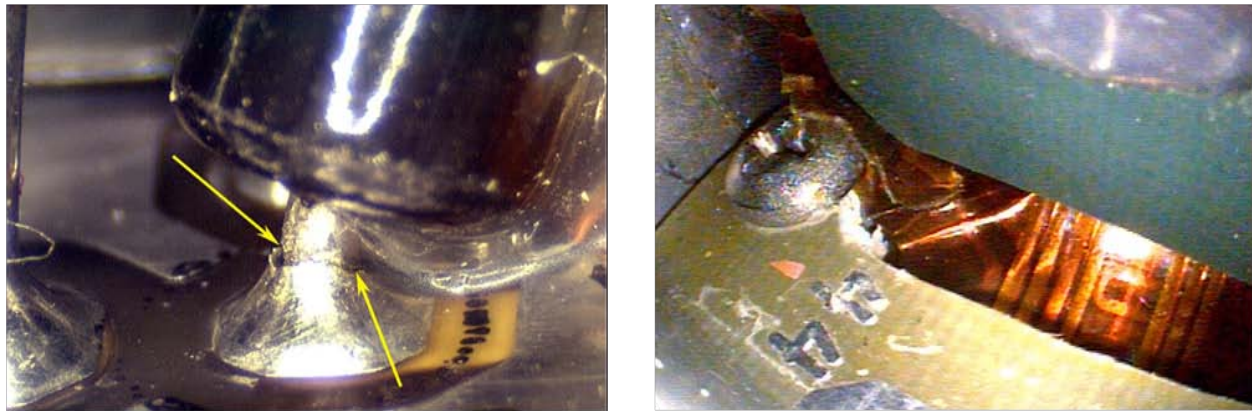
PSB s/n 108 and its mating 55P84 connector which had been previously removed were subjected to full acceptance tests, both of which were completed successfully. This test included thermal and vibration testing to levels above those seen on the vehicle during flight. The box was then torn down completely, and two discrepancies were found that appeared to be related to the two loading anomalies. A tear in the flexprint assembly, which is used to route signals from the box's motherboard to its connectors, was found in the LH2 ECO #3 circuit (see Figure 5). The tear was determined to extend only halfway through the path and did not compromise the integrity of the circuit. It was concluded that the tear was created during installation of the motherboard / flexprint assembly into the chassis, since trimming of the assembly was apparently required to make it fit. The other discrepancy found was a broken cold solder joint at a resistor in the LH2 ECO #4 circuit, but this electrical path was also verified to be good under vibration loads and other testing at the card level. Several other discrepancies (missing conformal coating, debonded card guides, a debonded capacitor, soldering issues, etc.) were also noted, but none could be traced to either of the original failures. In conclusion, no direct cause for the intermittent open circuit could be found within PSB s/n 108 used in the first tanking test.

Figure 5. PSB s/n 108 inspection found two discrepancies. On left is shown a defective solder joint in ECO channel #4 resistor R109. On right is shown a tear in the ECO #3 flexprint. Both were found to be only coincidentally related to the ECO #3 and #4 anomalies.
