Inspection for Damage to Carbon/Epoxy Composite Overwrapped Pressure Vessels

**NASA White Sands Test Facility
August 2010**

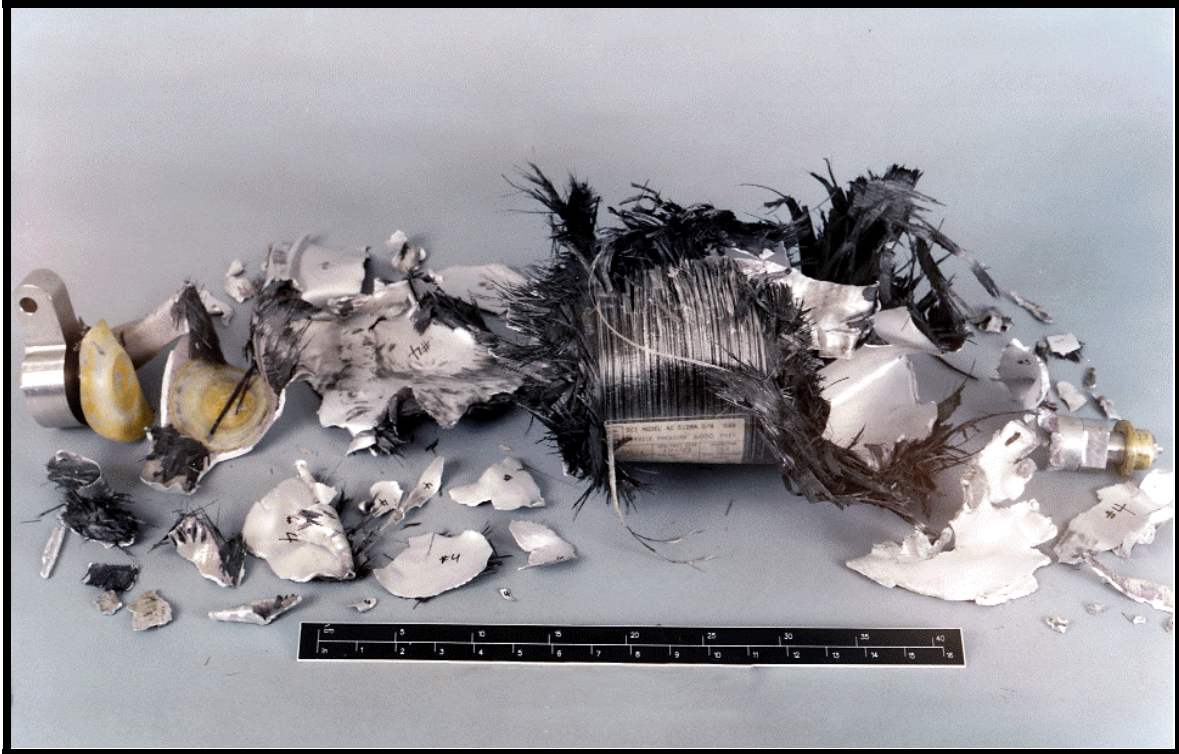
Pneumatic BUI Vessel Posttest

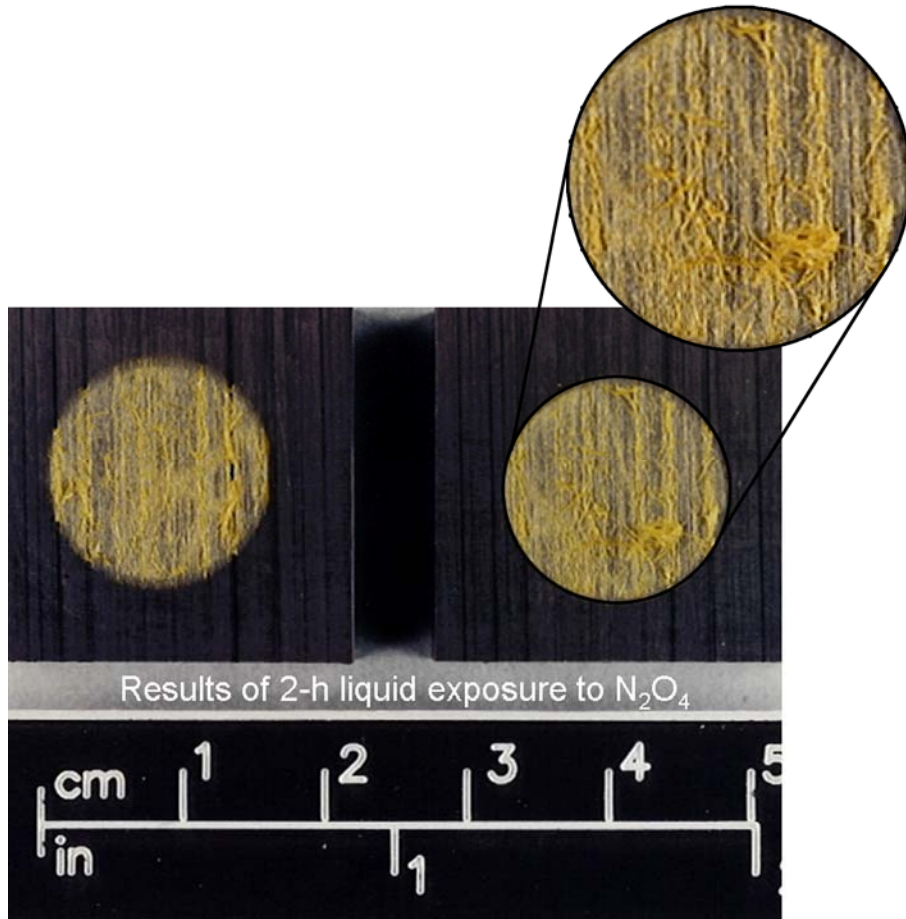
- Visual
 - Minor surface dulling with fuels
 - Yellow oxidizer/matrix reaction product
- No significant strength loss or modulus change

NTO Coupon Damage

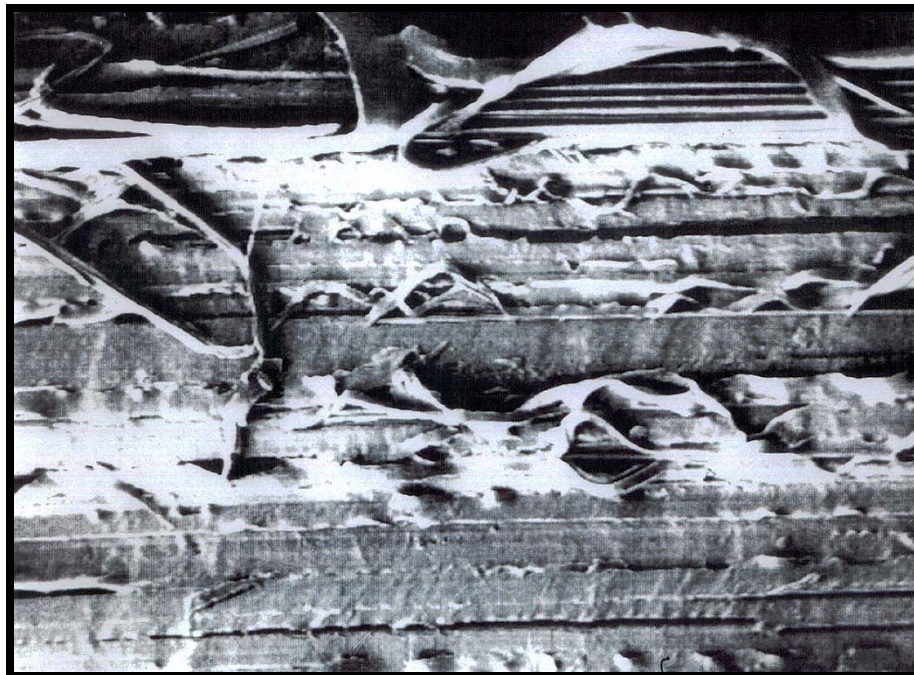
NTO Coupon Damage Detail

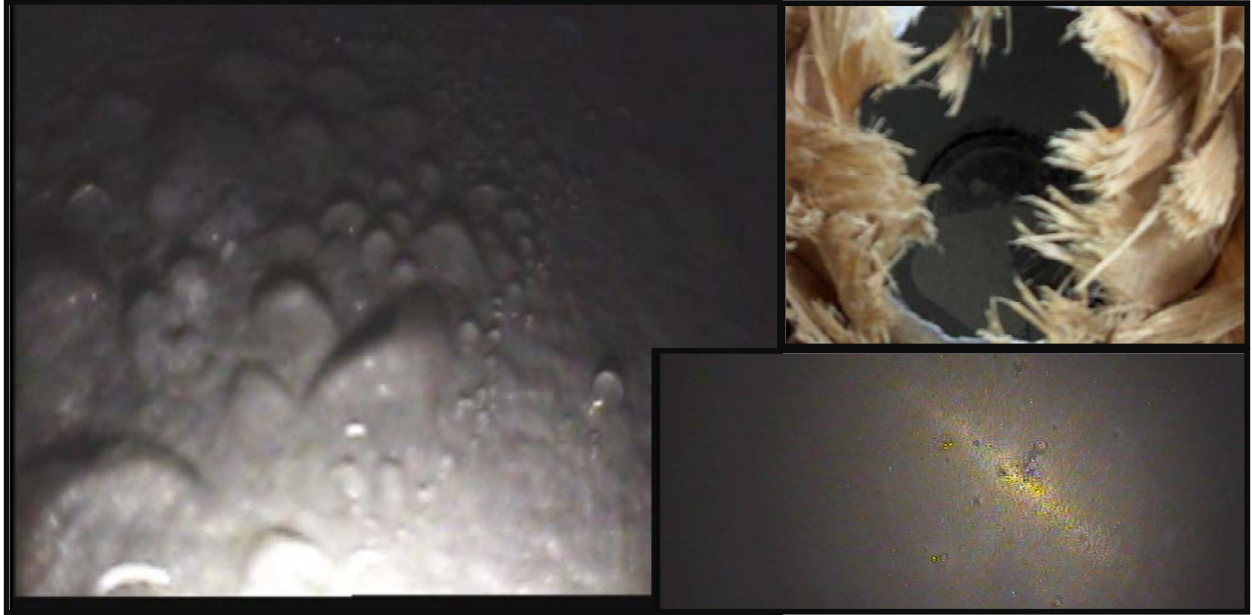
- Aluminum liner with water contamination at receiving
- Aluminum liner after sustained de-ionized water exposure

Liner Corrosion

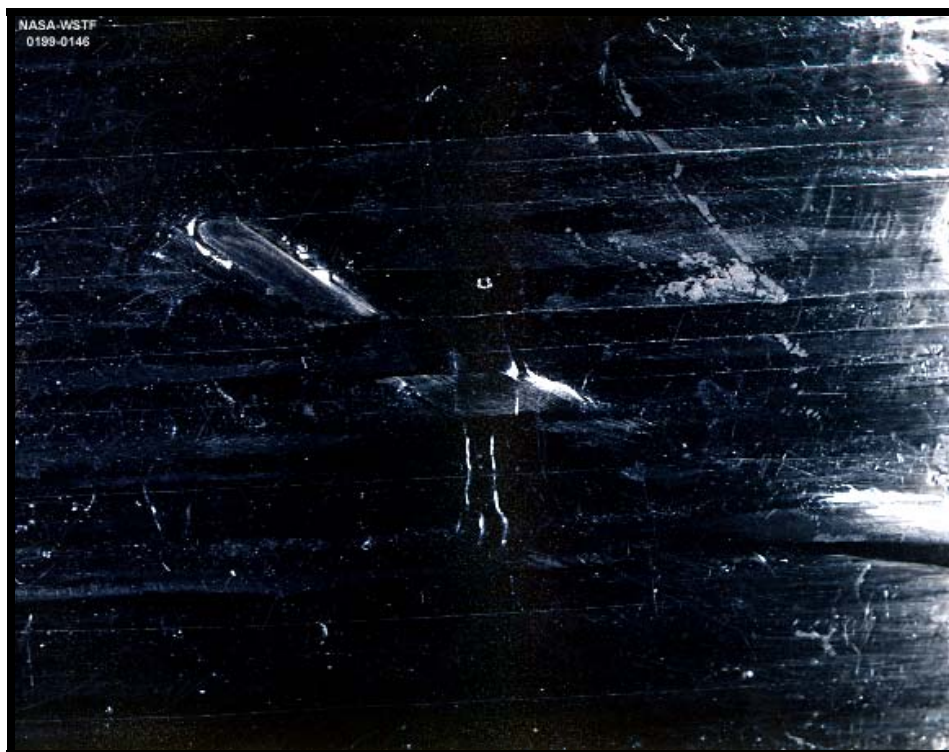
Small Sphere, Abnormal Tie-off

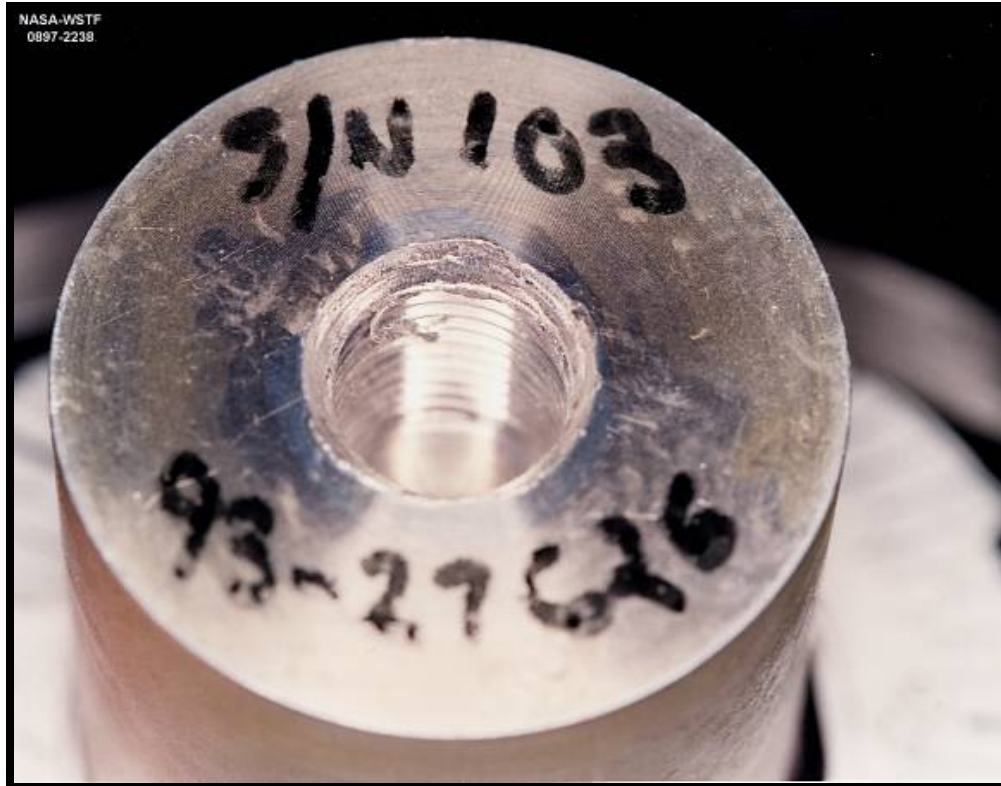
Inlet Thread Damage

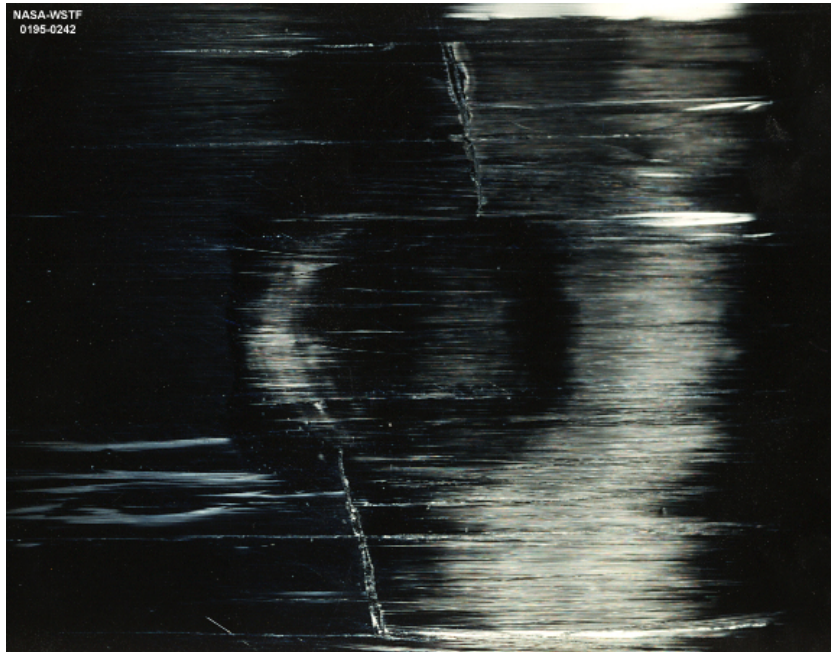
Small Cylinder, Unpressurized, 5 ft-lb Impact, 0.5 in. Tup

A low-energy impact to an unpressurized cylindrical COPV in the hoop region usually results in a shallow indentation. Note the transverse cracks emanating from the indentation edges and joining/ending at the longitudinal cracks parallel to the fiber winding direction. Typically there are no significant transverse cracks in the indentation itself at this energy level. This type of impact damage is near the visible threshold and is easily overlooked.

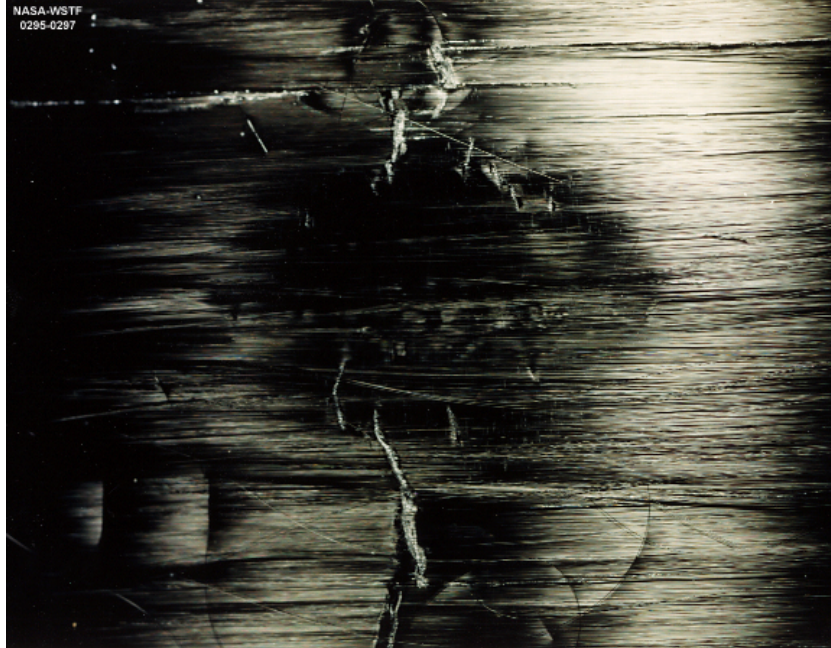
NASA-WSTF
0295-0297

Small Cylinder, Unpressurized, 15 ft-lb Impact, 0.5 in. Tup

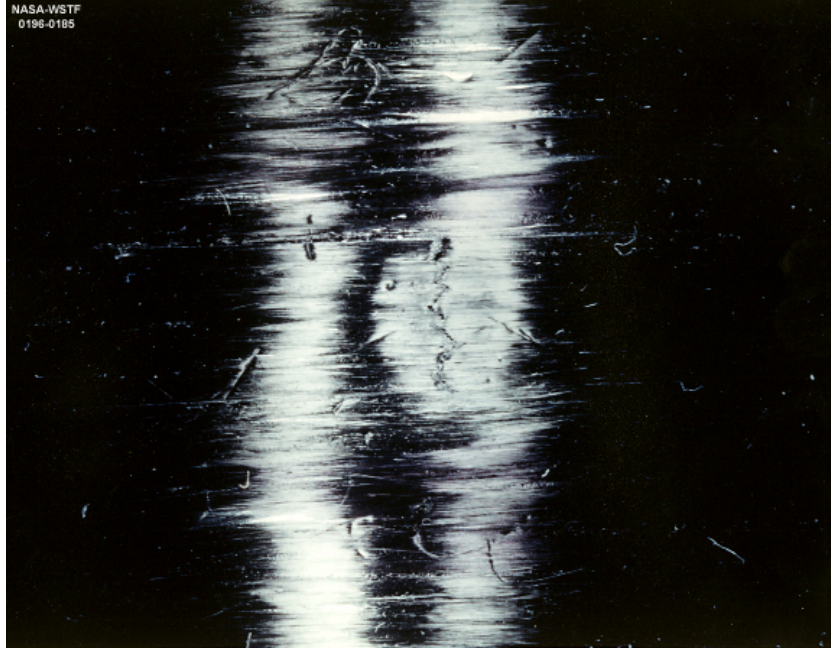
Small Cylinder, 6000 psi Hydraulic, 15 ft-lb Impact, 0.5 in. Tup

An impact to a hydraulically pressurized to MEOP cylindrical COPV in the hoop region usually results in a very shallow indentation. Note the continuous transverse crack bisecting the indentation and joining/ending at longitudinal cracks parallel to the winding direction. Trans-impact site cracking is a prominent feature of this type of impact damage and can result in fiber delamination. 15 ft-lb is the designated damage threshold level for this type of COPV.

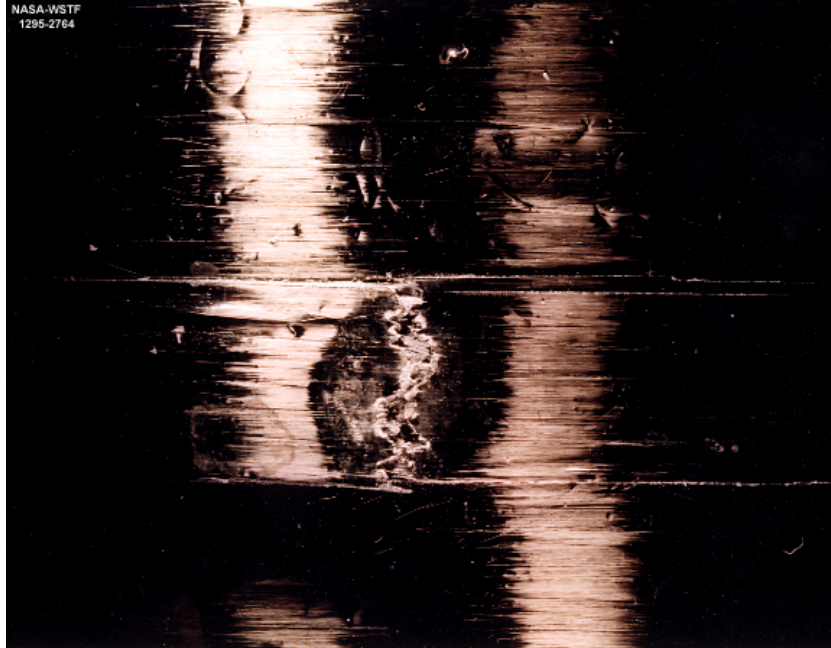
Small Cylinder, 6300 psi Pneumatic, 15 ft-lb Impact, 0.5 in. Tup

An impact to a pneumatically pressurized to MEOP cylindrical COPV in the hoop region usually results in a clearly visible indentation. Transverse damage site cracking and fiber low delamination are characteristic and more highly visible than the hydraulic case.

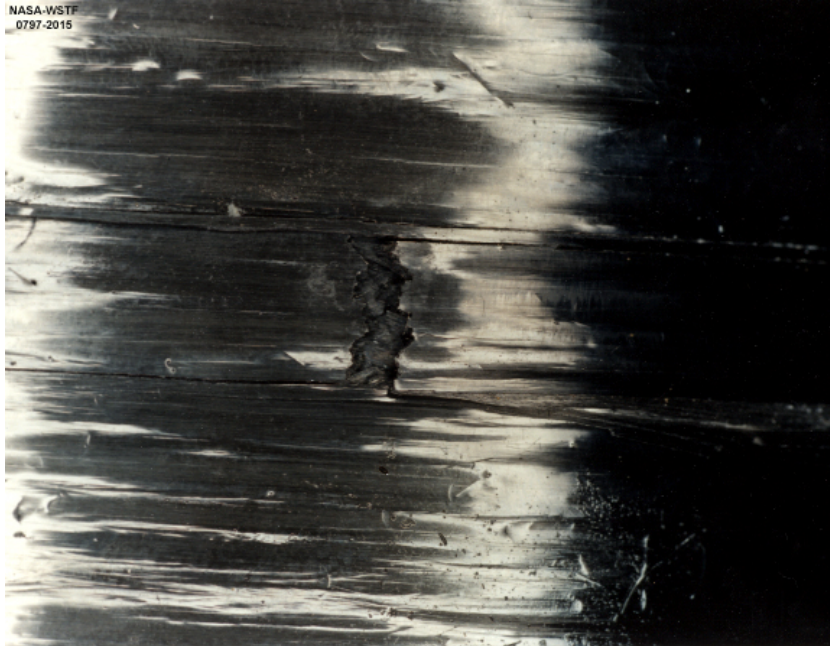
Small Cylinder, 6000 psi Hydraulic, 15 ft-lb Impact, 0.5 in. Tup

Another example of the same type of impact conditions as previous. Note the more highly visible transverse impact site cracking, separation and delamination. This impact resulted in a 31.1 percent degradation of strength with the resulting burst occurring just below the proof pressure level (7500 psig) for this type of COPV.

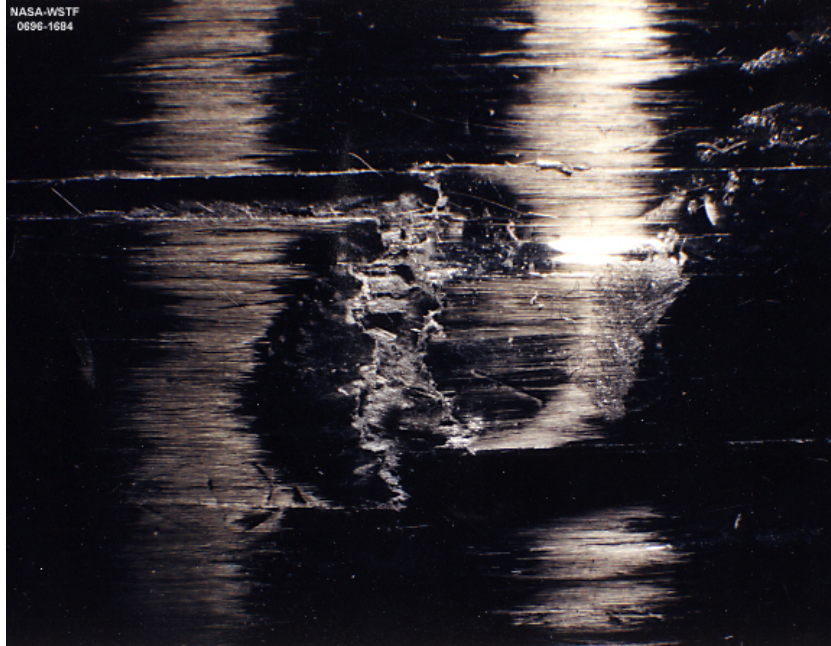
Small Cylinder, 6300 psi Pneumatic, 15 ft-lb Impact, 0.5 in. Tup

Another example of the same type of impact conditions as in a previous example. Here indentation, transverse damage site cracking, and delamination are more evident. This example indicates pneumatic damage is more visible than the hydraulic or unpressurized cases.

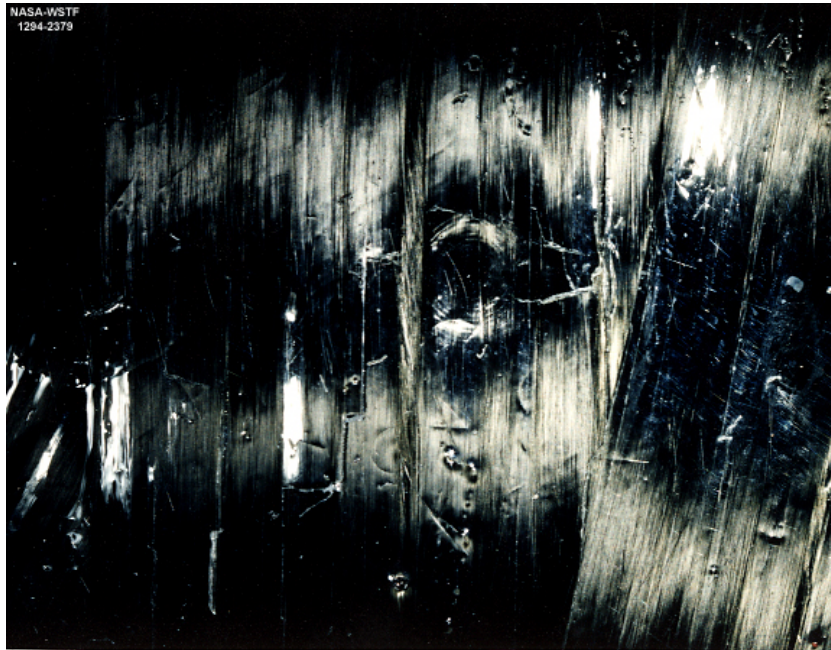
Small Sphere, Unpressurized, 25 ft-lb Impact, 0.5 in. Tup

A low energy impact to an unpressurized spherical COPV in the membrane region usually results in a shallow indentation. Note the transverse cracks emanating from the indentation edges and joining/ending at the longitudinal cracks parallel to the fiber winding direction. Typically, significant transverse cracks in the indentation itself are not found at this energy level. The concentric circular lines seen in the indentation are of unknown origin as the tup surface is basically featureless, and may be some sort of low energy resin response.

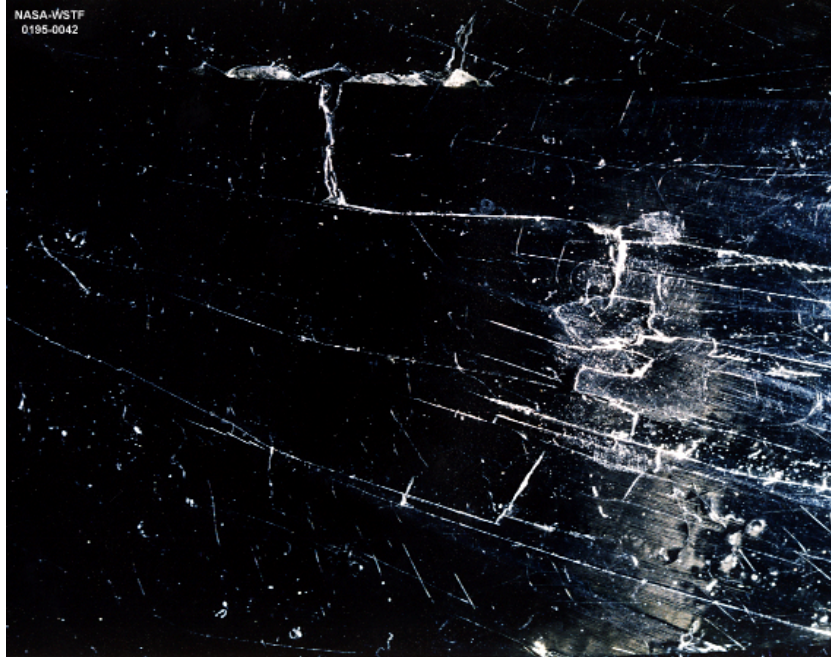
Small Sphere, Unpressurized, 35 ft-lb Impact, 0.5 in. Tup

A slightly higher energy level impact than in the previous example. In this case, the vessel was impacted at the damage threshold level, which resulted in more widespread cracking in and around the impact site. Note the transverse crack path in the impact indentation area is still discontinuous. This COPV failed just below its proof pressure level.

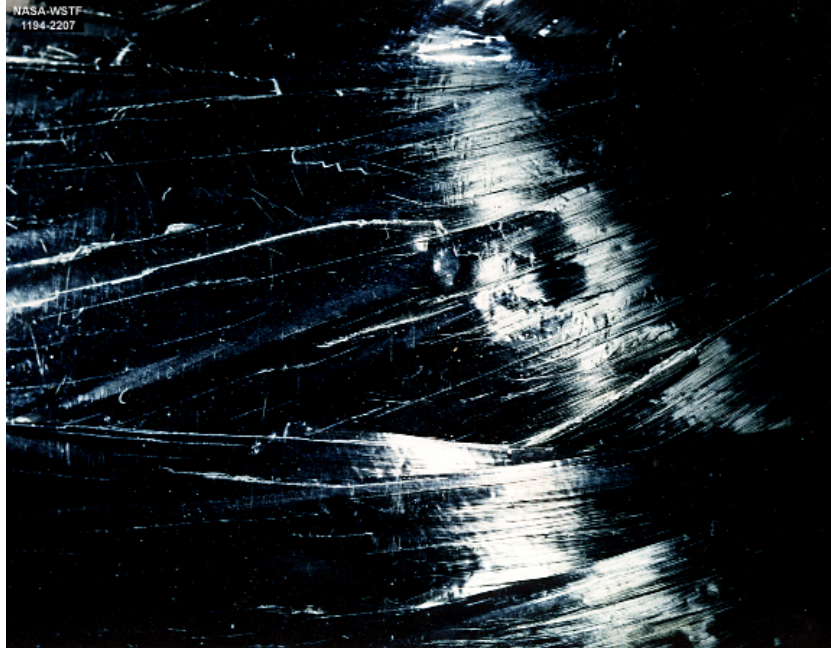
Small Cylinder, Unpressurized, 50 ft-lb Impact, 0.5 in. Tup

A higher energy impact to an unpressurized spherical COPV. Visible damage is not significantly different (or worse) than previous examples, but the resultant burst was well below the proof pressure. This is a good example of the statistical variation in visible damage. Even for a given energy level, several impacts can vary from easily detected to almost invisible and still have a significant effect on strength degradation.

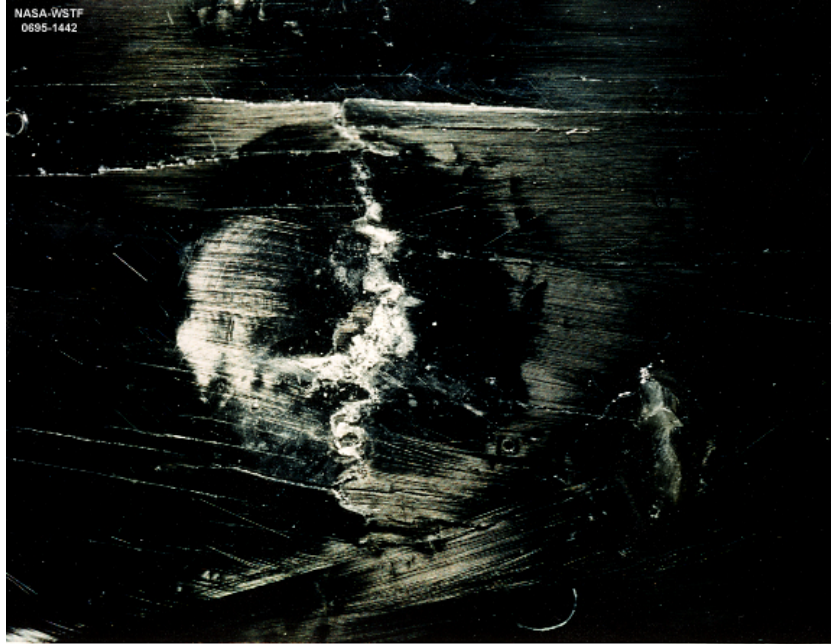
Small Sphere, 6000 psi Hydraulic, 35 ft-lb Impact

An impact to a hydraulically pressurized to MEOP spherical COPV in the membrane region normally results in a highly detectable impact indentation with full width transverse cracking. Outside the indentation, transverse cracking continues until joining/ending at longitudinal cracks that are running parallel to the fiber winding directions. This impact energy level, again represents the damage threshold level.

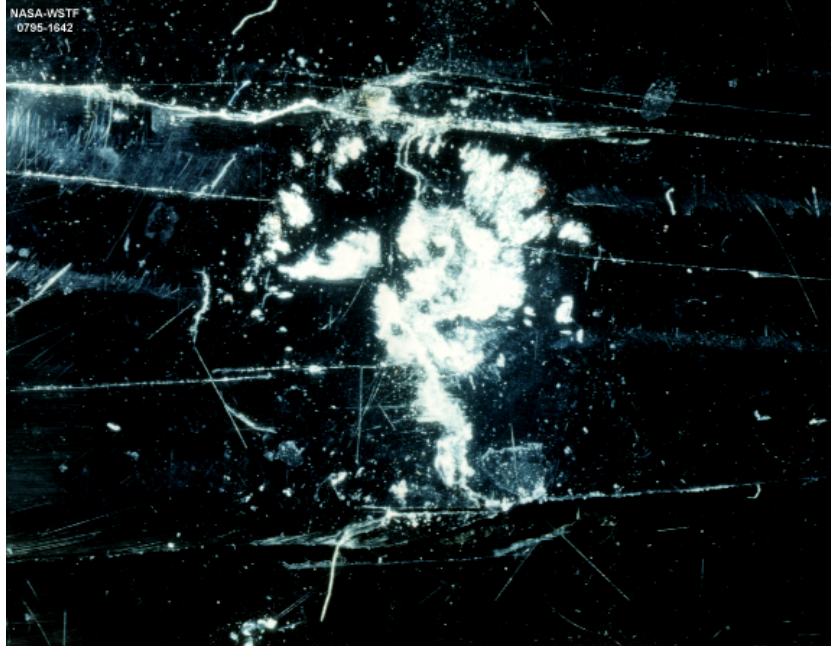
Small Sphere, 6000 psi Hydraulic, 35 ft-lb Impact

Another example of the same type of impact conditions as the previous one. Damage associated with the impact site is slightly more detectable under oblique lighting conditions.

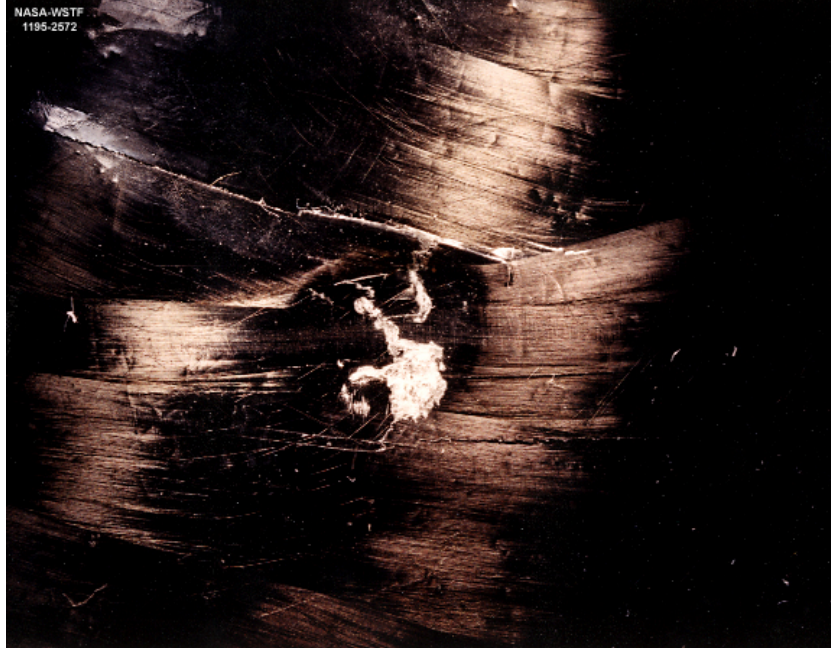
NASA-WSTF
1195-2572

Small Sphere, 6300 psi Pneumatic, 35 ft-lb Impact, 0.5 in. Tup

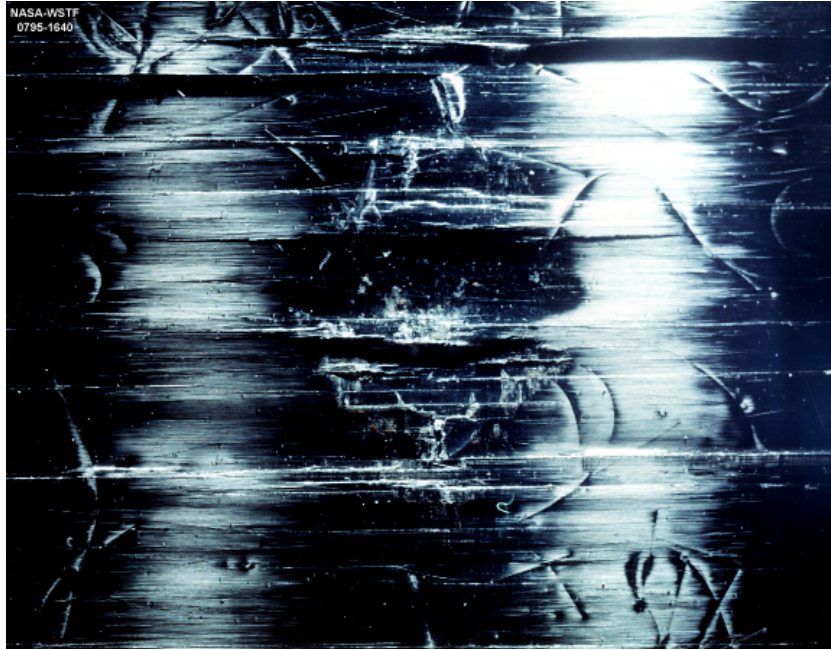
Large Cylinder, Unpressurized, 50 ft-lb Impact, 0.5 in. Tup

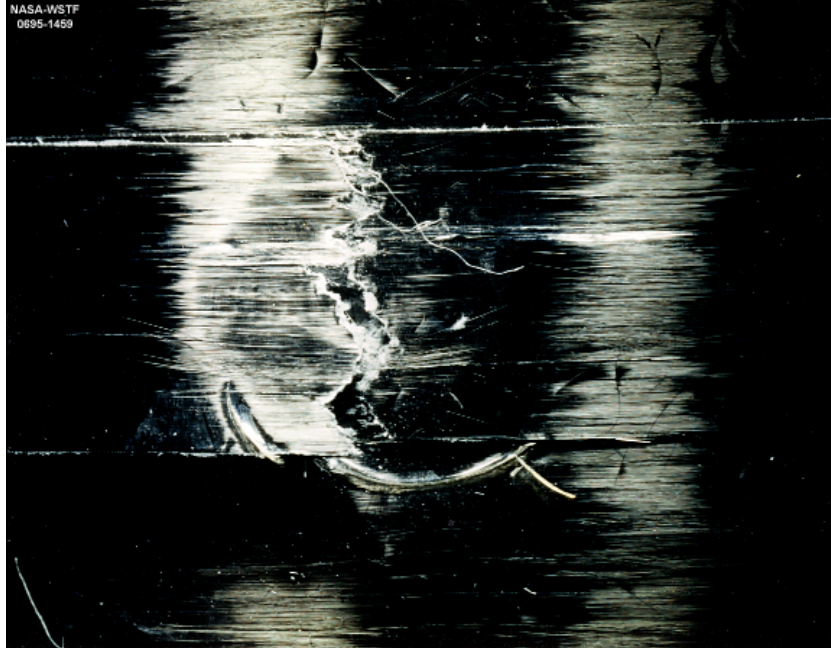
Large Cylinder, Unpressurized, 65 ft-lb Impact, 0.5 in. Tup

The impact energy level here is almost twice the damage threshold level of 35 ft-lb. Transverse cracking is now both significant and highly visible. Tow separation is evident, and some delamination has occurred. Burst occurred well below the COPV's proof pressure.

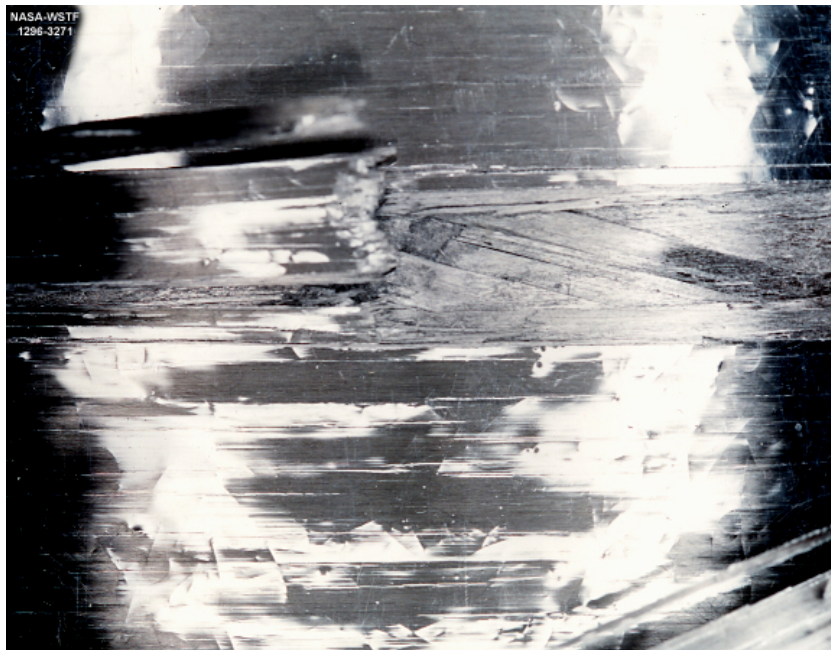
Large Cylinder, 4500 Hydraulic, 35 ft-lb Impact, 0.5 in. Tup

An impact to a hydraulically pressurized to MEOP large cylindrical COPV in the hoop region resulted in full fiber tow breakage, delamination and detachment. Clearly seen is the angular cross-tow winding pattern of the next fiber layer down. This COPV burst slightly above proof.

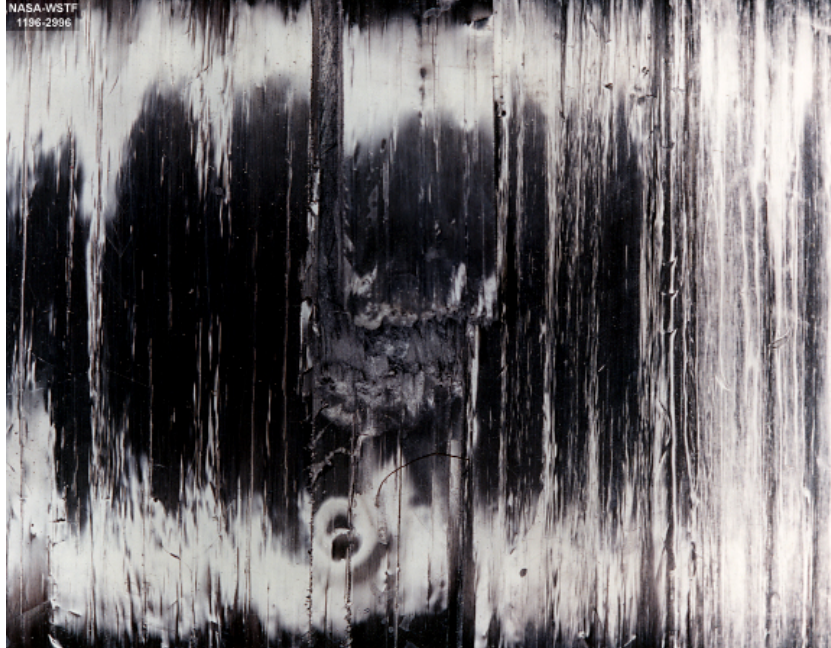
Large Cylinder, 4500 Hydraulic, 35 ft-lb Impact, 0.5 in. Tup, Direct Lighting

This photo shows damage photographed using direct lighting. Overall damage is visible, and fiber tow fracture and delamination is evident.

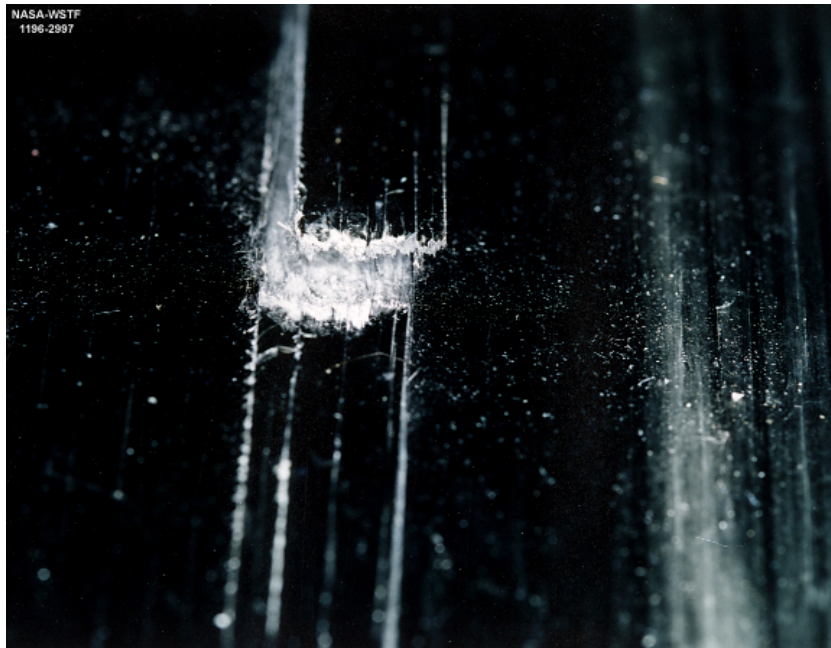
Large Cylinder, 4500 Hydraulic, 35 ft-lb Impact, 0.5 in. Tup, Oblique Lighting

The photo is the same impact site using oblique lighting. Note how change of light angle highlights fracture and cracking. COPV surface is now in black body condition.

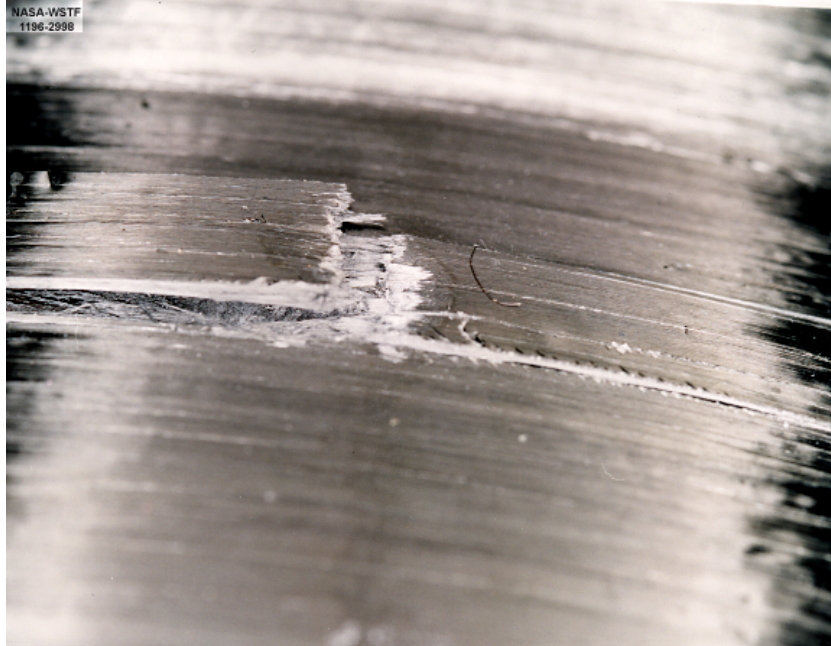
Large Cylinder, 4500 Hydraulic, 35 ft-lb Impact, 0.5 in. Tup,
Oblique View in Direct Light

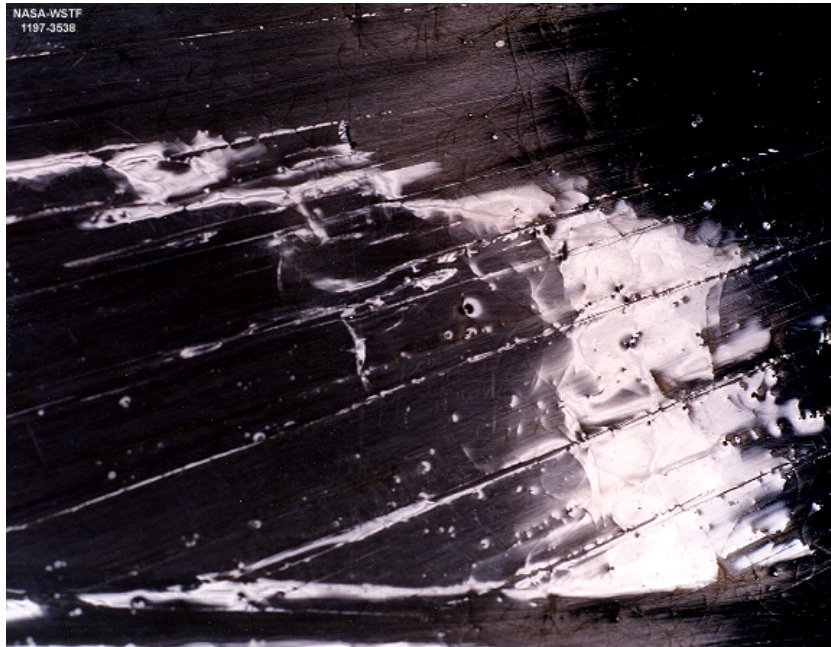
Large Sphere, Unpressurized, 25 ft-lb, 0.5 in. Tup

A low energy impact to an unpressurized large spherical COPV in the membrane region is almost undetected except for some associated fracture.

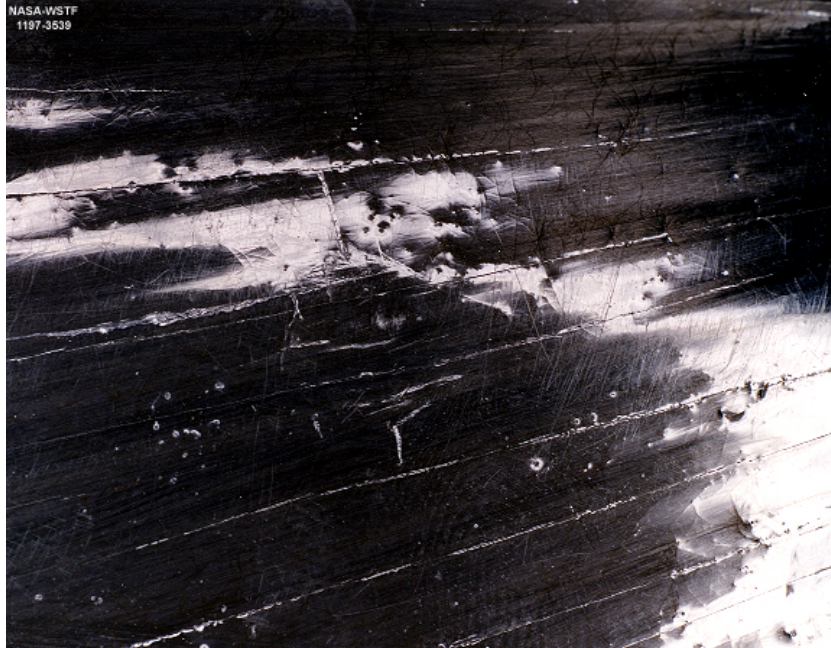
Large Sphere, Unpressurized, 35 ft-lb Impact, 0.5 in. Tup

A slightly higher impact energy to the same COPV (different location) produces some visible transverse cracking.

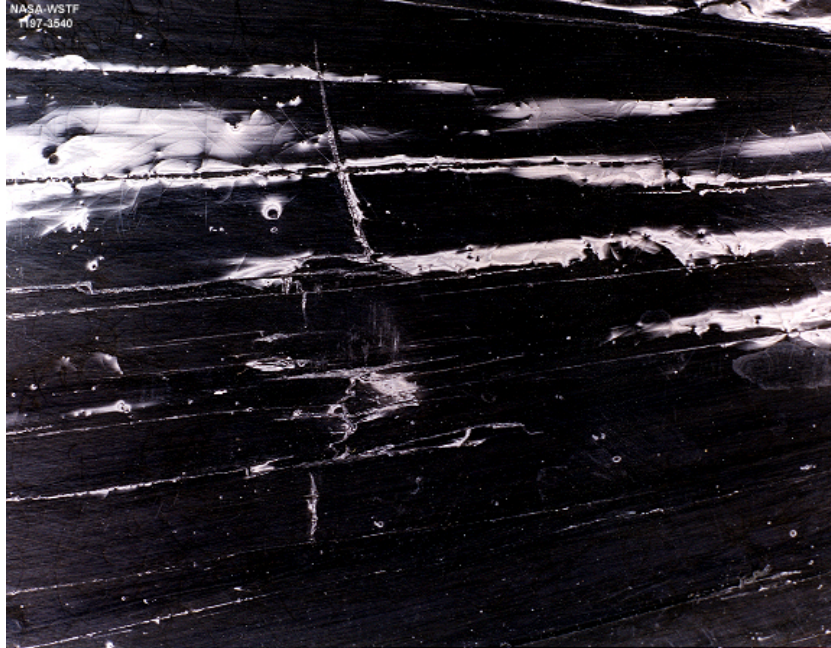
Large Sphere, Unpressurized, 45 ft-lb Impact, 0.5 in. Tup

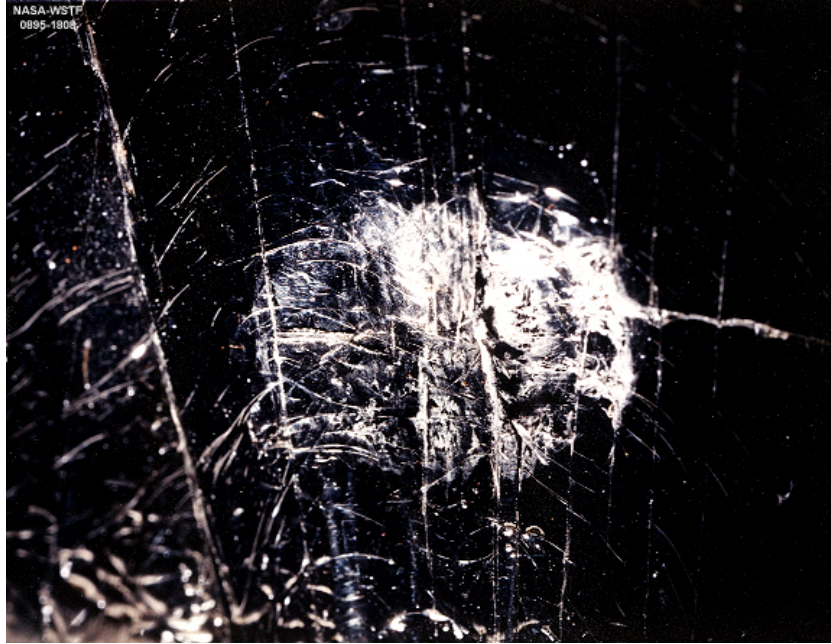
Large Sphere, Unpressurized, 100 ft-lb Impact, 0.5 in. Tup

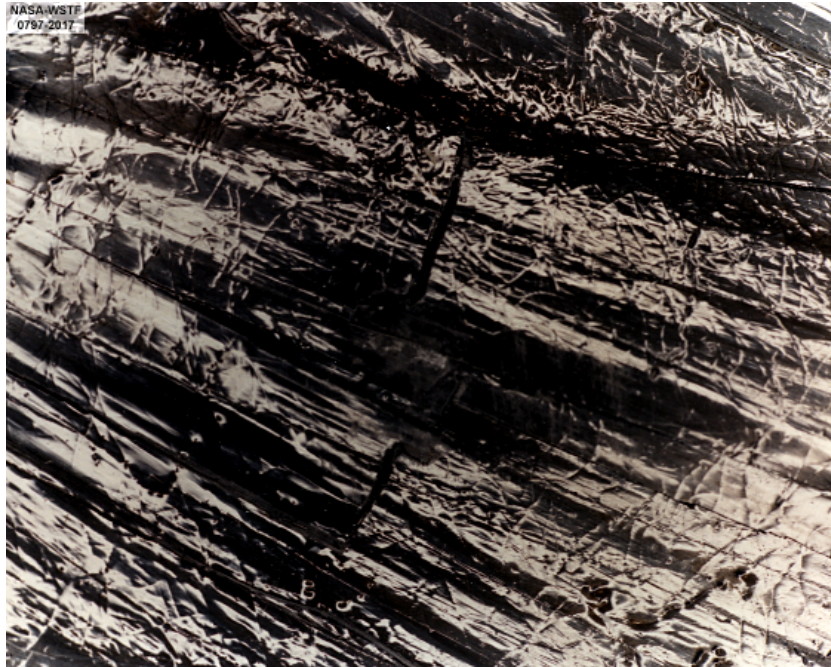
Large Sphere, Unpressurized, 100 ft-lb Impact, 0.5 in. Tup

Another example of the same kind of impact conditions as previous (direct light).

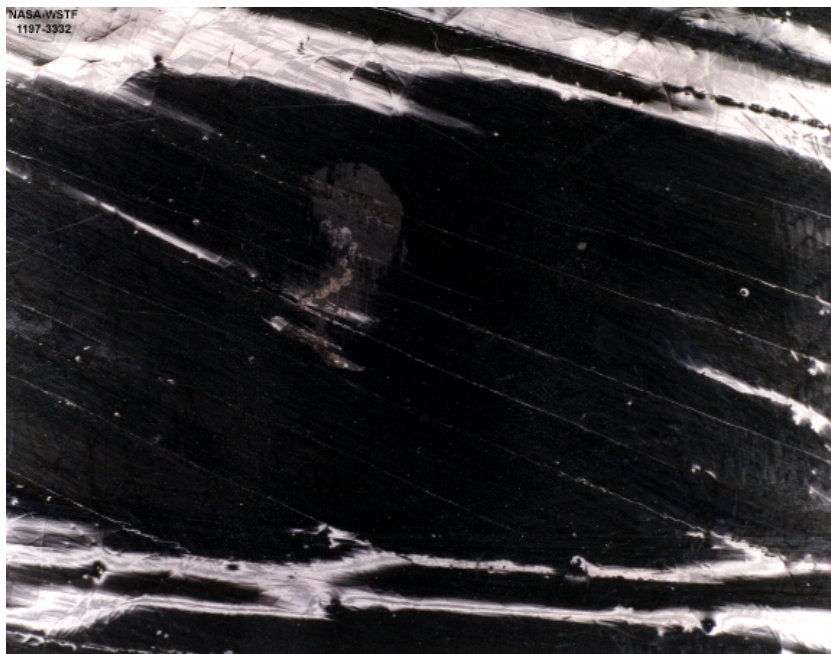
Large Sphere, 4500 psi Hydraulic, 5 ft-lb Impact, 0.5 in. Tup

A very low energy impact to a hydraulically pressurized to MEOP large spherical COPV in the membrane region results in a just visible impact indentation, with some slight associated cracking. This could be easily missed.

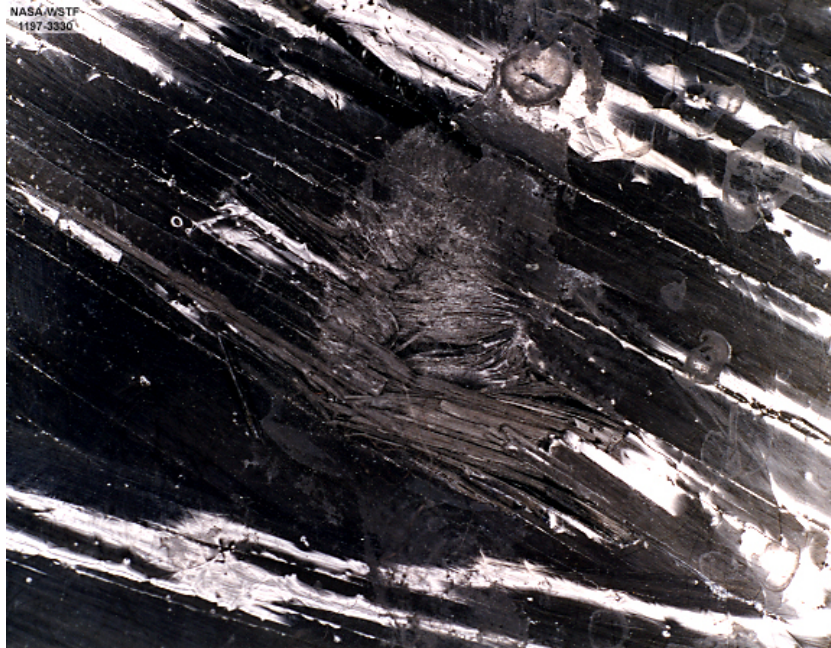
Large Sphere, 4500 psi Hydraulic, 15 ft-lb Impact, 0.5 in. Tup

A slightly higher impact energy level produces clearly evident mashed and distorted fiber in the damage site.

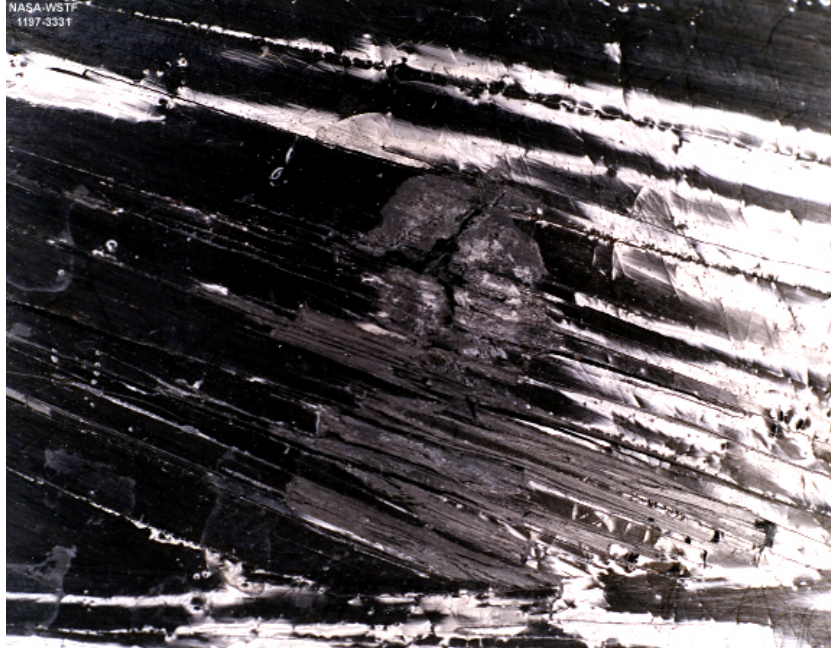
Large Sphere, 4500 psi Hydraulic, 35 ft-lb Impact, 0.5 in. Tup

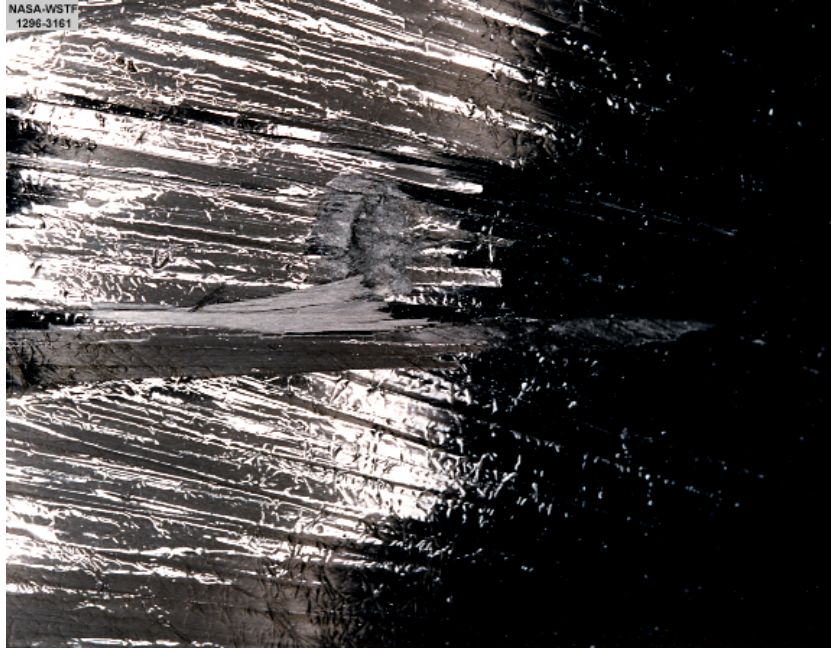
Large Sphere, 4725 psi Pneumatic, 100 ft-lb Impact, 0.5 in. Tup

An impact to a pneumatically pressurized to MEOP large spherical COPV in the membrane region results in a highly visible damage site composed of transverse fracture, tow detachment and delamination.

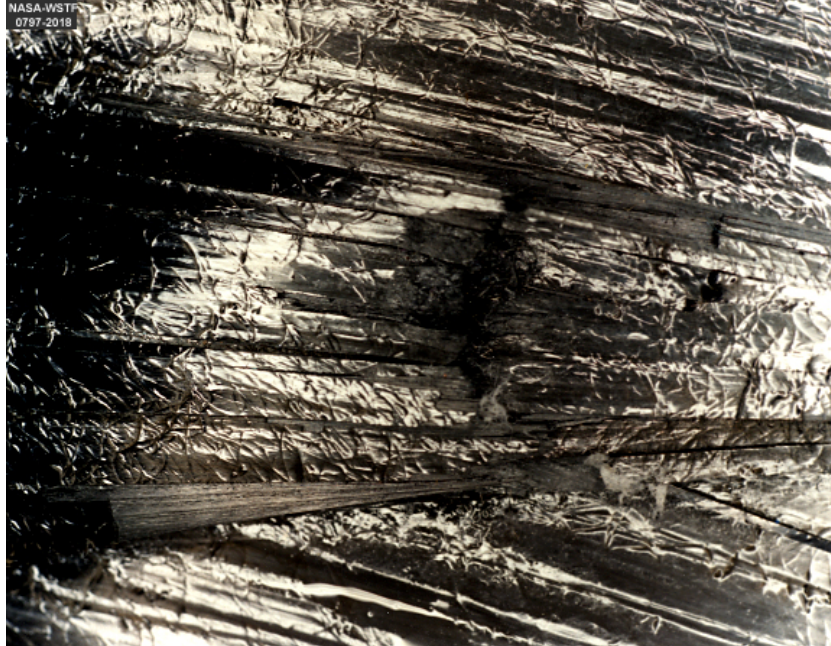
Large Sphere, 4725 psi Pneumatic, 100 ft-lb, 0.5 in. Tup

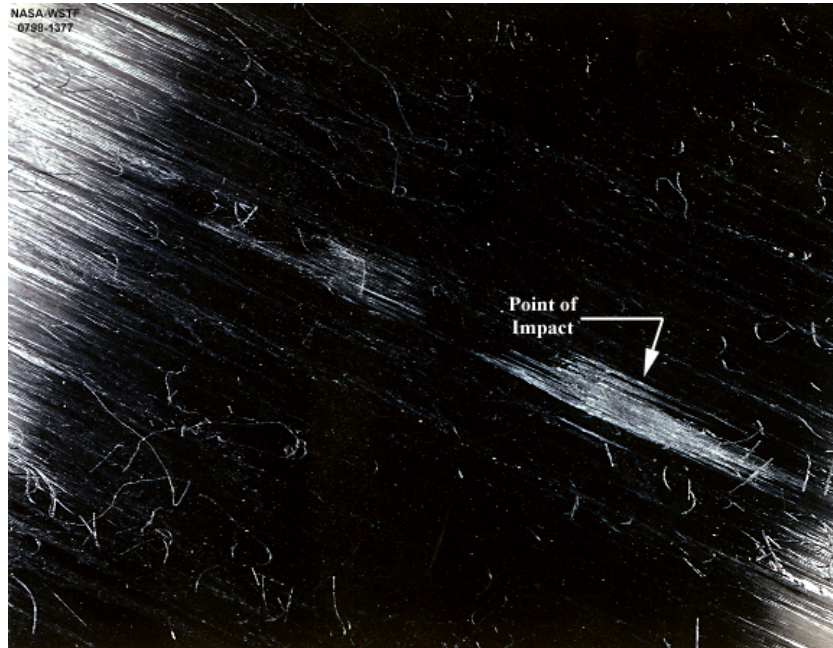
Small Cylinder, Unpressurized, Oblique Impact, 0.5 in. Tup

Shown is the case of an oblique (~45°) impact in the hoop region of an unpressurized cylindrical COPV. Initial impact is seen as a very pronounced scuff or smear. The point of impact is seen with some slight cratering or sliding type indentation with a second slight impact just ahead of it. This damage, while significant had no measurable effect on COPV burst strength. This example is shown as it represents a “real world” impact, such as that from the glancing blow of a dropped tool.

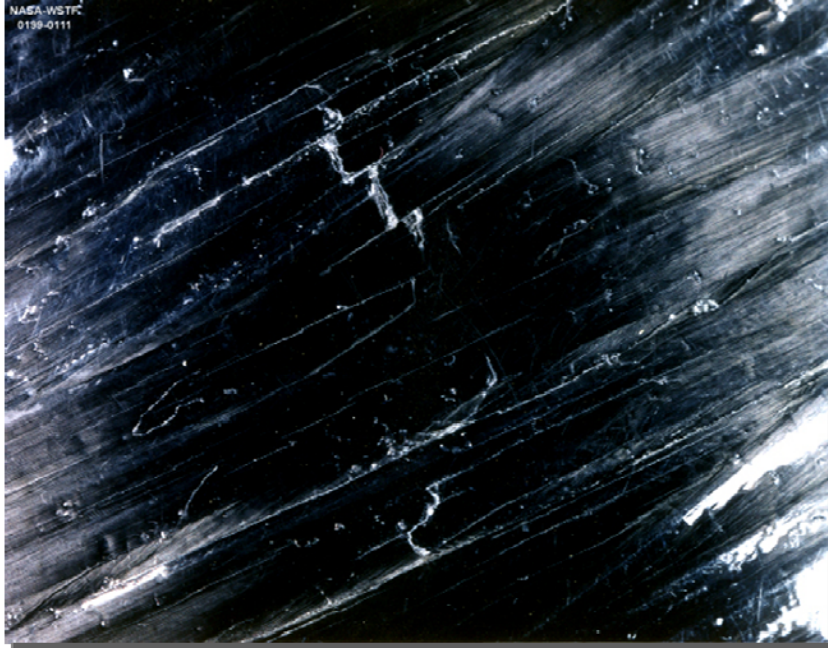
Small sphere, unpressurized, wide field cracking
