Inspection for Damage to Carbon/Epoxy Composite Overwrapped Pressure Vessels

**NASA White Sands Test Facility
August 2010**

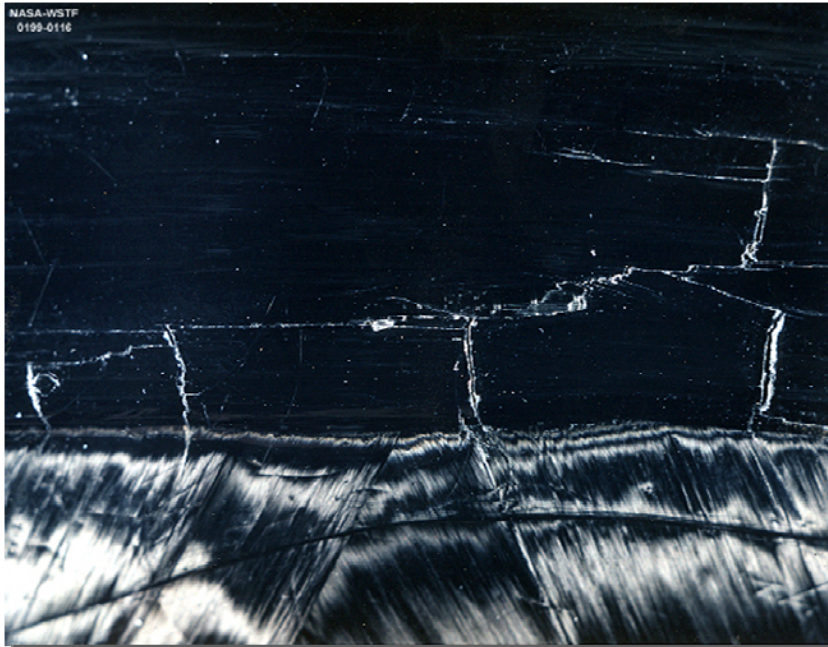
Small cylinder, manufacturing defect, nonelastic end crack

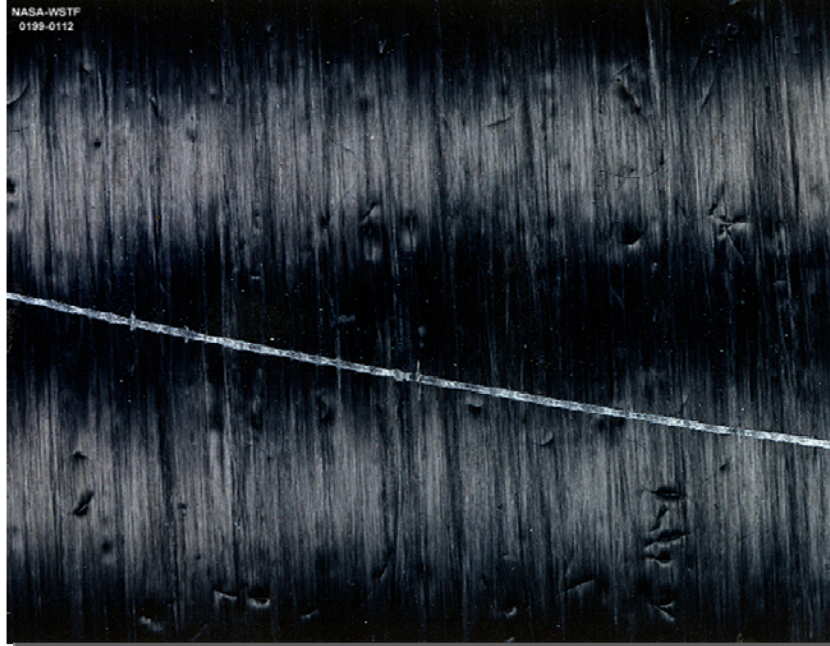
Small cylinder, scratch, transverse to winding direction

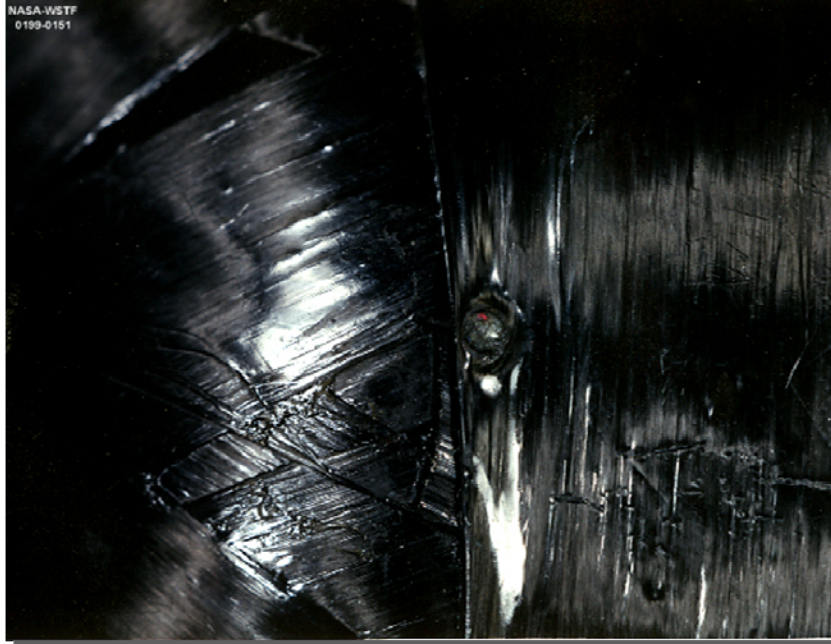
4 x 9 in. cylinder, broken tow

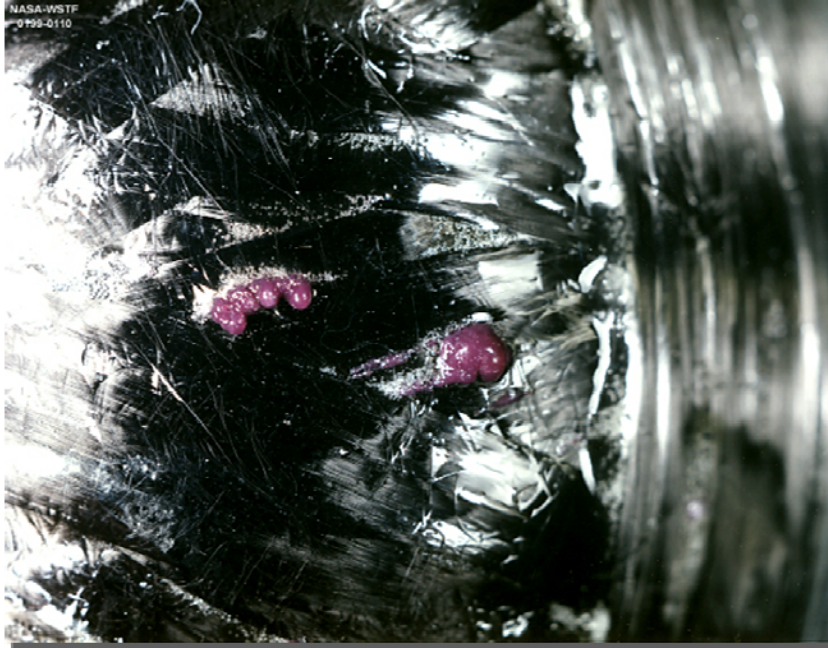
4 x 9 in. cylinder, excess bonding agent

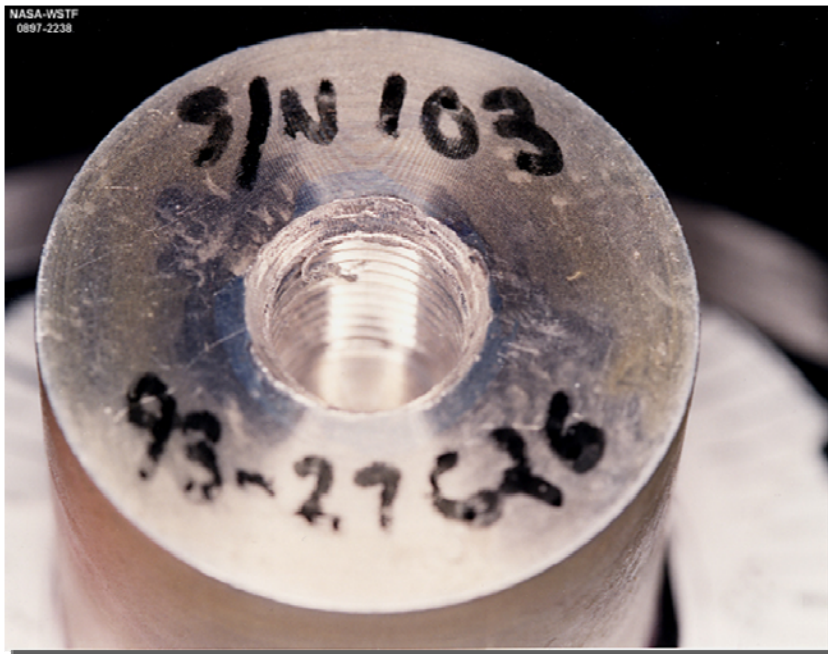
Inlet thread damage
