# BURST PRESSURE FAILURE OF TITANIUM TANKS DAMAGED BY SECONDARY PLUMES FROM HYPERVELOCITY IMPACTS ON ALUMINUM SHIELDS

*American Physical Society  
Shock Compression of Condensed Matter  
June 26-July 1, 2011  
Chicago, IL*

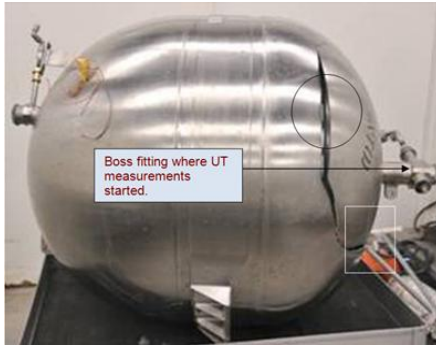
The two damaged tanks (#0062 and #0092) and a third undamaged tank #0251 were pressurized to burst at WSTF. As shown in Fig. 2, tank #0251 failed at the ellipsoidal ends opposite of the hemispherical end that was targeted in the HVI tests. Tank #0092 failed at the same ellipsoidal end as #0251. However, Fig. 3 shows that tank #0062 failed at the hemispherical end that was targeted and where excessive and unexpected damage occurred because of the late sabot separation. Moreover, the #0062 tank failed at significantly lower pressure of 580 psig compared to tank #0251 that failed at 795 psig and tank #0092 at 785 psig.

**Figure 2.** Tank #0251 failure at Ellipsoidal end. Tank #0092 exhibited the same failure.

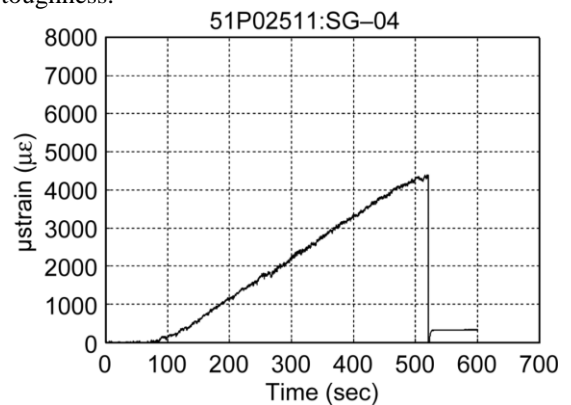
The strain versus time history of tank #0251 during pressurization and up to the failure is shown in Fig. 4, while Fig. 5 shows the same data

**Figure 4.** Strain-time curve for tank #0251.

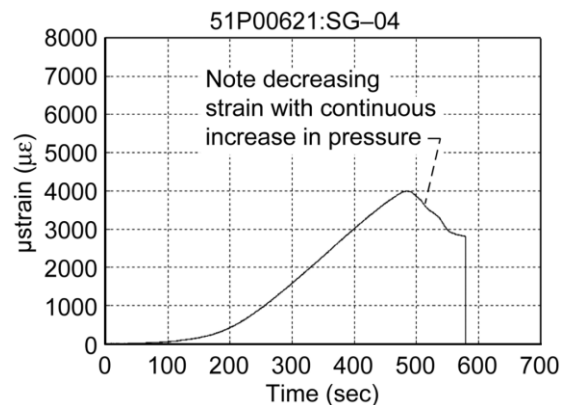
for tank #0062. From the strain-time history curve, it was apparent that the failure of tank #0062 was preceded by a time interval of declining strain which could be caused by a slow depressurization of the tank. At about 575 sec, an abrupt decline in strain was observed similar to tank #0251 at about ~520 sec. However for tank #0062, the interval between the peak strain and the abrupt decline in strain invited suggestions of slow damage progression (a stable crack growth process) before final failure.

**Figure 5.** Strain-time curve for tank #0062 that failed at the damaged area.

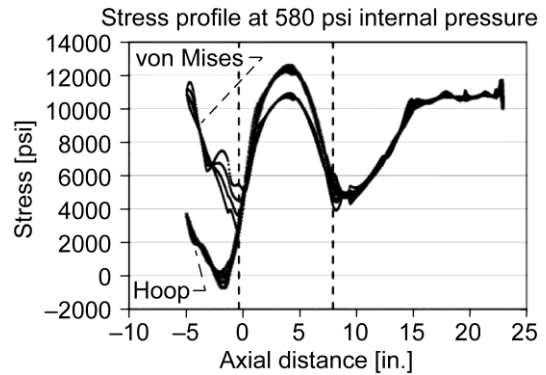
To further corroborate the argument, a finite element analysis (FEA) on the tank was performed. For a pressure of 580 psi, the FEA showed in Fig. 7 that the Von-Mises stresses/criterion was below the yield limit of Ti-6Al-4V, yet the calculated stresses from the shell theory showed yield and ultimate strength exceedance at the higher burst pressures of tanks #0092 and #0125.

**Figure 7.** Finite Element Analysis of Ti tank at 580 psig.

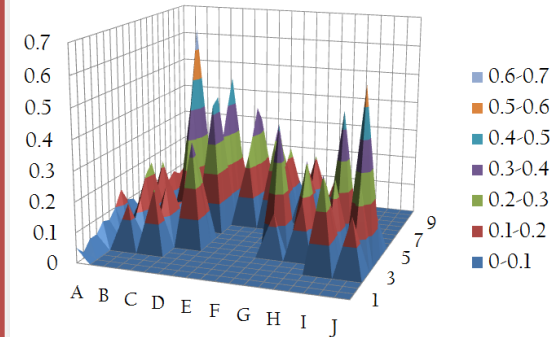
0062 Tank

- Damage Distribution of Tank 0062 caused by 1.6 mm Al projectile and Sabot pieces
  - Exhibits two areas of damage which may have been caused by the sabot piece impacting the Al shield
  - Distribution exhibited deeper than expected impacts
- Damage Distribution of Tank 0092 caused by 3.6 mm Nylon projectile
  - Exhibited Uniform damage distribution as seen in stressed and unstressed coupon HVI tests

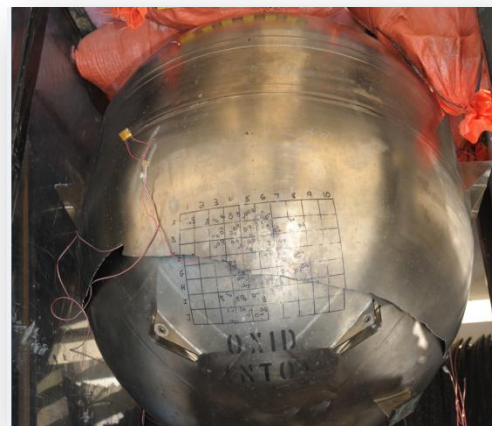
B-Tank with crack shown in the impacted area

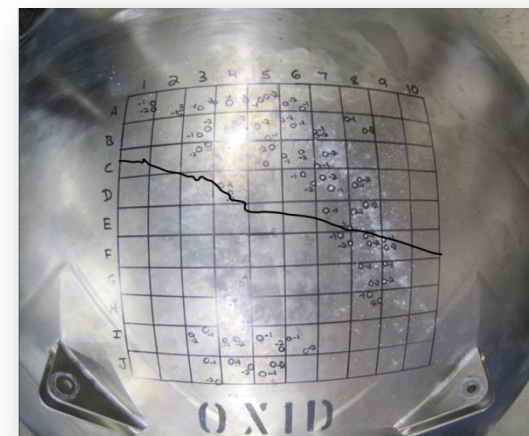
C-Crack line superimposed on tank

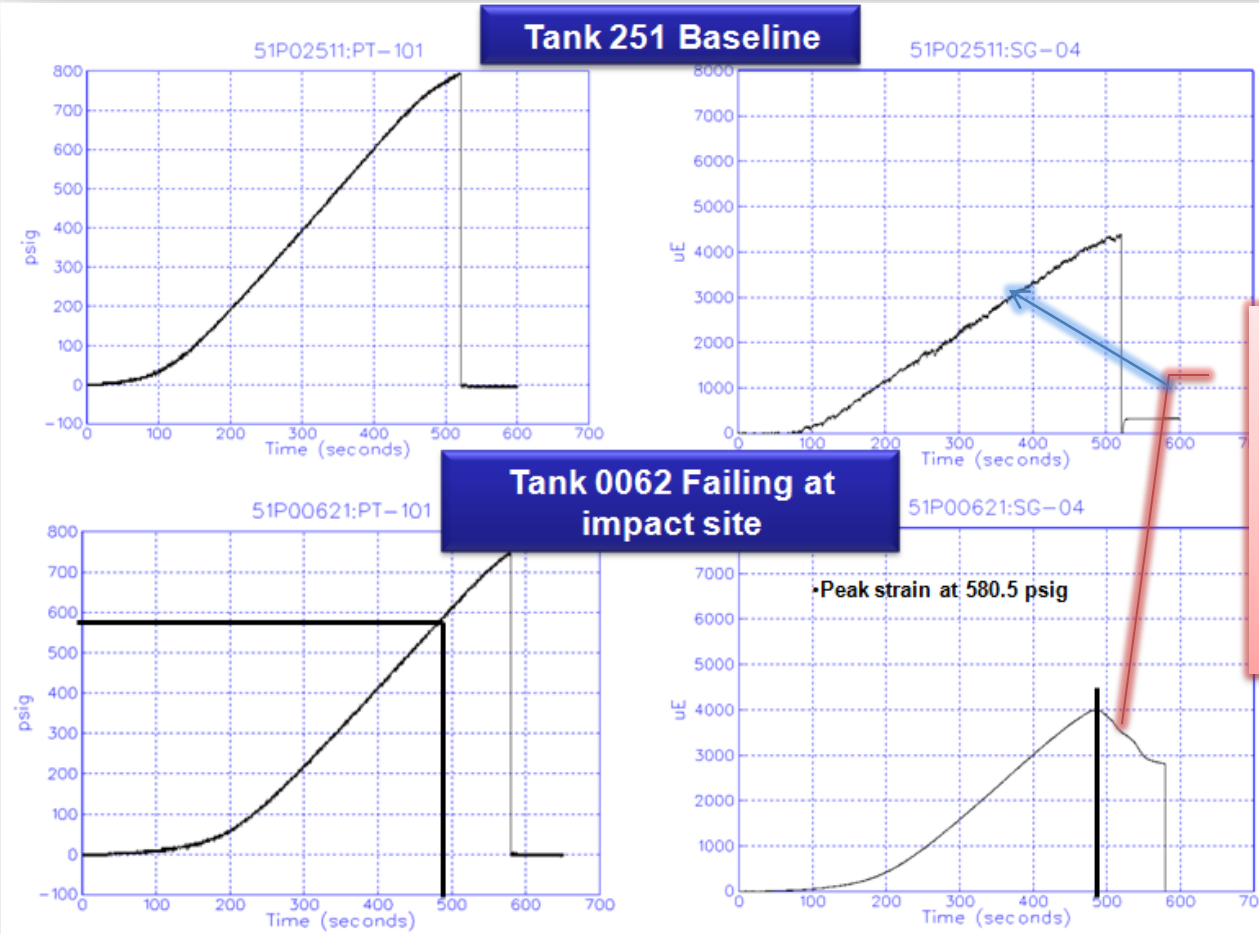
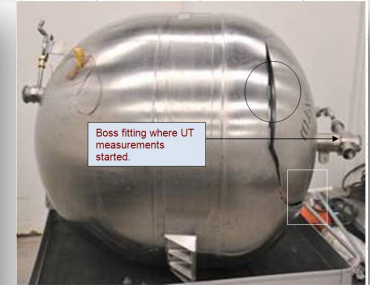
Decrease in strain eluding to a relief process followed by the tank failure. **Note the difference with tank 251**

Failure of Tank 0062 could have been induced by a crack propagation
