# Degradation of Multi-Layer Insulation (MLI) Retrieved from the Hubble Space Telescope

2011 Contamination, Coatings, &  
Materials Workshop

Jelila S. Mohammed  
Materials Engineering Branch  
NASA Goddard Space Flight Center

Kim K. de Groh  
Space Environment & Experiments Branch  
NASA Glenn Research Center

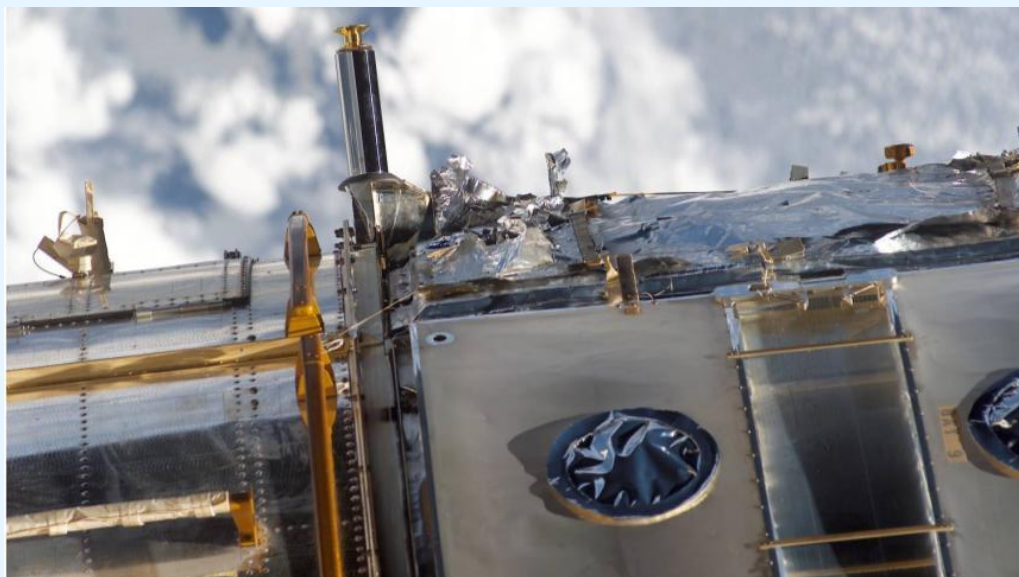
On-orbit insulation degradation and embrittlement

Previous analyses of returned HST Al-FEP from SM1 to SM3B indicate that material properties degrade due to combined effects of radiation and thermal cycling.

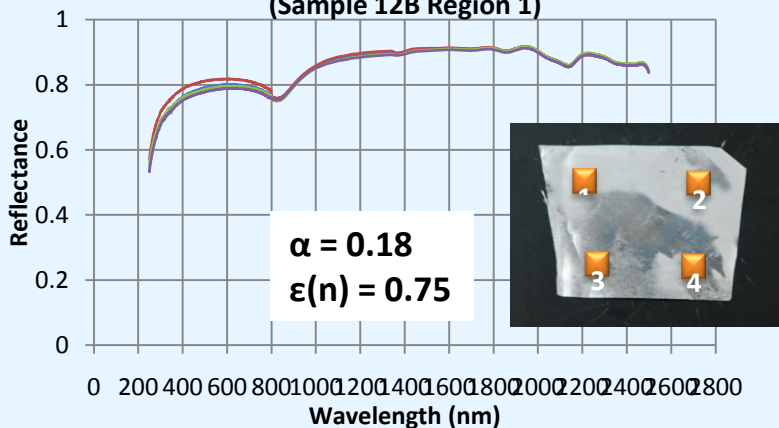
(Sample 12B Region 1)

**Bay 8, Shiny +V3**

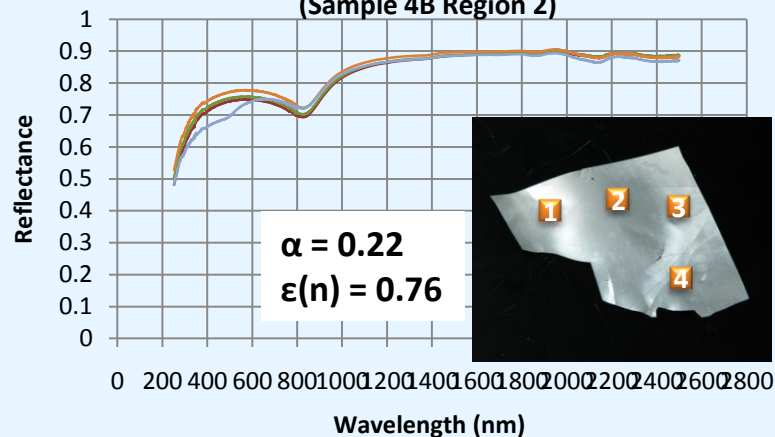
(Sample 4B Region 2)

**Bay 8, White hazy +V3**

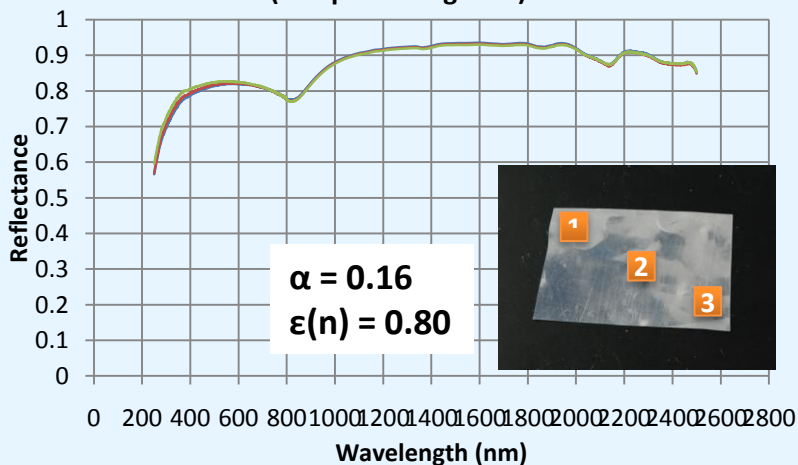
(Sample 7C Region 1)

**Bay 5, Shiny +V2**

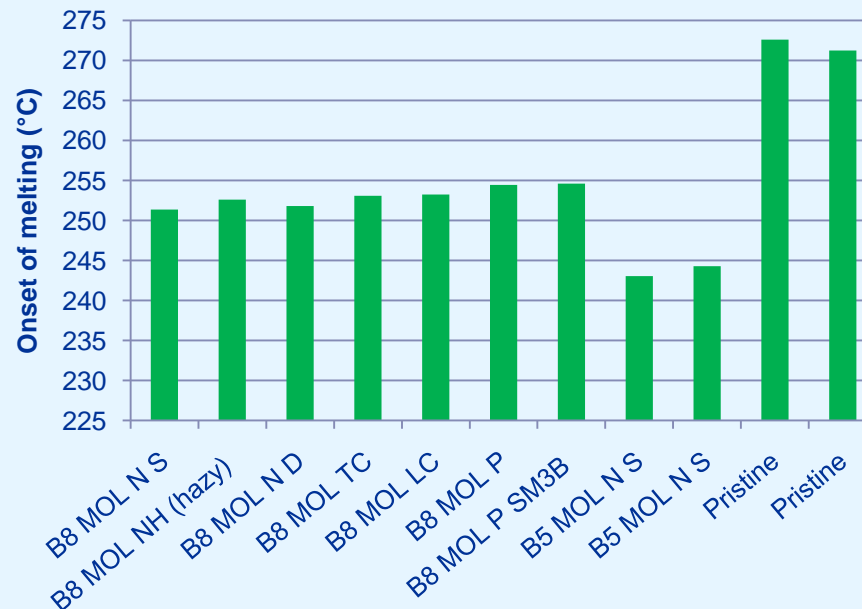
- Enthalpy of melting correlates with crystallinity**

- Bay 8 has increased crystallinity over Bay 5.
- Exposed aluminum due to the curl resulted in increased temperatures on orbit for that material that was curled – higher crystallinity.

- Reduction in melting temperature indicates shortened polymer chains due to radiation effects.**

- Bay 5 may exhibit more chain scission than Bay 8 (due to radiation).

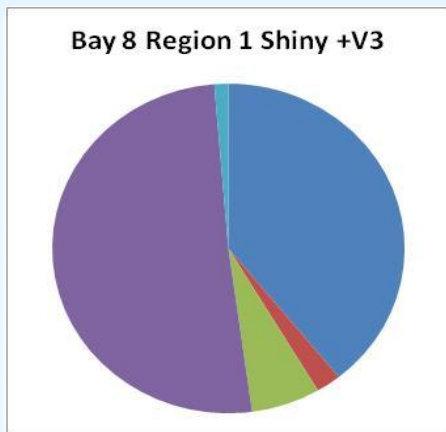
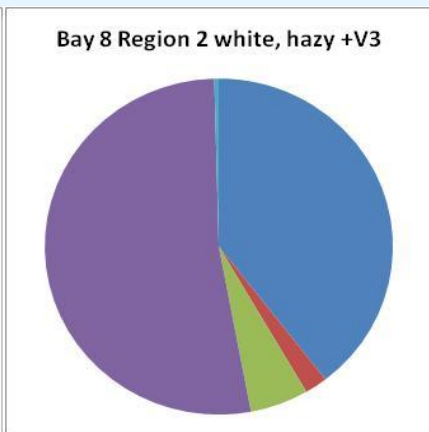
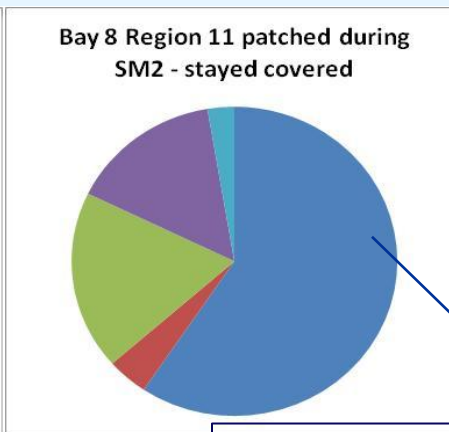
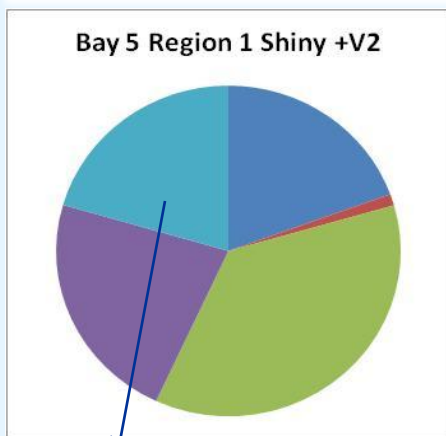
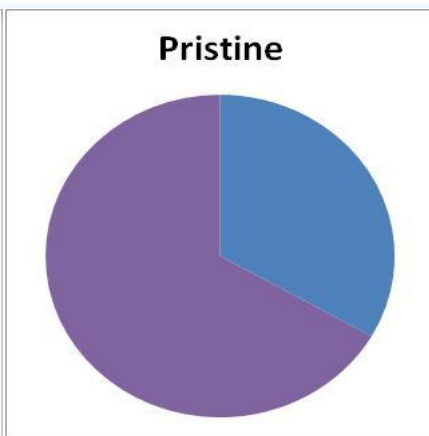
High C concentration may indicate contamination from patch velcro, in agreement with the large degradation in optical properties observed for the patched Bay 8 MLI.

High Si may be due to contamination from astronaut gloves.

Lower F/C ratio indicates damage to the MLI

When Teflon is subjected to radiation damage and the polymer chains are broken, F is expelled from the chain

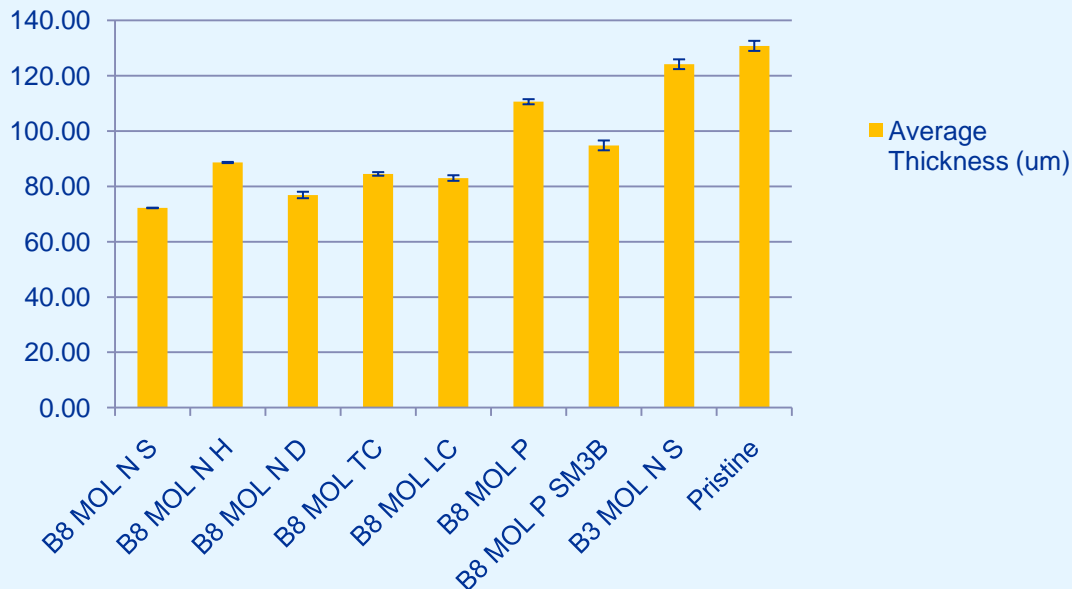
Teflon on Bay 8 was overall more eroded than on Bay 5.

Patches protected underlying material from erosion.

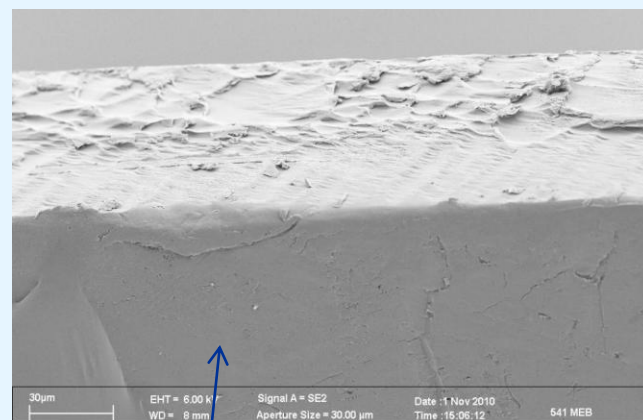
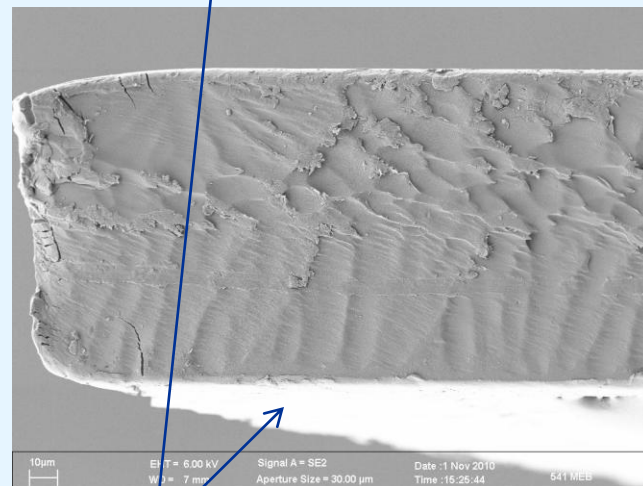
SEM images of on-orbit crack edge
