Shuttle Liquid Hydrogen (LH2) Engine Cut-Off (ECO) System Anomaly

Michael D Stirling

NASA Electrical Systems

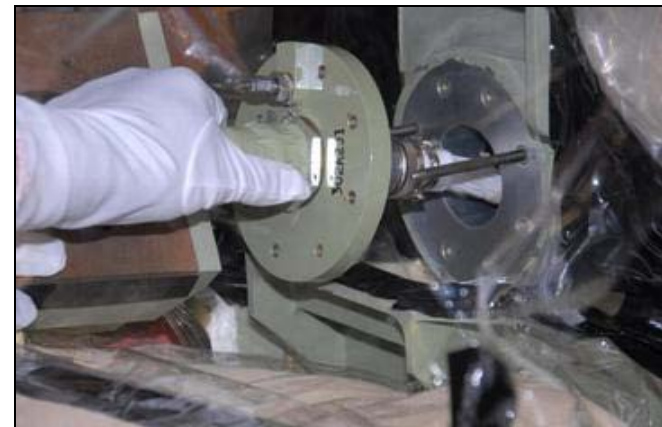
- All circuit anomalies experienced during testing were able to be repeated as seen during the two launch attempts and tanking test.
- Open circuits in the part that connects wires from the interior to the exterior of the liquid hydrogen tank, commonly known as the feed through plate, were identified as the culprit that caused false readings during two launch attempts and a tanking test in December 2007.
- The external plug and feed through connector were removed from the tank and shipped to Marshall Space Flight Center in Alabama to determine whether the failure could be recreated in a test facility using focused and limited nondestructive and destructive physical tests. The tests were configured to replicate tank chill down temperatures, loading pressures and environmental conditions during the two launch attempts.

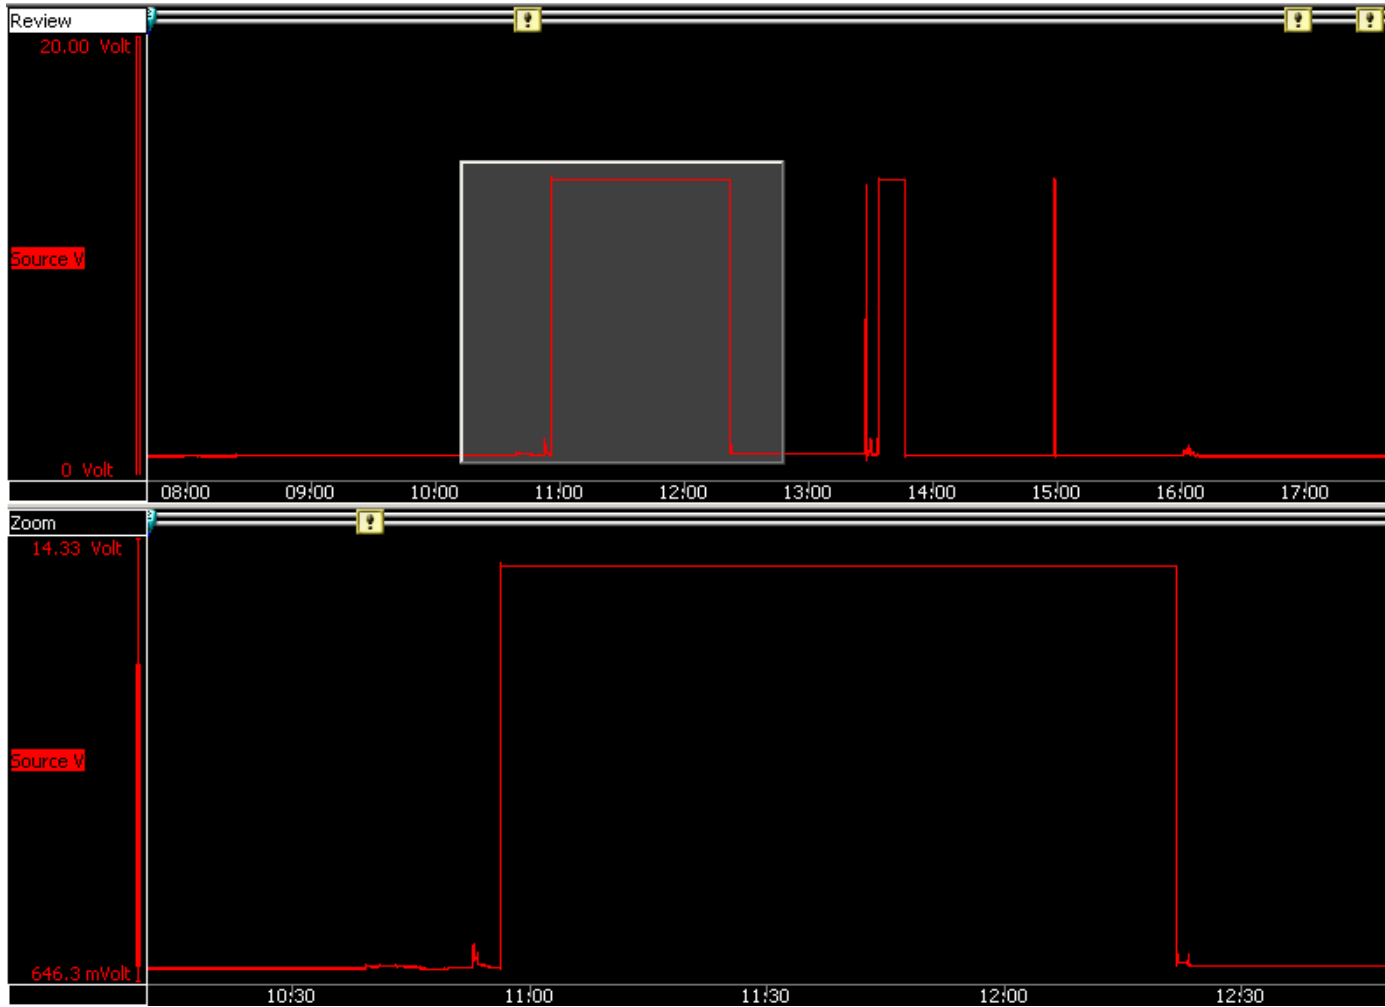
Krytox® 240 AC + moisture

Noise precursor, mostly open (required about 1
3 mils to initiate open)

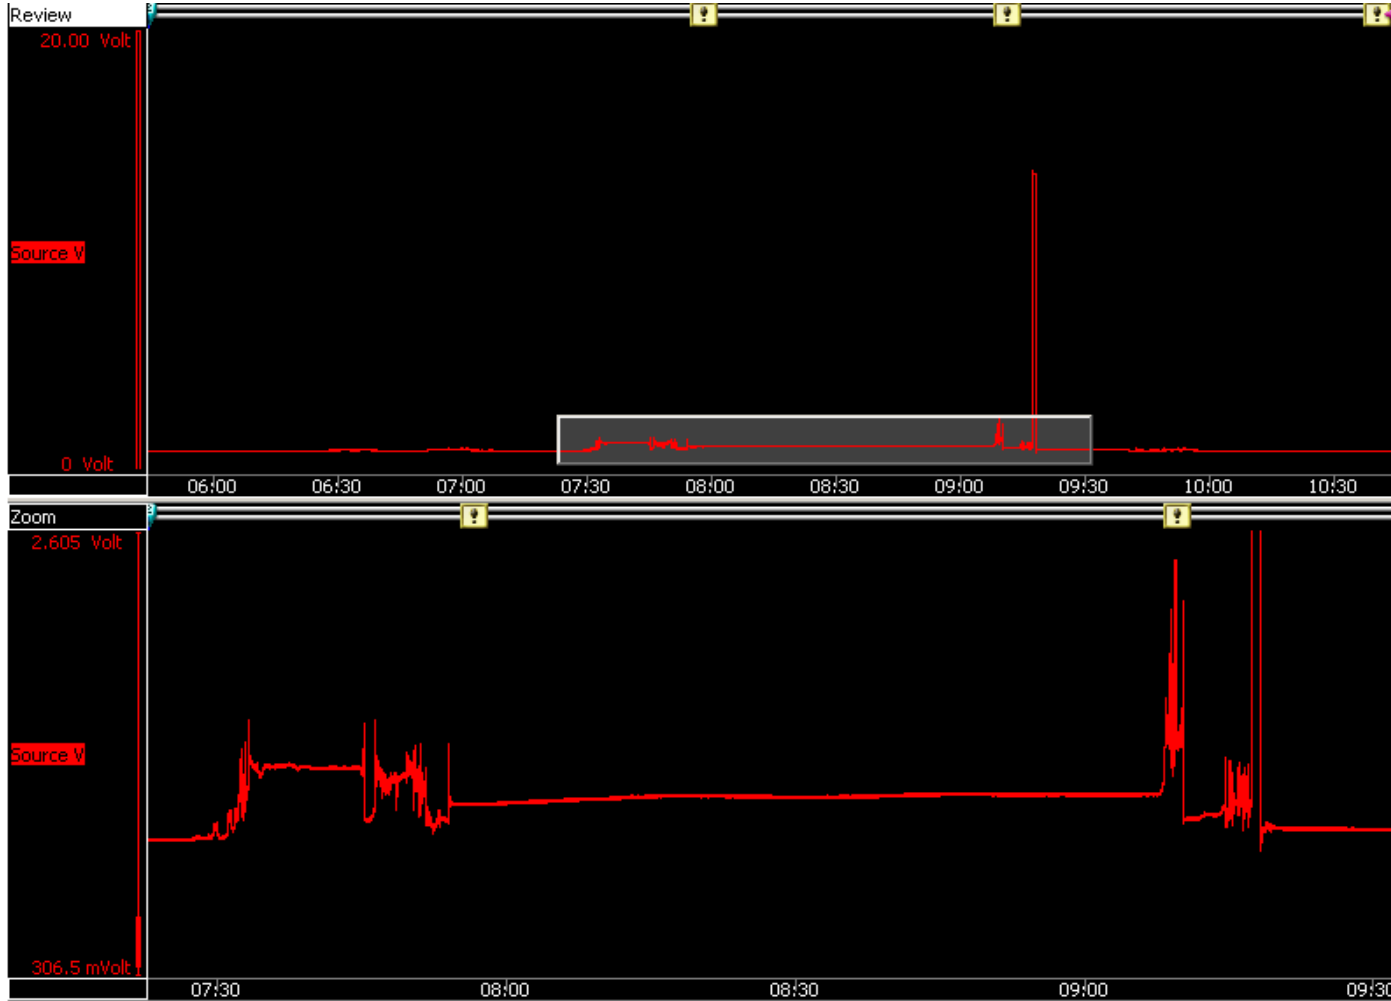
Moisture/water ONLY

Some noise, one short transient open

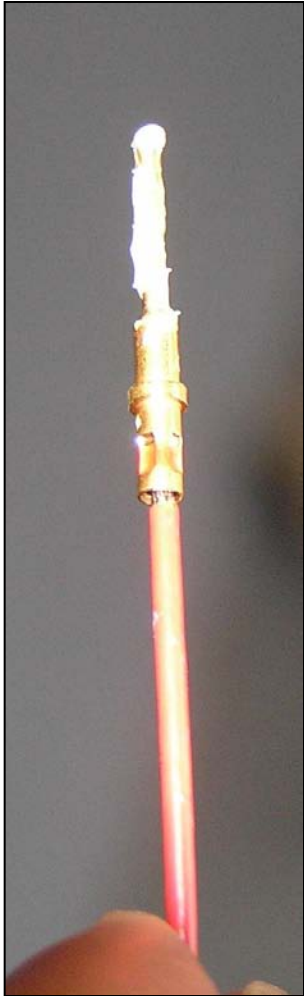
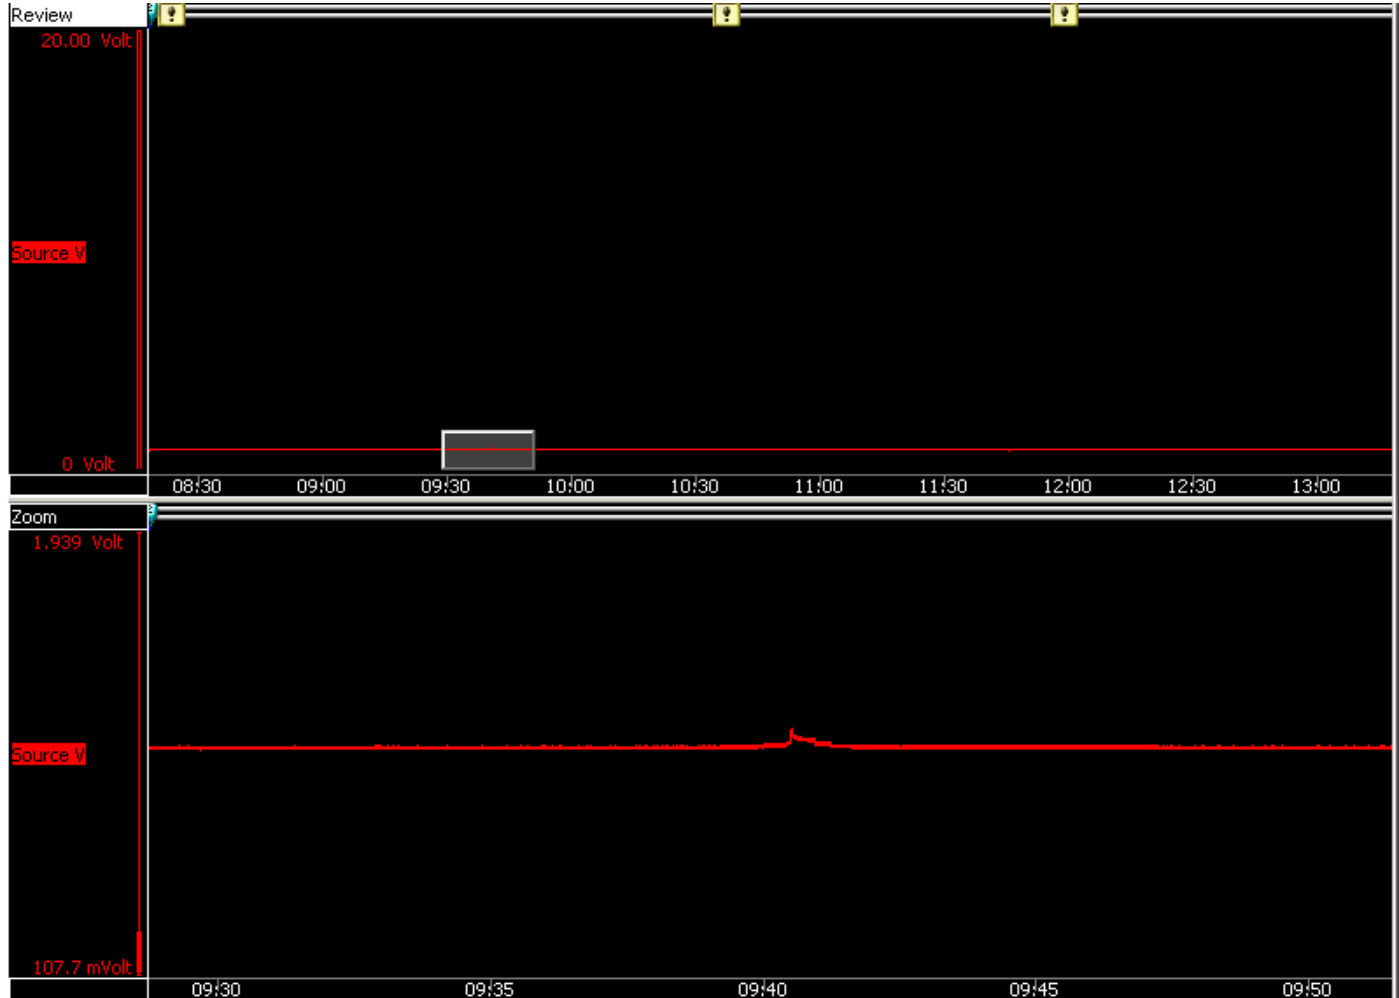
Krytox® 240 AC ONLY

No noise (1 instance of min noise), no opens

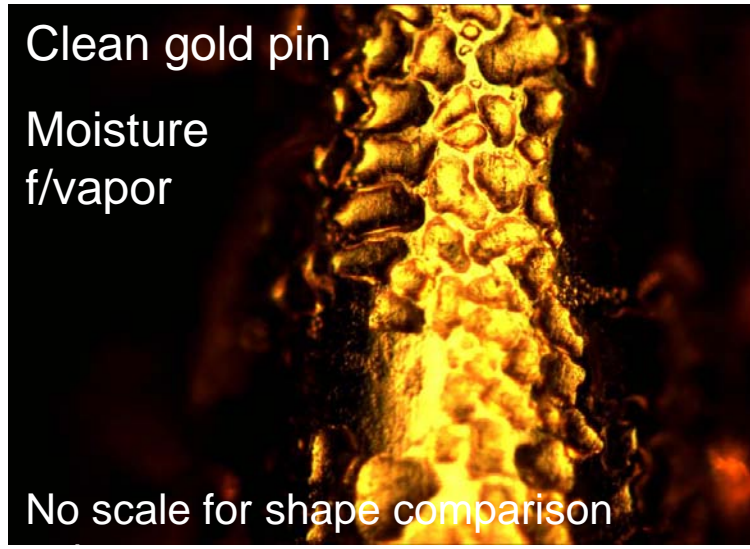
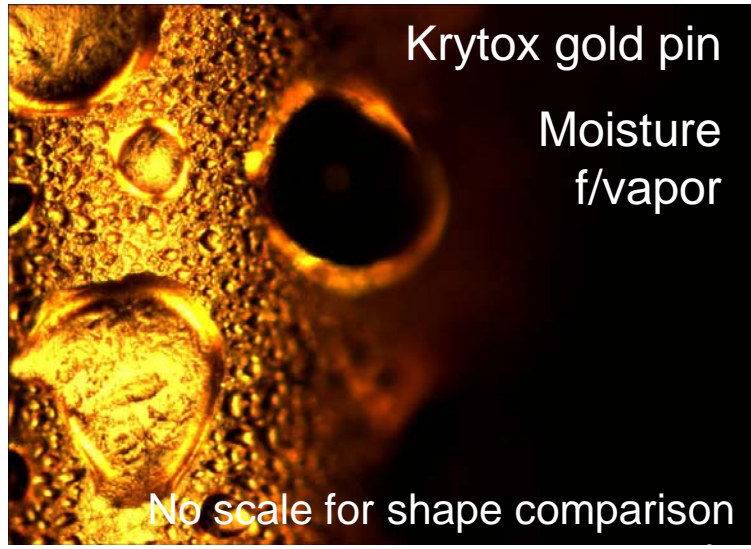
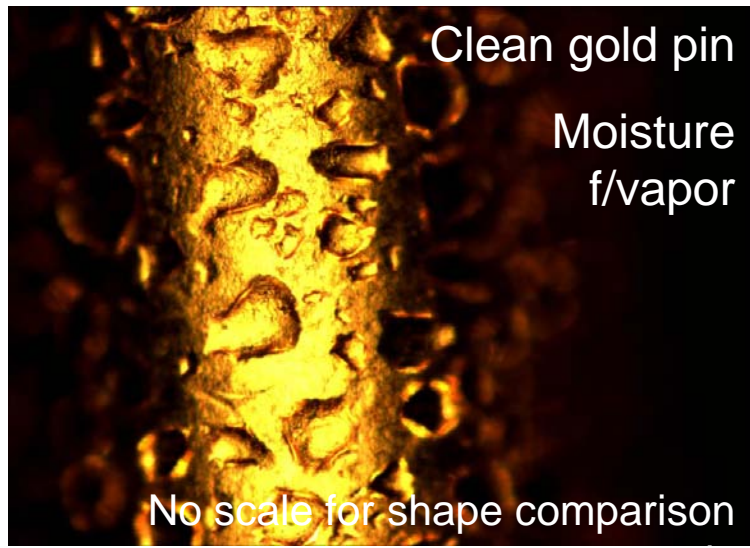
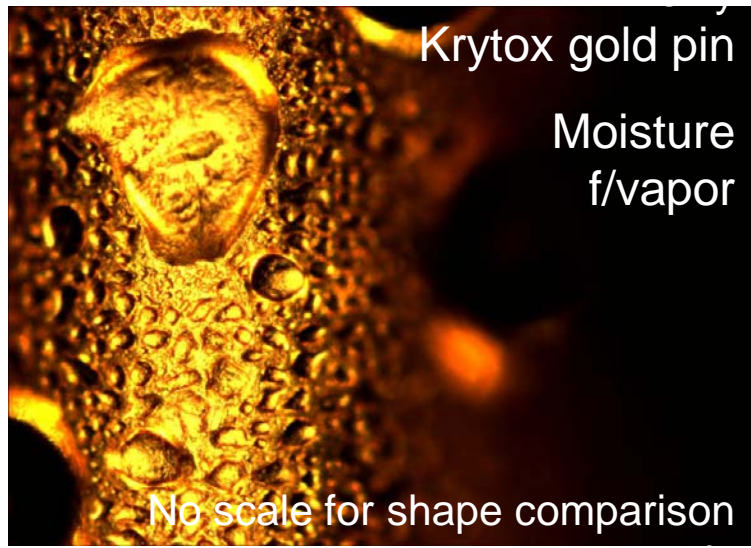
Frost formation on Krytox® 240 AC coated pin/socket after immersion in LN2 for at least 3 minutes beginning to melt.
