# Final Report

## Shearography NDE of NASA COPV

Tests Performed at NASA  
White Sands Test Facility, NM  
Sept. 12-16, 2006

Prepared By  
John W. Newman  
October 25, 2006

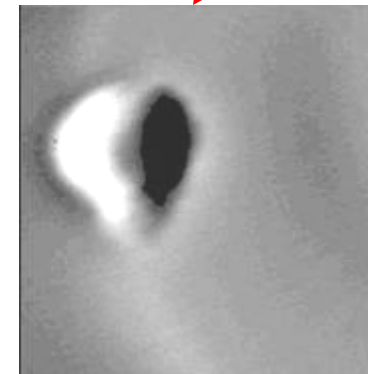
Shearography  
Impact Damage  
Indication

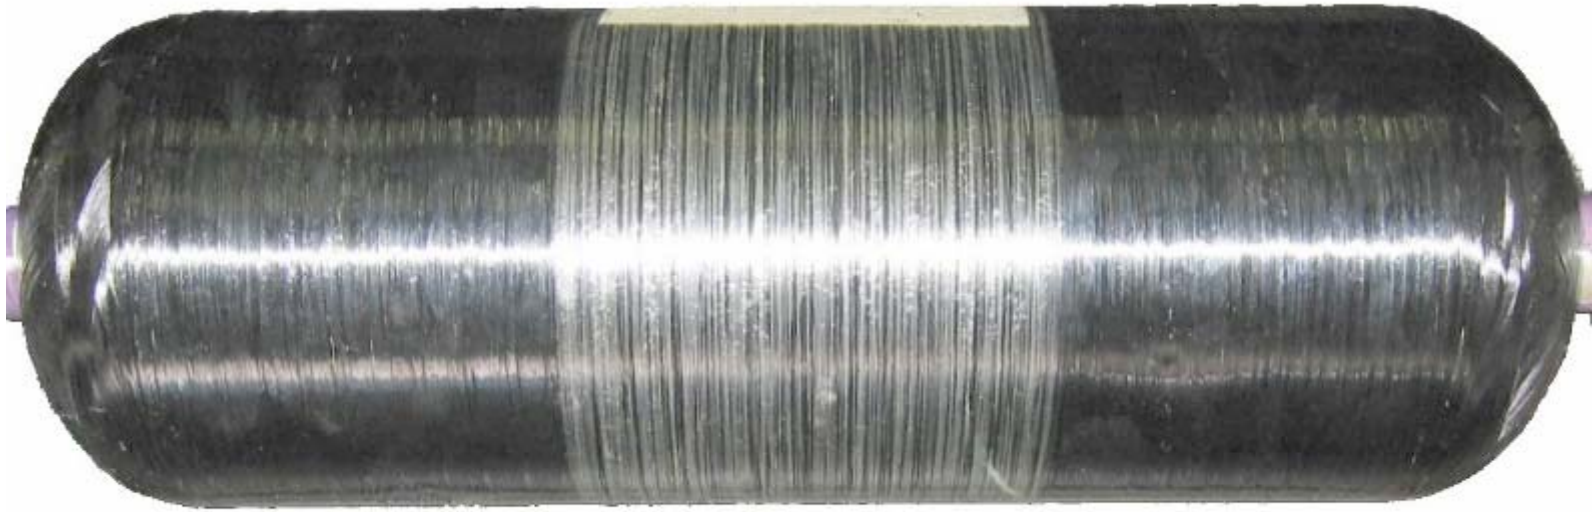
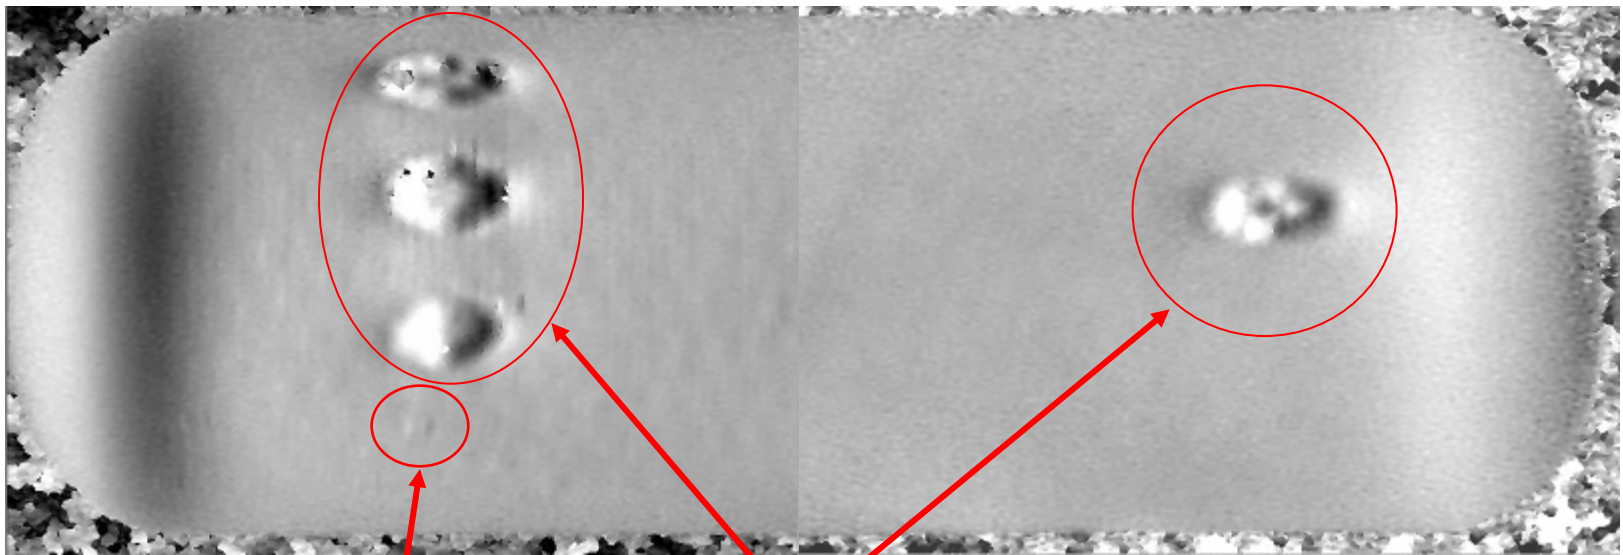
**6 x 22 Inch Graphite COPV Shearography Inspected with 10 psid.  
Three impact areas are seen and one small un-programmed defect.**

**Un-programmed Damage**

**4 Impact Sites**

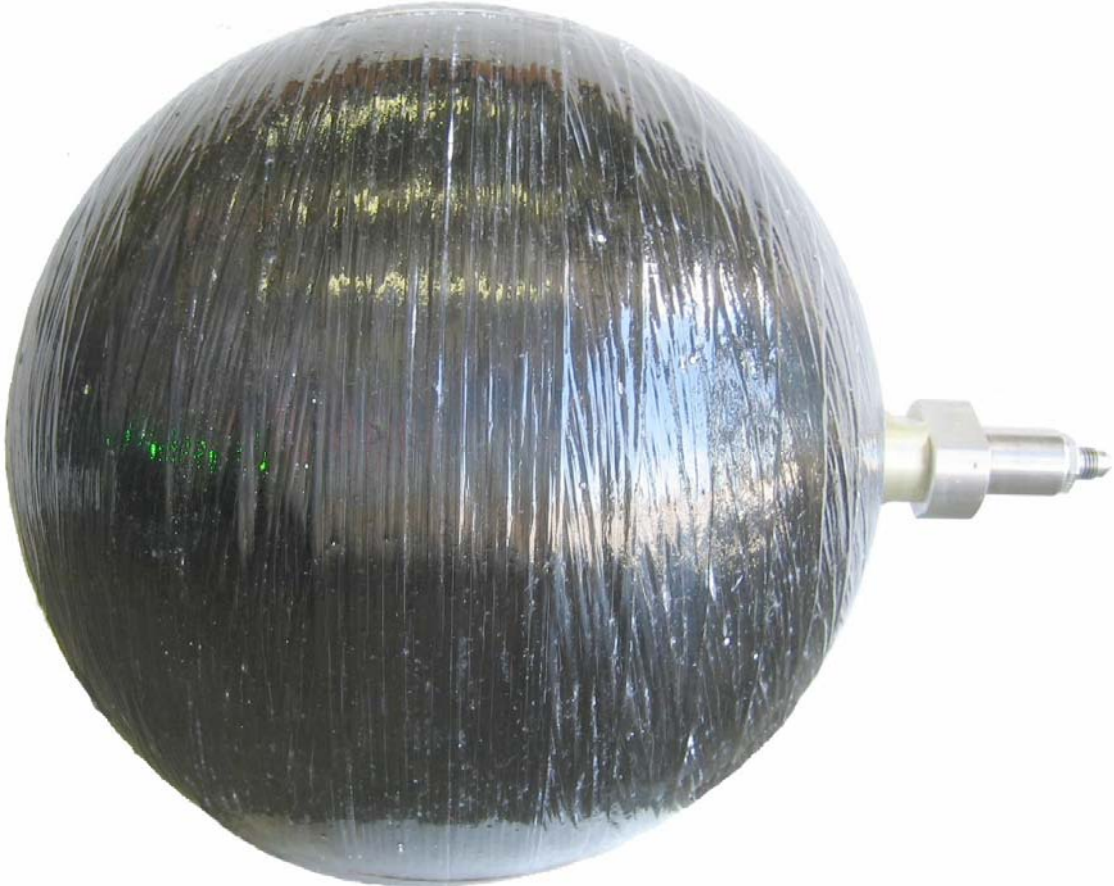
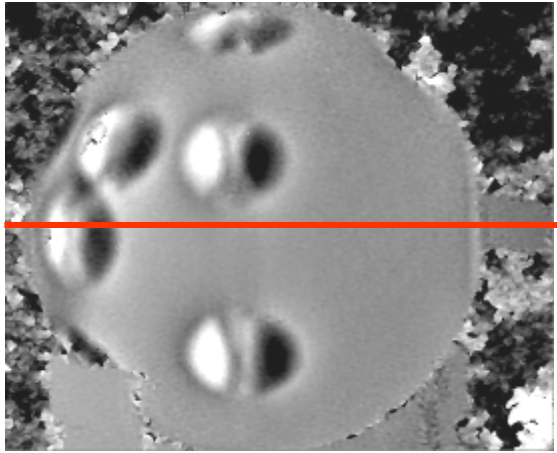
**10 Inch Diam. Carbon Fiber COPV – Typical Images  
Side View Showing Pressure Fitting  
Shearography Test, at right with  
1.2 psid, rotating 120 Degrees per test.**

**No visible damage except 0.15 inch diameter dimple at impact sites.**

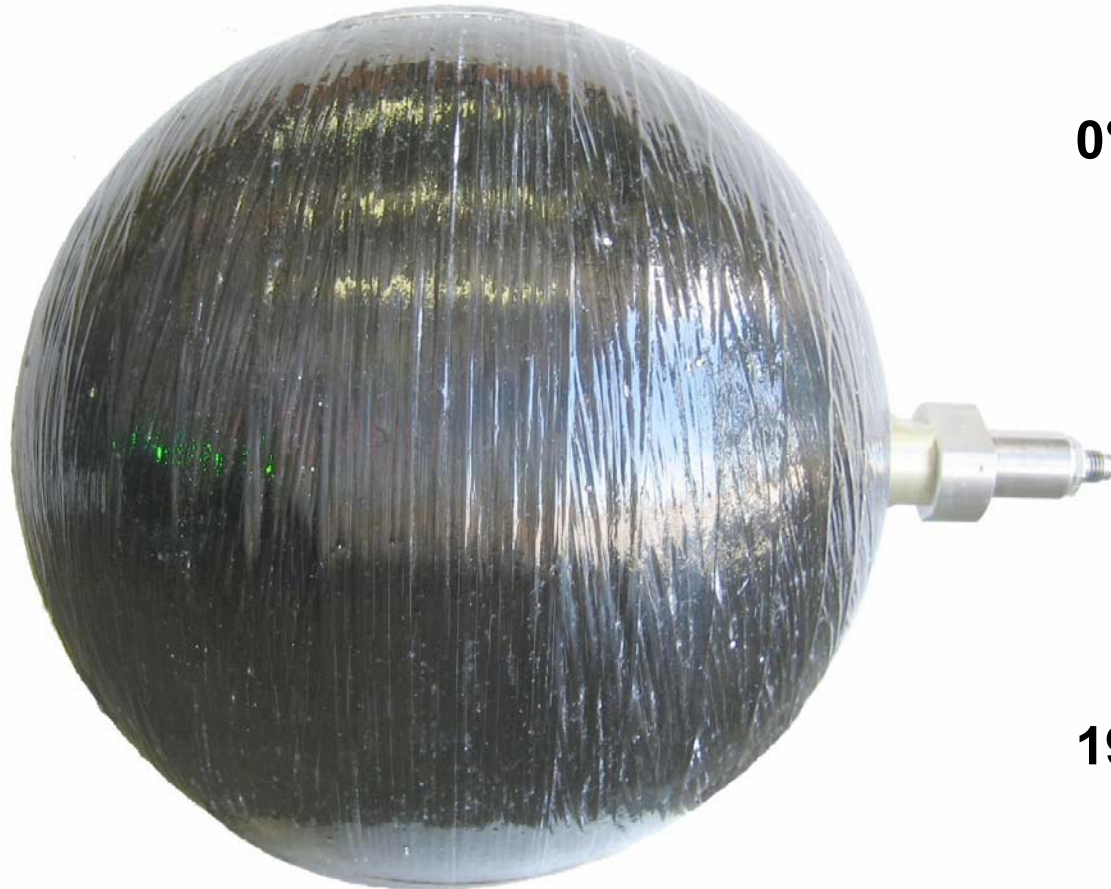
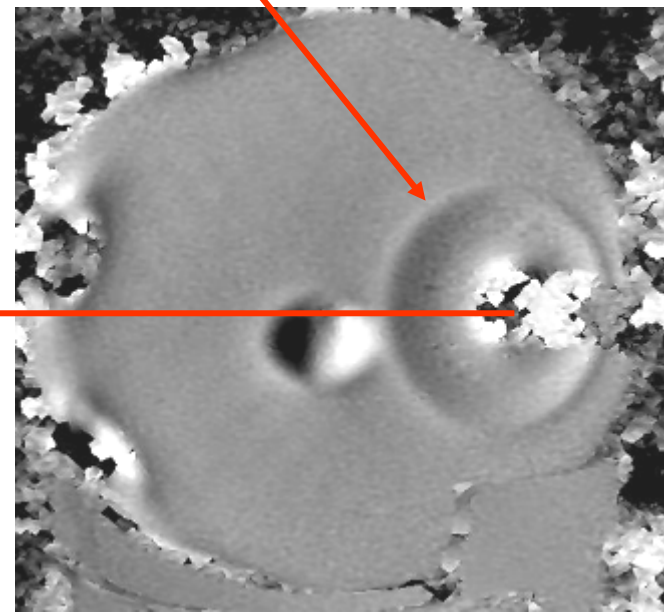
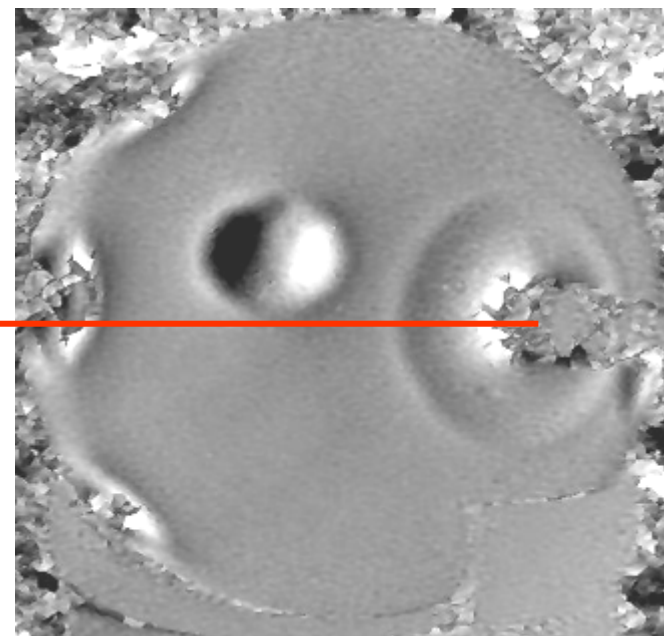
**10 Inch Diam. Carbon Fiber COPV – Typical Images** Stress Concentration Around Boss  
Side View Showing Pressure Fitting  
Shearography Test, at right with  
1.2 psid, rotating 190 Degrees per test.

No visible damage except 0.15 inch diameter dimple at impact sites.

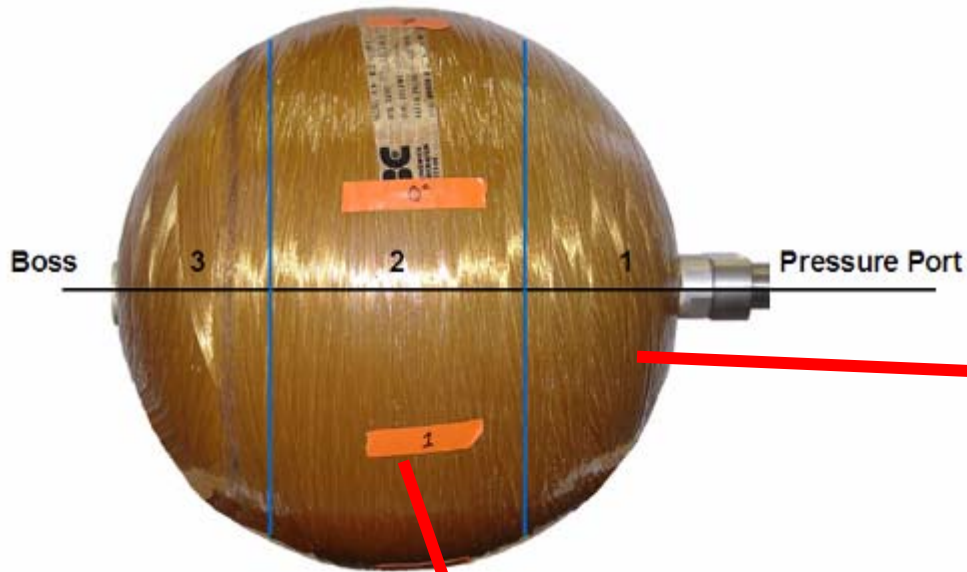
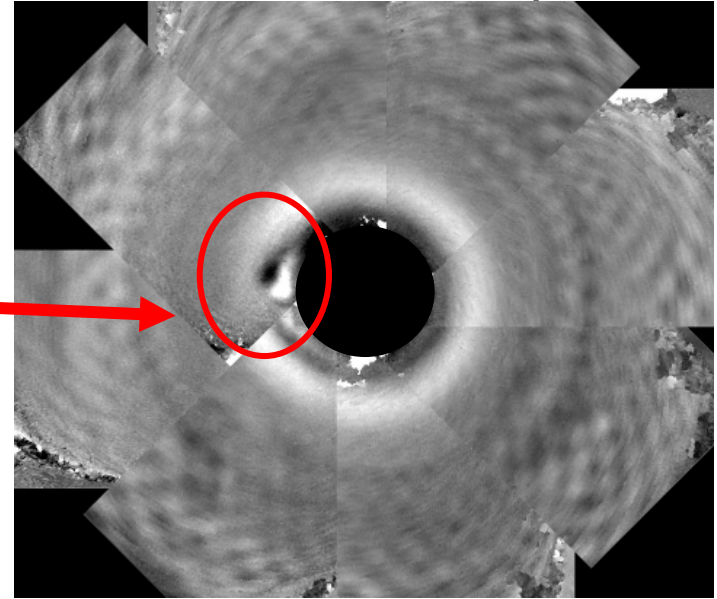
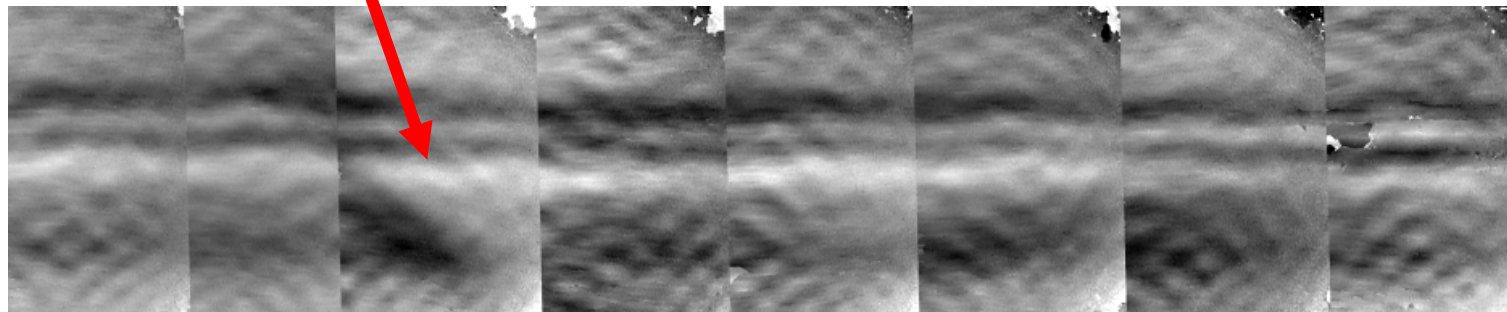
Shearography scan Band 1. The pressure port boss is in the center, a stress riser (circled) due to a defect or fiber closure pattern.

Shearography Scan of Band 2 at the equator showing the Strain concentration over the circumferential liner girth weld.

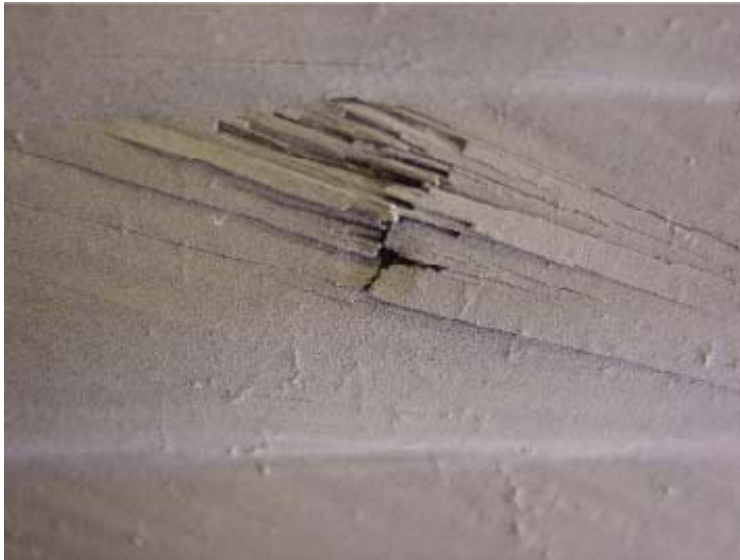
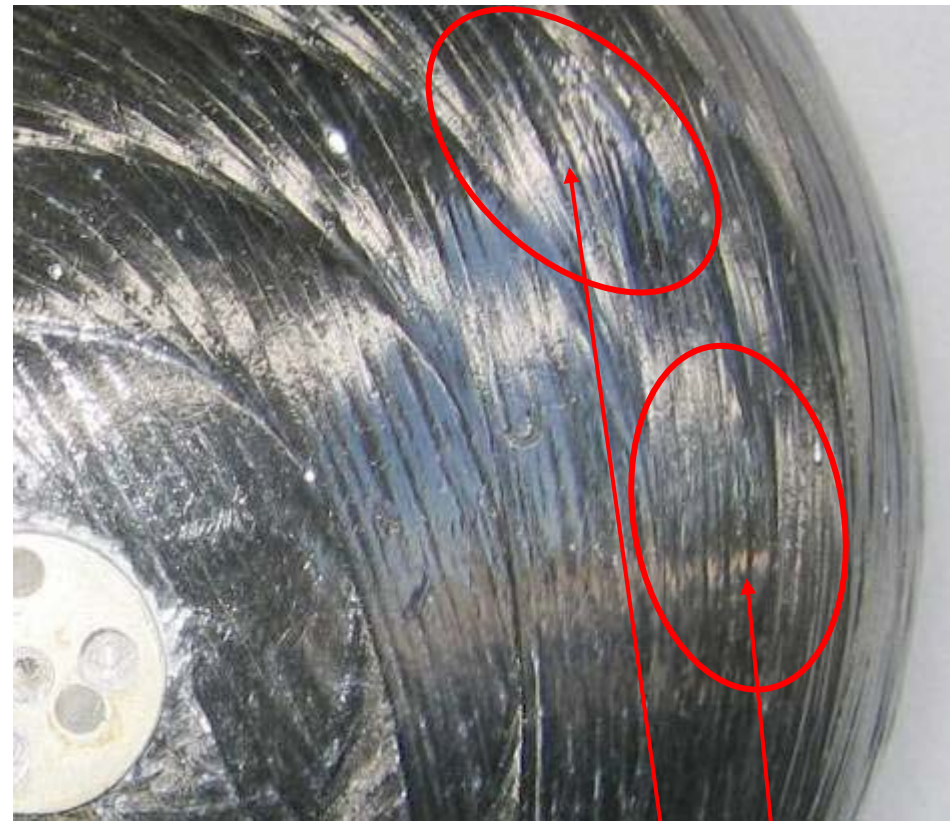
**Visual impact damage for the graphite COPV ranged from severe fracture seen below, enhanced with dye penetrant coating, to little or no discernable damage beyond the very small, 0.1-0.2 inch impact sites seen on 10 ¼ inch COPV at right.**

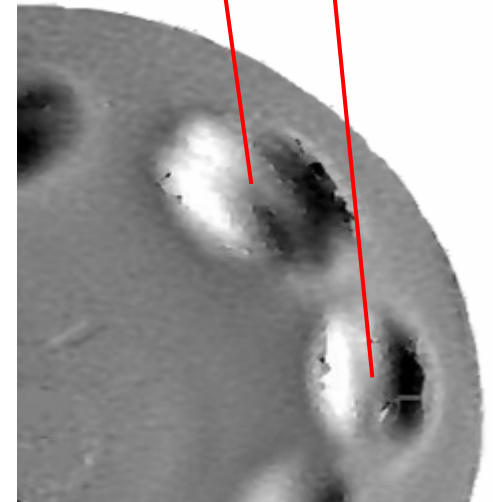
**Shearography image of area on the 10 ¼ inch COPV above.**

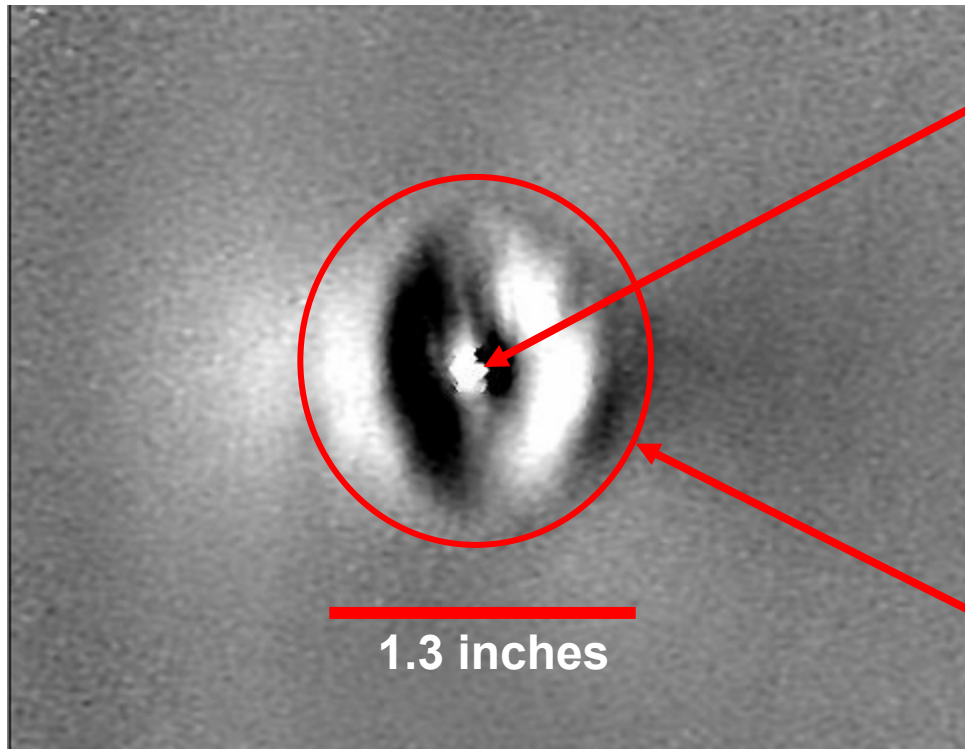
**Impact Site for intentional Defects are seen visually as dimple, fiber breakage and/or color change.**

**Visual indication of composite damage ranged from severe fracturing at area around impact site to a small crack or dimple, to no visual indication.**

**Shearography indications seen in graphite COPV ranged from 0.2 to 4 inches in diameter.**

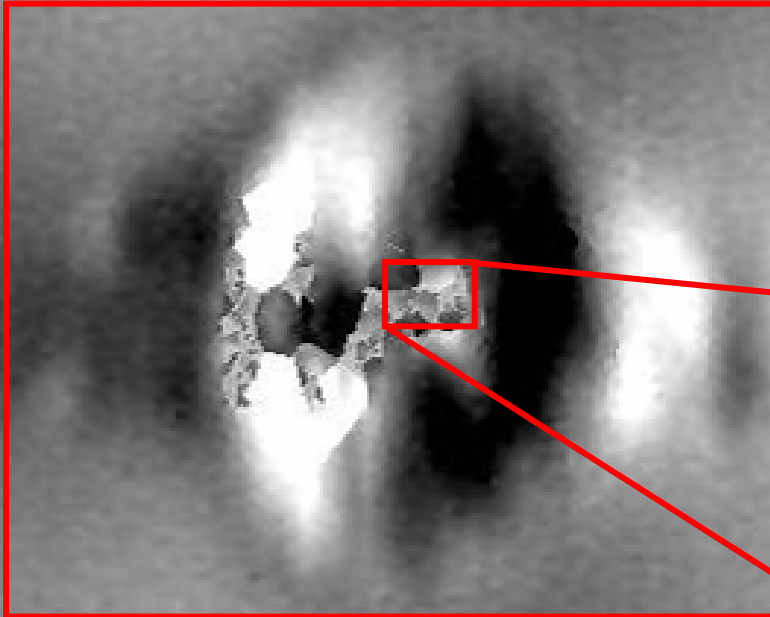
Shearography Damage Indication  
Measures 4.1 inches

Comparison Between The  
Measured Shearography  
Damage Dimensions and  
Visual Damage of 50 Ft-Lb  
Impact @ 180°, 10 Inches  
from Forward Boss

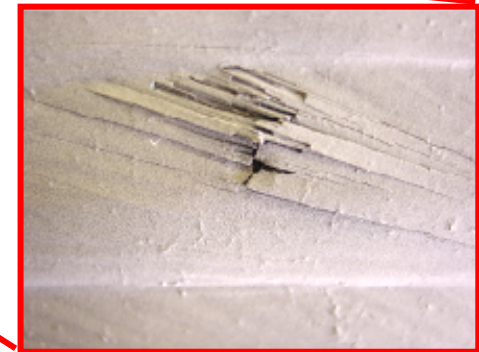
Visual Damage  
Measured 0.5 in.

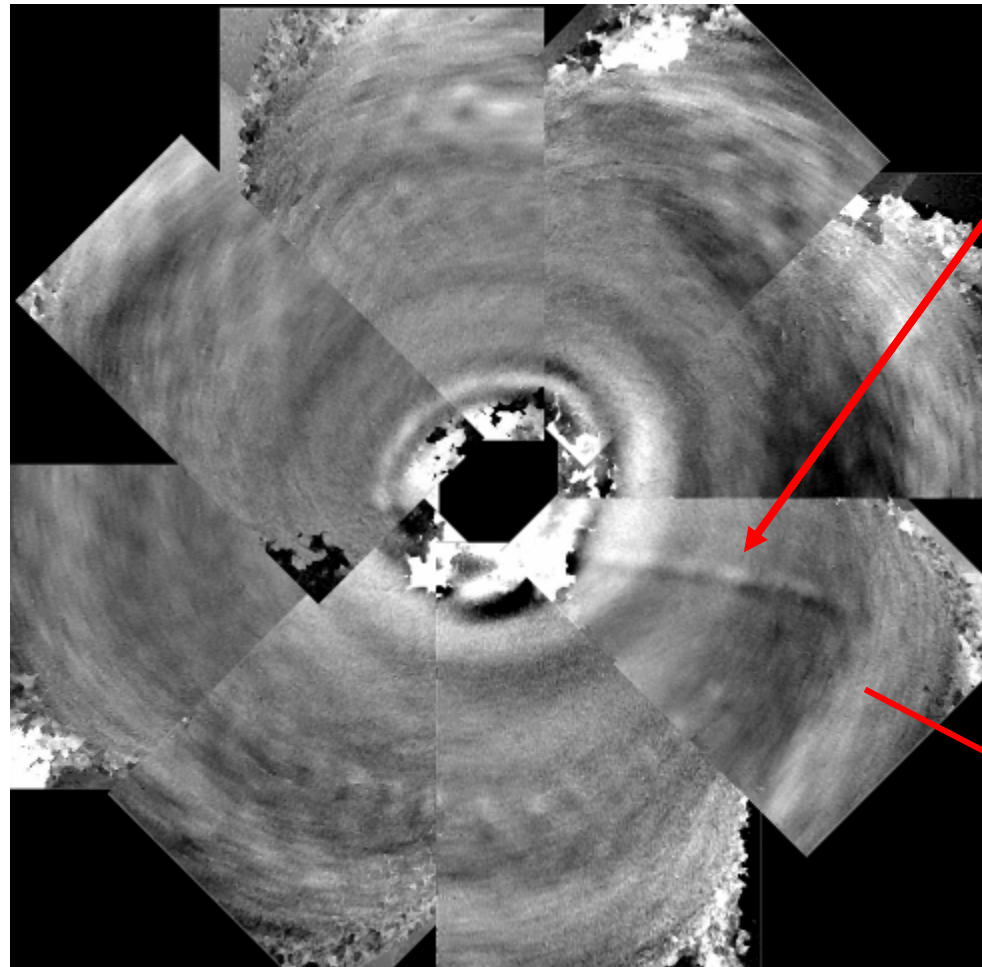
Normal Stress  
Concentration  
Due to Closure  
Pattern at Boss

**Results:  
No Anomaly  
Indications  
Detected**

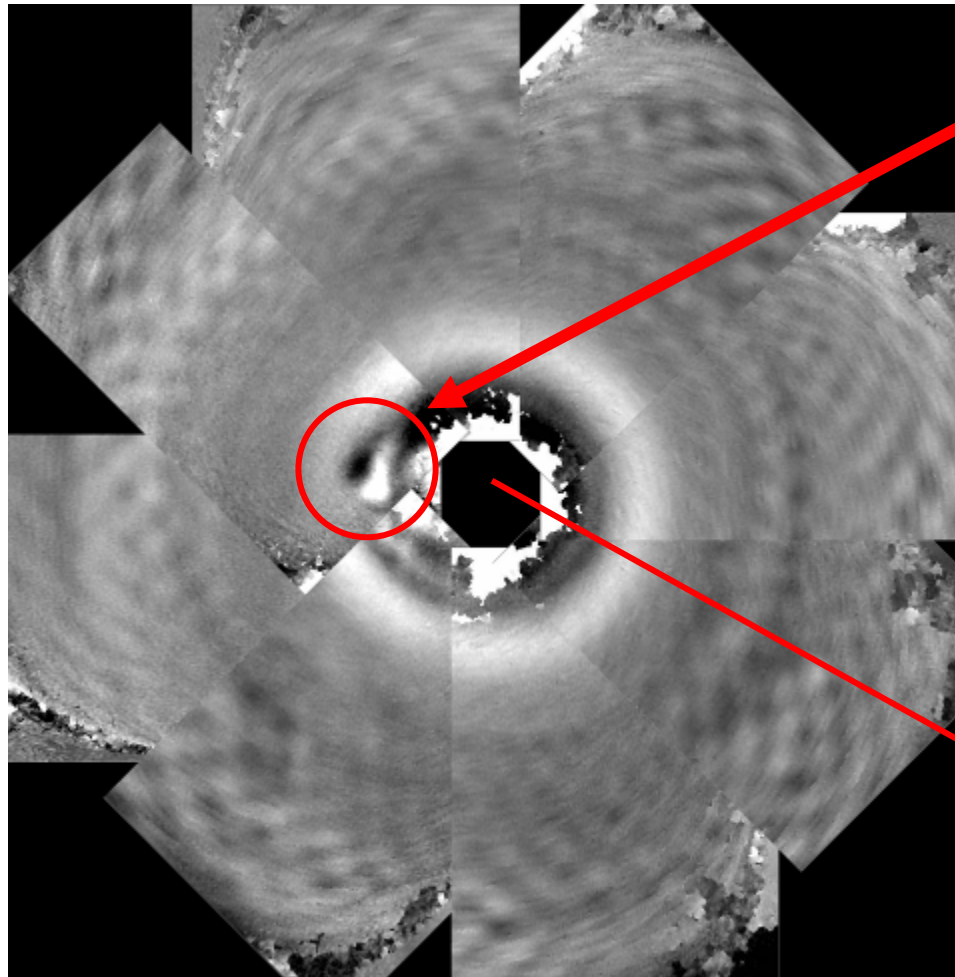
**Results:  
Anomaly  
Indications  
Detected.  
Unusually  
High Stress  
Concentration  
At Pressure  
Port Boss**

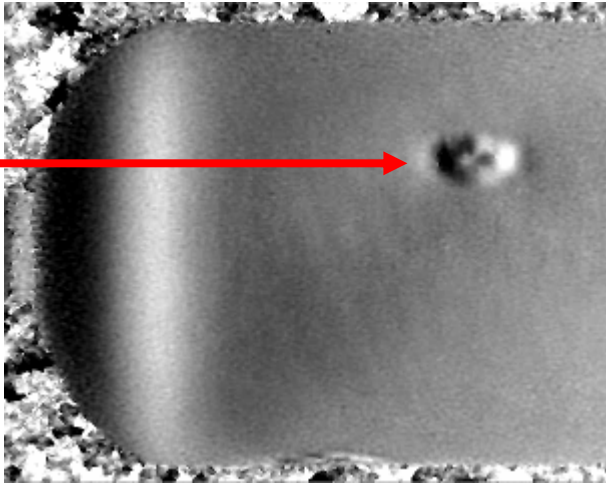
250° x 14.1°  
Damage  
.9x1.5 in.

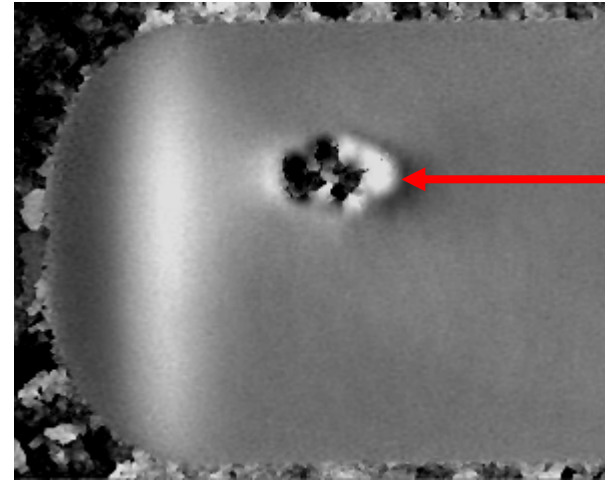
145° x 16.0°  
Damage  
1.3 x 2.2 inch

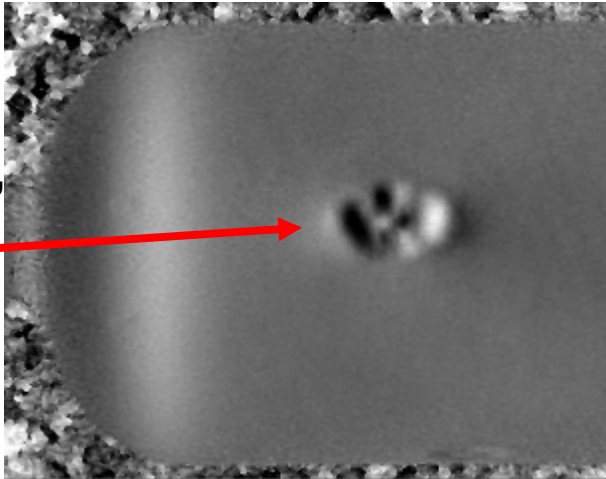
320° x 15.25°  
Damage  
1.1 x 2.0 inch

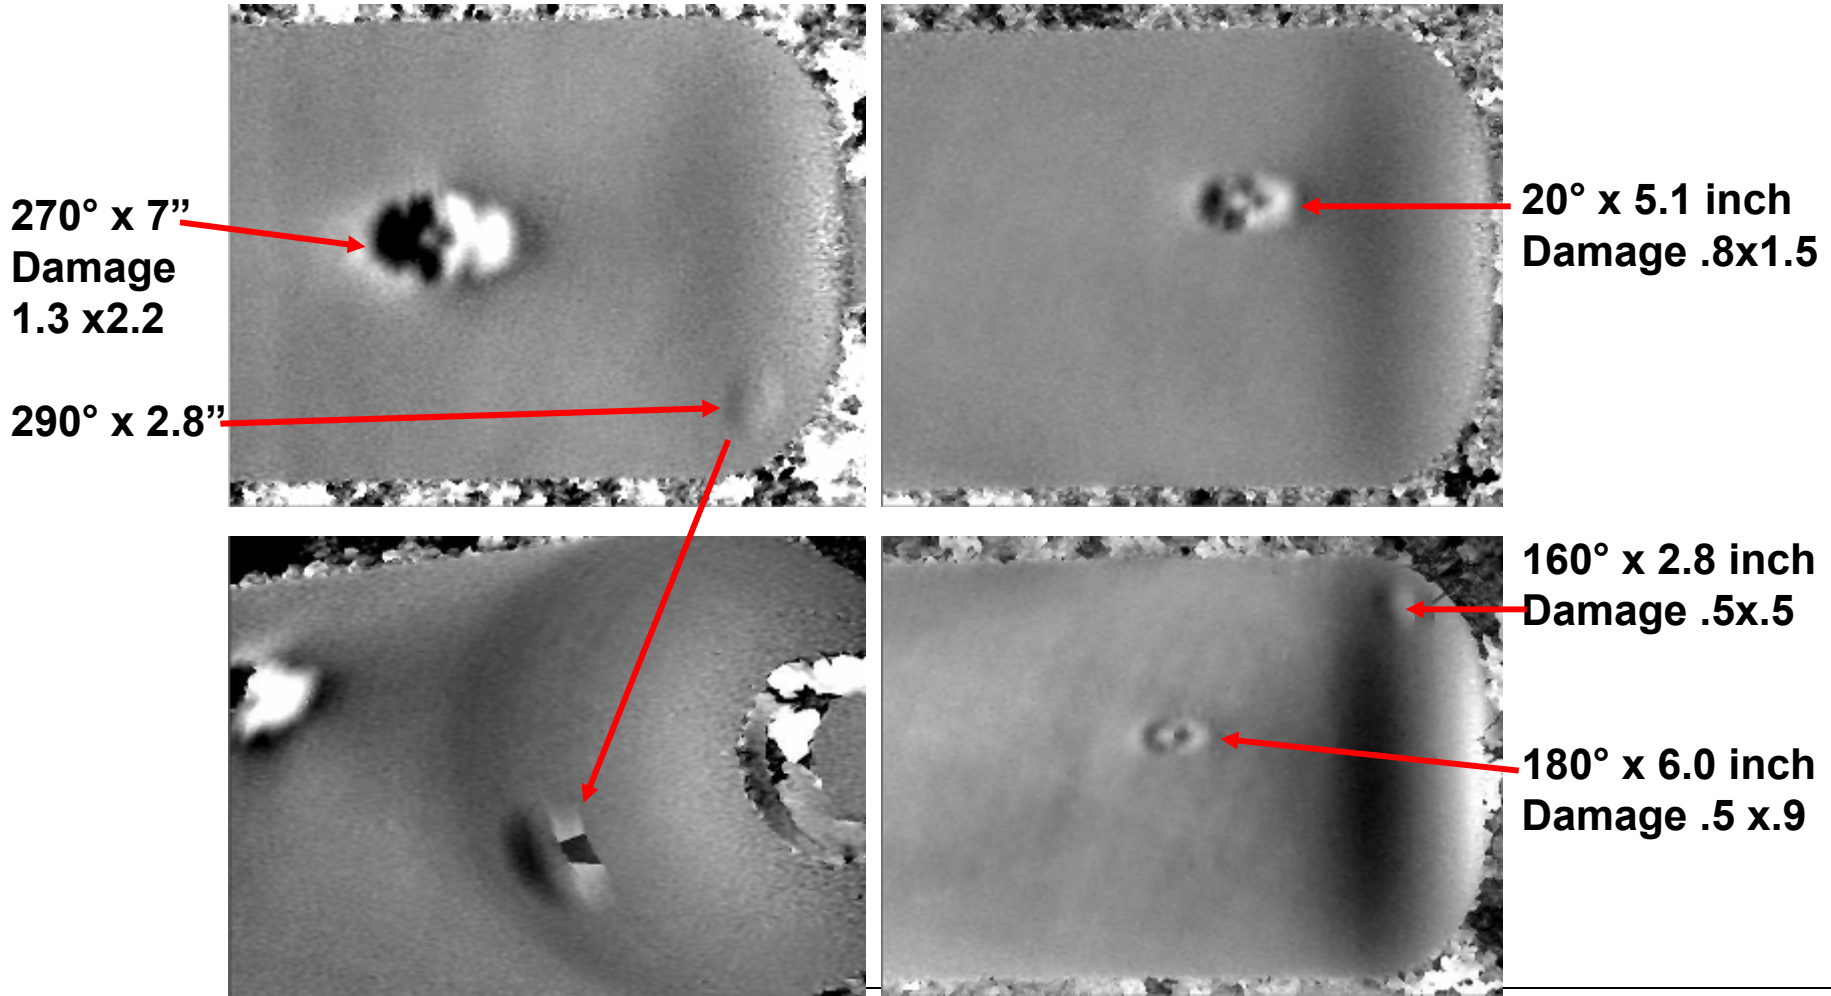
**Note: Indications at 160°, and 290° are not listed on the VT Score Card provided.**

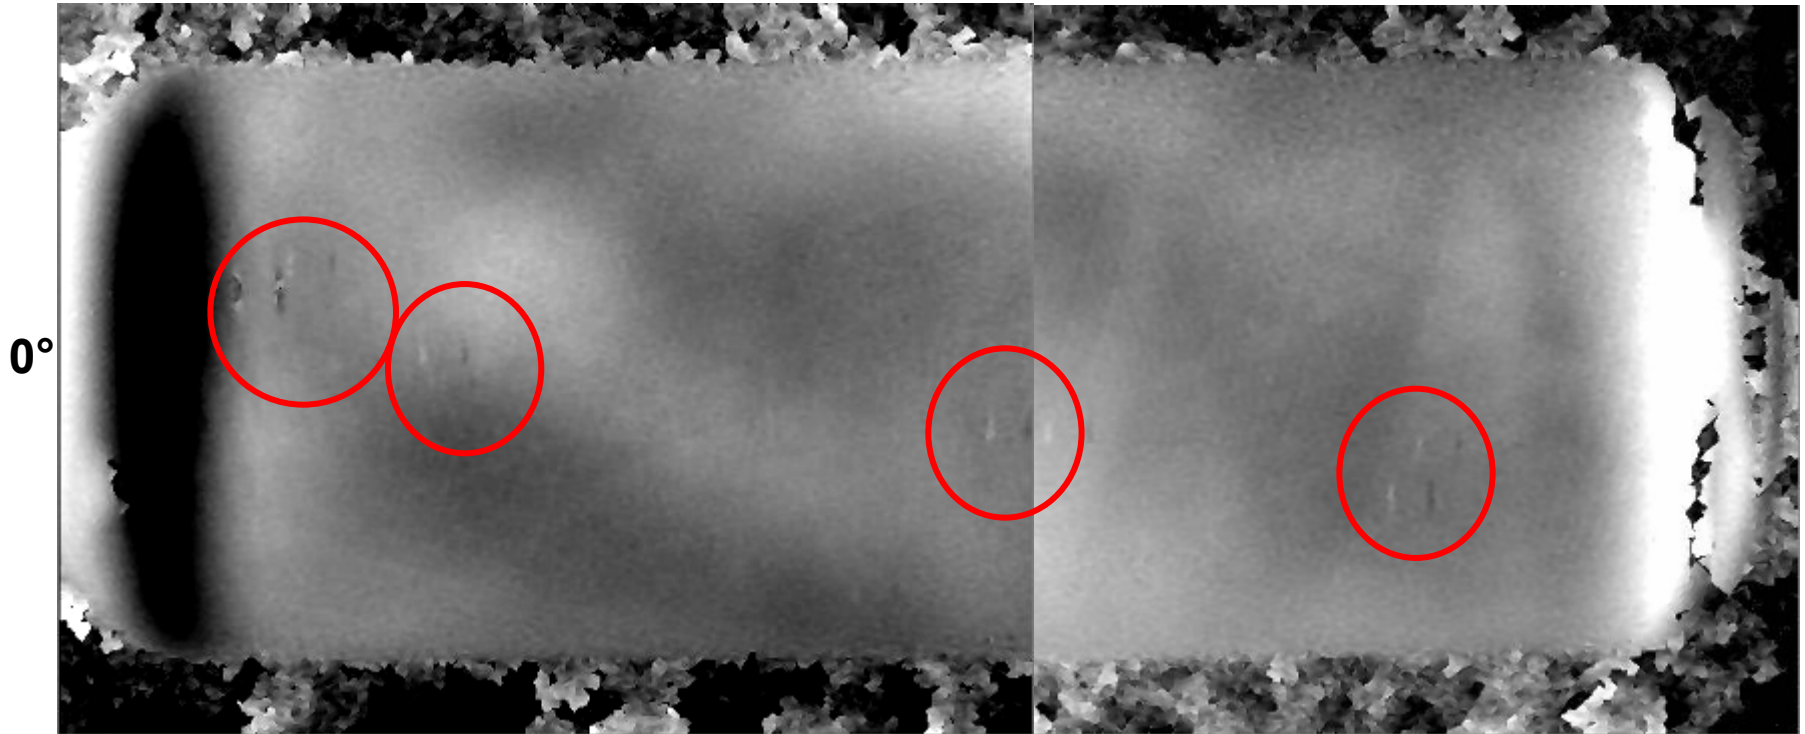
Circled areas are small cracks due to impact.

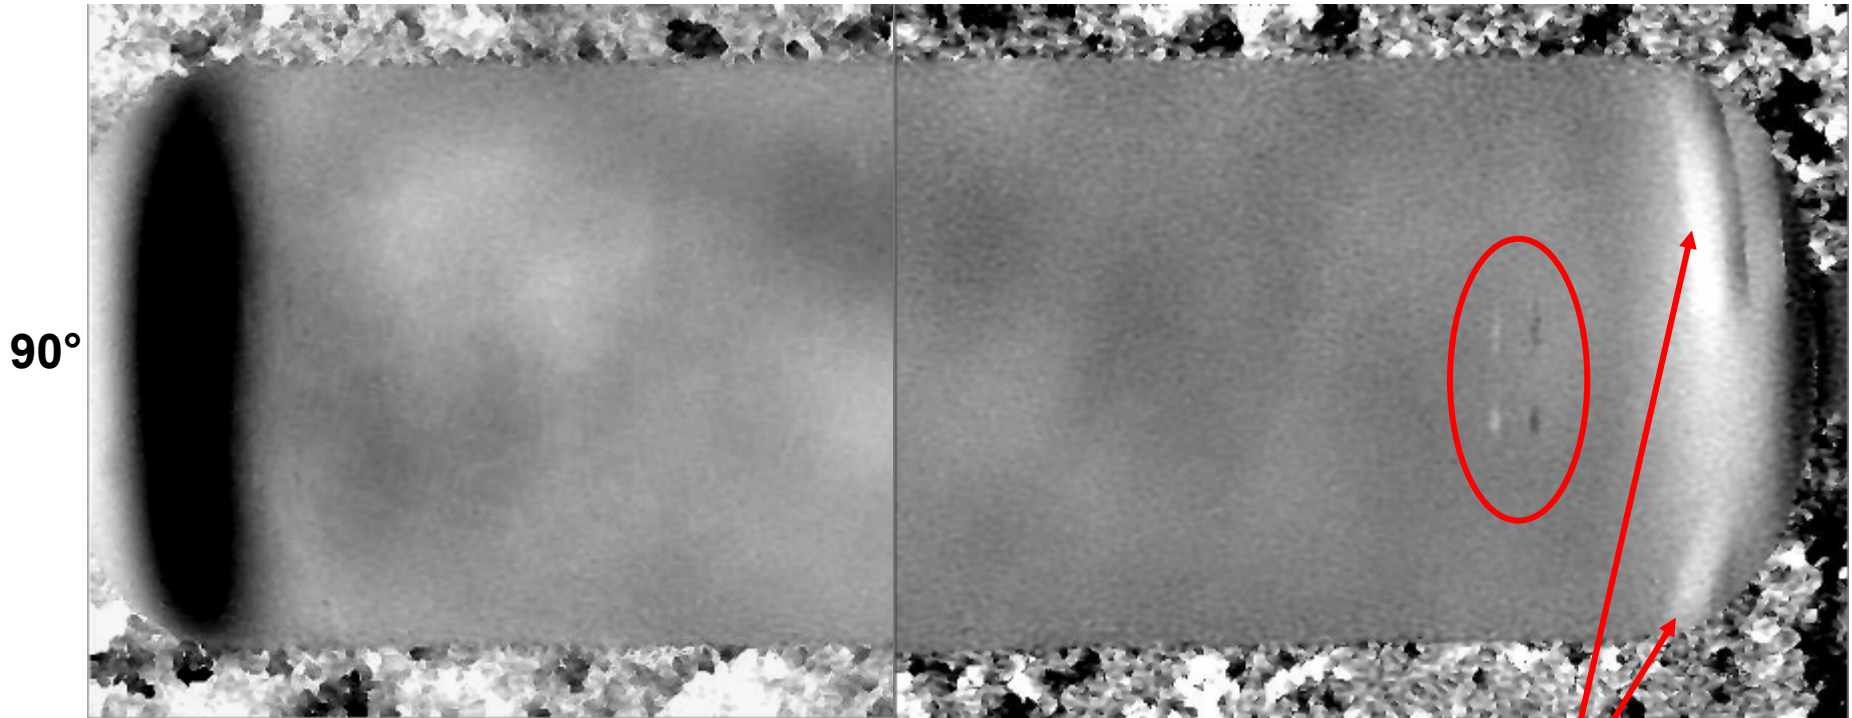
**Bridging Delaminations  
at base of dome end.**

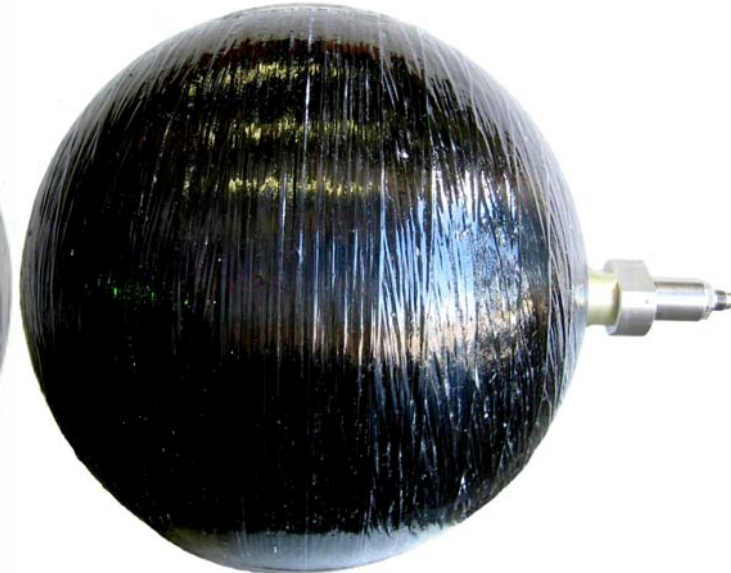
**Note: Due to the large number of damaged areas and limited time, images were recorded but no dimensions are provided, nor correlation with VT.**
