NASA/TM-2011-217318  
NESC-RP-10-00680

# Space Transportation System (STS)-133/ External Tank (ET)-137 Intertank (IT) Stringer Cracking Issue and Repair Assessment: Proximate Cause Determination and Material Characterization Study

*Robert S. Piascik/NESC  
Langley Research Center, Hampton, Virginia*

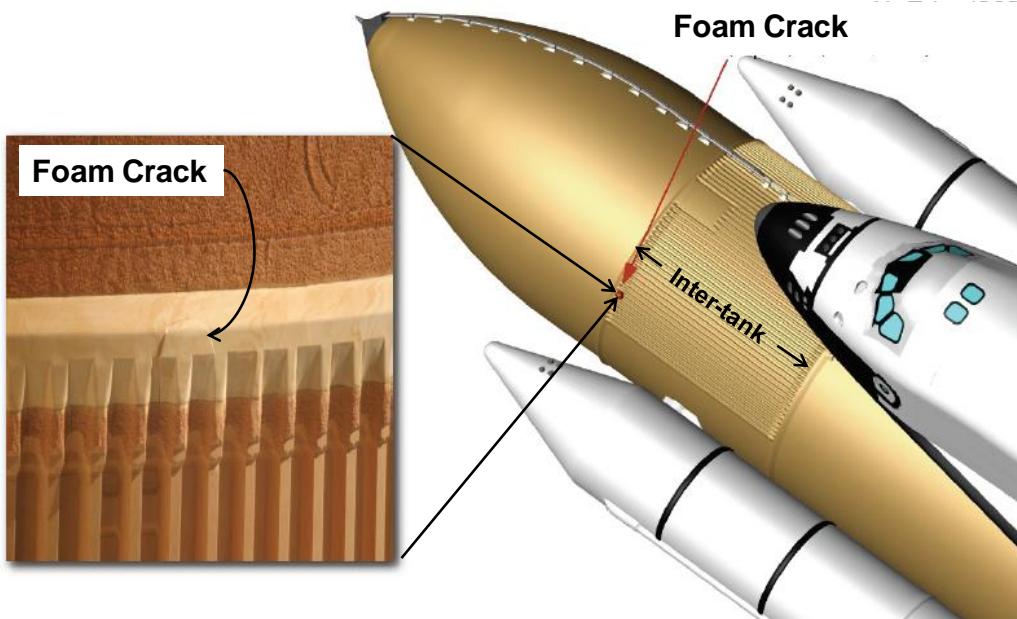
Following the launch scrub of STS-133 on November 5, 2010, a foam crack was observed on the ET adjacent to the IT-to-liquid oxygen (LO<sub>2</sub>) tank flange (Figure 5.0-1). Subsequent imagery analysis determined the foam crack occurred during the ET propellant fill when the LO<sub>2</sub> level was at this location. Non-destructive evaluation and foam removal revealed axial cracking in five Al-Li 2090-T83 stringers (Figure 5.0-2). Two cracked stringers, S6 and S7, were on Panel 2, and three cracked stringers, S6, S7, and S11, were on Panel 6 (Figure 5.0-3). The cracks were in the stringer “foot” near the radius transition. The crack lengths ranged from approximately 4 to 9 inches, with the longest crack allowing sufficient radial displacement during the cryogenic propellant fill to exceed the foam tensile strength.

*Figure 5.0-1. Location of the ET IT Cracked Foam [ref. 1]*

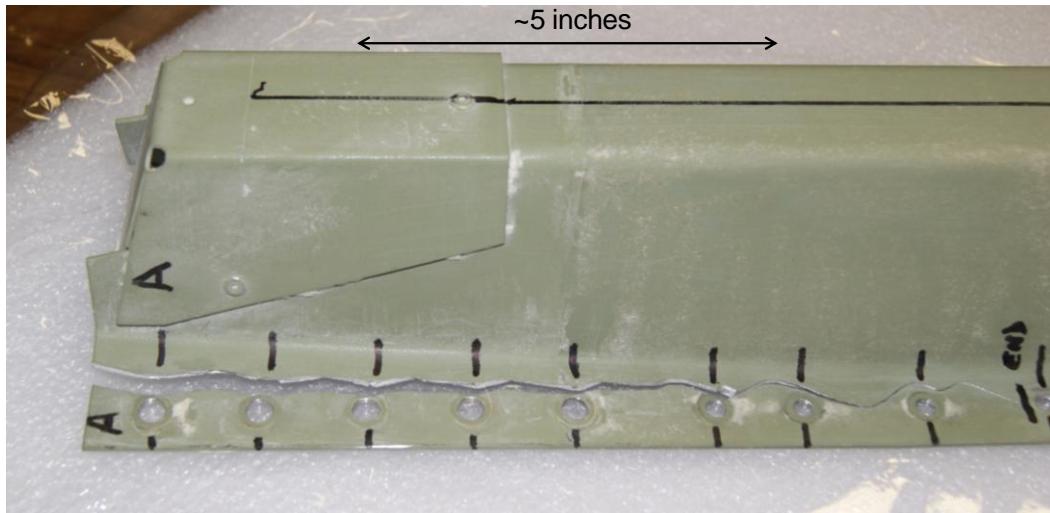
*Figure 5.0-2. Panel 2, S7 Cracked Stringer (LO<sub>2</sub>flange end) after IT Removal*

- Crack growth was along the rolling direction (axial).
- Multiple thumbnail cracks nucleated on the stringer bottom surface, away from the end of the stringer, and propagated through the thickness.
- No indications of pre-existing defects at the region of crack nucleation or along the crack path.
- The crack path relative to the fastener clamping and IT construction suggests a complex stress state consistent with the expected mixture of bending and shear stresses during cryogenic tanking.

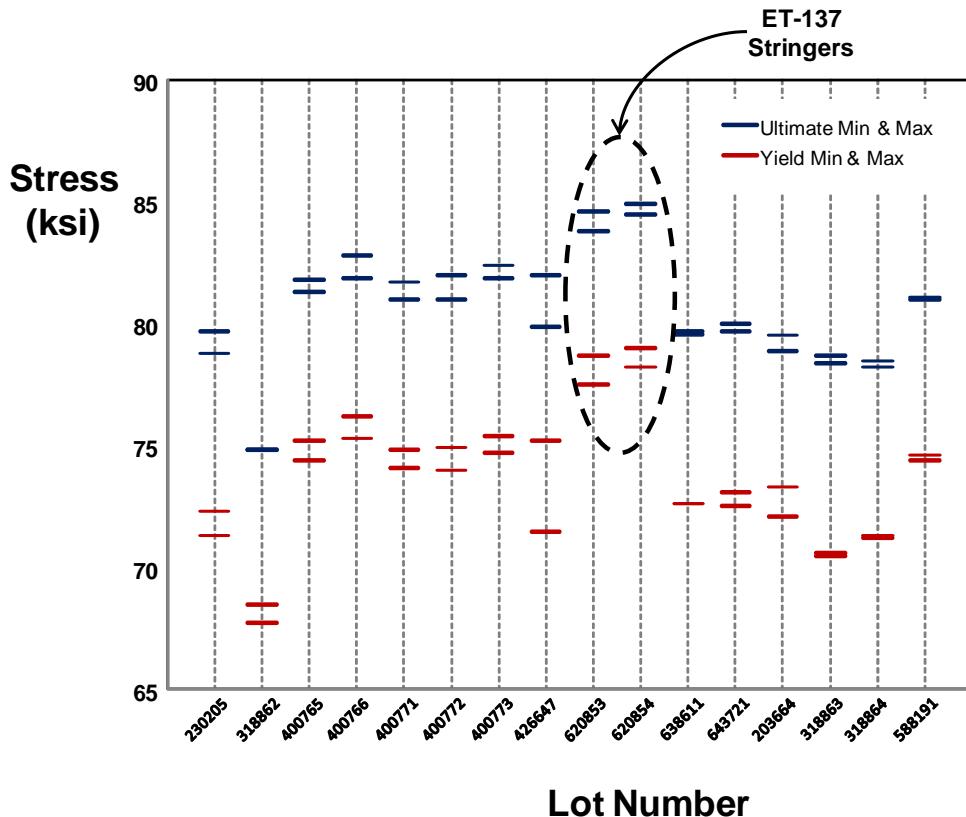
The 2090 Al-Li alloy used to manufacture the stringers was obtained in sheet (coil) T3 product form. Each coil was identified by a unique lot number. The material exhibited a nominal thickness of about 0.064 inches and a width of about 8.5 inches. Prior to incoming receipt lot acceptance, tensile coupons were extracted from each lot and aged using the nominal peak aging process (T8 condition of 25 hours at 325°F) and tensile tests were conducted to certify that the yield stress, ultimate stress, and elongation minimums could be achieved after peak aging. A plot of lot acceptance test data is shown in Figure 5.0-4. The plot shows the lot-to-lot and within-lot tensile property variation. Note that the yield and ultimate stress data for the lots used to fabricate most of the ET-137 stringers (lots 620853 and 620854) are greater than the measured values for the other lots.

**Figure 5.0-4. Lot-to-Lot and Within-Lot Variation in Yield Stress and Ultimate Stress for 2090 Al-Li Lots Aged to the T8 Condition and Tested in the Long-Transverse Orientation [ref. 3]**

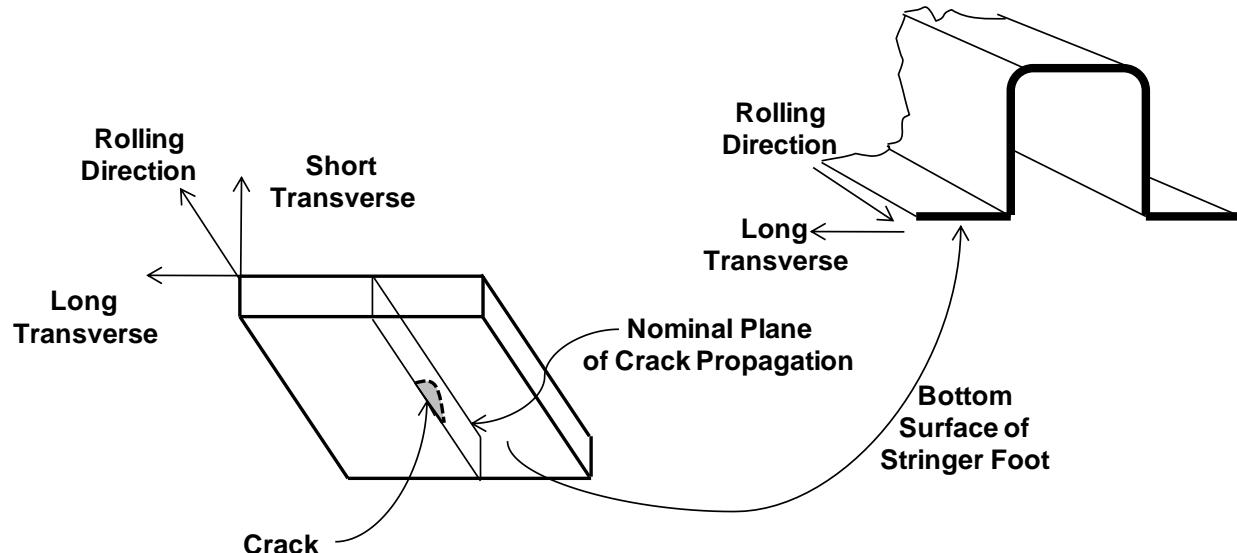
The failure analysis of the ET-137 cracked stringers indicated that the cracks initiated on the side of the stringer flange that mated with the IT skin, as illustrated in Figure 5.0-7. This region is subjected to a complex combination of tensile and bending loading due to the installation process, material processing, and the cryogenic thermal loading. Given the complex loading, material anisotropy must be considered. Alloy 2090 rolled products are known to have dramatically reduced mechanical properties in specific directions relative to the rolling direction, especially in thin sheet material. Short transverse and longitudinal (long transverse) properties are important for the initial stages of stringer crack propagation and later stages of through-the-thickness cracking, respectively. The observations of the complex loading, crack path, material anisotropy, and the lack of publically available data for these variables led to the development of unique test methods in an attempt to understand the complex failure mode. Furthermore, the limited cross-sectional size of the stringer and the localized hot forming area preclude the generation of American Society for Testing and Materials (ASTM) standard size test coupons in the required orientation. This required additional testing to validate sub-sized specimen data.

**Figure 5.0-7. Schematic of Crack Location and Nominal Plane of Propagation**

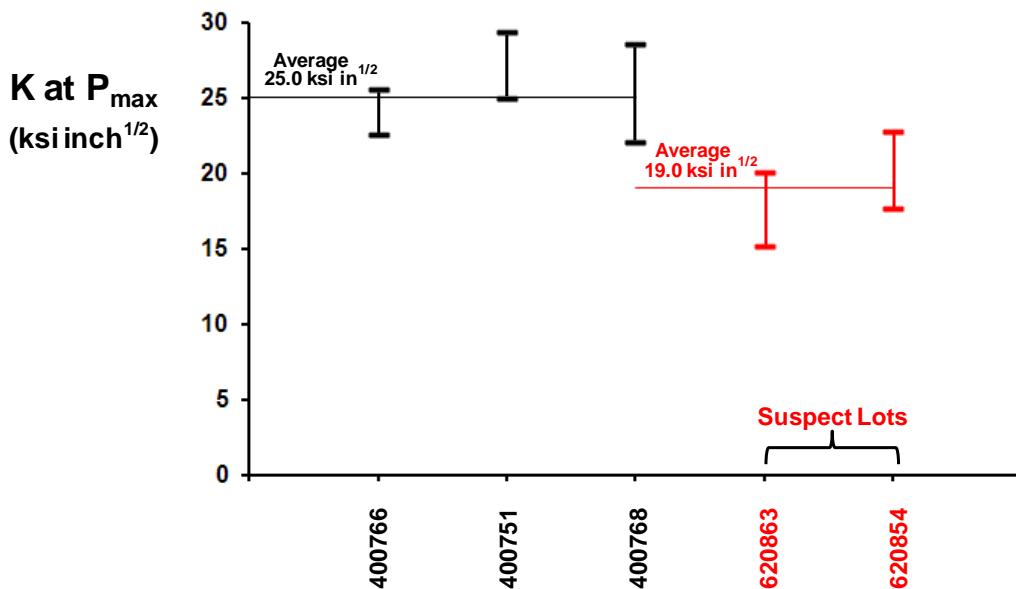
Based on MSFC fracture criteria, the stress intensity factor ( $K$ ) at peak load ( $P_{max}$ ) was used to characterize the test specimen fracture behavior. Fracture tests were conducted on the control and suspect lot materials following nominal peak aging processing (325°F for 24 hours), as shown in Figure 5-4.1. The  $K$  at  $P_{max}$  for the suspect lot materials was about 6 ksi in<sup>1/2</sup> lower than the corresponding averages for the control lot materials. **The fracture test results showed that the suspect lot materials were less tough than the control lot materials (Observation 4).**

**Figure 5.4-1. Fracture Test Results from Suspect and Control Lot Materials Following Nominal Peak Aging**

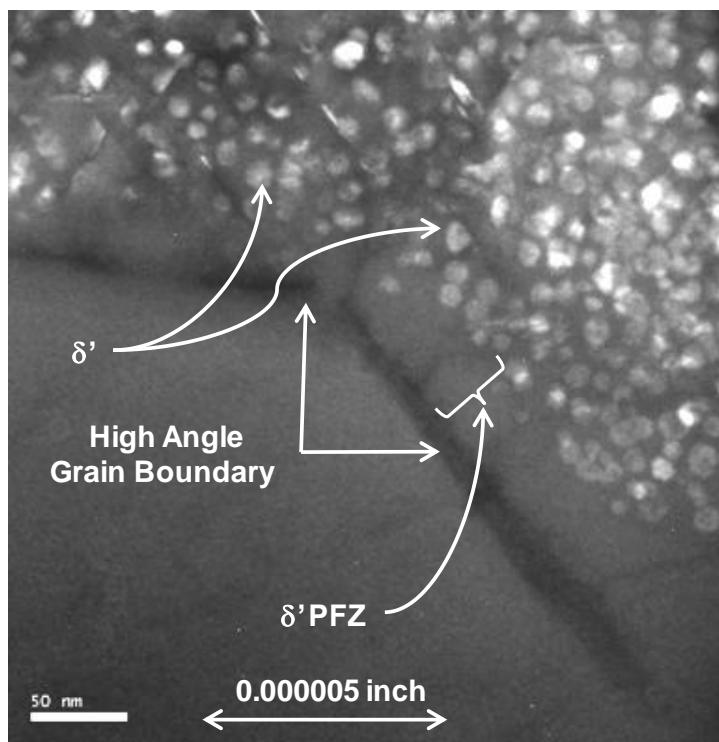
Multiple dark and bright field TEM images were used to obtain an estimate of the size and number of matrix  $T_1$  and  $\delta'$  precipitates, as summarized in Table 5.5-1. **The TEM examinations revealed that the suspect material had fewer and larger matrix  $T_1$  precipitates compared to the control material (Observation 9). The sizes of the matrix  $\delta'$  precipitates were about the same in the suspect and control stringer material, but more precipitate particles were present in the control stringer material (Observation 10).** These are significant observations and will be discussed further relative to the EBSD analysis results discussed in the following section.

**Figure 5.5-1. Example of a High Angle Grain Boundary  $\delta'$  PFZ**

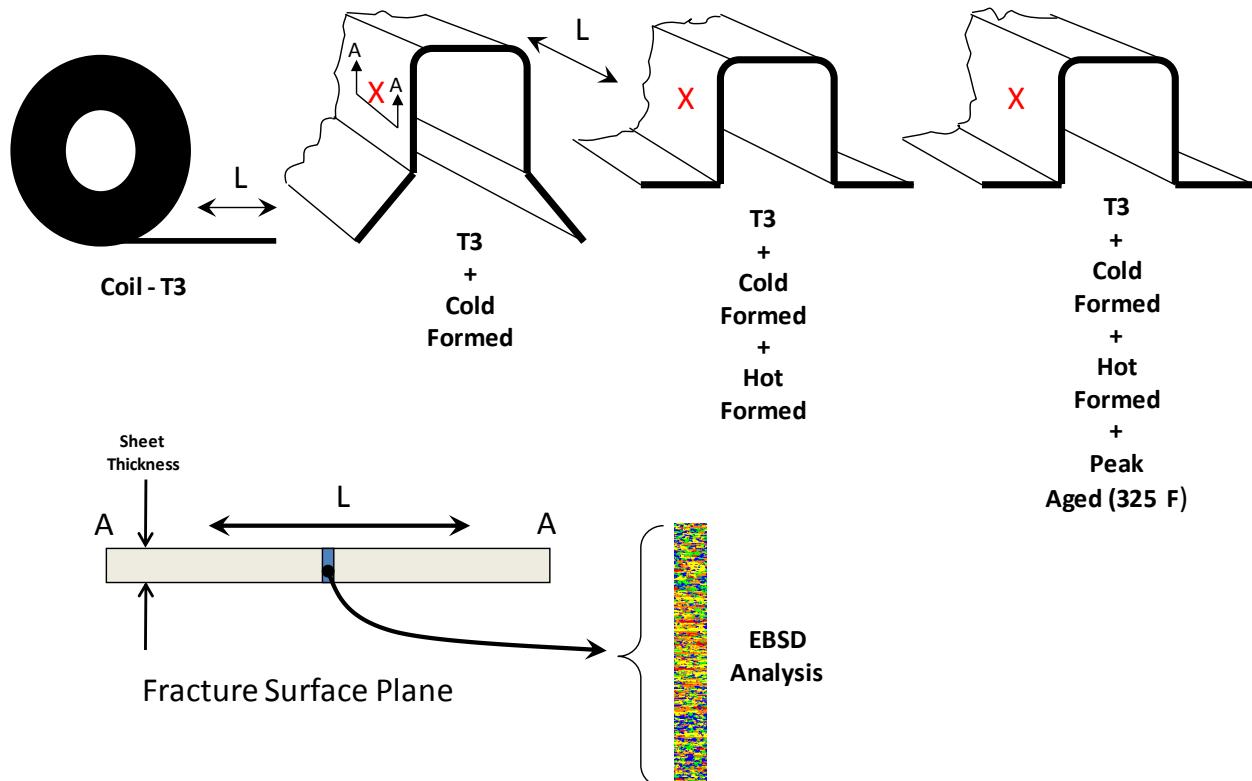
The EBSD data revealed that the suspect material exhibits evidence of grain recovery parallels the TEM observations 8, 9, and 10. Grain recovery (removal or redistribution of dislocations) reduces or changes the number of energetic sites for precipitation; removal or redistribution of dislocations could alter precipitate morphology (alter precipitate size, number, and location). Thus, the EBSD analysis revealed that the as-received suspect lot microstructure exhibits grain recovery (reduced dislocation density) and confirms the TEM observations relative to differences in precipitate morphology (Observation 12).

**Figure 5.5-3. Schematic Describing the Location of the EBSD Analysis for the Stringer Materials**
