The Space Shuttle Columbia Accident Investigation and Reconstruction: Two Years Later

S. J. McDanel*

*Chief, Failure Analysis and Materials Evaluation Branch, YA-F1, NASA, Kennedy Space Center, FL, 32899

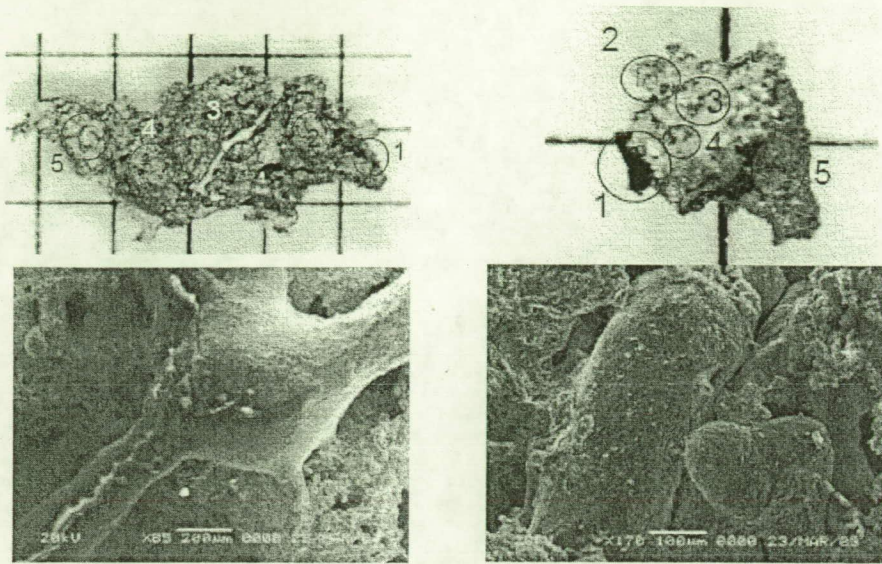
During the initial stages of the investigation, samples as shown in Fig. 1 were harvested from selected pieces of debris and subjected to further examination. Ultimately, the information derived from the sampling and analysis was used to determine the most likely location of a breach in the left wing leading edge of the Columbia, as shown in Fig. 2. Similarly, the information was used to determine the path which the impinging plasma followed once inside the wing structure.

FIG. 1. Macroscopic views of typical slag samples (magnification of top photos approximately 5X) and scanning electron micrographs (magnification of bottom photos 85X (left) and 170X (right)) of selected areas.

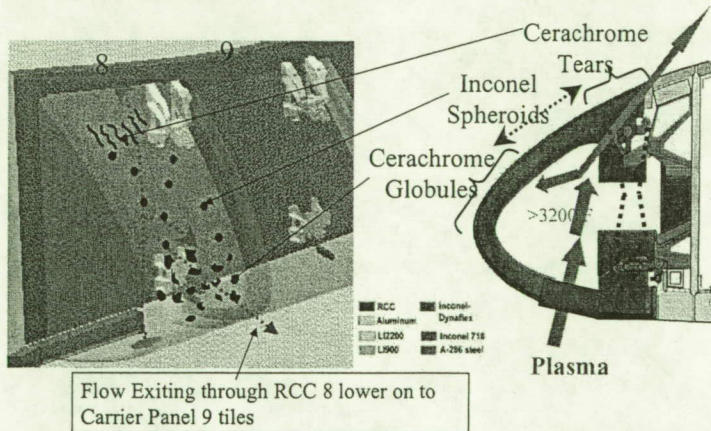
FIG. 2. Schematic representation of the suspected breach location and plasma flow path. Taken from the STS-107 Columbia Reconstruction Report, NSTS-60501, National Aeronautics and Space Administration, June, 2003.
