Techniques and Tools of NASA's Space Shuttle Columbia Accident Investigation

Steve McDanel¹

1. Steve McDanel, Chief, Failure Analysis and Materials Evaluation Branch, National Aeronautics and Space Administration (NASA), Kennedy Space Center, Florida, USA

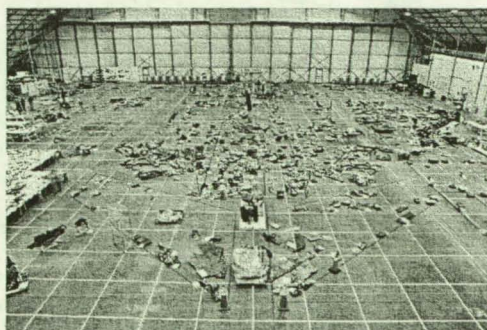
Figure 1. Columbia Reconstruction Hangar. The debris represents approximately 3% of the total debris recovered and includes metallic structures, reinforced carbon-carbon composites, and ceramic heat insulation tiles [1].
