SHUTTLE PROPULSION SYSTEM MAJOR EVENTS AND THE FINAL 22 FLIGHTS

James W. Owen, NASA, Marshall Space Flight Center

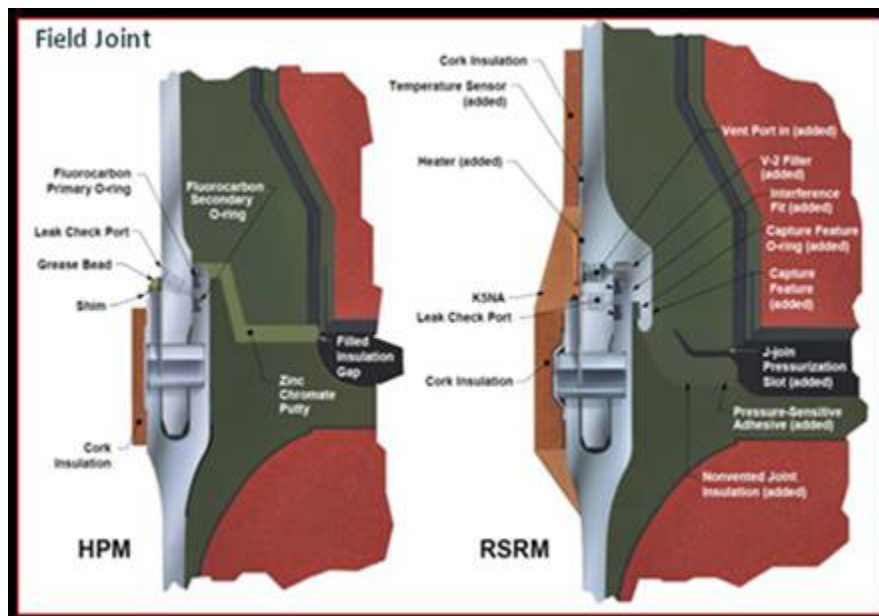
STS 51-L Loss of Crew and Vehicle: The failure of the solid rocket motor field joint sealing system during launch of Challenger on January 28, 1986 has been well documented, and investigated by the Rogers Commission. The combination of a design which allowed the joint to open during motor pressurization coupled with extremely cold temperature on the day of launch resulted in hot gas leakage leading to structural failure of the vehicle and loss of the crew. The investigation revealed prior warnings of problems with the field joints, and an increasing acceptance of risk as flights proceeded. Redesign following the accident corrected the design's shortcomings, and produced a design that has multiple layers of protection. These improvements include a capture feature that greatly reduces gap opening, an innovative seal within the segment insulation called a j-leg, joint heaters, and improved assembly procedures. The redesign flew successfully throughout the remainder of the program, with no indications of sealing problems. A number of cultural, managerial, and decision making process improvements were implemented, and the government/industry team performed exceedingly well during the remainder of the program.

Figure 7. Solid Rocket Motor Field Joint Redesign

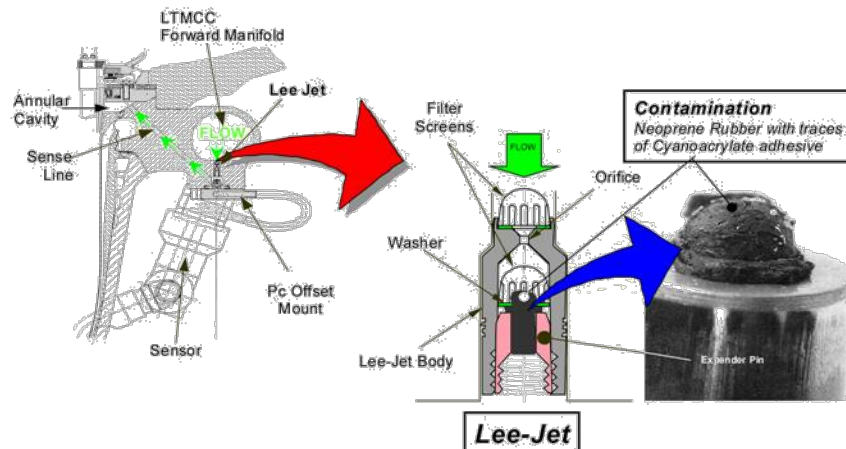
STS-91 SSME Chamber Pressure Channel A Failure: On 06/02/1998, during Discovery's ascent, the Main Combustion Chamber (MCC) Chamber Pressure Channel A sensor ceased to respond on main engine one. During throttle down, channel A exceeded the 200 PSID limit (the sensor did not follow the engine power level). Main Engine one was controlled by Channel B for the remainder of ascent. No engine problems were experienced and Discovery continued to a nominal orbit insertion. The channel A sensor, however, remained qualified for redline monitoring by the controller, since it was with reasonable limits. If the engine had experienced a real problem that drove the engine to a chamber pressure redline, sensor B (the good one) would have called for an over-speed shutdown which would have been ignored by the controller because sensor A (the bad one) remained qualified for redline monitoring. Hence redline protection had been lost. Contamination was found (post flight) to have plugged the chamber pressure port (a material from a leak check performed during engine manufacture). Control of foreign object debris is essential.

Figure 8. Contaminated Chamber Pressure port

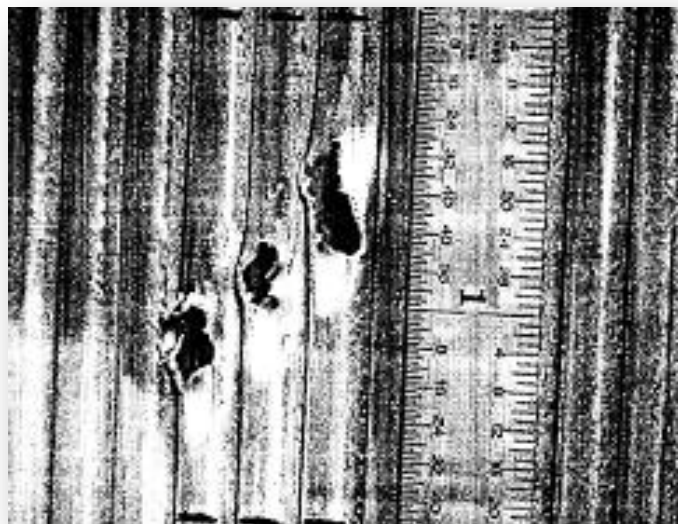
STS-93 Orbiter wiring and Space Shuttle Main Engine (SSME) nozzle tubes punctured during ascent flight: Two serious in-flight anomalies occurred during ascent flight on STS-93. One main engine controller primary circuit, and one back-up circuit, on separate engines dropped offline when an Orbiter AC power bus experienced a short circuit 6 seconds after liftoff. The redundant controller circuits (one on each engine) worked throughout ascent, but redundancy had been lost on two engines. This flight observation initiated a system level inspection of all Orbiter wiring. Clearly redundancy management had been key to mission success. Additionally, on STS-93, a nozzle fuel leak on one engine resulted in a premature main engine shut down (low level liquid oxygen cutoff) due to an SSME liquid oxygen pin being ejected from an injector post in the main combustion chamber. The pin penetrated 3 nozzle coolant lines causing a hydrogen leak from the nozzle. The loss of fuel caused the main engine controller to increase power level (an increase in turbine power requires an increase in oxidizer flow) which depleted oxygen prematurely. Acceptable orbit insertion, or orbital velocity, was provided by the Orbiter Maneuvering System, post main engine shutdown. Corrective action called for elimination of pins used in the main

Figure 9. Punctured nozzle coolant tubes from STS-93

combustion chamber liquid oxygen posts. Redline protection was essential in achieving mission success.

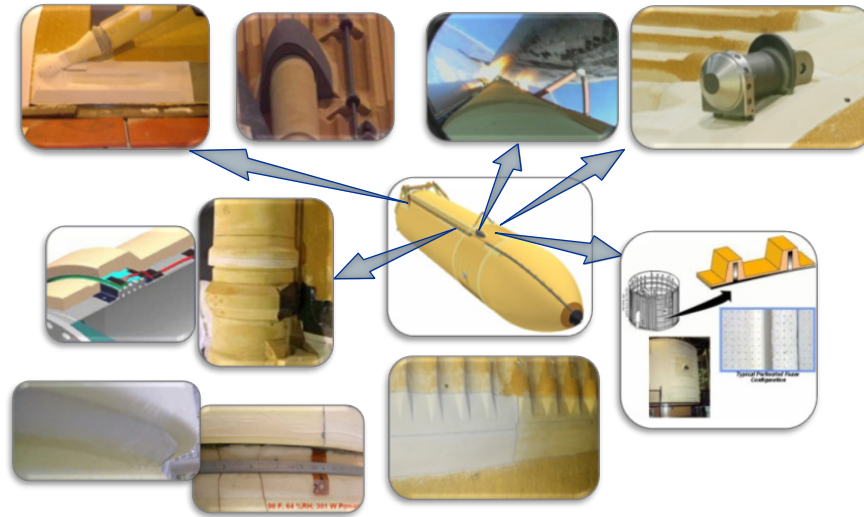
STS 107 Loss of Crew and Vehicle: The loss of crew and vehicle during entry of Columbia on February 1, 2003 was a result of debris damaging the Orbiter wing during ascent. This accident was well documented by the Columbia Accident Investigation Board report. Prior warnings of debris damage had been evident throughout the history of the program, but had usually been treated as a maintenance and refurbishment item. Following STS-107 corrective actions were implemented to remove sources of foam debris where possible, improve process controls, and preclude ice formation in selected components as well. The debris risk mitigation efforts continued as the flight program continued. Generally the effect of debris mitigation efforts during the final 22 flights resulted in a two order of magnitude reduction in possible impact energy. The program also implemented on orbit inspection to assess the Orbiter heat shield prior to entry, and developed a thermal protection system repair capability if needed during orbit.

Figure 10. STS-114 External Tank Redesigns resulting in Reduced Ascent Debris Risk

The resulting redesigns and operational procedures enabled successful management of risk during the remainder of the flight program.

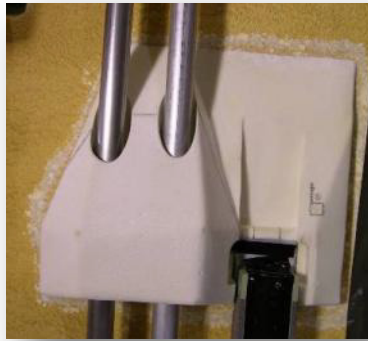
External Tank (ET) Liquid Hydrogen Tank (LH2) Ice Frost Ramps: A unique opportunity arose following STS-114, when an External Tank (ET-120) was returned to the manufacturing facility after undergoing two cryogenic cycles on the launch pad. Detailed inspection of a flight tank following partial operation had never been done before. Dissection data of the thermal protection foam material from ET-120 (post cryogenic cycling) revealed significant foam cracking and delaminations within the liquid hydrogen tank ice frost ramps and protuberance air load ramps (PAL). The PAL ramps were subsequently removed. Subsurface cracking and delaminations in the ice frost ramps, were believed to be linked to stresses induced by thick foam. Reducing foam thickness was thought to be a solution. However, reshaping the ramps revealed conflicting thermal and debris requirements and did not address root cause. Subsurface cracks and delaminations were later found to be caused by cryogenically induced liquid air intruding into "built-in" leak paths and reservoirs. Once the failure mode was fully understood, a redesign was initiated which met thermal and debris requirements. Additionally, identification of the correct failure mode enabled updated risk assessments showing greatly reduced ascent debris risk from these ramps. The lesson to remember is that failure modes and effects must be fully understood and characterized. The ability to get direct inspection of actual hardware after service is invaluable.

Figure 11. Liquid Hydrogen Tank Ice Frost Ramps

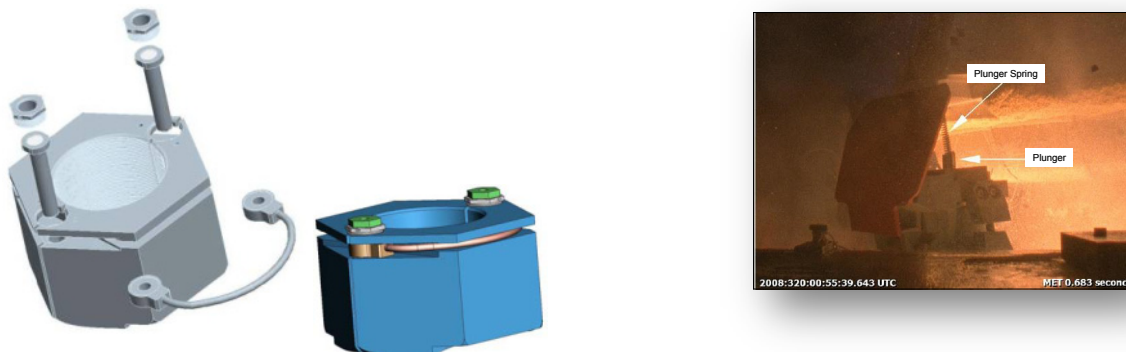
Solid Rocket Booster (SRB) Pyrotechnic Cross-over Redesign and Debris Containment Plunger Failure: During launch of STS 126 video showed the SRB hold-down post (HDP) plunger spring, and plunger, extending during liftoff from the debris containment system. Concurrent with this launch a design change had been implemented to reduce the occurrence of a condition called “stud hang-up” a recurring

anomaly during the program. A pyrotechnic crossover feature had been added to the SRB frangible nut, part of the system which released the Shuttle from the pad. The change enabled nearly simultaneous firing of two pyrotechnic charges in the nut. The crossover successfully mitigated the potential for stud hang up, but an unintended consequence was discovered. The decreased pyrotechnic skew time (the time between the two charges firing) increased the velocity of the debris containment system plunger, and increased the chance of a plunger being released. A design modification (called retention blocks) was successfully implemented within the debris containment system housing to address this issue for STS-119 and subsequent missions. All changes must be evaluated for potential unintended consequences.

Figure 13. Pyrotechnic cross over and plunger/spring released during lift-off

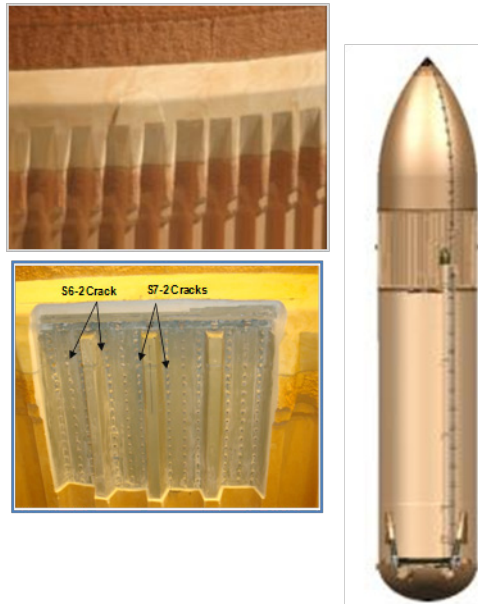
STS-133 External Tank Cracked Stringer: During preparations for launch of STS-133 stringer cracks were observed on the External Tank intertank liquid oxygen flange during propellant loading. Subsequent cracks were identified by nondestructive evaluation following roll back to vehicle assembly building. Extensive root cause investigation was performed and identified two primary contributors, first a material with low fracture toughness (isolated to two lots of material) had been used during assembly, and second loads and resulting residual stresses had been imparted during assembly of stringers due to tolerance stack up. A corrective action was successfully implemented by reinforcing the stringer feet near the end of the stringer. The lessons include the need for adequate sub-tier vendor controls, and material acceptance inspections must assure proper configuration. Also, design and assembly tolerances must accommodate the potential for residual stresses.

Figure 14. External Tank stringer cracks

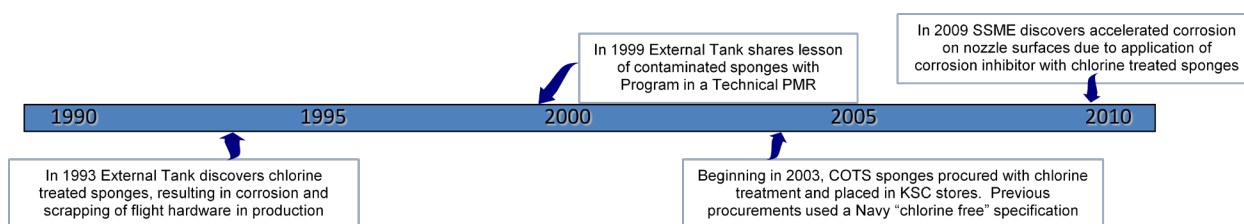
STS-127 and STS-128 Nozzle Hotwall Leakage: A post-flight hotwall leakage increase on two nozzles was noted. Inspections showed presence of high levels of chloride ions which is well known corrosion accelerant. Investigation also found that the sponges used to apply corrosion inhibitor contained high levels of chloride ions. Use of these sponges was discontinued. The affected nozzles were repaired, cleaned and dry purges were implemented to protect against any future occurrence. Further investigation showed that a change in the procurement specification had allowed the sponges to become available in inventory. Interestingly, a similar condition had been identified years earlier during external tank manufacturing. A timeline is shown in Figure 15 below. Lessons are that adequate specifications are necessary for everything that touches the flight hardware and that process controls must be assured for multi-decade, multi-element programs. Implementation of effective problem reporting and corrective actions systems across a multi-element program, with multiple prime contractors and independent reporting systems, is quite a challenge.

Figure 15. Timeline describing unrelated corrosion events.

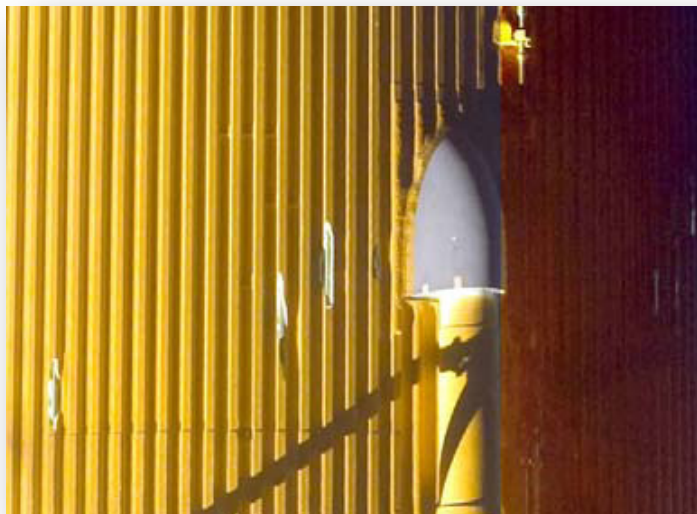
External Tank (ET) Inter Tank Foam Loss: Unexpected foam losses occurred from the ET Intertank during ascent of STS-127. Imagery indicated visible areas of shiny primer from loss sites, indicating adhesion failures. Although the root cause could not be determined, most probable cause was inadequate cleaning of the surface prior to foam application. This was the first intertank to be processed following the plant shutdown after STS-107 and also following hurricane Katrina and damage to the plant. Since all remaining intertanks had already been sprayed at the time of STS-127, corrective action

Figure 16. Example of inter tank foam losses due to poor bond adhesion

consisted of performing bond adhesion testing (sampling) on future intertanks. Since it is not over 100% of the area, the sampling could only provide confidence that the cleaning anomaly was not widespread or systemic. Unexpected events (i.e. Katrina) can lead to consequences revealed only in flight performance. Ensure that adequate controls/verifications are in place for critical processes. If you are unable to implement corrective action, anticipate recurrence in the future.
