NO. KSC-2005-018-00002

VEHICLE ASSEMBLY BUILDING FIRE

MISHAP INVESTIGATION REPORT

March 11, 2005

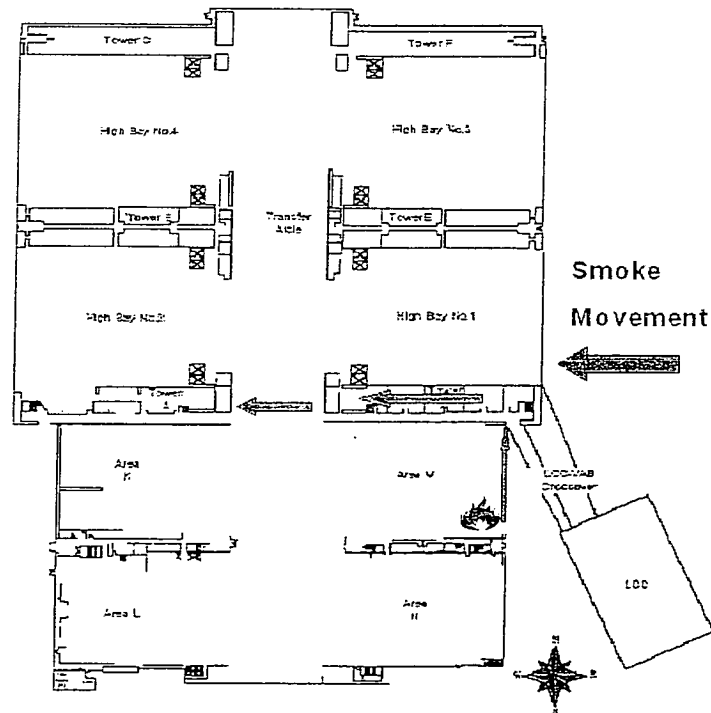
At approximately 1516, fire fighters found a small section of the roof glowing near the parapet wall. Upon further investigation, the fire fighters confirmed that there was a fire beneath the roofing membrane. Fire fighters began to extinguish the fire on the roof while other fire fighters continued to search for an additional fire source in the cable tunnel area.

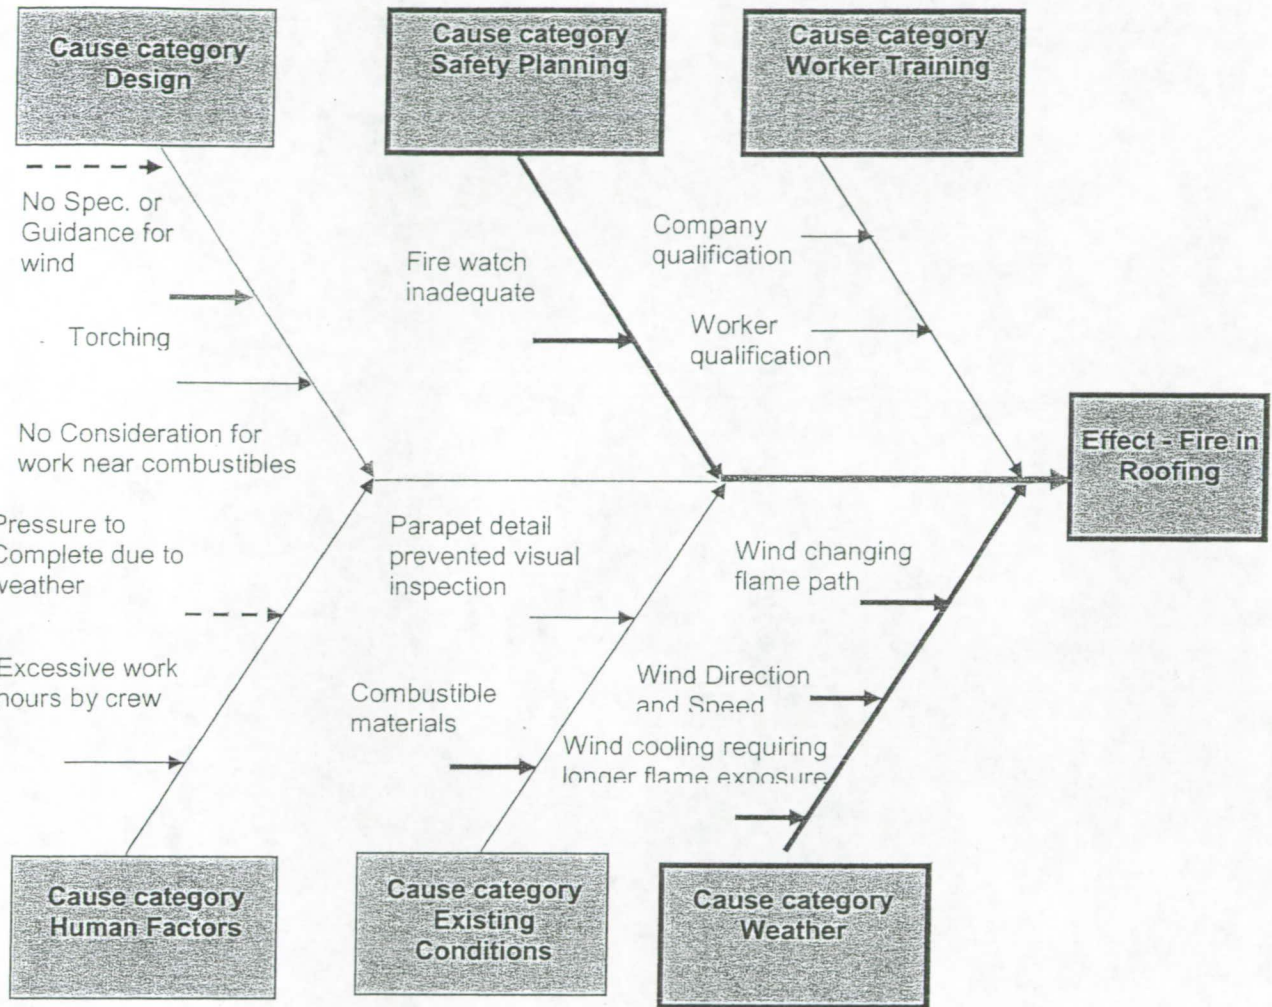
Figure 1: Cause Effect Diagram

In an effort to identify the proximate and root causes of this mishap, a cause – effect fishbone diagram was constructed (*see Figure 1: Cause – Effect Diagram*). This diagram was used to ensure all potential cause categories were considered. The categories identified include:

The open flame torch, by providing a flame source on the roof to ignite combustibles, was determined to be the proximate cause and if eliminated would have prevented the mishap.

The inadequate fire watch technique is considered to be a root cause.

The presence of combustibles is considered to be a root cause.

Wind speed and direction is considered to be a root cause.
