# The Space Shuttle Columbia: A Materials Forensic Analysis

## MICROSCOPY 2007

Steve McDanel  
Failure Analysis and Materials Evaluation Branch  
NASA  
Kennedy Space Center, Florida

# Shuttle Columbia: STS-107

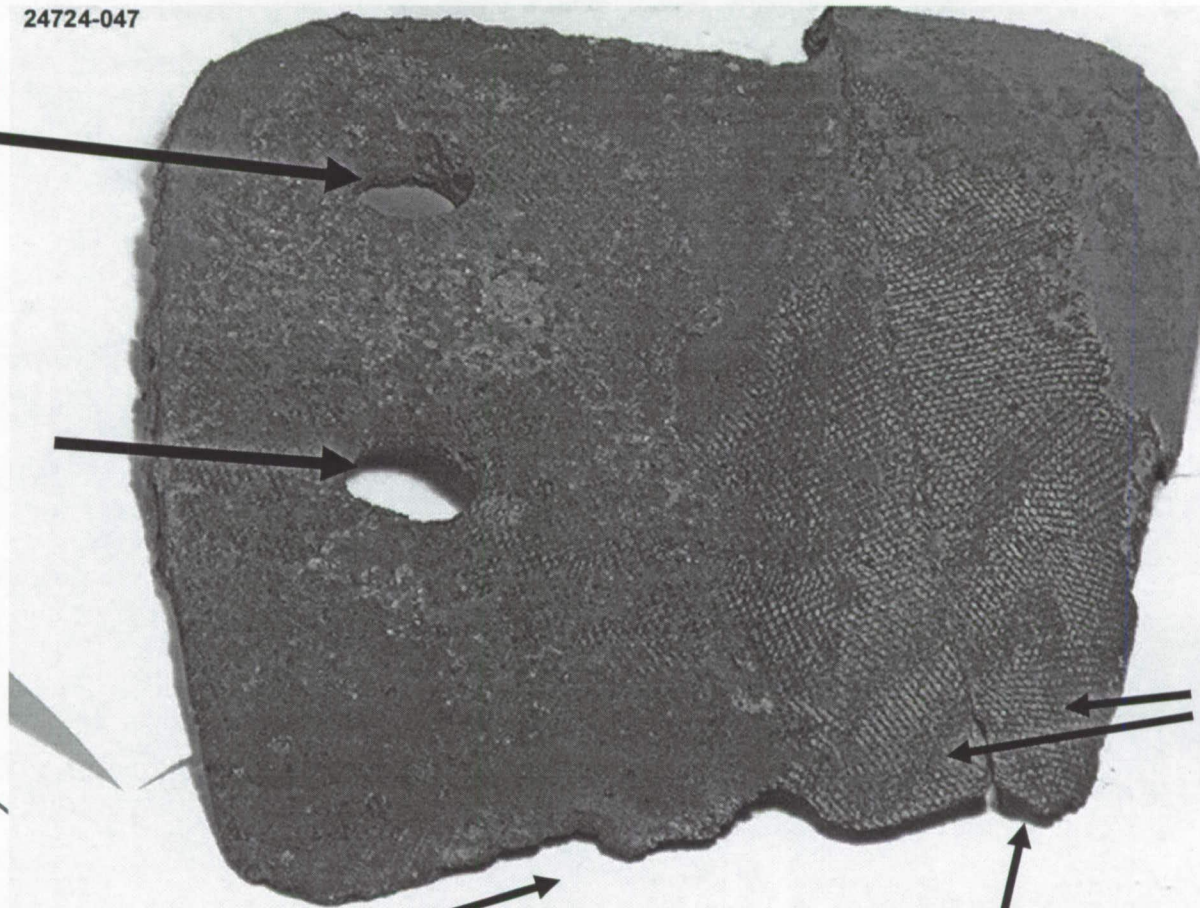
# Erosion on Gap Surfaces of Panel 8 Outboard Lug & Matching Heel Piece

Heavy deposits in  
holes

Inconel bushings  
missing, yet  
attach holes still  
intact

Matching  
eroded  
plies

Lug fragment  
tapers from .499" to  
a min knife edge of  
0.063"

Heel fragment tapers from .233" to  
a min knife edge of 0.052"

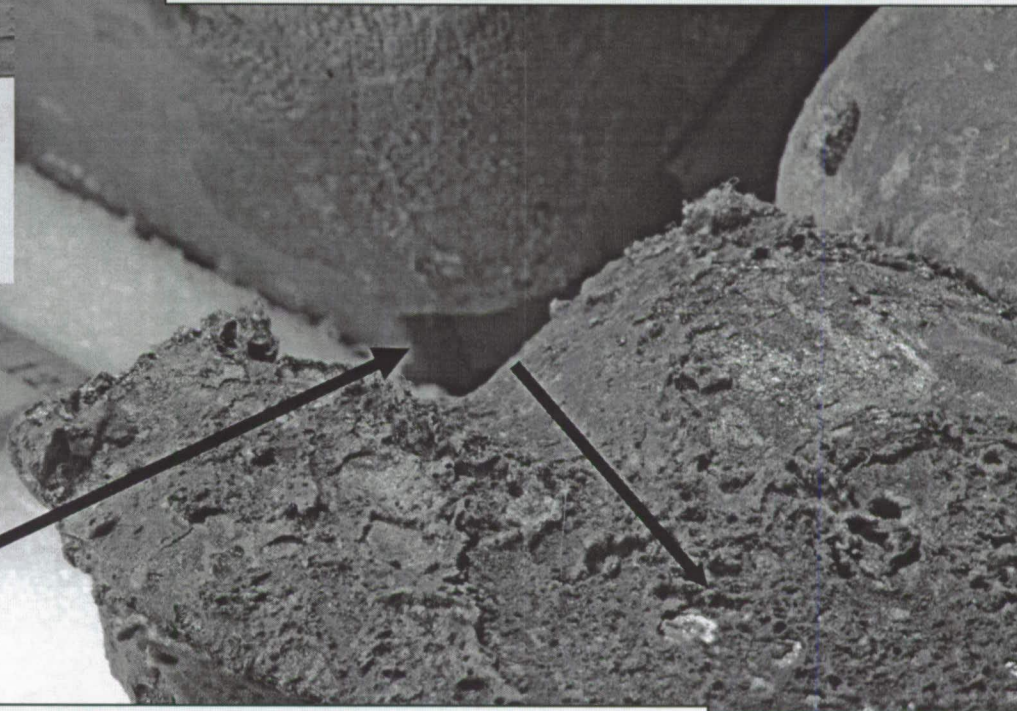
# Slumping Source for Carrier Panel 9 Tile was Revealed

**Slumping of C/P 9 Tile #1 Corresponds with Design Slot in Corner of RCC Panel 8**

**Slumping and erosion patterns suggest plasma flow across the carrier panel tile (from 8 toward 10)**

**Evidence of Hot Gas Flow Exiting Design Slot Indicates Significant Breach Was Into Panel 8**

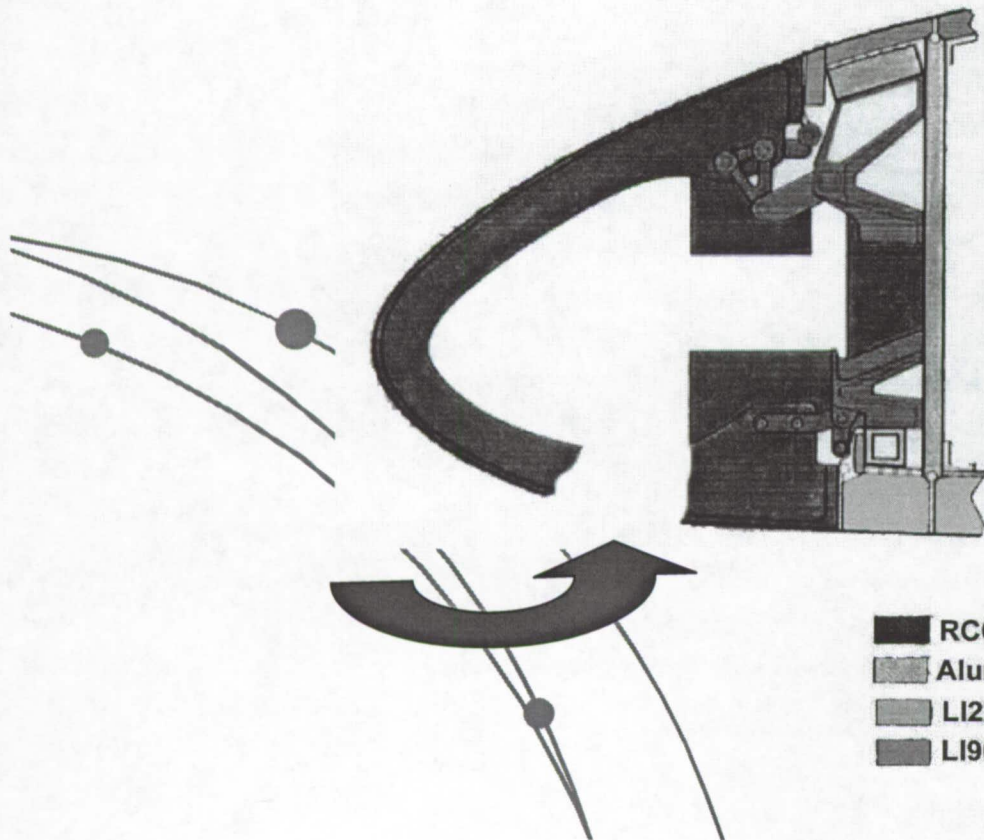
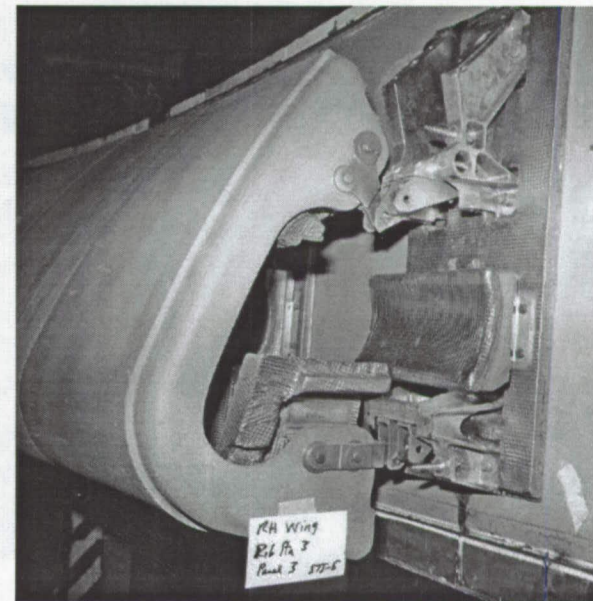
# Debris Indicates Highest Probability Initiation Site

- Wing failure initiated in the panel 8 area
  - ◆ Most likely at the panel 8 area near 8-9 joint
  - ◆ Condition existed before or shortly after entry interface

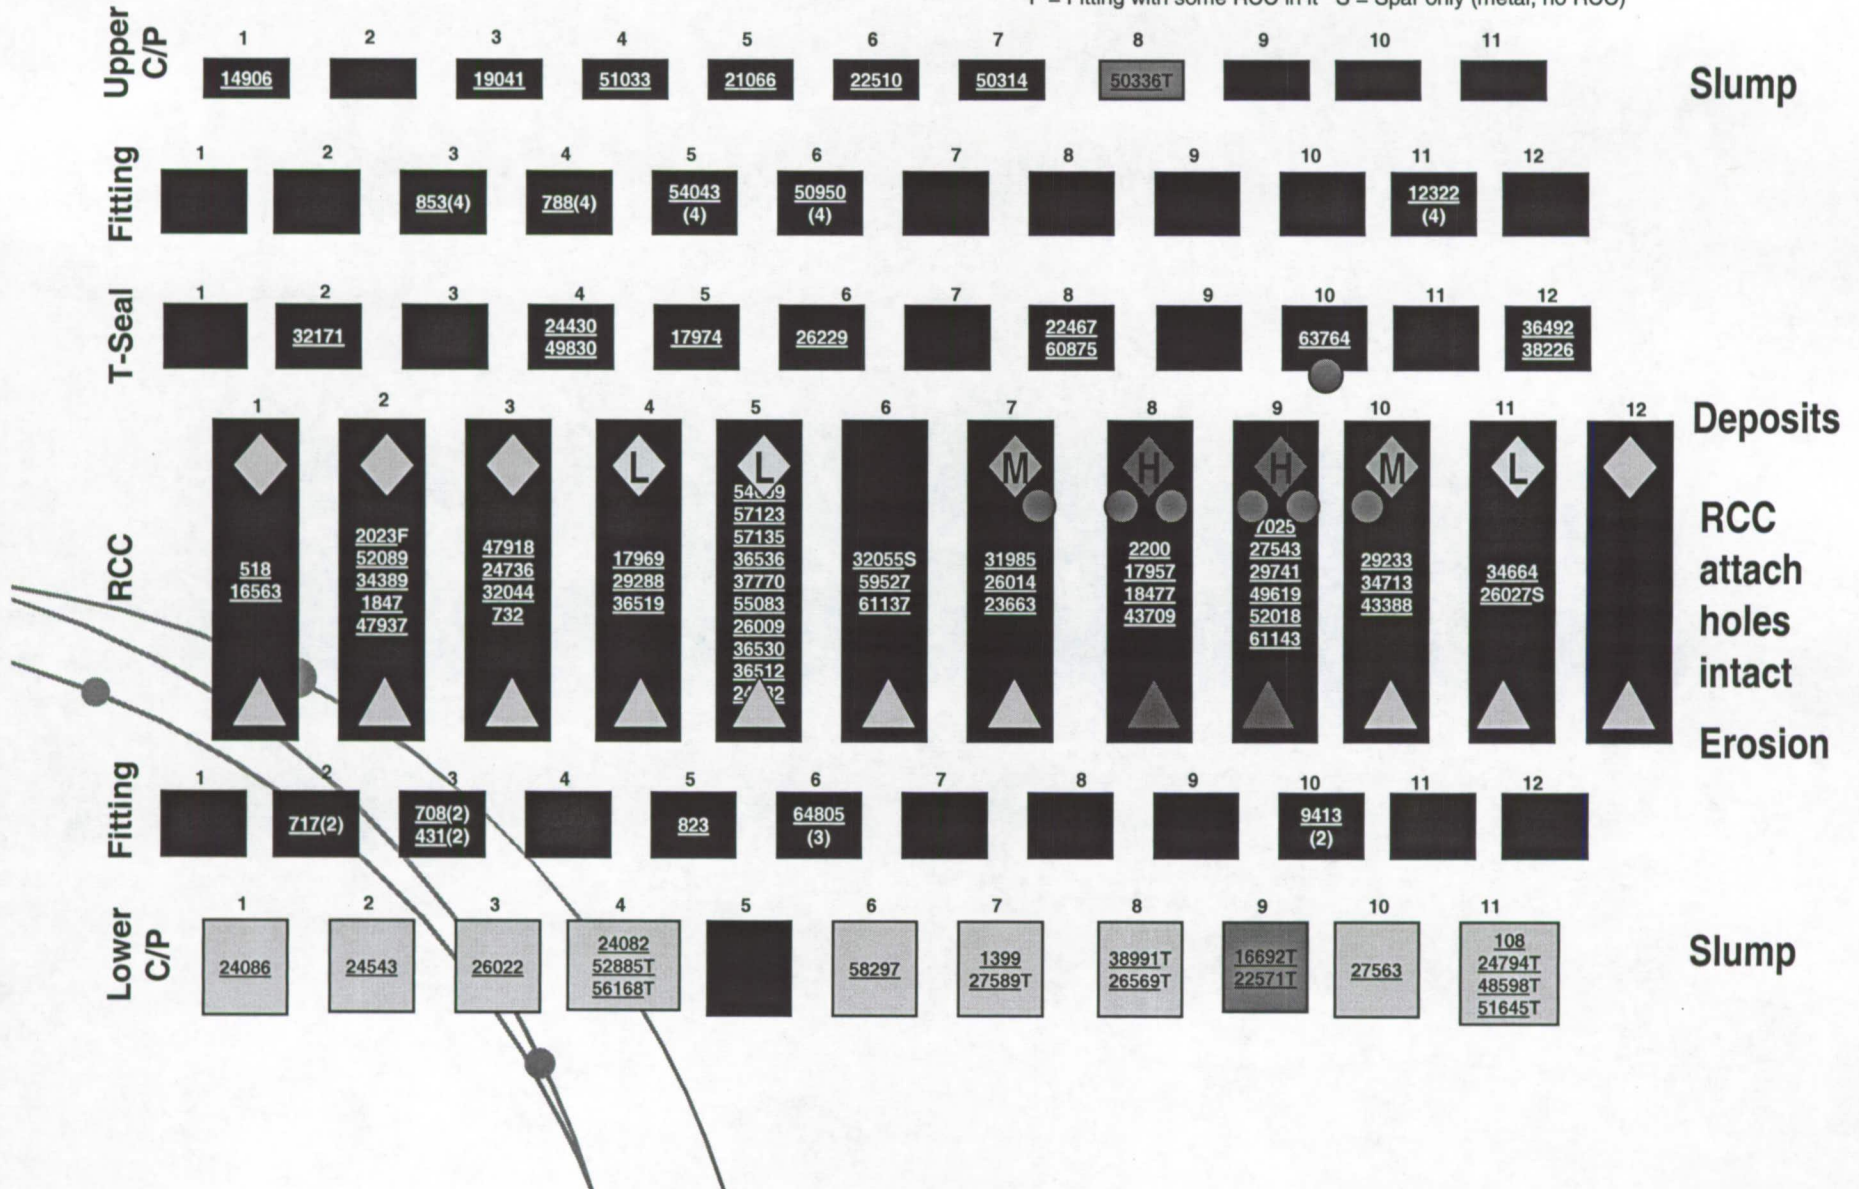
# Left Hand Wing Debris Points to RCC 8/9

(#) = Number of attach fitting bolts on the piece T = Tile piece, no structure  
 F = Fitting with some RCC in it S = Spar only (metal, no RCC)

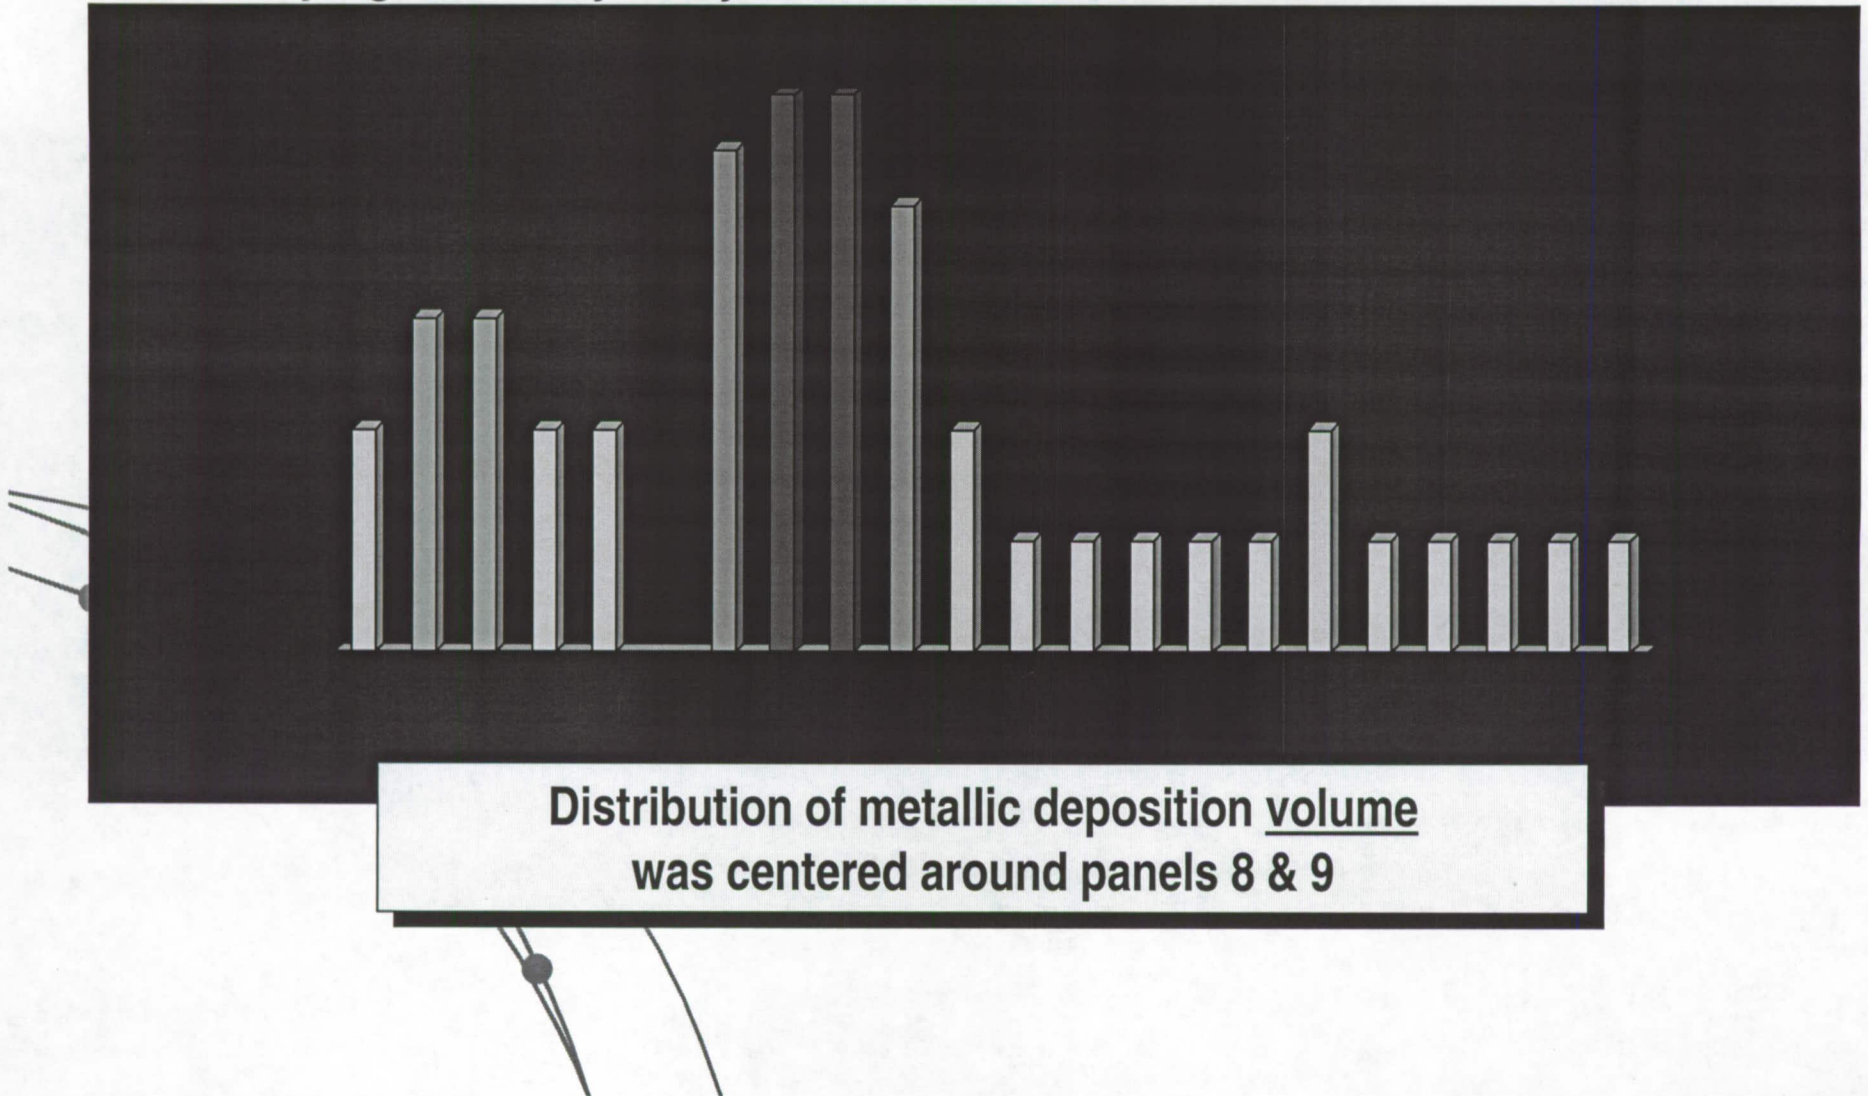
# Relative Metallic Deposition on L/H Wing Materials

*Qualitative deposition assessment:  
from "Very Light" to "Very Heavy"*

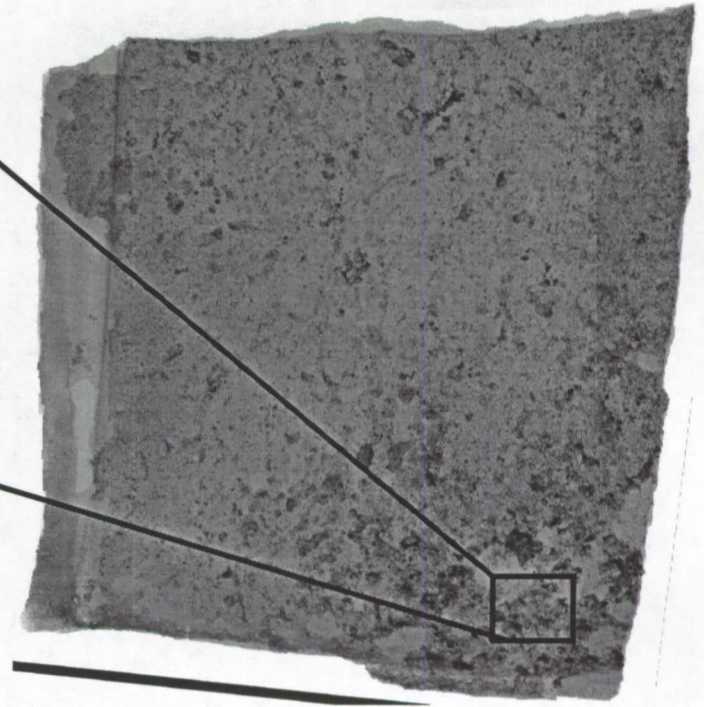
Slag Item 2200, Sample 6A1

# LH RCC #8 - Slag Feature 2

## Thick Globules

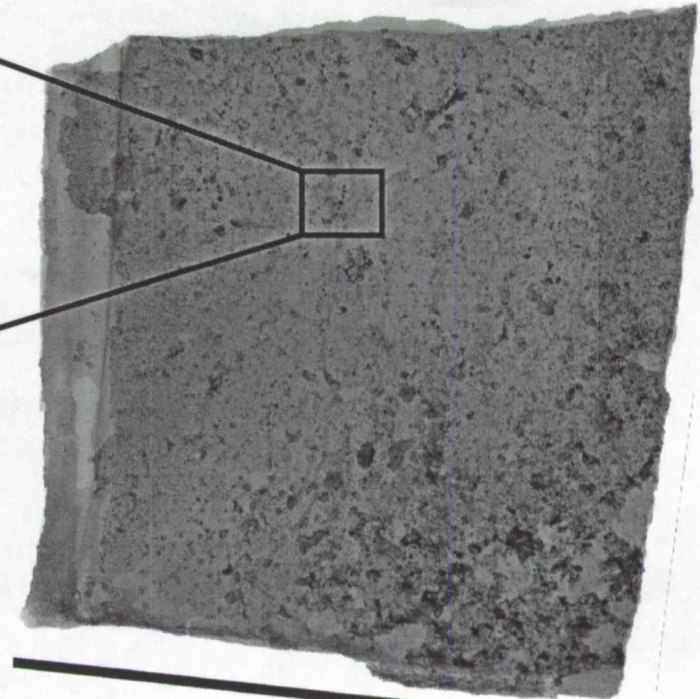
Slag Item 2200, Sample 6C1

# LH RCC #8 - Slag Feature 3 Spheroids

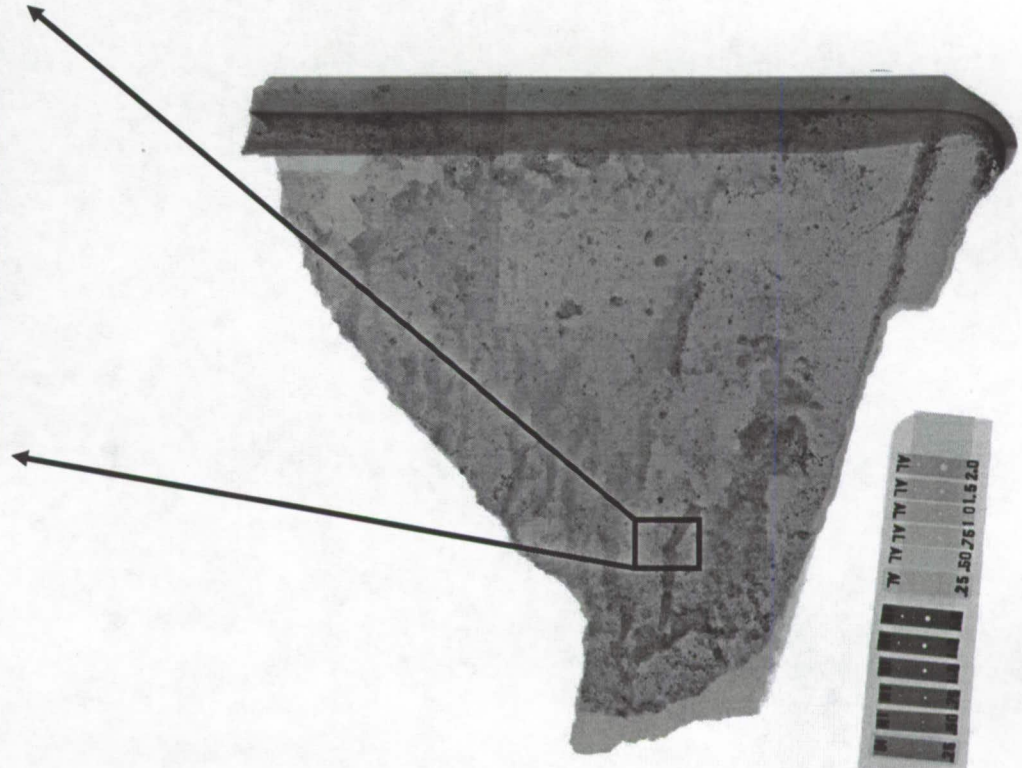
Slag Item 43709, Sample 2A1

# LH RCC #8 - Slag Feature 1

## Tubular Shaped

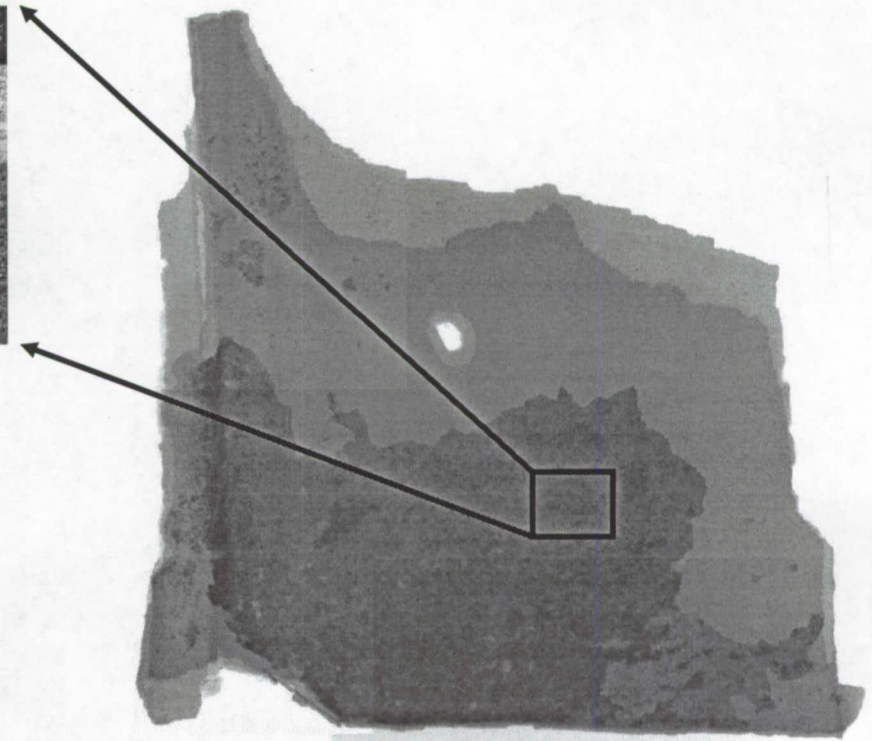
Slag Item 16523, Sample 4A1

# RH RCC #8 - Slag Feature 4 Uniform Deposit

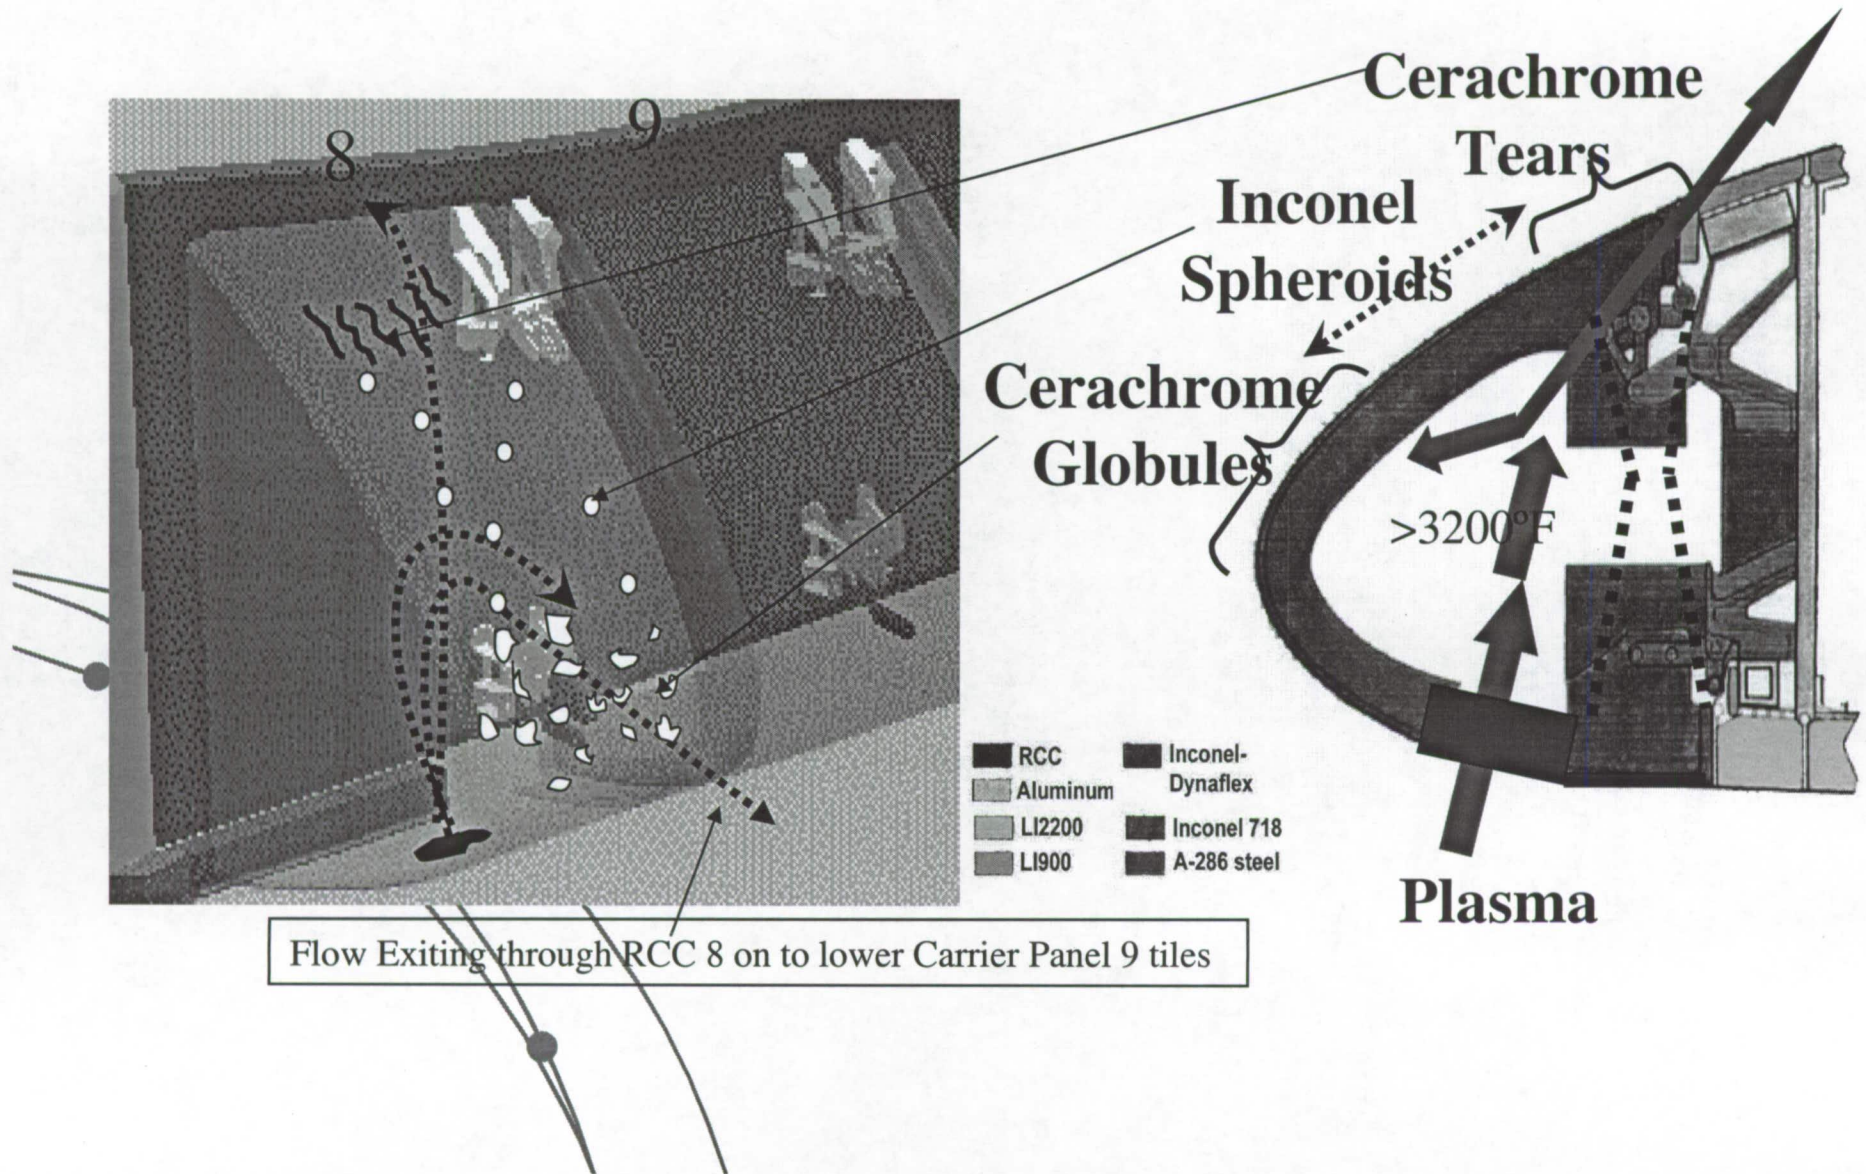
# Proposed Breach Location & Plasma Flow Based On Slag Results

- Large amounts of melted ceramic cerachrome insulator
  - **High temperature >3200°F**
- No indication of stainless steel spar fittings (A286) in deposit
  - **Breach location away from spar fittings**
- Cerachrome + Inconel in first deposited layers
  - **Melting of spanner/foil/fittings + Insulator**
- Aluminum deposition secondary event

**Deposit layering suggests plasma impingement location**

**Deposit distribution & shape suggests plasma flow direction and deposition duration**

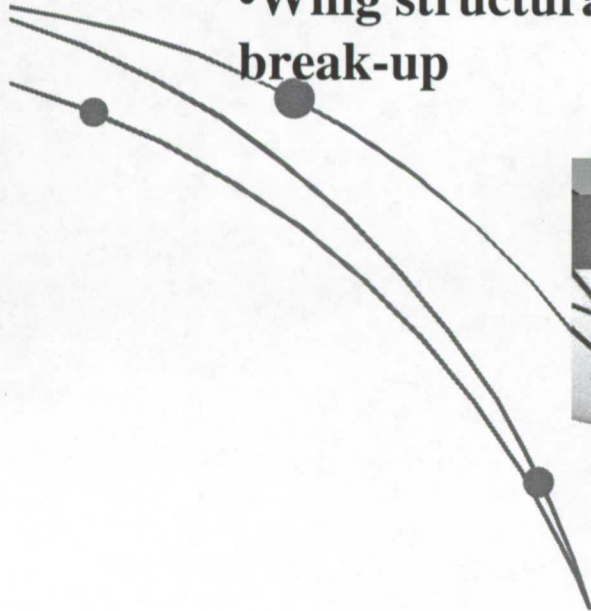
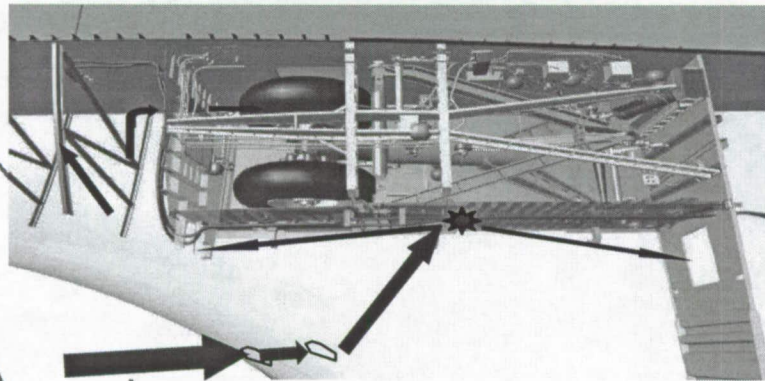
# Failure Sequence

- **Cerachrome insulation blankets covered with Inconel 601 foil melt and vaporize**
- **Wing carrier panel tile immediately aft of the breach slump**
- **RCC adjacent to, and downstream of, breach erode**
- **Inconel 718 and A286 leading edge attach hardware melt and/or weaken**
- **Instrumentation and wire bundles damaged**
- **Aluminum wing leading edge spar penetrated**
- **Wing internal structure degraded by plasma flow**
- **Wing structural failure leads to loss of vehicle control and break-up**
