Investigation into the High-Voltage Shutdown of the Oxygen Generation System Aboard the International Space Station

The Oxygen Generation System (OGS) Hydrogen Dome Assembly Orbital Replacement Unit (ORU) serial number 00001 suffered a cell high-voltage shutdown on July 5, 2010. The Hydrogen Dome Assembly ORU was removed and replaced with the on-board spare ORU serial number 00002 to maintain OGS operation. The Hydrogen Dome Assembly ORU was returned from ISS on STS-133/ULF-5 in March 2011 with test, teardown and evaluation (TT&E) and failure analysis to follow. The purpose of this paper is to summarize the results of the failure analysis.

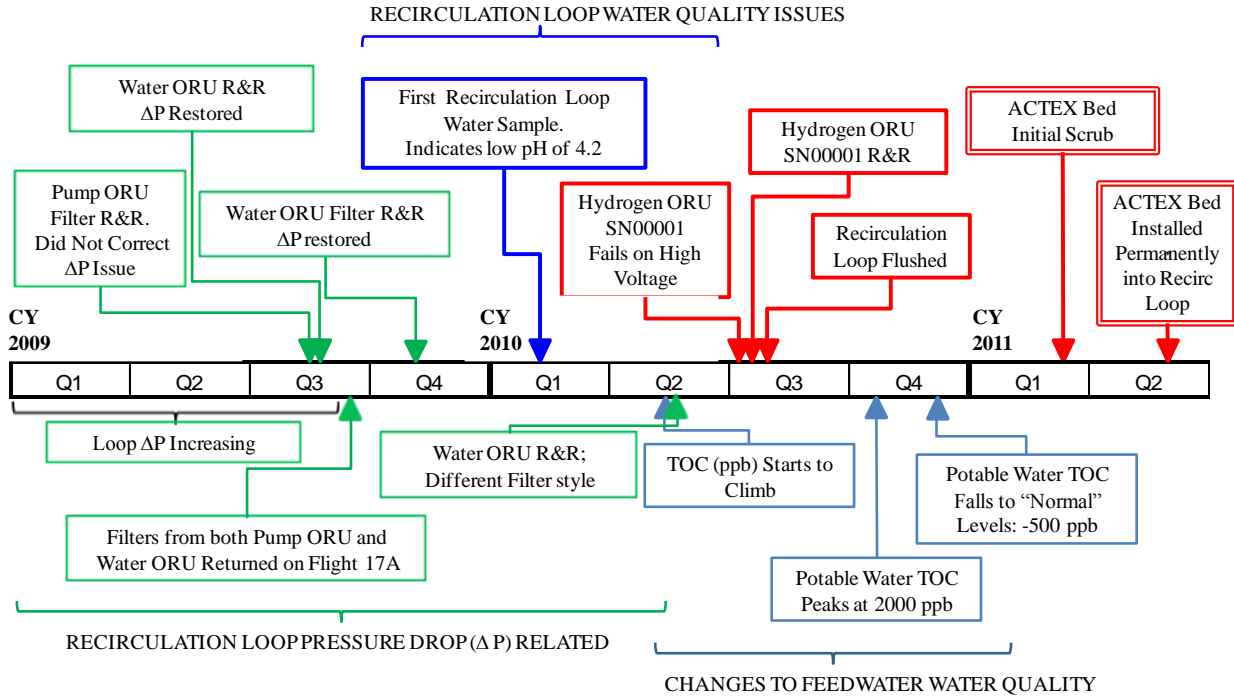
Figure 3. Timeline of Events On-Orbit Before and After Hydrogen ORU S/N00001 Fault.

Preceding the Hydrogen ORU high-voltage fault, several anomalies occurred on-orbit. Figure 3 shows a timeline of events pre- and post- ORU fault.

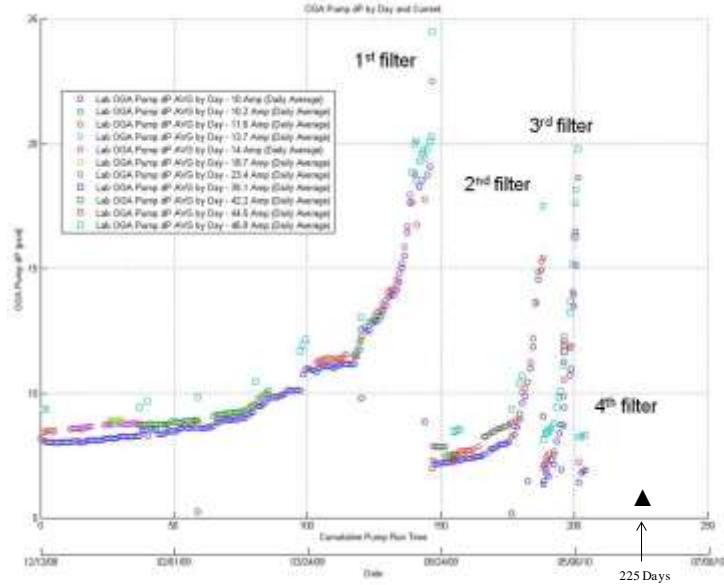
Figure 4. OGS Recirculation Loop Differential Pressure (DP7131) by Day (0-250 days).

The differential pressure sensor across the recirculation loop pump showed increasing pressure drop indicative of a flow blockage somewhere in the recirculation loop. Figure 4 illustrates several exponential curves with increasing slopes. Early troubleshooting of the rising ΔP assumed that the *most likely* cause was the Pump ORU inlet filter. Initially it was thought that the source of particulate clogging the filter was catalyst material shed from the cell stack. The Pump ORU inlet filter was replaced August 18, 2009 with no improvement in the loop pressure drop. The next most likely component was a filter in the Water ORU Flow Measurement Zone. In this case it was thought that the source of particulate clogging the filter was from the gears in the OGS recirculation loop pump. This second attempt to restore pressure drop called for the replacement of the Water ORU with an on-orbit spare. The ORU was replaced August 22, 2009 and pump ΔP returned to normal (1st filter). This was short-lived as the increasing ΔP returned at a more rapid rate. Two additional water inlet filters were replaced in the Water ORU with similar, short-term, successful results (2nd & 3rd filters). It was noted, however, that each additional filter replacement saw faster filter loading. The inlet water filter in the Water ORU was ultimately replaced with an alternate design (4th filter) that provided approximately four times as much effective filter area. Figure 4 shows the filters' pressure rise graphically and indicates (\blacktriangle) Hydrogen ORU S/N00001's high-voltage fault approximately two months after the last filter replacement.

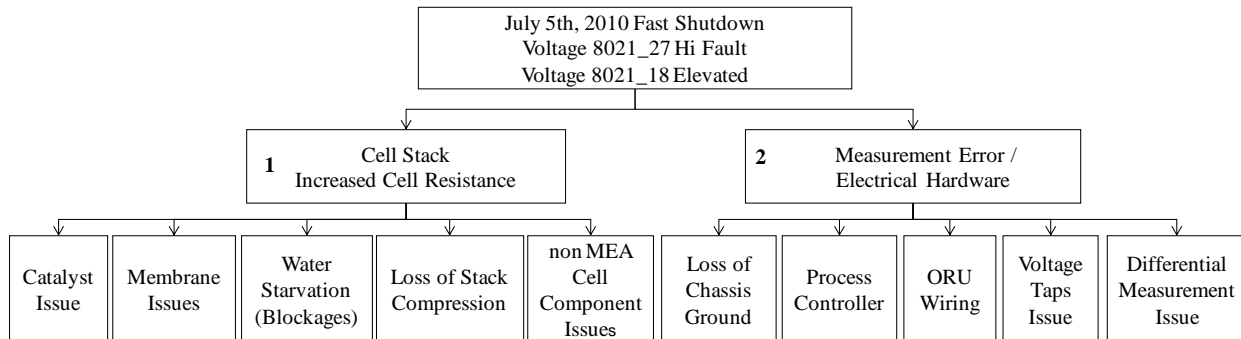
Figure 5. High-Level Breakdown of Fault Tree.

The initial fault tree had two main branches: increased resistance in the cell stack and/or issues with the electrical hardware/measurement issues in the Hydrogen Dome ORU, associated rack wiring and/or process controller. A high-level view of the fault tree is shown in Figure 5.

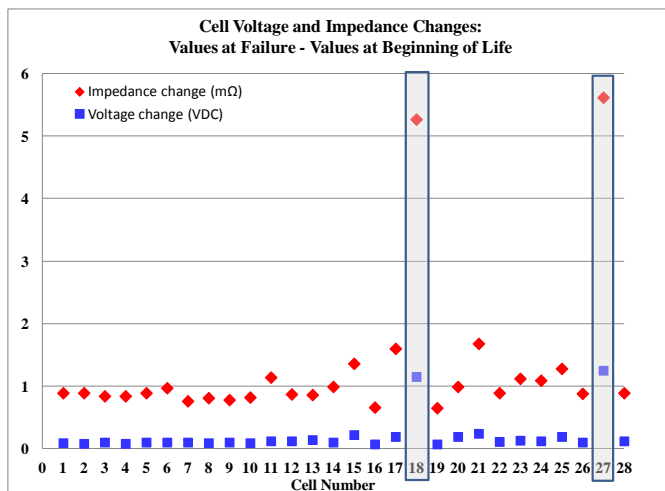
Figure 6. Changes in Cell Impedance and Voltage.

There was significant evidence supporting cationic contamination of the membrane adversely impacting the cell resistance. As can be seen in Figure 6, the resistance of all the cells in the cell stack assembly increased, with the largest gains observed in Cell 27, which had triggered the fast shutdown of the Hydrogen ORU, and Cell 18, which exhibited the next highest voltage in the cell stack.

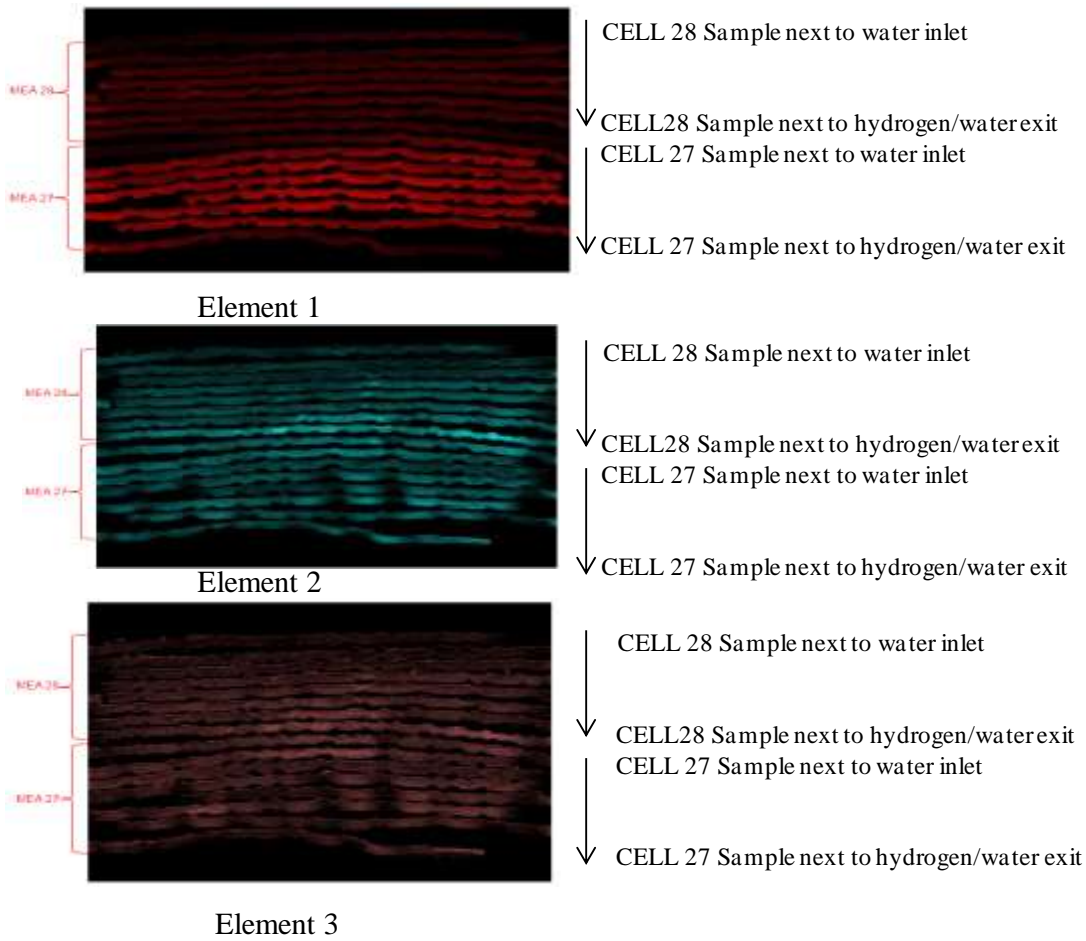
Figure 7. SEM/EDS MEA Cross-Sections for Three Elements.

The results of the microprobe analysis of select membranes conducted by the United Technologies Research Center (UTRC) and the aqua regia digestion of a wide cross-section of cell membranes (14 total) by UTC Power and Hamilton Sundstrand revealed significant cationic contamination. Figure 7 shows multiple membrane cross-sections cut from the MEA corresponding to the flow path of water transport plate from water inlet to hydrogen/water exit. Location and intensity of each element are indicated by intensity of color in the figure. For the same elements shown in Figure 7, Table 3 contains the milligrams of contamination (digested sample result scaled to a whole MEA). These analytical results provided the first insight into the degree of cationic contamination of the cell membranes.

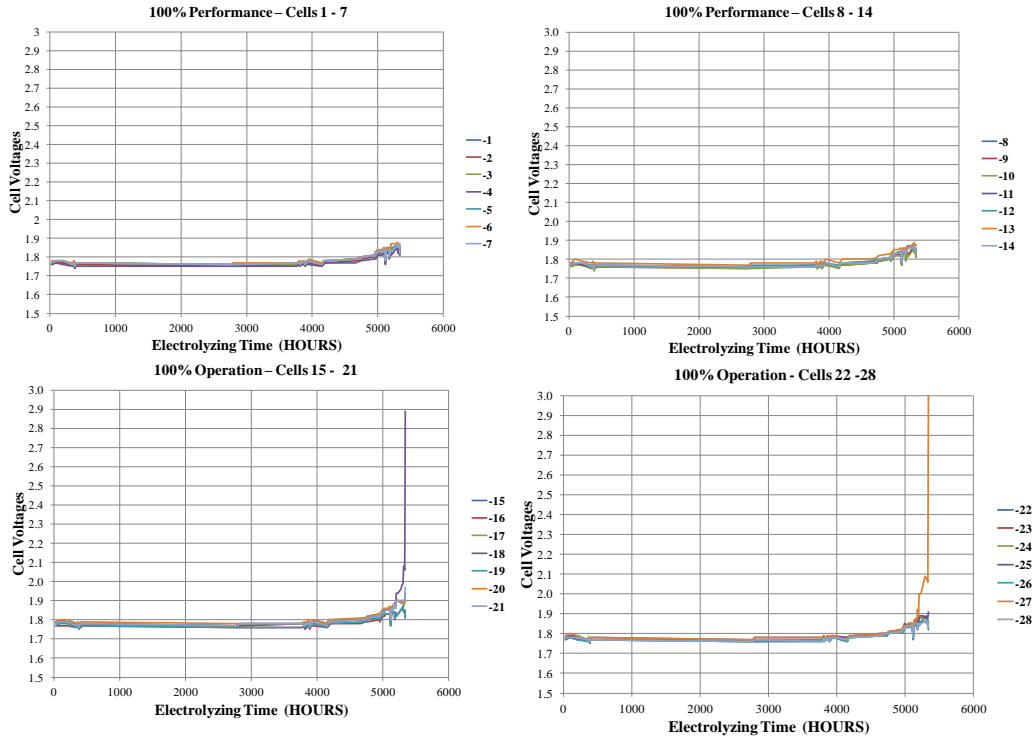
Figure 8. On-Orbit Performance Data at 100% Operation for Electrolysis Cell Stack S/N00003.

Chemical degradation of the cell membrane due to cationic contamination reduces the water content of the membrane, adversely impacting both the cell resistance (discussed above) and the water transport characteristics of the membrane. With a liquid cathode feed water electrolyzer, water must transport from the bulk fluid stream on the cathode side of the cell to the anode for electrolysis to occur. As the diffusion coefficient is strongly dependent on the water content of the membrane, cationic contamination retards the water transport characteristics of the membrane significantly increasing the concentration overpotential of the water electrolysis cell. This characteristic is apparent in the cell polarization curve where the plot of cell voltage versus current density becomes asymptotic at the cell’s limiting current density. As the water content of the cell is reduced due to cationic contamination, the polarization curve and the cell’s limiting current density shift to the left due to the inability of the cell membrane to maintain the water transport rate at a specific oxygen output level. The asymptotic change in the cell’s limiting current density is evident in the steep increases in the cell voltages observed just prior and up to the point of the fast shutdown of the Hydrogen ORU as seen in Figure 8.

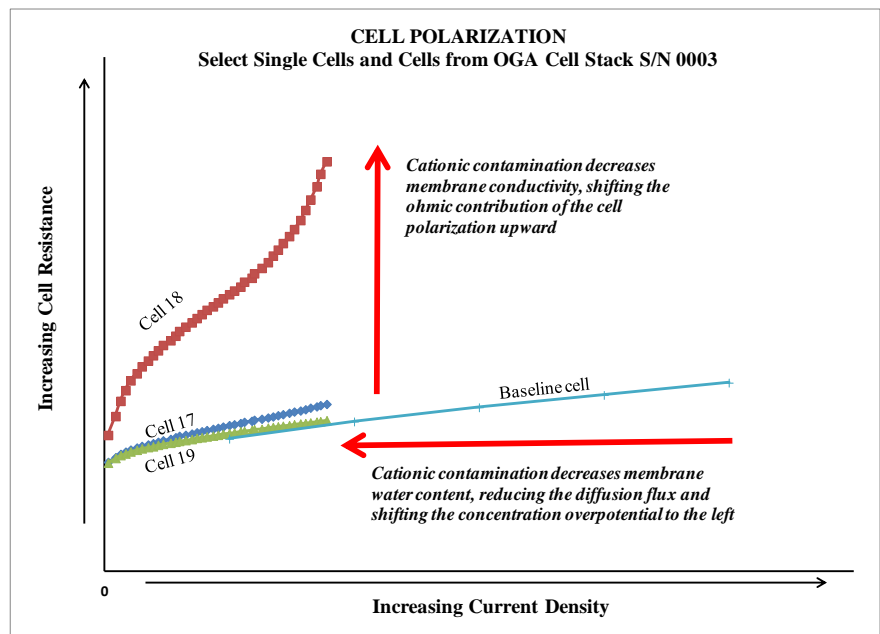
Figure 9. Polarization Curve – Cells 17, 18, 19 from Hydrogen ORU and Baseline MEA.

Testing of Cells 17, 18 and 19 in the laboratory showed stable operation at low oxygen production rates (25%); however, as the production rate was increased to 50% or 100%, Cell 18 triggered an automatic shutdown of the test article and test system due to rapid voltage rise. The polarization curves for the triplet of Cells 17, 18 and 19 is included in Figures 9, and provides evidence of reduced membrane water content and its adverse impact on the concentration overpotential and limiting current density of an operational water electrolysis cell.

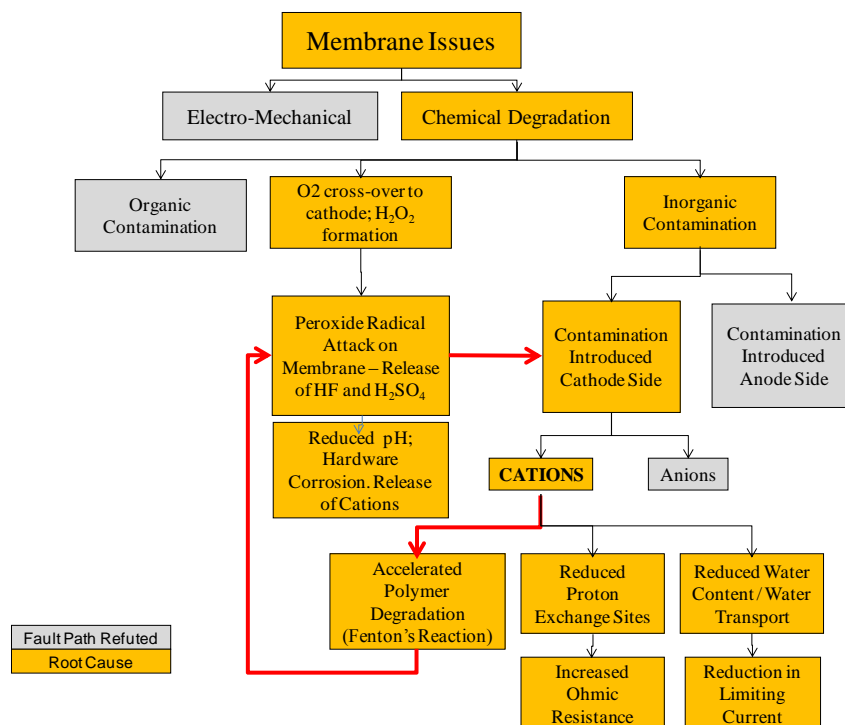
Figure 10. Fault Tree Branch for Membrane: Chemical Degradation Branch.

Figure 10 illustrates the Membrane Chemical Degradation branch of the fault tree and pictorially summarizes the mechanistic causes of the electrolysis cell stack increased cell resistance.
