NASA WG3 MMOD Protection Summary

Interagency Space Debris Coordination Committee (IADC)

May 2012

Summary of MMOD Protection Activities

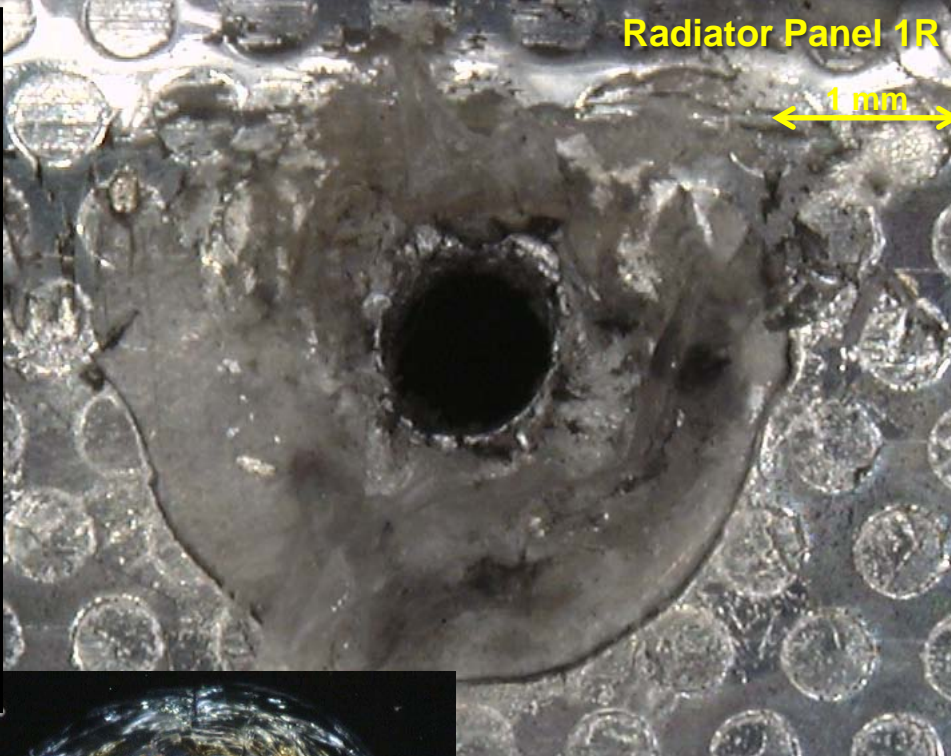
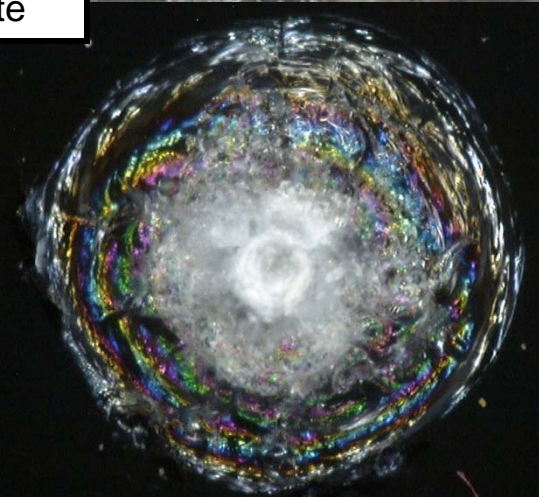
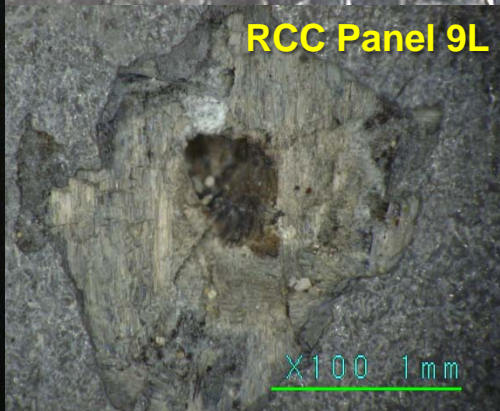
Number of MMOD Impacts	Largest MMOD Impacts
Windows	7 craters	W6: 2.5 x 2.5 mm damage extent
Radiators	3 MMOD damages reported	1 face sheet perforation
RCC	9 MMOD indications	Panel 9L: 2.3 x 1.9mm, depth = 0.4 mm exposed substrate

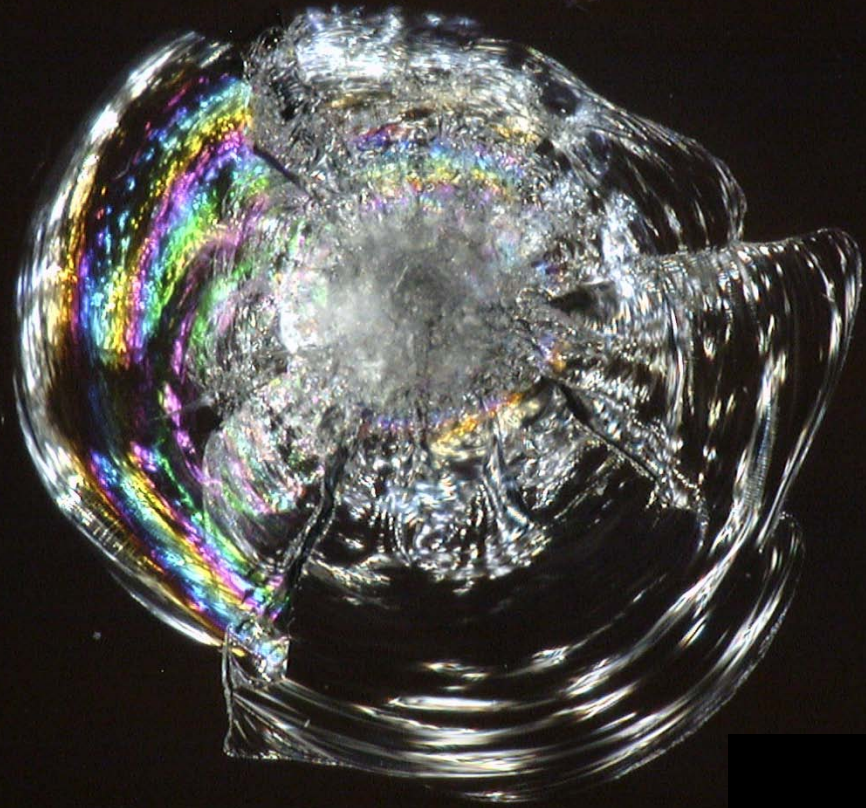
Window 3

Number of MMOD Impacts	Largest MMOD Impacts
Windows	10 craters	W3: 3.7 x 3.5 mm damage extent
RCC	13 MMOD indications	Panel 9L: 1.3 x 1.0mm, depth = 0.27 mm no exposed substrate

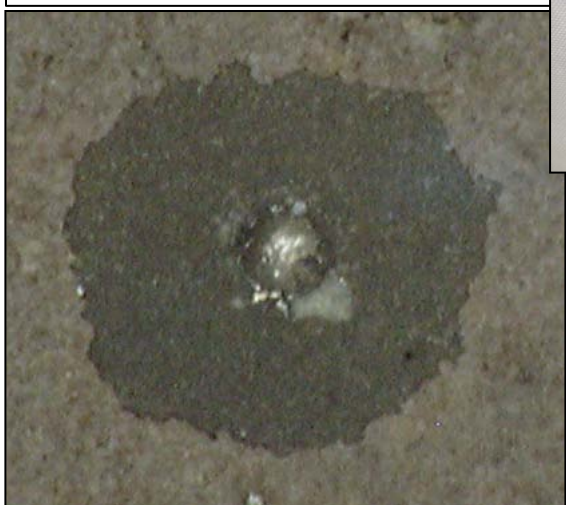
MPLM grapple fixture coating spall dia. = 0.6 mm

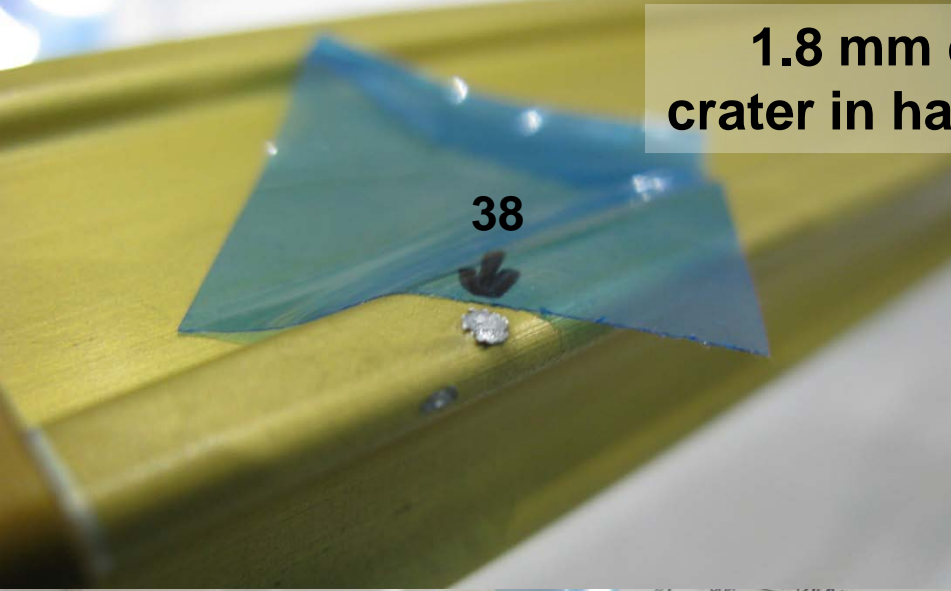
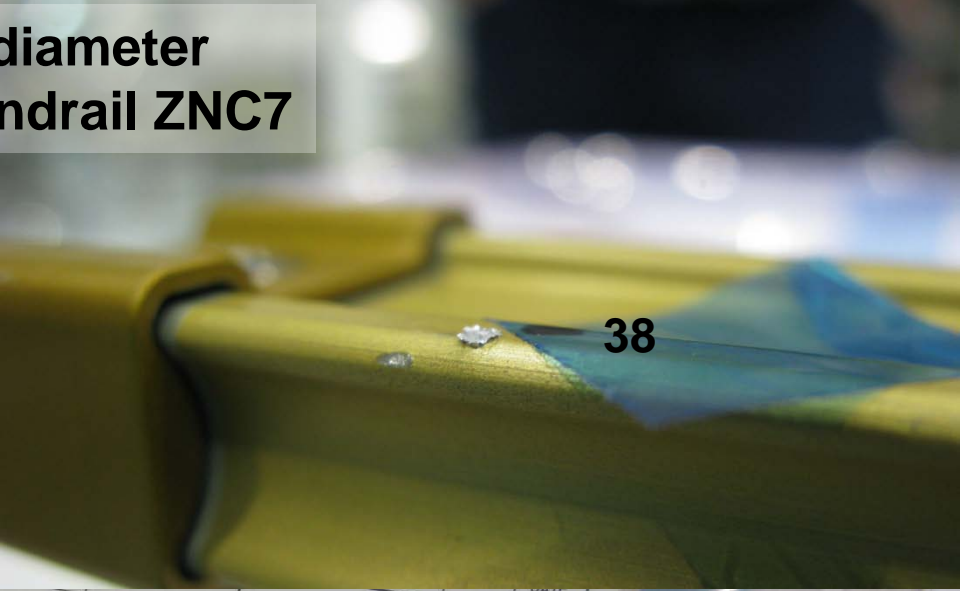
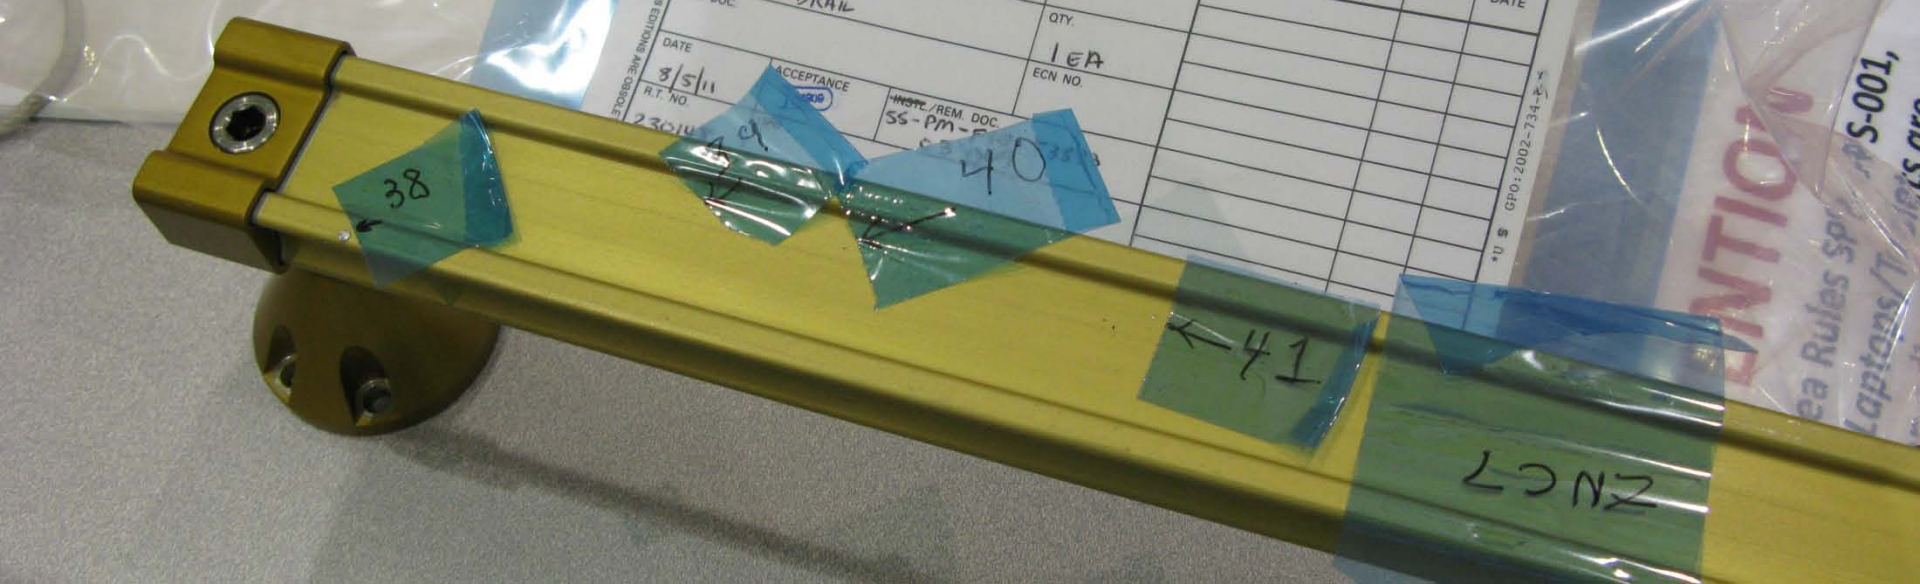
LAPA
Handrail
ZNC7

1.8 mm diameter crater in handrail ZNC7

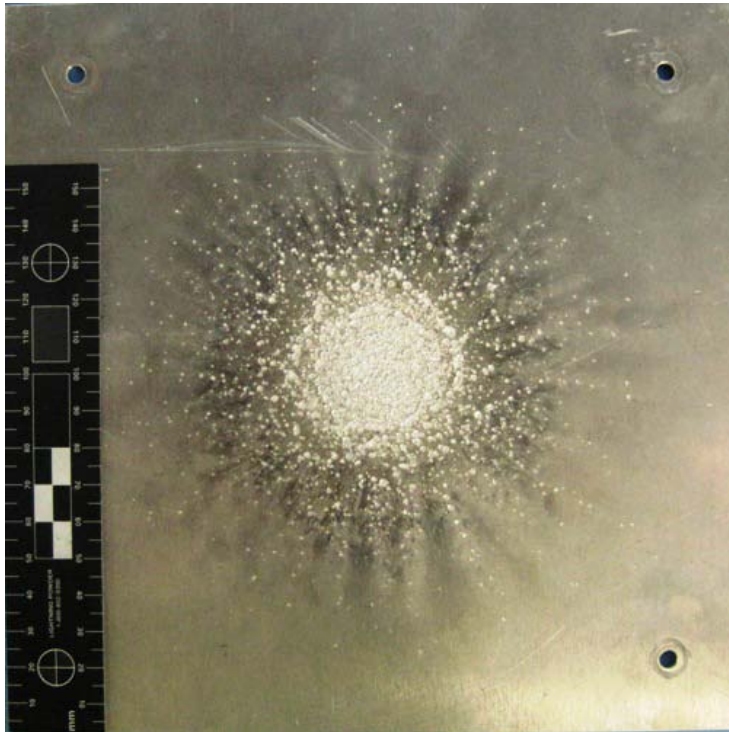
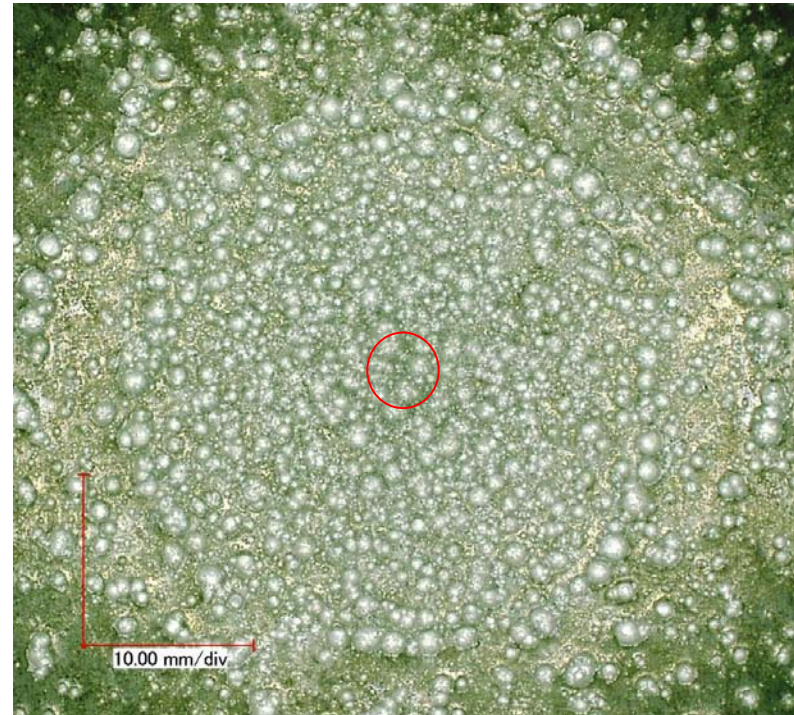
- HITF-11146, 3.2mm AL 2027 projectile, 0.04779g, 5.77km/s, 0deg
 - **2nd layer front side:** multiple craters (no through-holes), maximum crater size 1.6 mm diameter x 1.7 mm deep, circular area of concentrated crater damage within 44 mm diameter, majority of crater damage (>95% of craters) are within 130 mm diameter

Deepest penetration within red circle

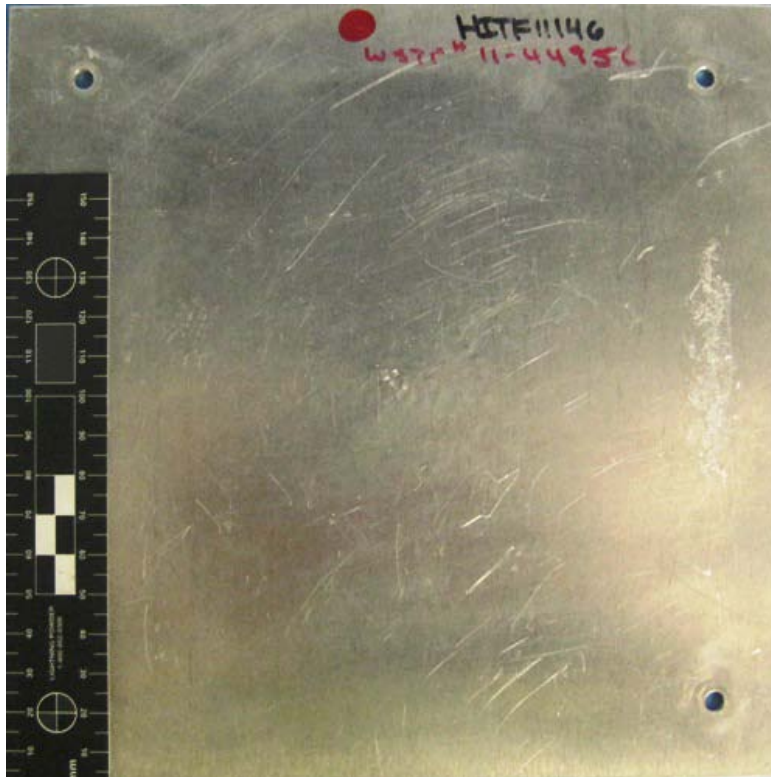
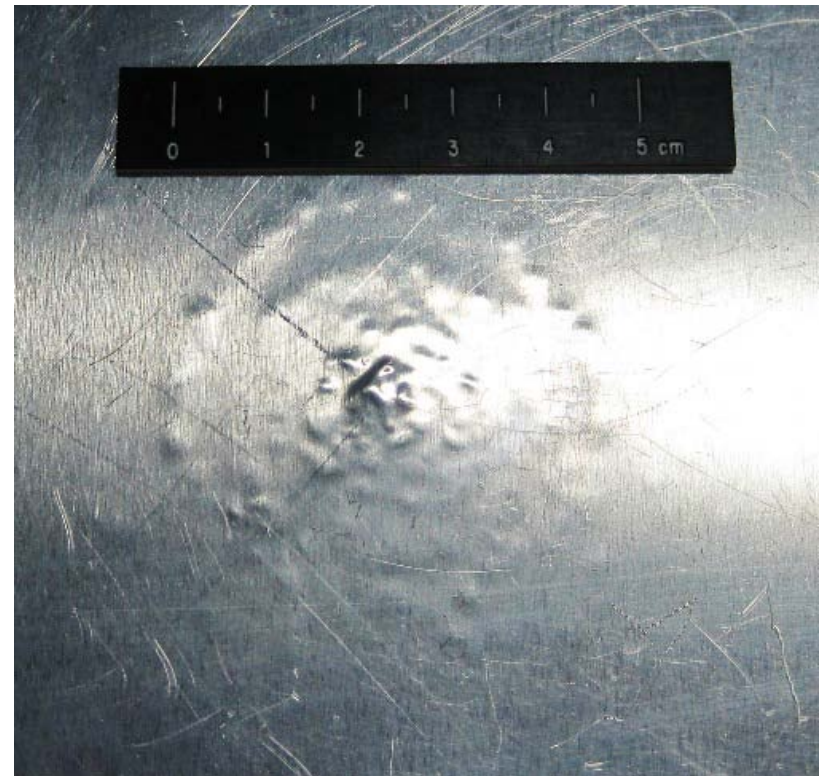
- HITF-11146, 3.2mm AL 2027 projectile, 0.04779g, 5.77km/s, 0deg
 - **2nd layer back side:** small bumps on back side of plate within 64mm x 66mm area, maximum height 0.8mm, no detached spall present

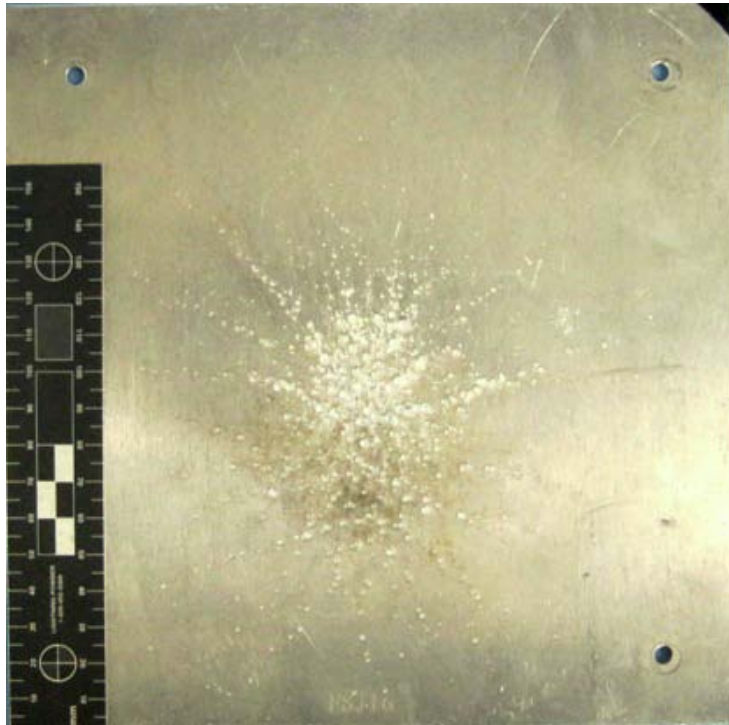
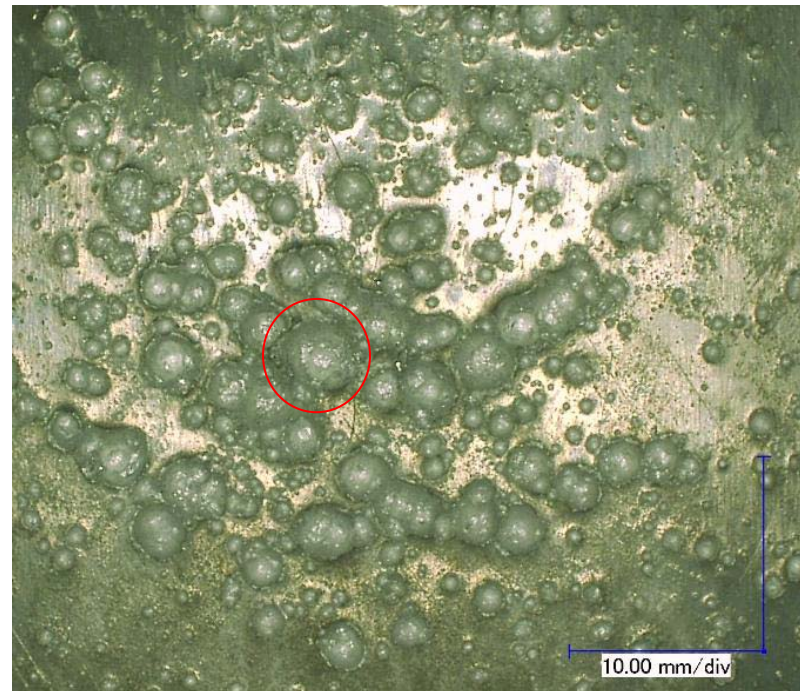
- HITF-11147, 3.2mm AL 2027 projectile, 0.04788g, 5.30km/s, 30deg
 - **2nd layer front side:** multiple craters (no through-holes), maximum crater size 3.5 x 3.2 mm diameter and 1.8 mm deep, concentrated area of crater damage within 44 x 36 mm diameter

Deepest penetration within red circle

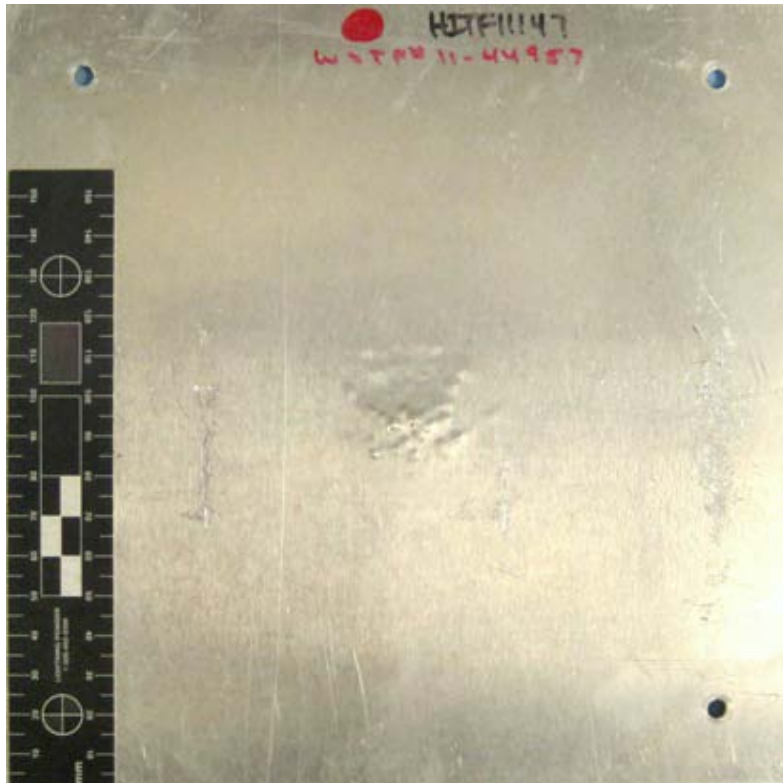
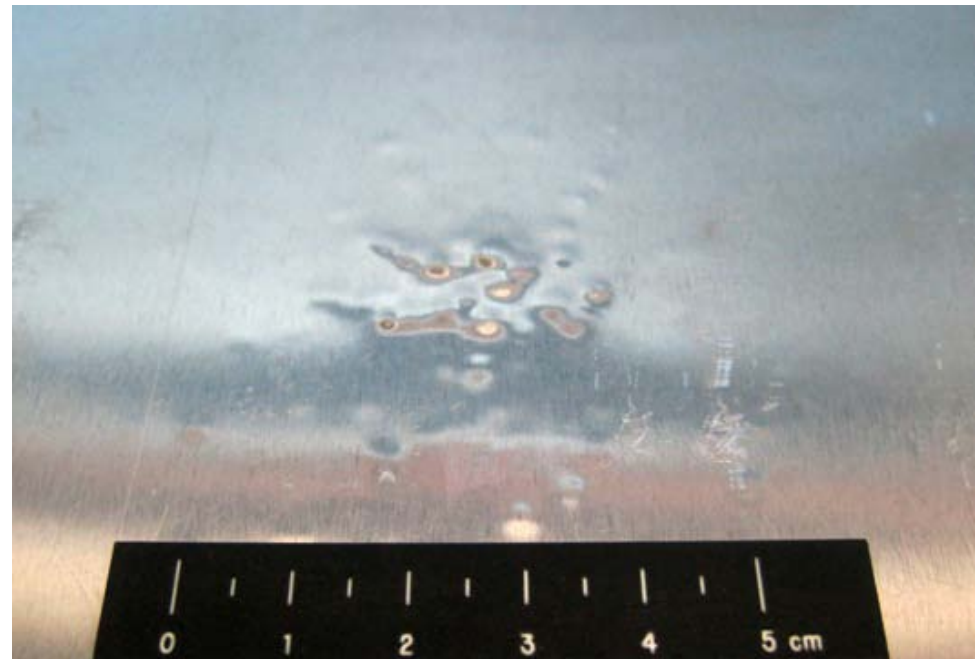
- HITF-11147, 3.2mm AL 2027 projectile, 0.04788g, 5.30km/s, 30deg
 - **2nd layer back side:** small bumps on back side of plate within 65mm x 63mm area, maximum height 0.8 mm, no detached spall present

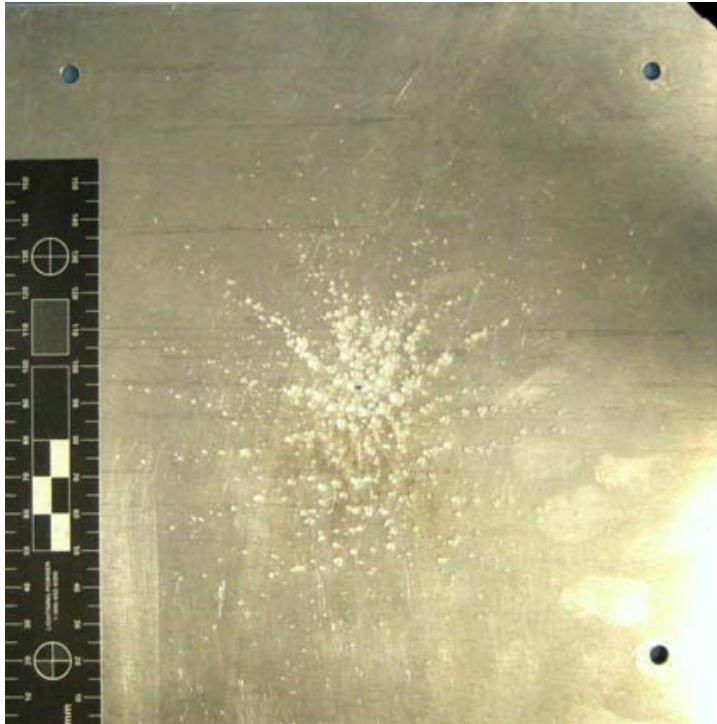
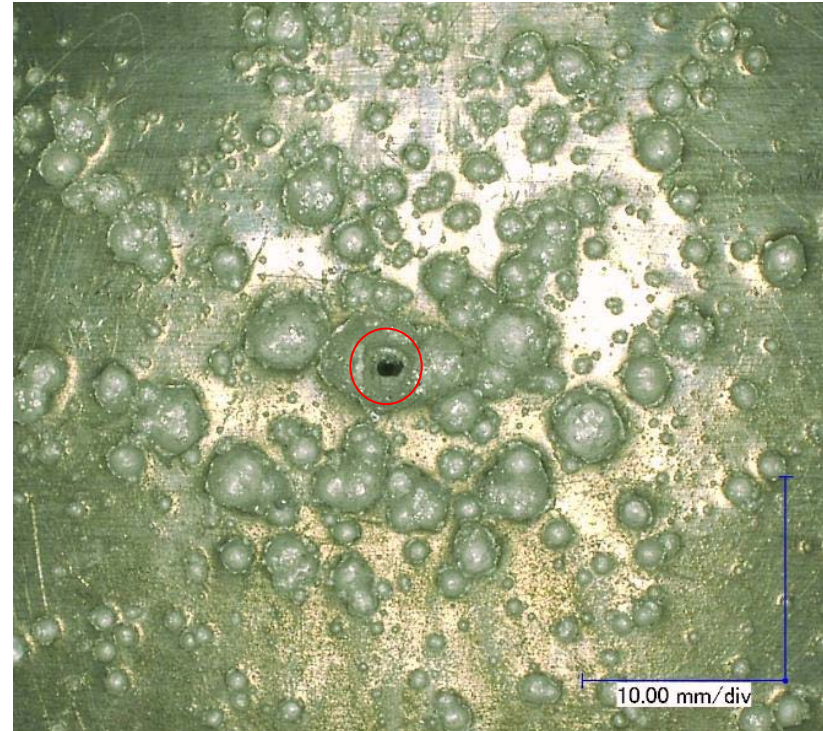
- HITF-12092, 3.2mm AL 2027 projectile, 0.04767g, 5.01km/s, 30deg
 - **2nd layer front side:** One through hole (rear wall failed), multiple craters, hole size 1.4 x 0.8 mm, maximum crater size 3.4 x 2.6 mm diameter, concentrated area of crater damage within 41 x 39 mm diameter

Complete penetration within red circle

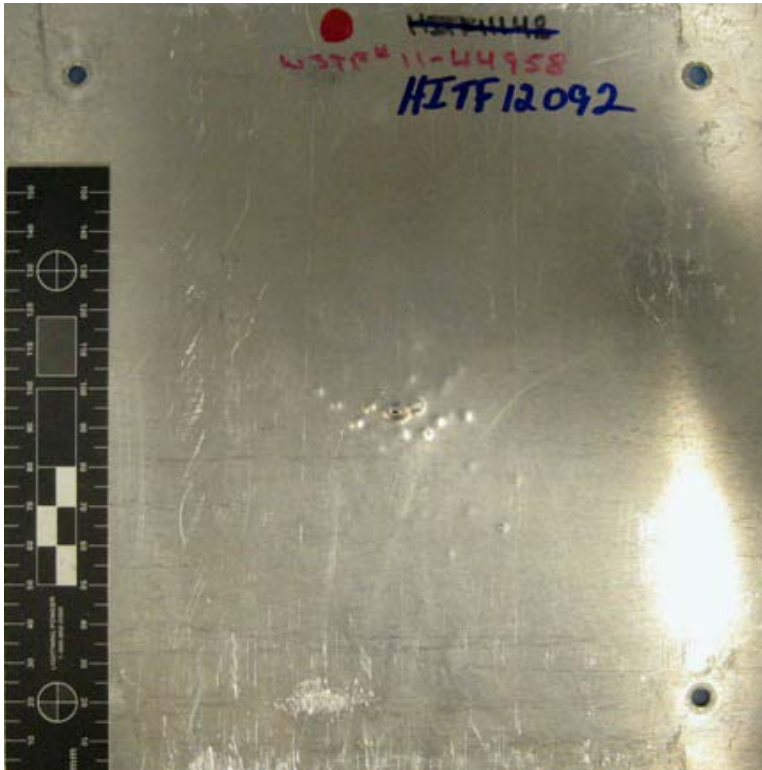
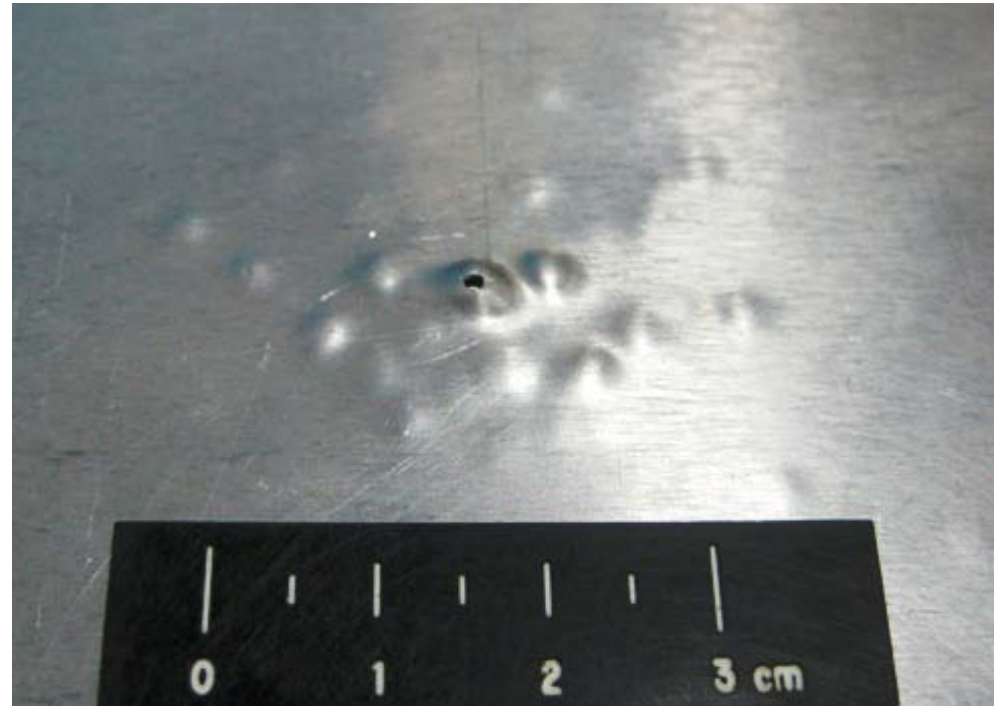
- HITF-12092, 3.2mm AL 2027 projectile, 0.04767g, 5.01km/s, 30deg
 - **2nd layer back side:** small bumps on back side of plate within 63mm x 61 mm area, maximum height of bump at perforation 2.1 mm above surface

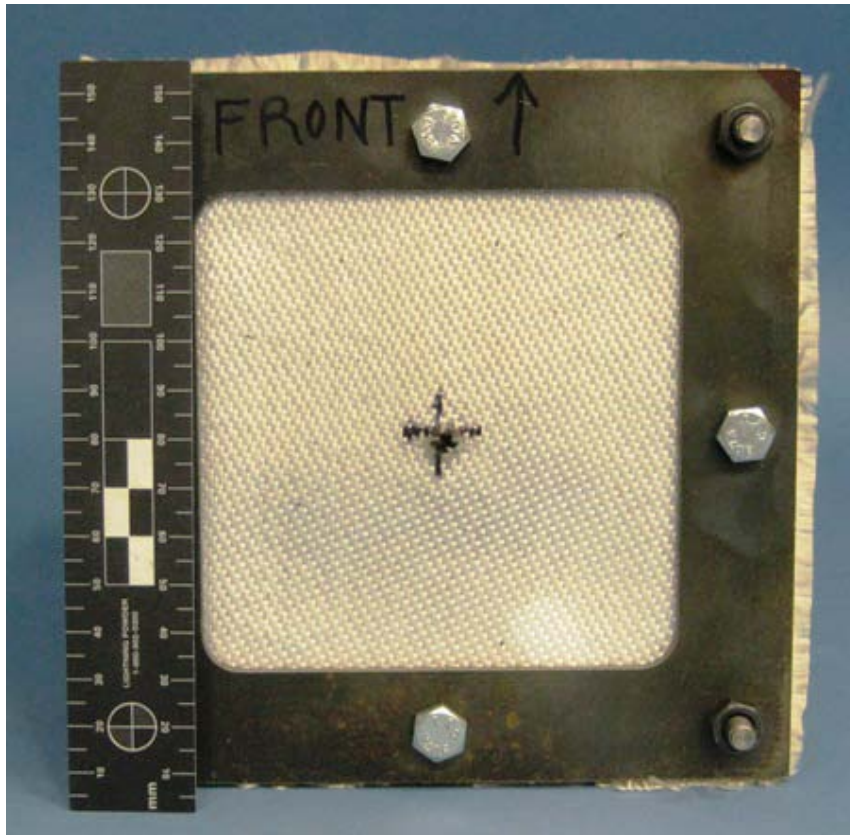
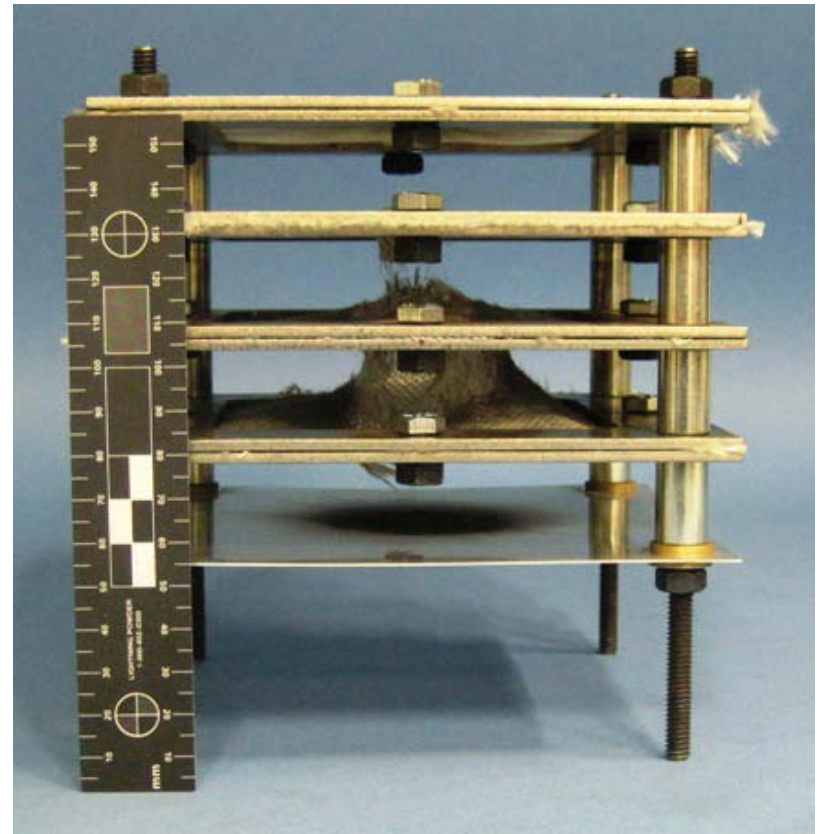
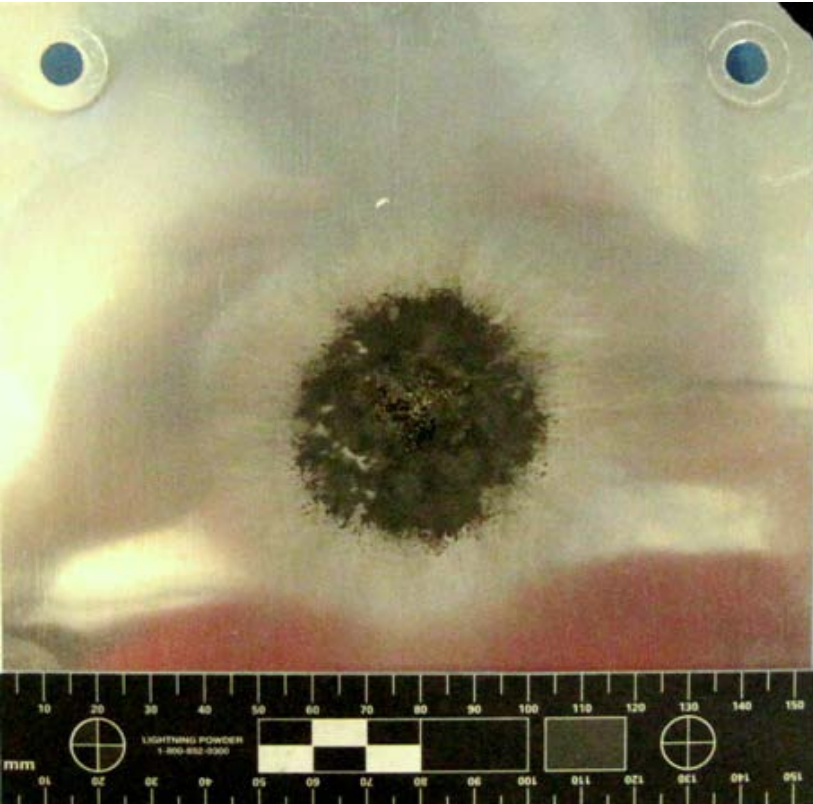
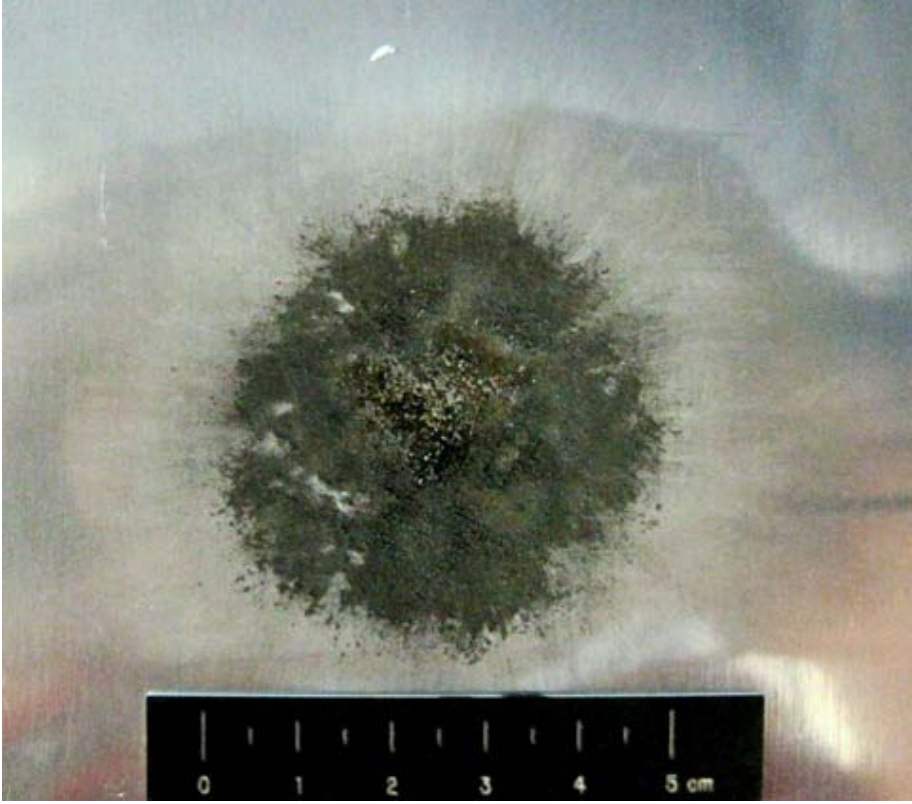
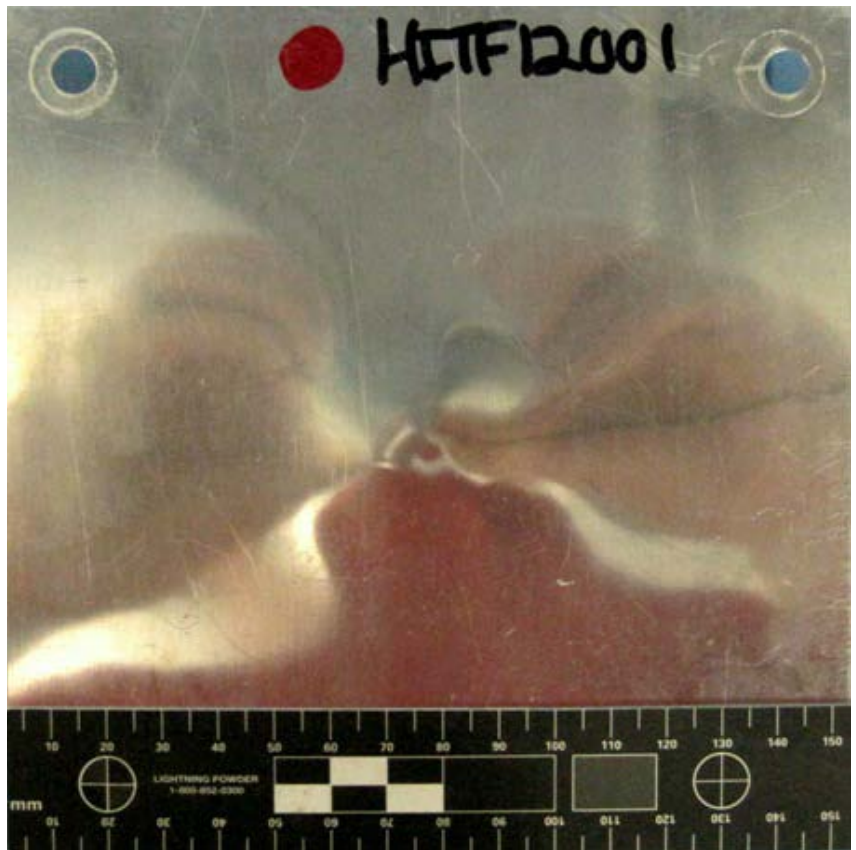
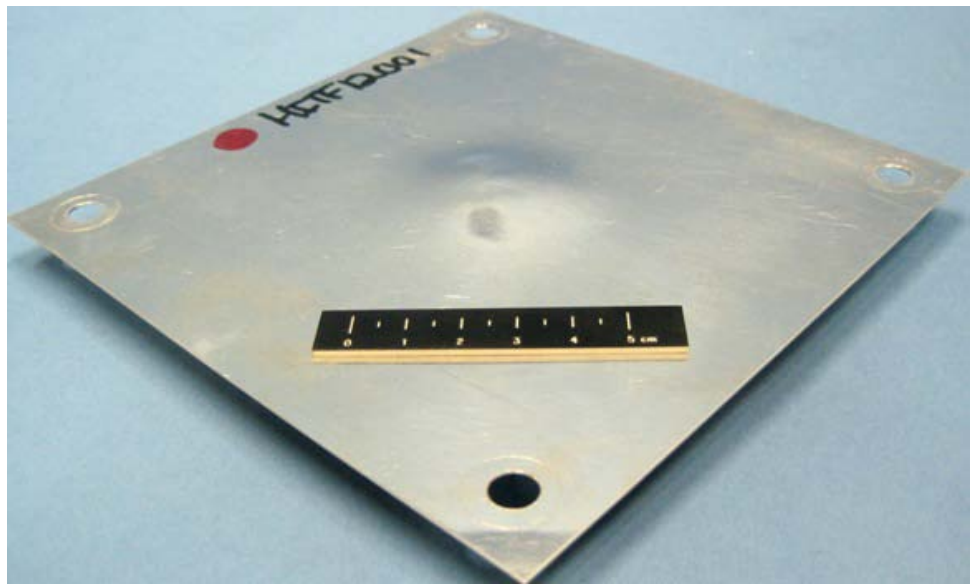
HITF-12001, Multishock $0.36\text{g}/\text{cm}^2$ 3.2mm diameter Al 2017T4, 6.93 km/s, 0deg

Test number	Projectile impact conditions	Target Configuration and overall mass per unit area	Damage to bumper layers	Damage to aluminum rear wall
#1. HITF-12001	3.2mm Al, 0.04725g, 6.93 km/s, 0 deg impact angle	Multishock shield 0.36 g/cm ²	1 st layer: 5.5 x 4.6 mm hole 2 nd layer: 17.0 x 16.7mm hole 3 rd layer: 42.9 x 27.5mm hole 4 th layer: 45.1 x 33.3mm hole	Bulge, dish (no failure) Impacted area 48mm diameter, bulge is 60mm diameter by 3.5mm high

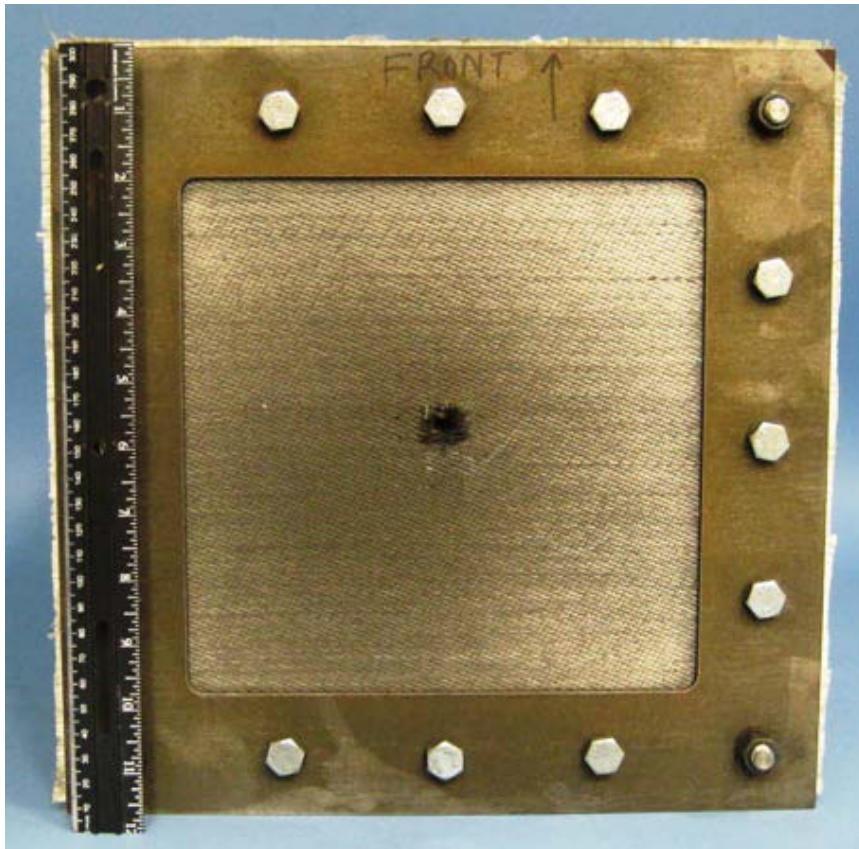
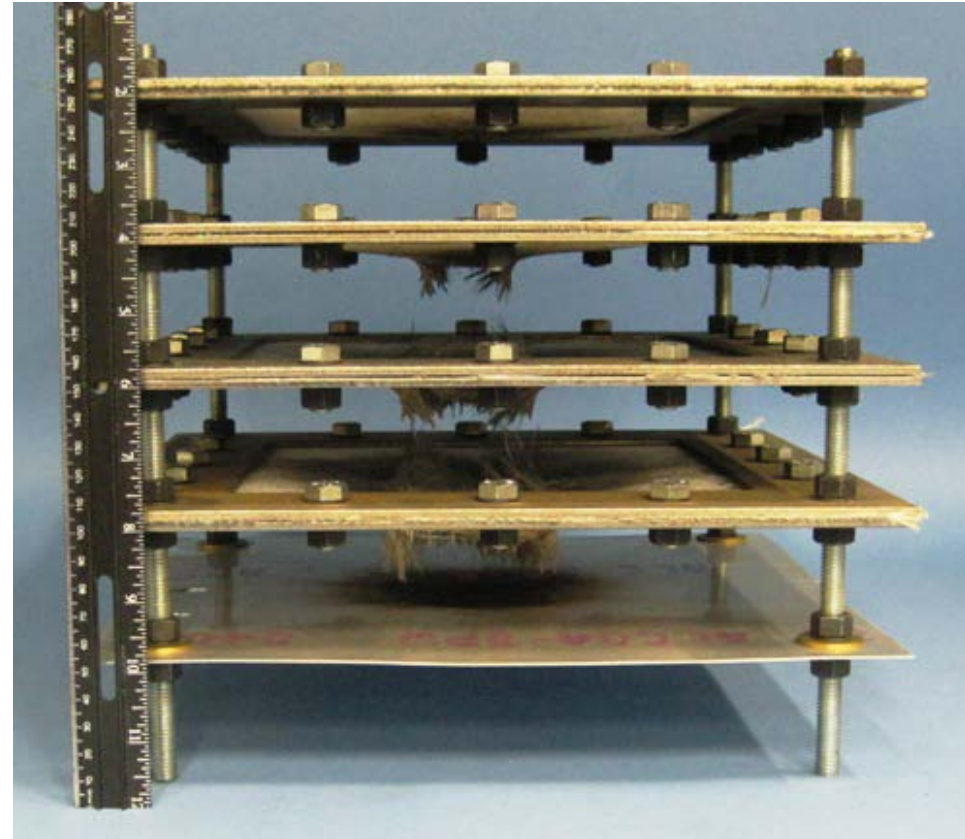
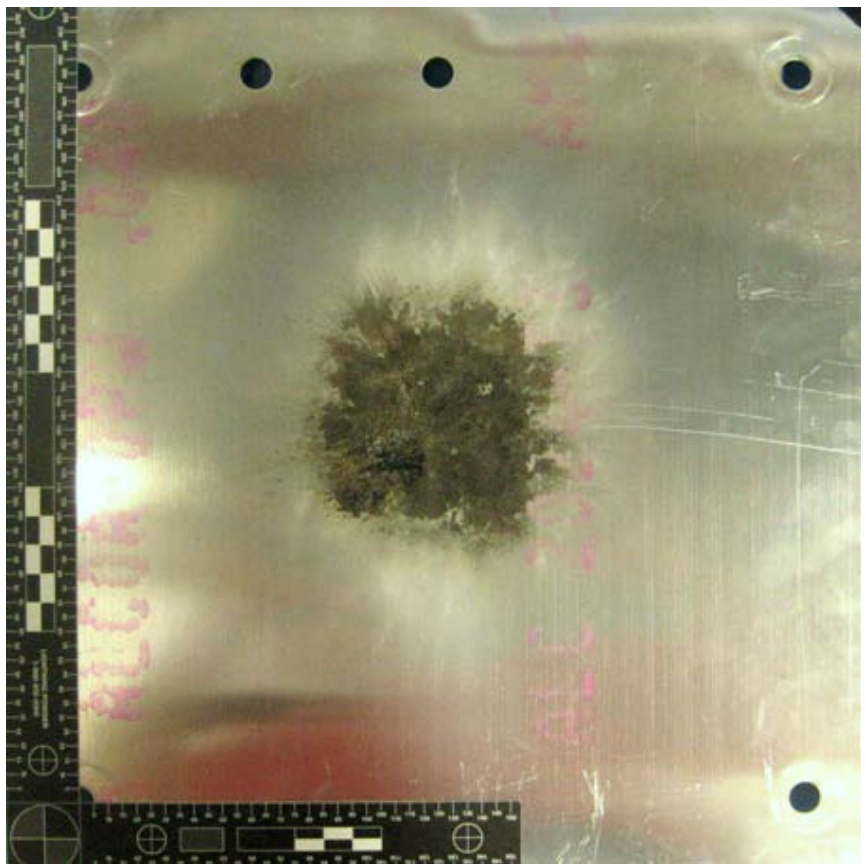
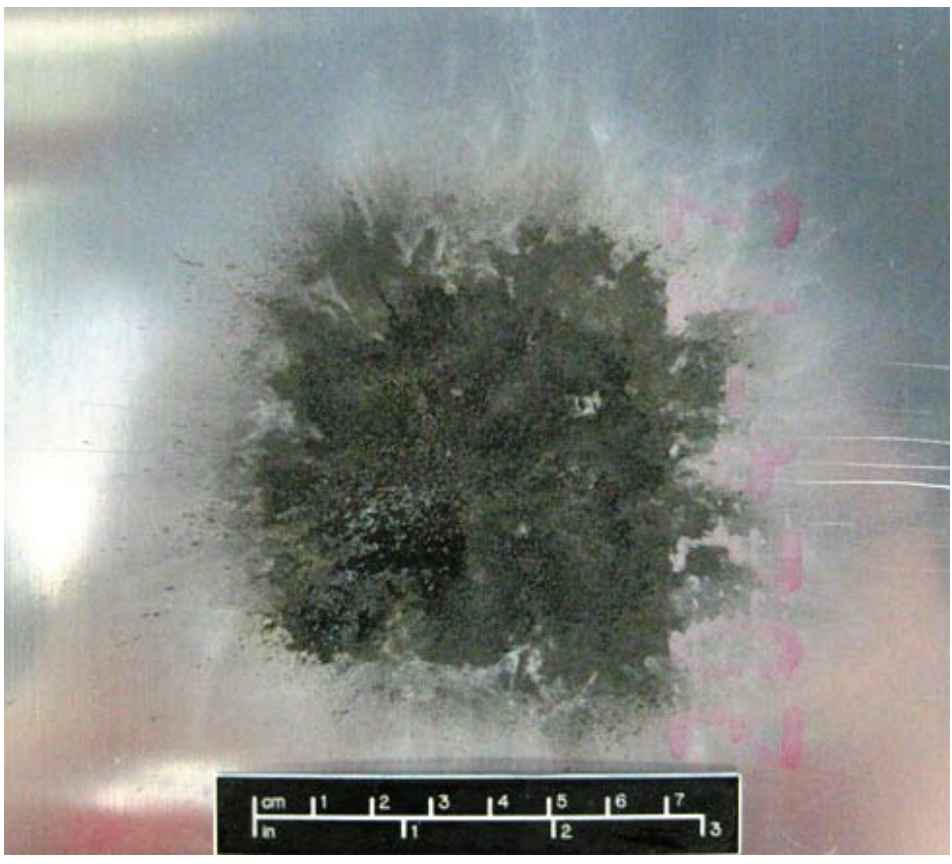
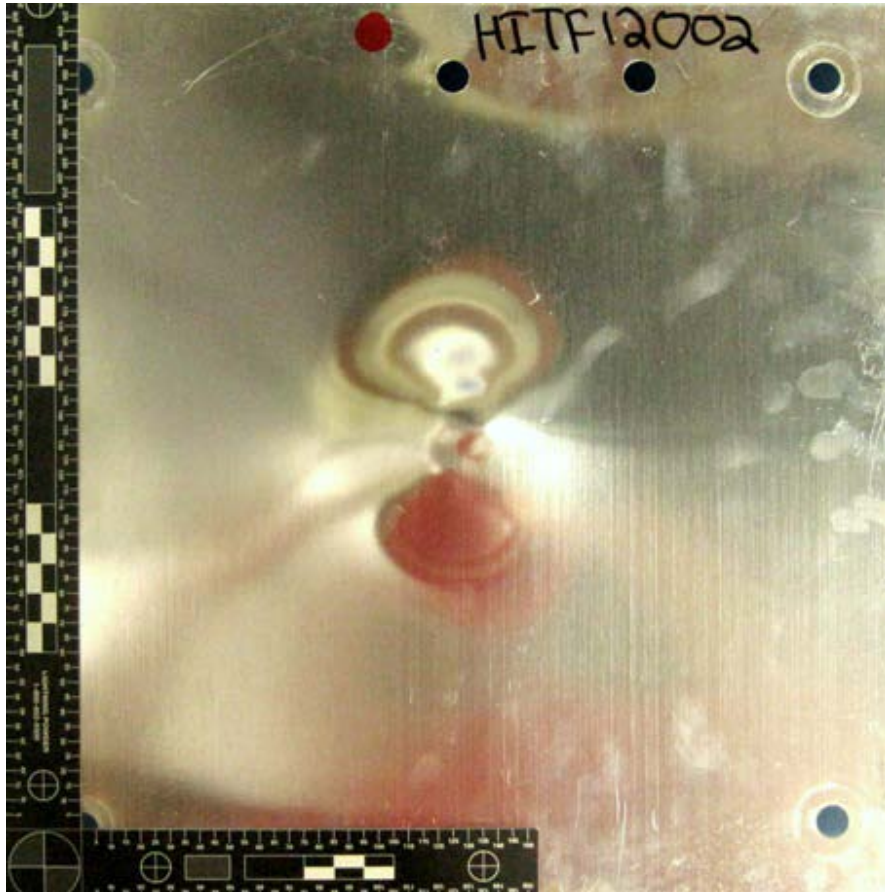
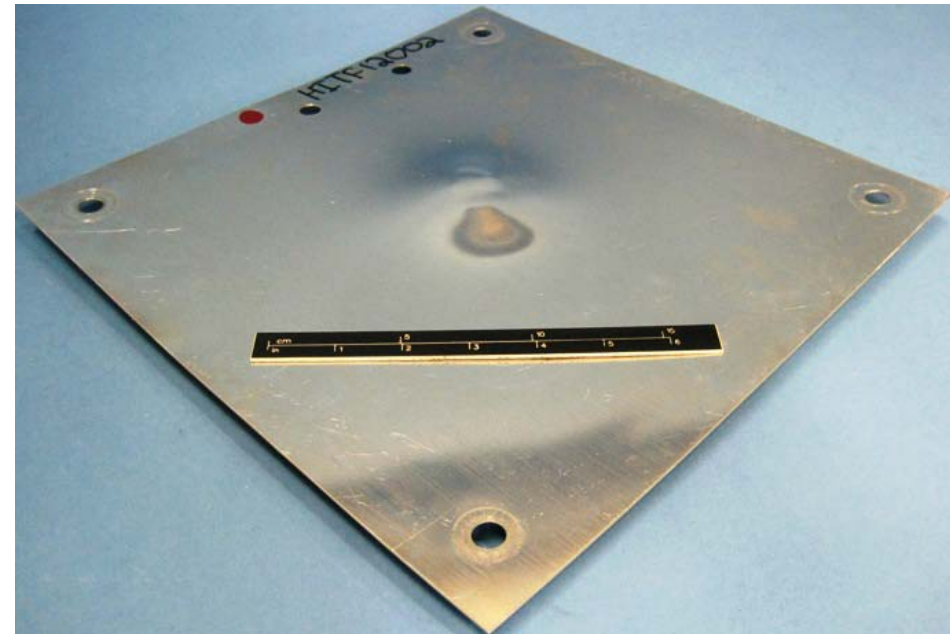
HITF-12002, Multishock 0.647g/cm^2 6.4mm diameter Al 2017T4, 6.86 km/s, 0deg

#2. HITF-12002	6.4mm Al, 0.37406g, 6.86 km/s, 0 deg impact angle	Multishock shield 0.65 g/cm ²	1 st layer: 10.0 x 9.8mm hole 2 nd layer: 30.1 x 27.3mm hole 3 rd layer: 46.7 x 44.3mm hole 4 th layer: 65.6 x 50.5mm hole	Bulge, dish (no failure) Impacted area 86mm diameter, bulge is 116mm diameter by 9.4mm high
