NASA WG3 MMOD Protection Summary

Interagency Space Debris Coordination Committee (IADC)

May 2012

Summary of MMOD Protection Activities

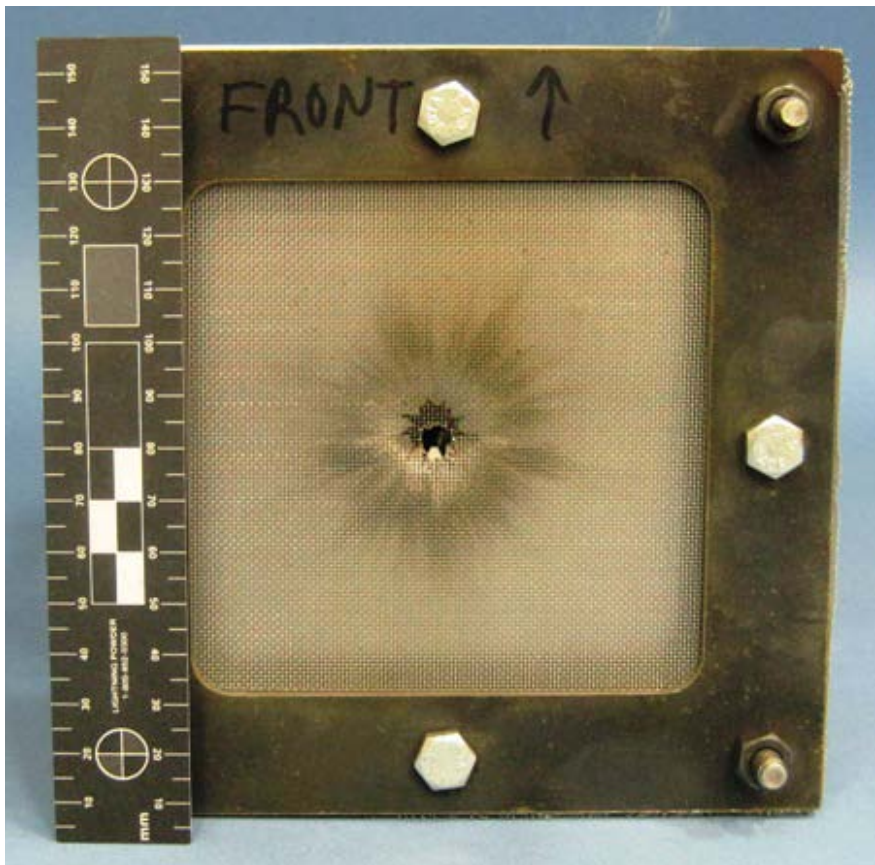
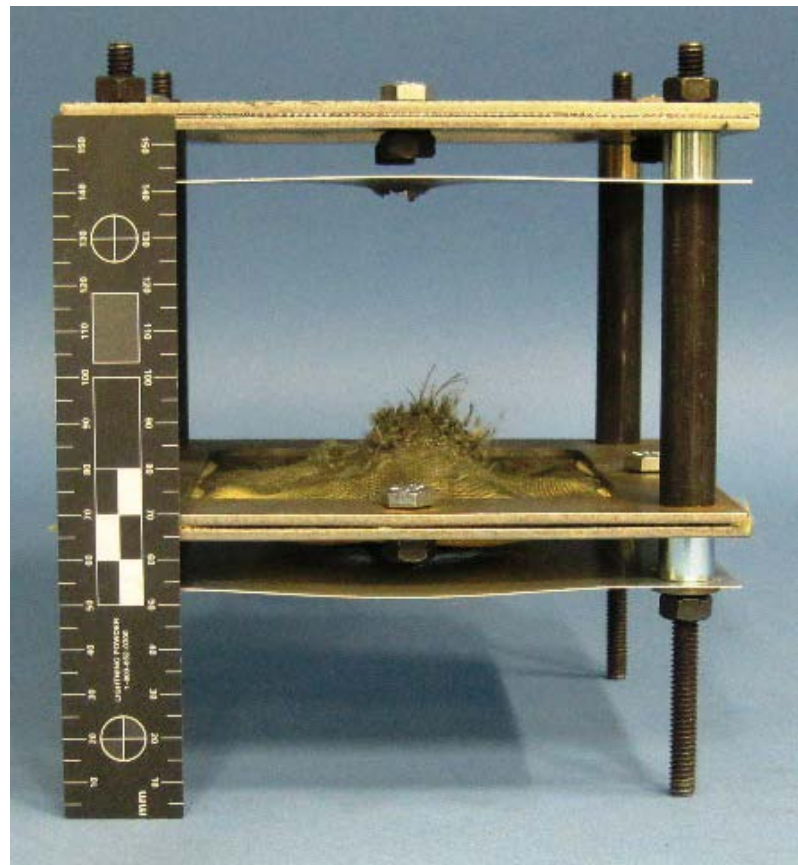
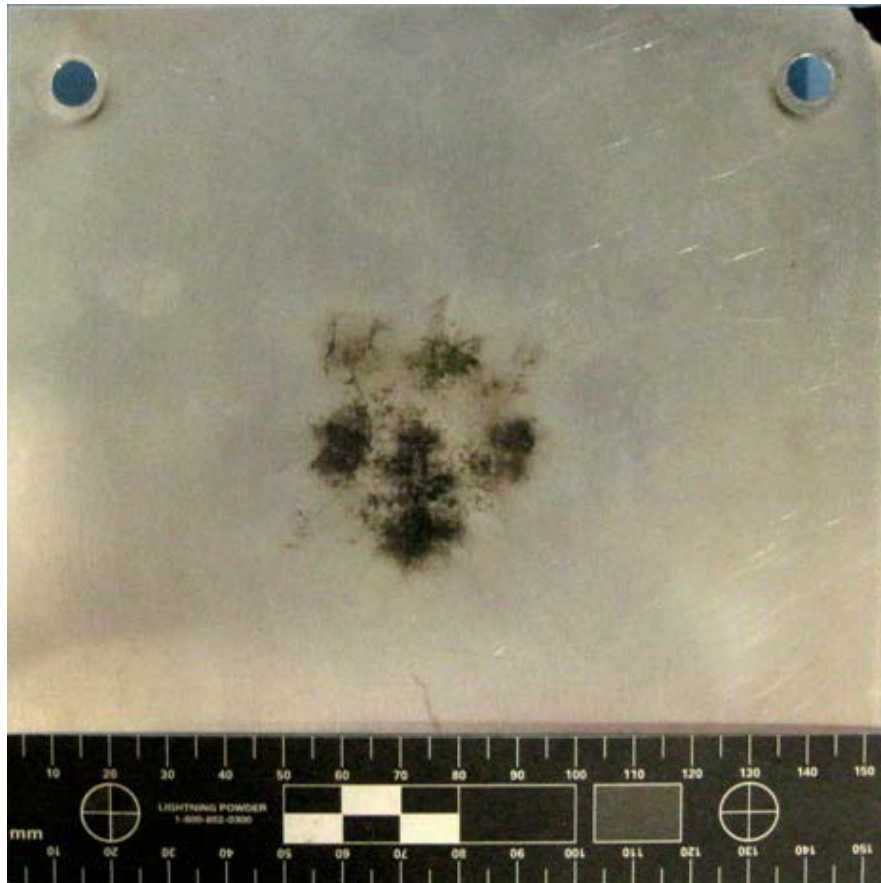
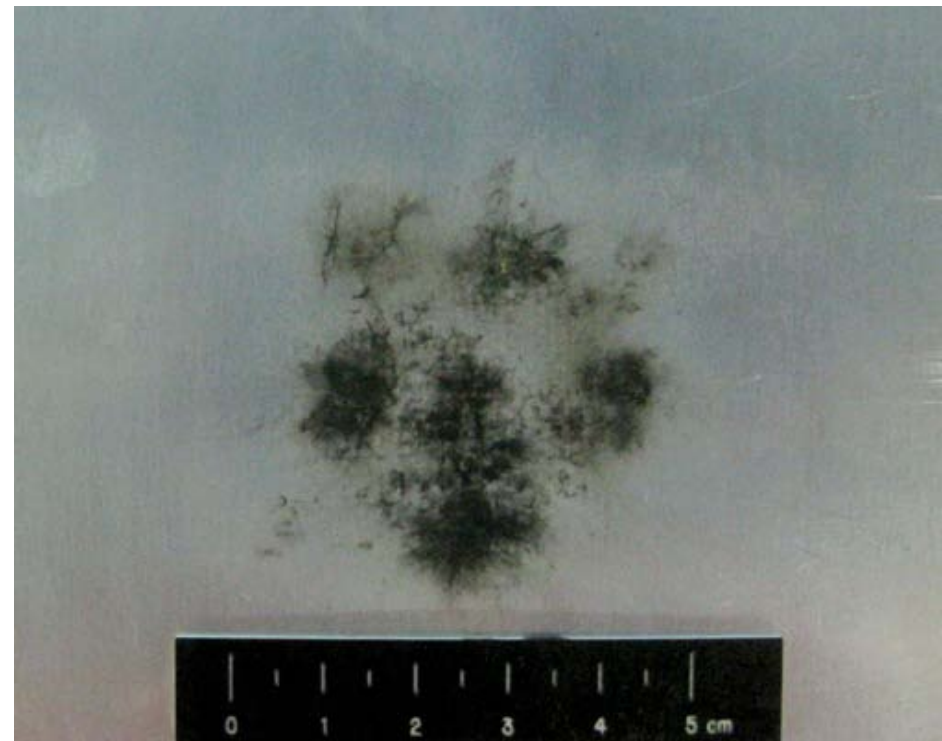
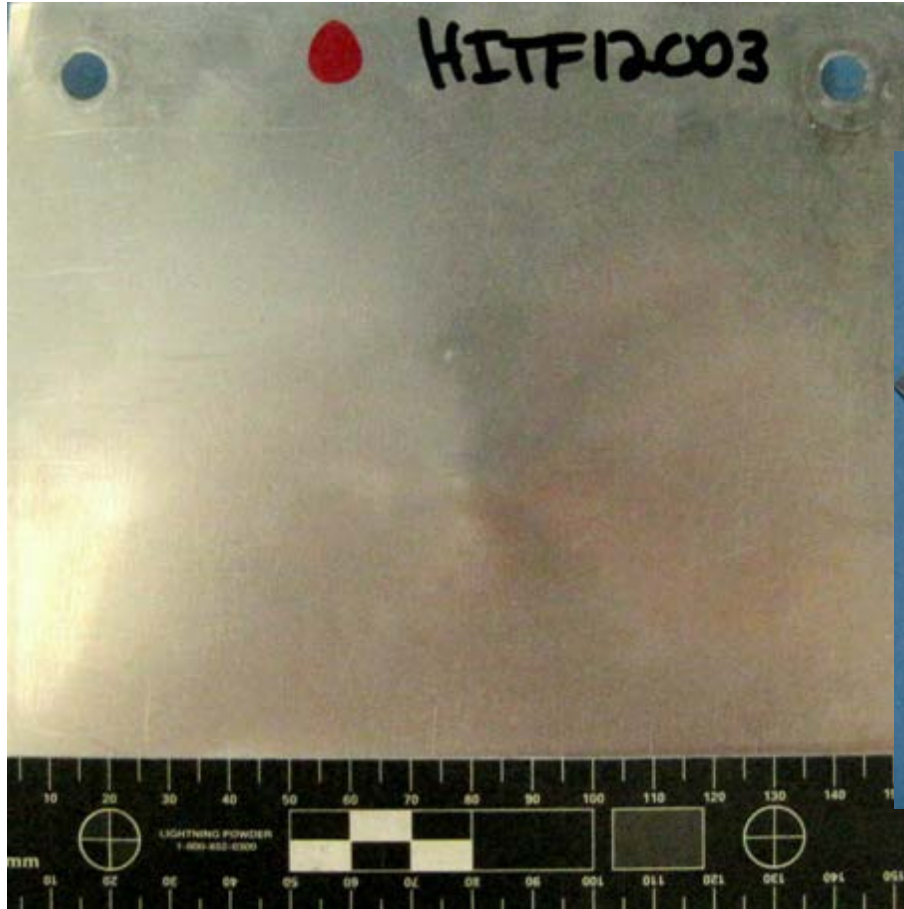
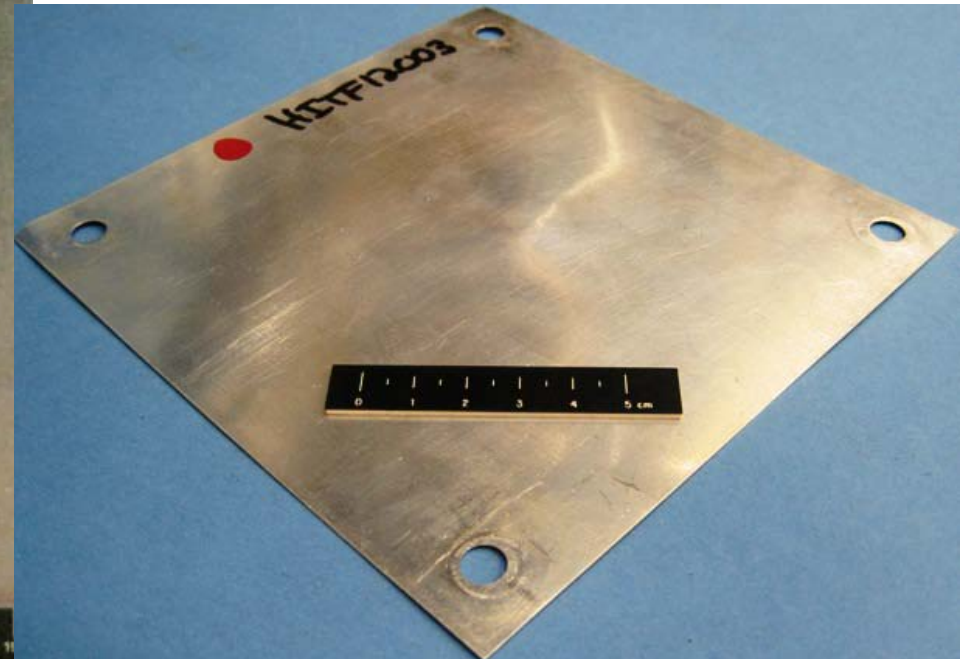
HITF-12003, Mesh Double Bumper 0.33g/cm² 3.2mm diameter Al 2017T4, 6.85 km/s, 0deg

#3. HITF-12003	3.2mm Al, 0.04725g, 6.85 km/s, 0 deg impact angle	Mesh Double Bumper shield 0.33 g/cm ²	1 st layer: 6.3 x 5.9mm hole 2 nd layer: 8.9 x 8.7mm hole 3 rd layer (last layer of Kevlar): multiple perforations in 54 x 42 mm area, with largest hole 3.9 x 3.8mm	Bulge, dish (no failure) Impacted area 48 x 42mm diameter, bulge is 43 x 37mm diameter by 1.3mm high

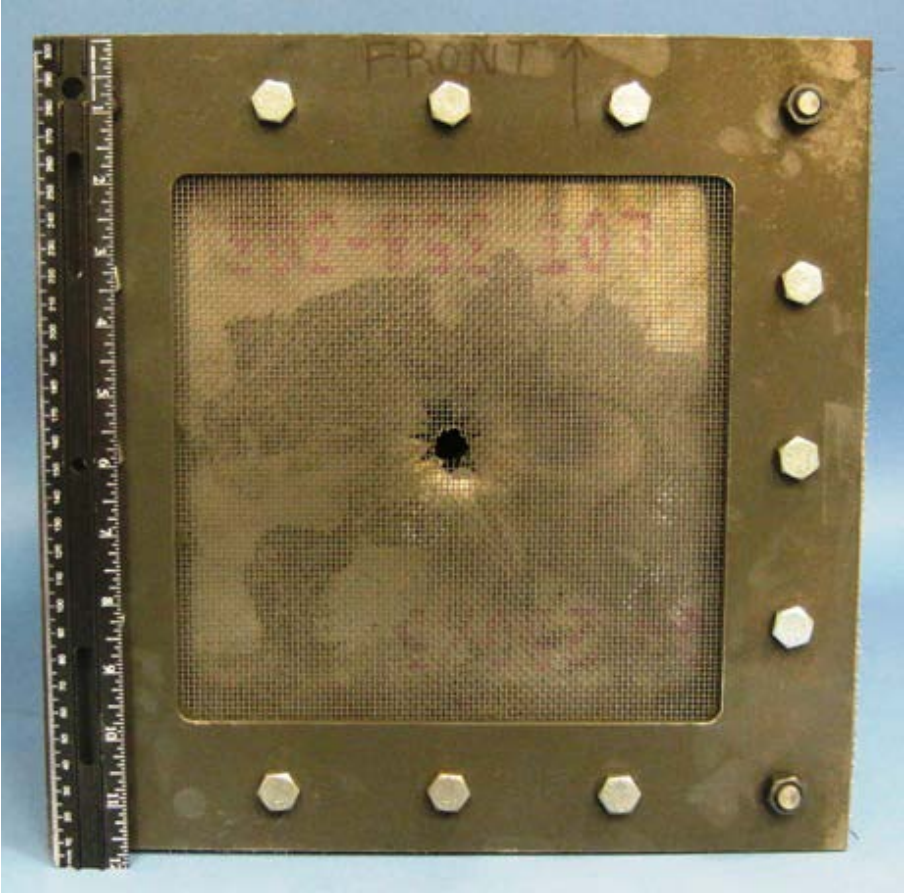
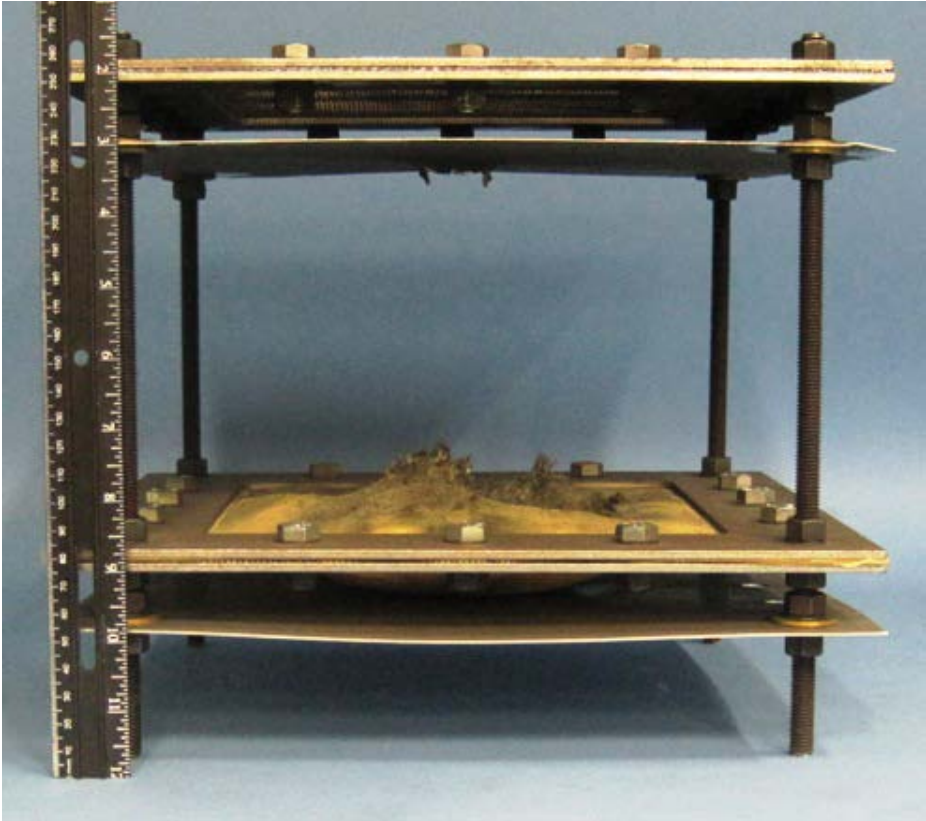
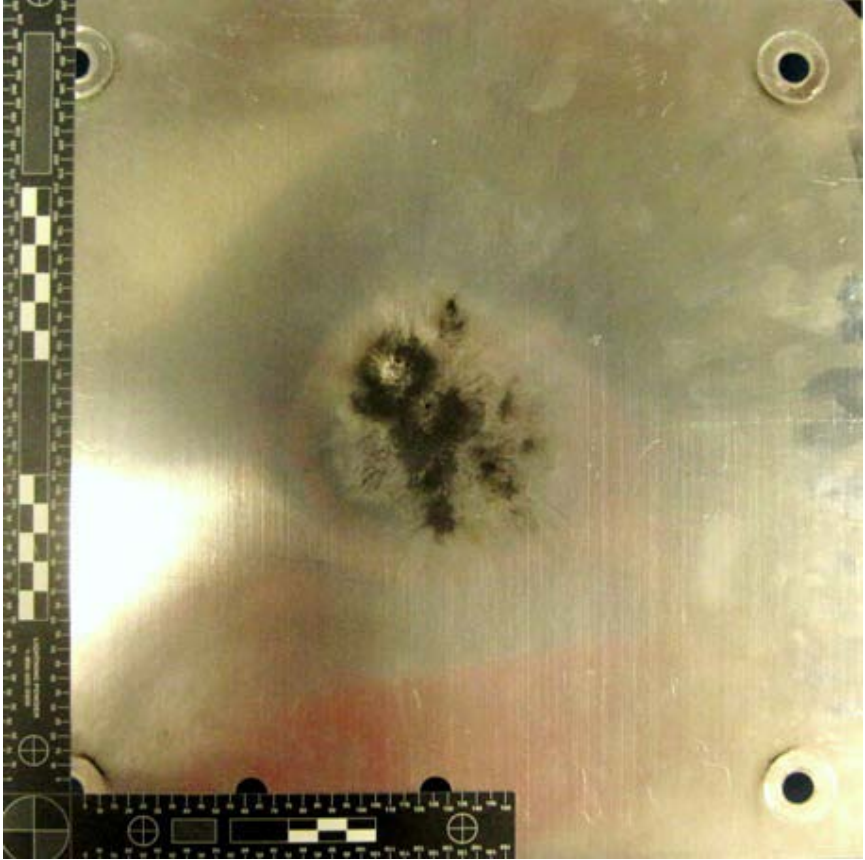
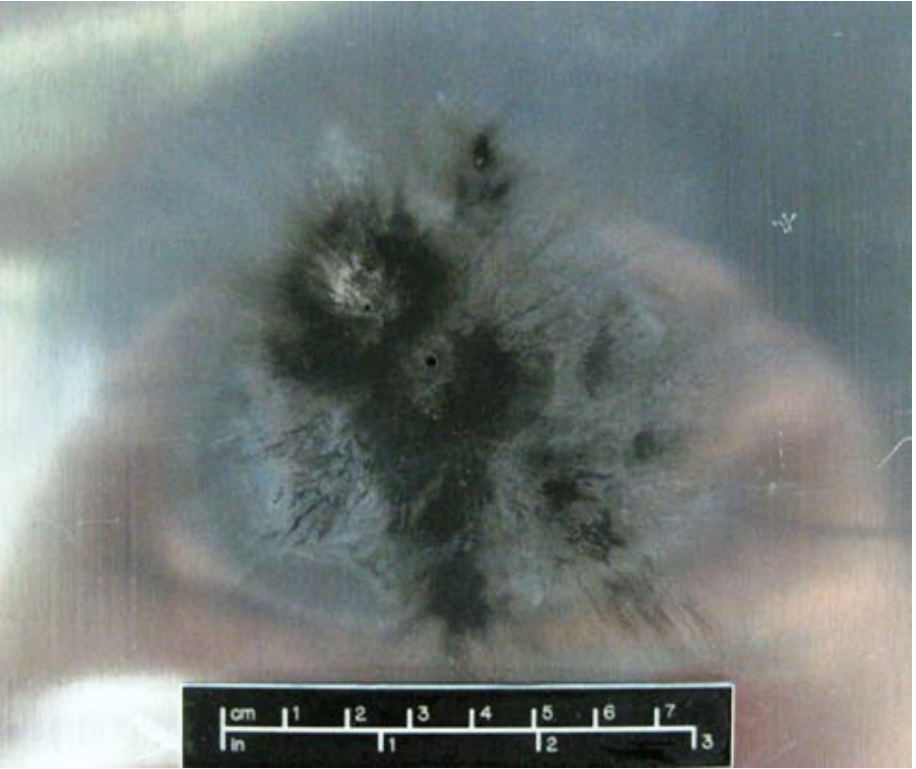
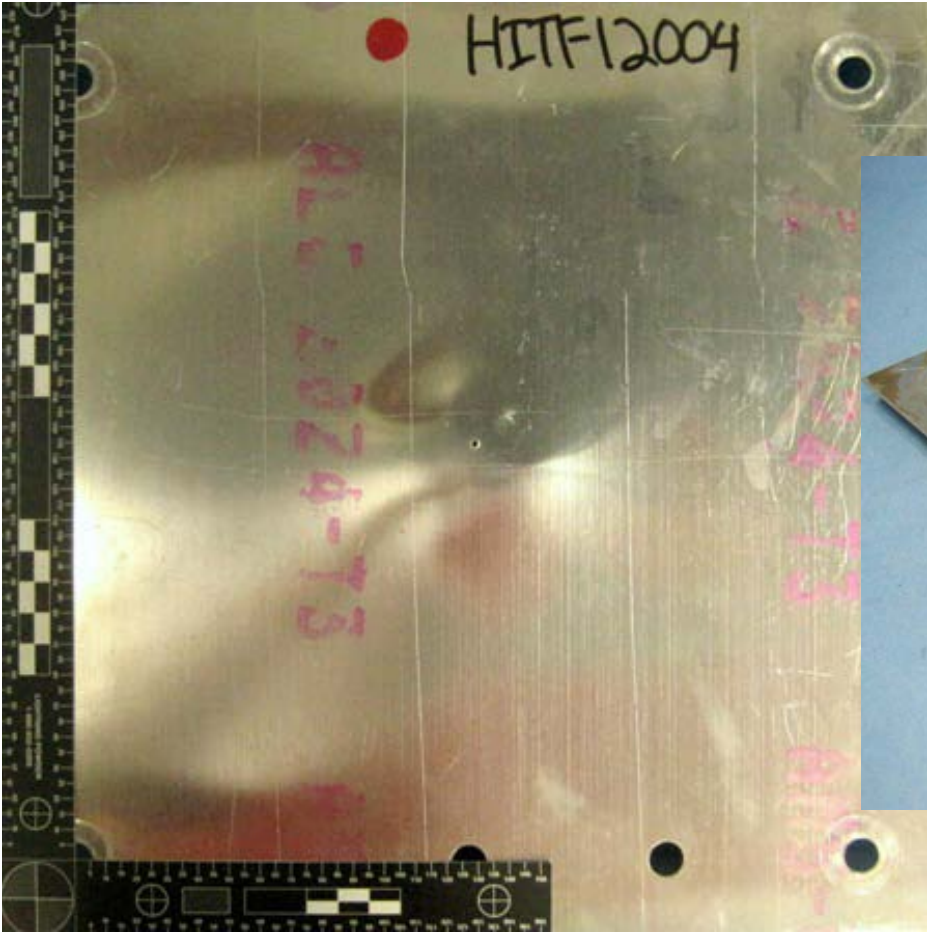
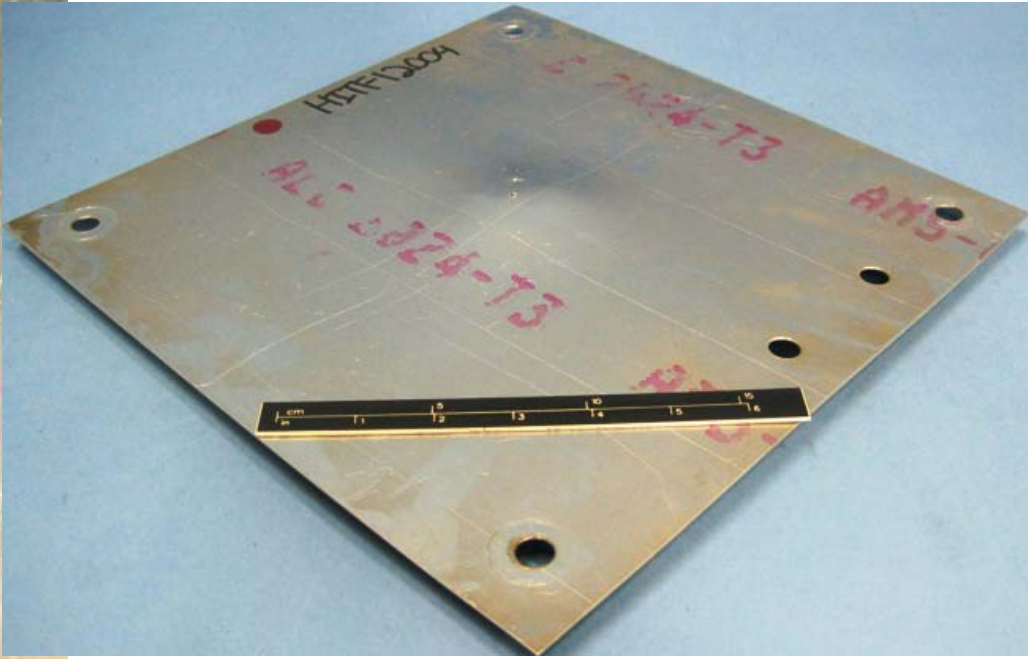
HITF-12004, Mesh Double-Bumper 0.651g/cm³ 6.4mm diameter Al 2017T4, 6.91 km/s, 0deg

#4. HITF-12004	6.4mm Al, 0.37407g, 6.91 km/s, 0 deg impact angle	Mesh Double Bumper shield 0.65 g/cm ²	1 st layer: 14.6 x 13.2mm hole 2 nd layer: 25.5 x 15.3mm hole 3 rd layer (last layer of Kevlar): two perforations in 65 x 41 mm area, with largest hole 53 x 44mm	Bulge, dish with two small perforations (fail) Impacted area 87 x 70mm diameter, bulge is 98 x 95mm diameter by 4.9mm high, largest perforation is 1.7mm x 1.6mm diameter
