Boiling eXperiment Facility (BXF)

Fluid Toxicity Technical Interchange Meeting (TIM) with the Payload Safety Review Panel (PSRP)

June 14, 2012

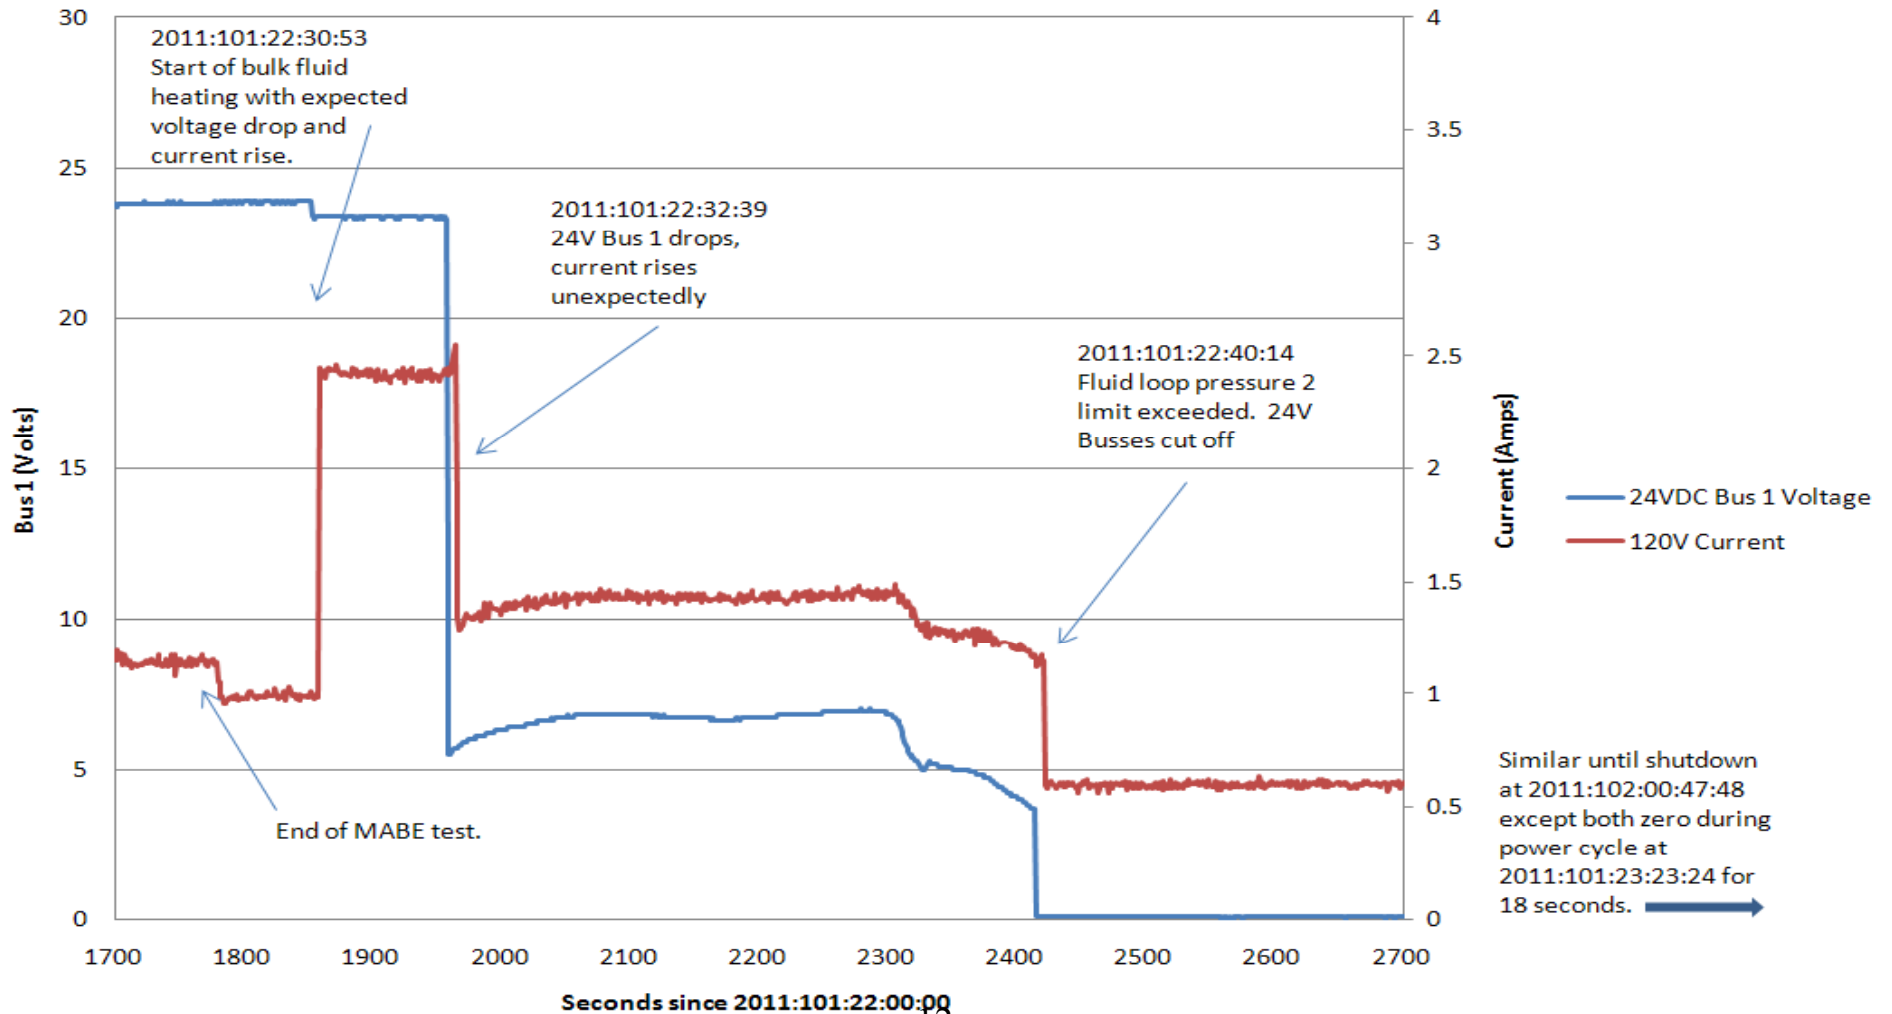
24V Bus 1 and 120V Current at time of anomaly

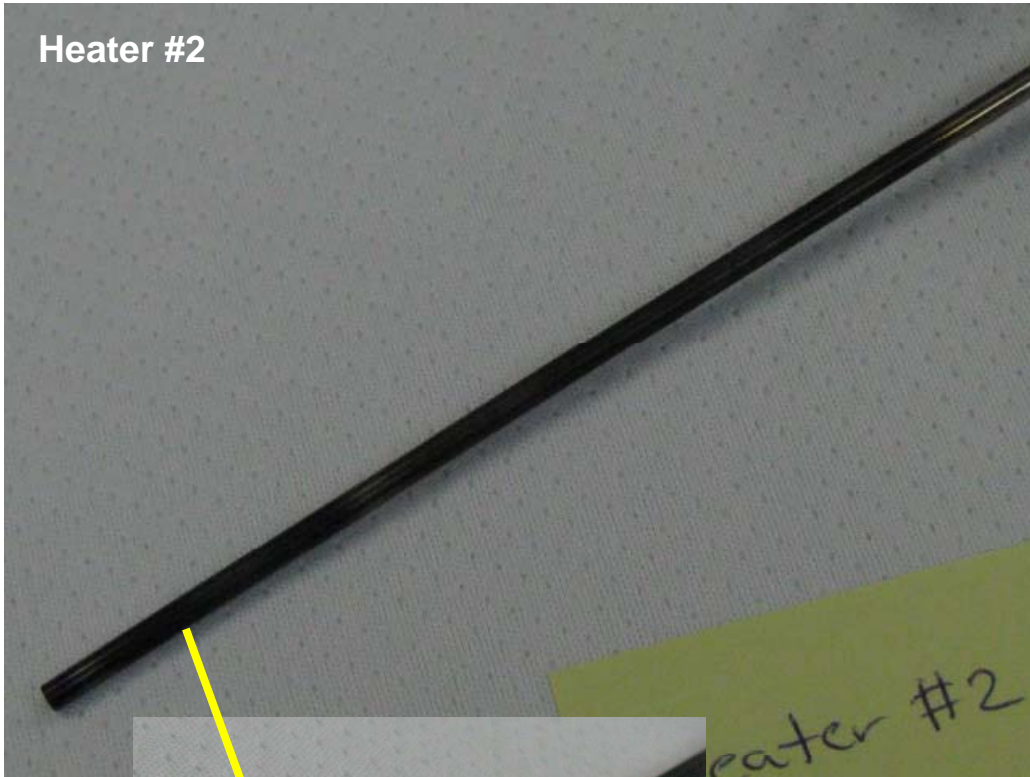
- Bulk Fluid Heaters #2 & #3 (Cartridge Heater S/Ns 012 & 009, respectively)
 - Discolored and blackened
 - Heater #2 more blackened than Heater #3
 - Aside from discoloration, no other damage observed
- Bulk Fluid Heater #1 (Cartridge Heater S/N 010)
 - Unable to extract through port fitting, so entire port fitting removed to extract heater
 - Extreme damage in two locations on heater sheath
 - Incoloy 800 melted in both locations
 - Brownish Magnesium Oxide and greenish Nickel-Chromium wiring visible

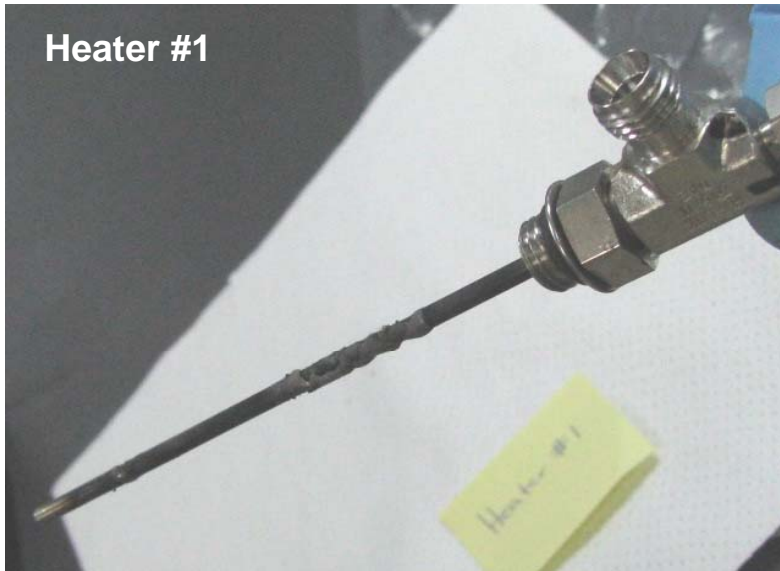
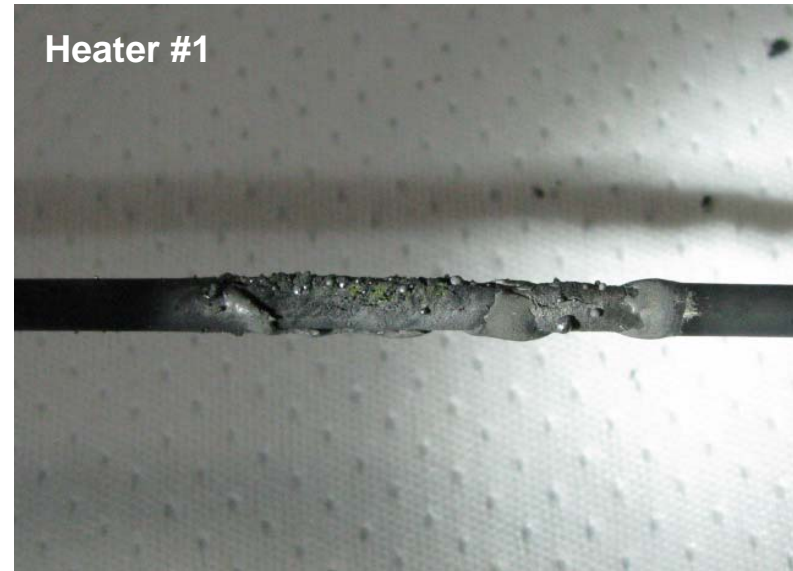
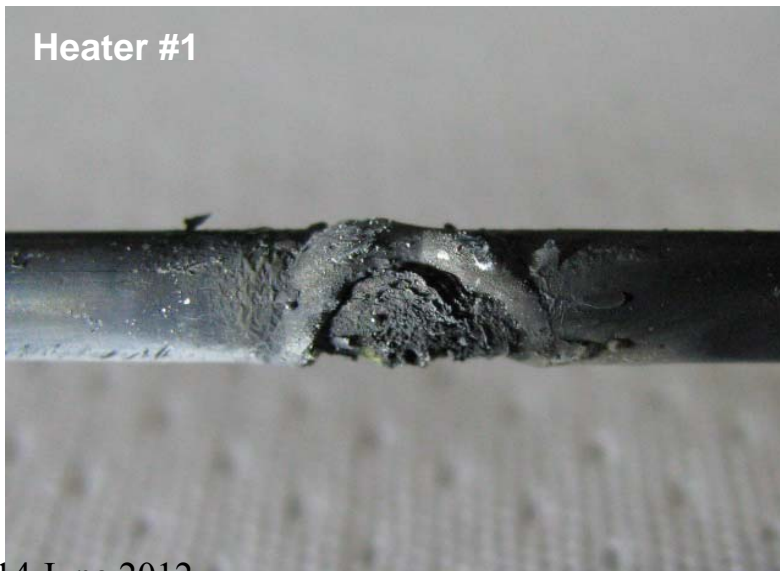
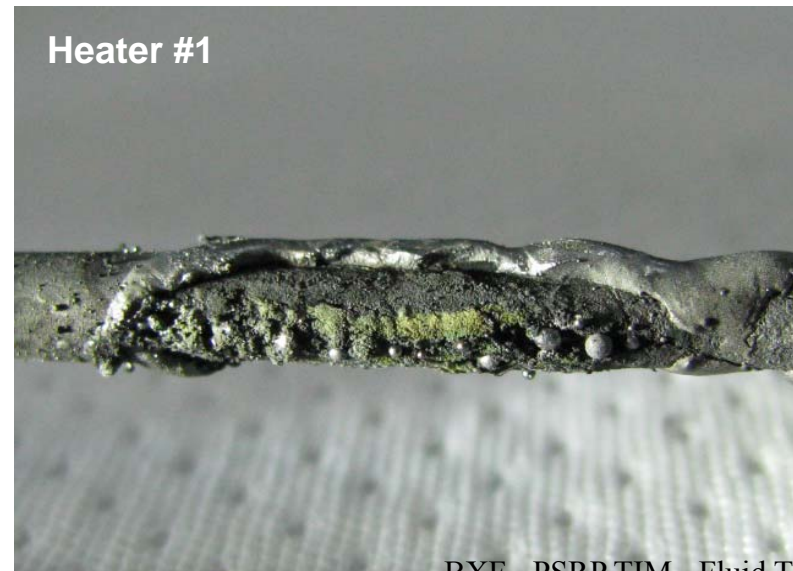
The damage of Bulk Fluid Heater #1 proves excessive temperatures were achieved on-orbit.

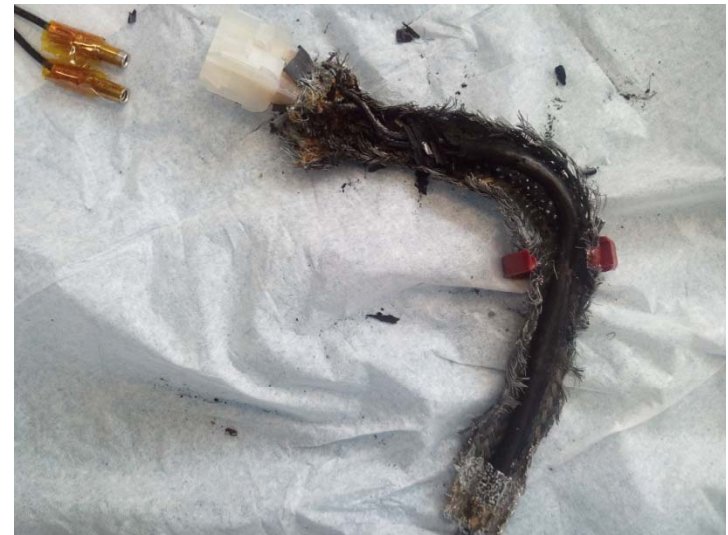
- Partial shorts to heater sheath found: $\approx 40 \text{ k}\Omega$, consistent with prior investigation results
- Bulk Fluid Heater 1 (Cartridge Heater S/N 010)

- Shield fused to inner insulation sleeving at connector, could not pull shield back from connector
 - Shield hardened, very tough and difficult to cut open

- Inner insulation sleeving carbonized near connector, crumbled apart
 - Internal wire insulation blackened overall, but whitened over crimped area; Exposed wire near connector.

- Connector melted, contacts completely encased, unable to extract
 - Wiring separated from heater on its own (no cutting needed)
 - Heater sheath bent at weakened damaged area due to handling

- Heater Resistance not stable, varied greatly during dissection
 - Heater Resistance at heater sheath = 7.08Ω , stable
 - Shorts found to heater sheath $\approx 8 \Omega$

- Wiring failed continuity measurements
