Space Mishaps

Apollo 1, Apollo 13, Challenger, and Columbia

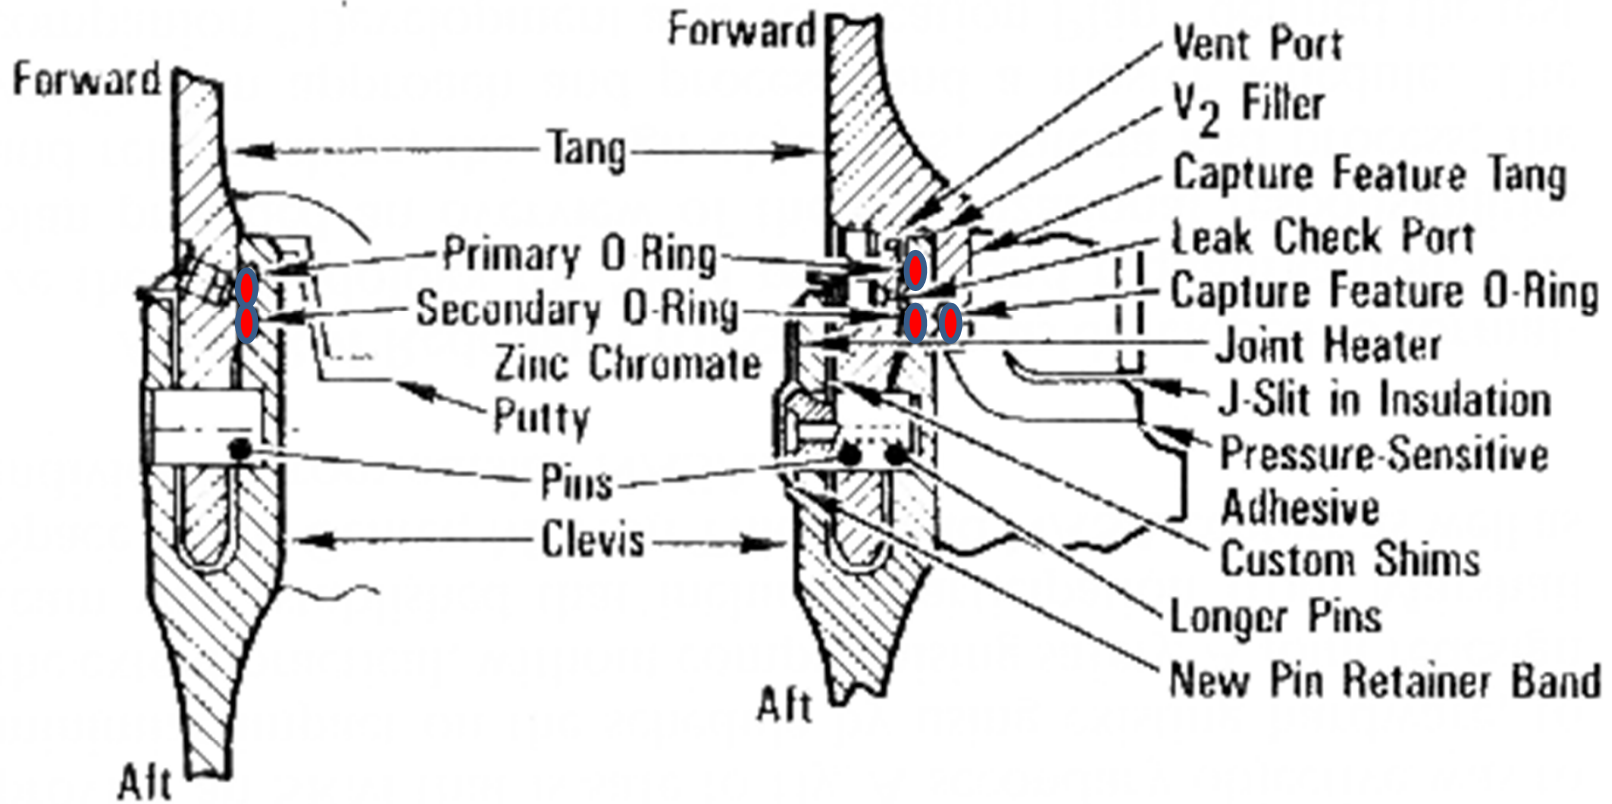
Field Joint Comparison

- In the STS-51L design, the application of actuating pressure to the upstream face of the O-ring was essential for proper joint sealing performance because large sealing gaps were created by pressure-induced deflections, compounded by **significantly reduced O-ring sealing performance at low temperature**.
 - The major change in the motor case is the new tang capture feature to provide a positive metal-to-metal interference fit around the circumference of the tang and clevis ends of the mating segments.
 - The interference fit limits the deflection between the tang and clevis O-ring sealing surfaces caused by motor pressure and structural loads. The joints are designed so that the seals will not leak under twice the expected structural deflection and rate.

- The new design, with the tang capture feature, the interference fit, and the use of custom shims between the outer surface of the tang and inner surface of the outer clevis leg, controls the O-ring sealing gap dimension. The sealing gap and the O-ring seals are **designed so that a positive compression (squeeze) is always on the O-rings**. The minimum and maximum squeeze requirements include the effects of temperature, O-ring resiliency and compression set, and pressure. The clevis O-ring groove dimension has been increased so that the O-ring never fills more than 90 % of the O-ring groove and pressure actuation is enhanced.

- The new field joint design also includes **a new O-ring in the capture feature and an additional leak check port to ensure that the primary O-ring is positioned in the proper sealing direction at ignition**. This new, or third, O-ring also serves as a thermal barrier in case the sealed insulation is breached.

- The **field joint internal case insulation was modified to be sealed with a pressure-actuated flap called a J-seal**, rather than with putty as in the STS-51L configuration.

- **Longer field-joint-case mating pins, with a reconfigured retainer band**, were added to improve the shear strength of the pins and increase the metal parts' joint margin of safety. The joint safety margins, both thermal and structural, are being demonstrated over the full ranges of ambient temperature, storage compression, grease effect, assembly stresses and other environments. **External heaters with integral weather seals were incorporated** to maintain the joint and O-ring temperature at a minimum of 75 deg F. The weather seal also prevents water intrusion into the joint.

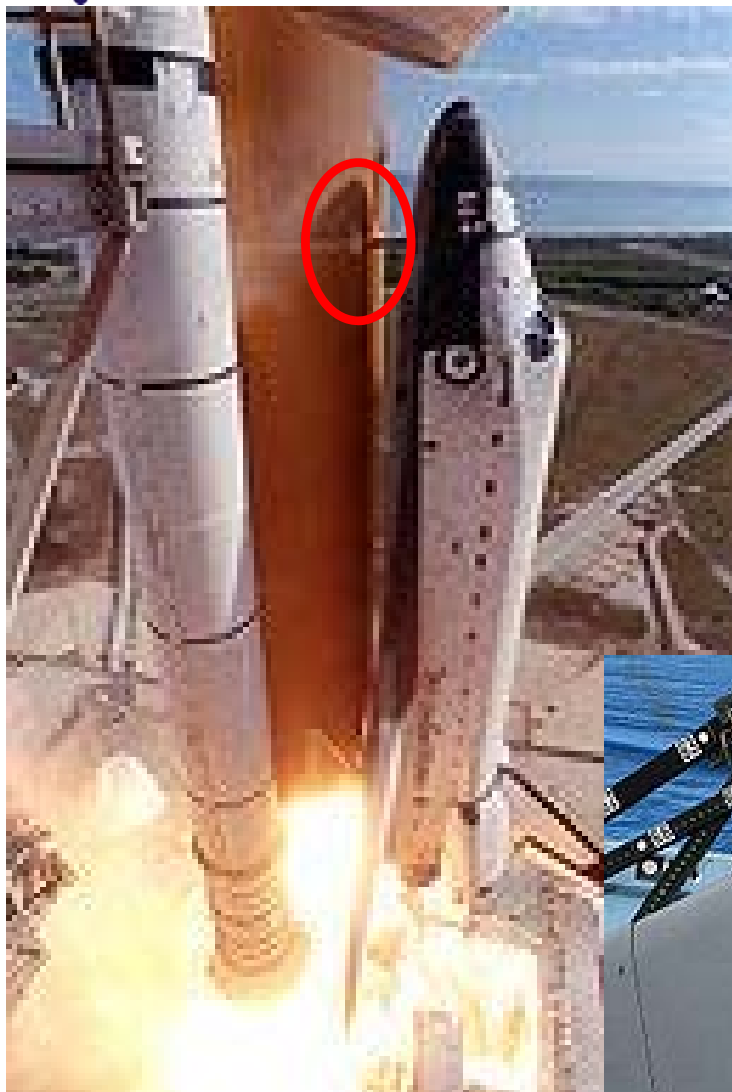
Bipod Ramp
(-Y, Left Hand)

- "The root cause of TPS foam debris shedding has been attributed to internal defects (voids) within the foam structure. Entrapped gas or liquid nitrogen/liquid air within the defect (void) expands during ascent due to the reduced ambient pressure and aerodynamic heating. Depending on the size, depth and geometry of the defect, the resultant pressure differential may cause failure of the surrounding foam. This type of failure mode has been identified as "cohesive" failure and results in chunks of foam being shed from the tank." – NASA ESC

- The ET bi-pod is susceptible to icing due to the ultra-cold fuel. Until the Columbia accident, the ET bi-pod was protected from ice buildup using thick sheets of foam. The improved **bi-pod** design now relies on electric **heaters versus foam** to keep the area clear of ice.
