# Stress Analysis and Testing at the Marshall Space Flight Center to Study Cause and Corrective Action of Space Shuttle External Tank Stringer Failures

After the launch scrub of Space Shuttle mission STS-133 on November 5, 2010, large cracks were discovered in two of the External Tank intertank stringers. The NASA Marshall Space Flight Center, as managing center for the External Tank Project, coordinated the ensuing failure investigation and repair activities with several organizations, including the manufacturer, Lockheed Martin. To support the investigation, the Marshall Space Flight Center formed an ad-hoc stress analysis team to complement the efforts of Lockheed Martin. The team undertook six major efforts to analyze or test the structural behavior of the stringers. Extensive finite element modeling was performed to characterize the local stresses in the stringers near the region of failure. Data from a full-scale tanking test and from several subcomponent static load tests were used to confirm the analytical conclusions. The analysis and test activities of the team are summarized. The root cause of the stringer failures and the flight readiness rationale for the repairs that

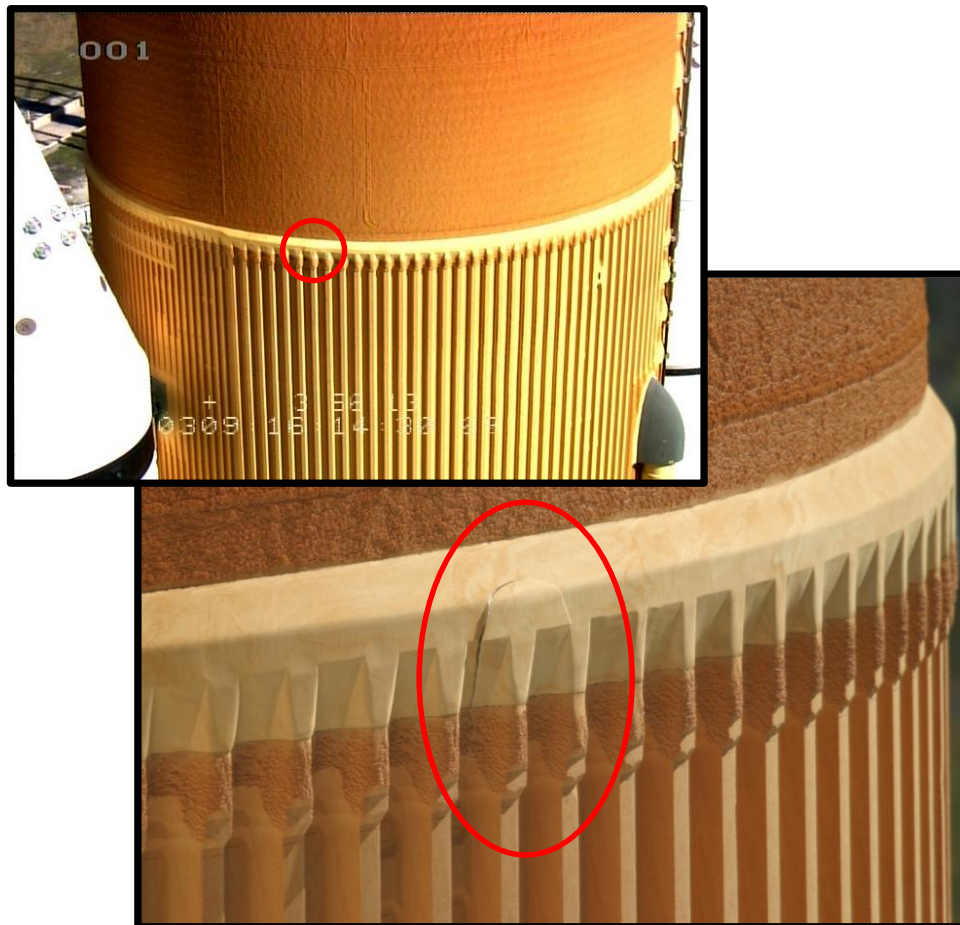
On November 5, 2010, the launch of Space Shuttle mission STS-133 was scrubbed after propellant loading due to a gaseous hydrogen leak at the ground umbilical connection to the External Tank (ET). During visual inspections following the scrub, a large crack in the ET sprayed-on foam insulation (SOFI) was observed at the forward end of the intertank near the interface to the liquid oxygen (LOX) tank (Figure 1). Cracks in the foam were not typical in this region and violated a launch constraint due to debris concerns, necessitating a foam repair before any future launch attempt.

**Figure 1. SOFI crack after STS-133 launch scrub.**

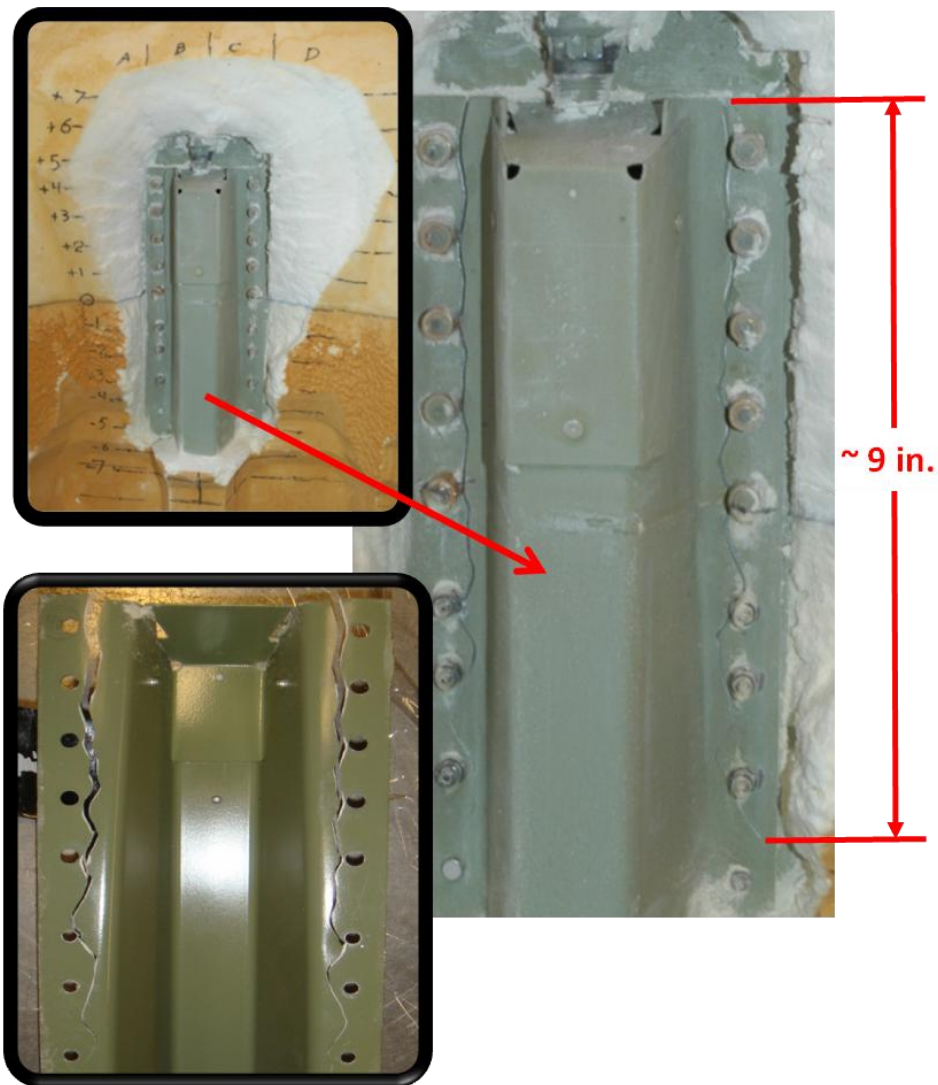
Removal of the damaged foam revealed that an underlying aluminum hat-section stringer had cracked approximately 9 inches along each side, just inboard of the fasteners that attached the stringer “feet” to the intertank forward flange chord (Figure 2). The crack in the foam was solely a result of the stringer failure. An adjacent stringer was also found to be similarly cracked on each side for about 3 inches along its forward end, although the SOFI directly over it had appeared undamaged.

**Figure 2. Stringer cracks discovered after STS-133 launch scrub. ET-137 stringer S7-2 shown. (Bottom left inset: stringer S7-2 after removal from ET-137 and foam residue cleaned off.)**

The two stringers were repaired in-situ at the launch pad by removing several inches of the forward end of each damaged stringer and splicing on an equivalent length taken from new stringers. Aluminum sheet stock doublers formed into a shape resembling the letter 'Z' were overlaid and fastened on the splice location to mechanically tie each portion of new stringer to the remaining portion of original stringer. The SOFI was then manually re-applied, allowed to cure, and trimmed to meet flight requirements. The remnants of the two stringers containing the cracks were shipped first to the MAF and later to the MSFC for forensic engineering.

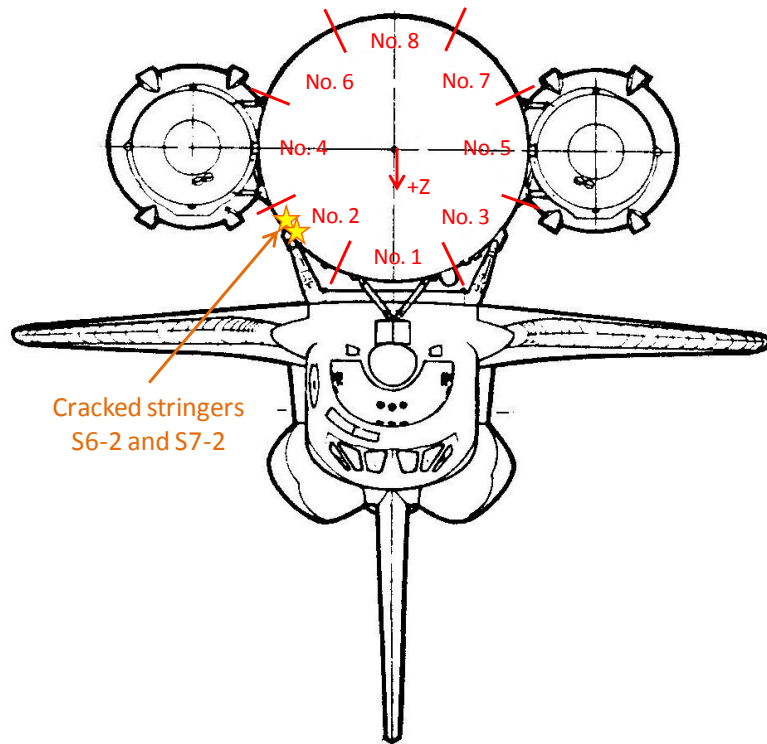
Figure 6. ET-137 intertank panel identification numbers and cracked stringer locations.

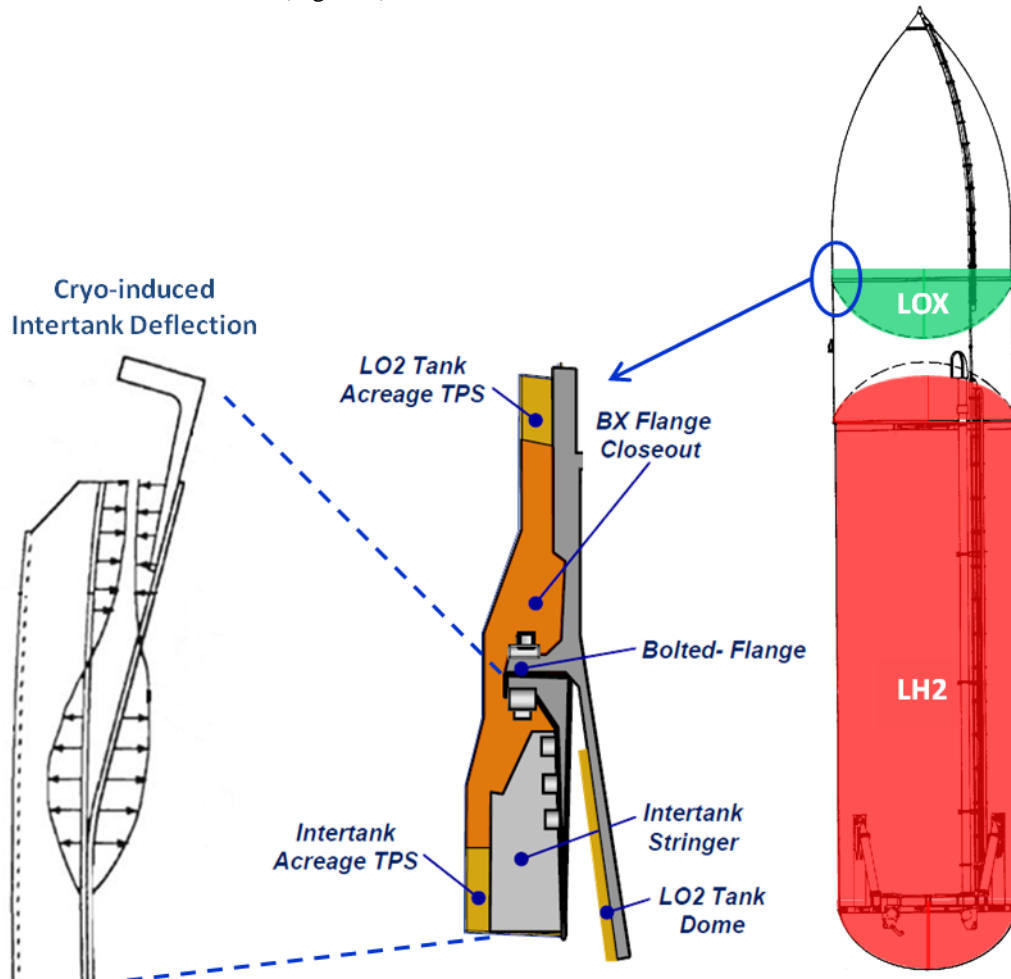
The LOX cryogenic temperatures cause a radial shrinkage of the aft ring frame of the LOX tank as the liquid level reaches that elevation during propellant loading. The forward flange chords of the intertank are bolted to the LOX tank frame and are constrained to follow this displacement. However, since the intertank is a dry structure that does not contain cryogenic propellant, a large temperature gradient exists at the forward end of the intertank. Bending is induced in the stringers as the forward end of the intertank deflects radially inward, but the warmer aft areas do not. This bending attempts to pry the stringer ends from the chords and skin, which is resisted by the mechanical fasteners attaching the feet of the stringers to the underlying structure, causing local bending in the stringer feet inboard of the fasteners (Figure 7).

**Figure 7. Notional cryo-induced stringer deflection due to LOX liquid level.**

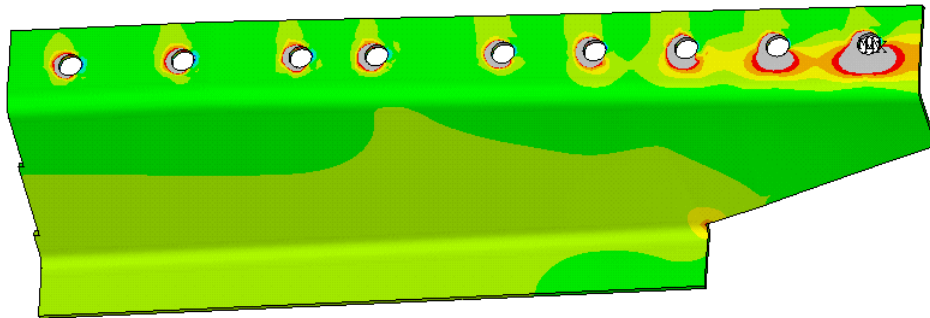
- Local peak stresses in the region of the first three fasteners (where the fractography indicated that the failures had initiated) occurred during the temperature profiles corresponding to the LOX liquid level reaching the ring frame to which the intertank forward chord was attached;
- The different skin configurations under the stringers had an effect, with the stringers closest to the thrust panels (where doubler skins were used and where the first observed stringer failure occurred) seeing higher peak local stresses at the forward fasteners due to transient thermal conditions. (Recall that fractography indicated that the failures initiated in the region near the second fastener from the chord.)
- Local peak stresses in the region of fastener locations 4 through 9 resulted from steady state thermal conditions combined with ascent flight loads.<sup>‡</sup>

**Figure 12. Example FE result of stringer foot 1<sup>st</sup> principal stress on the bottom of the foot at the 3700 sec thermal transient.**

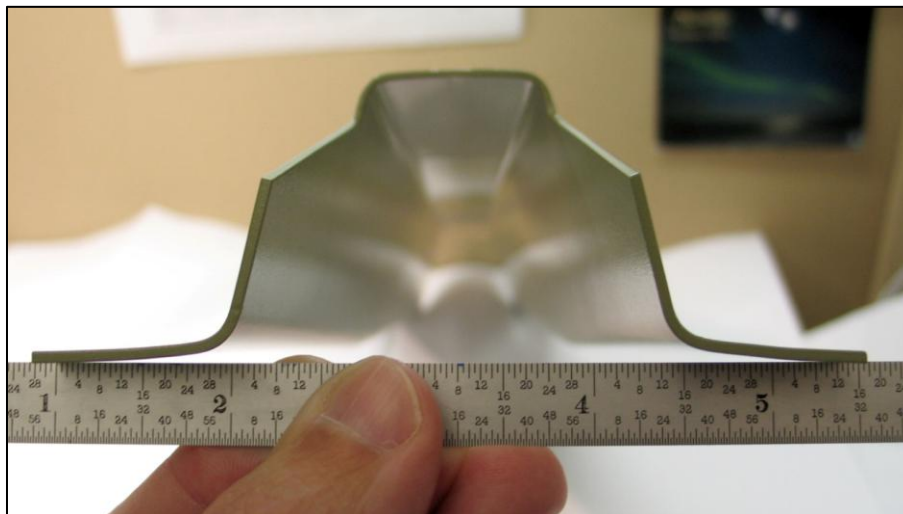
down” condition) as seen in Figure 14. An initial toe down geometric condition would cause bending in the stringer foot during fastener installation, resulting in stresses in the foot that would be additive to stresses caused by the prelaunch thermal transient. This condition was studied analytically by giving the FE model an initial toe down condition, and sequential installation (preloading) of the forward fasteners was simulated to obtain stringer internal forces and stresses. The results indicated that it was possible to induce assembly stresses that would be additive to subsequent cryogenic deflection-induced stresses.

Figure 14. Stringer “toe down” geometry variation at the hot formed ends.

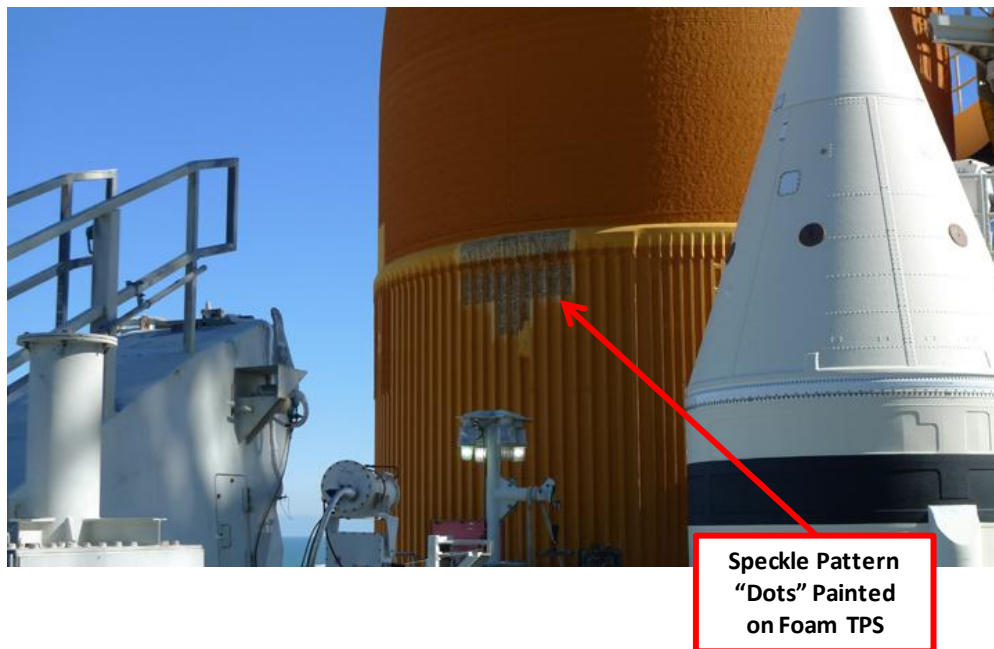
**Figure 15. ET-137 tanking test photogrammetry study of stringer deflections near the LOX tank.**

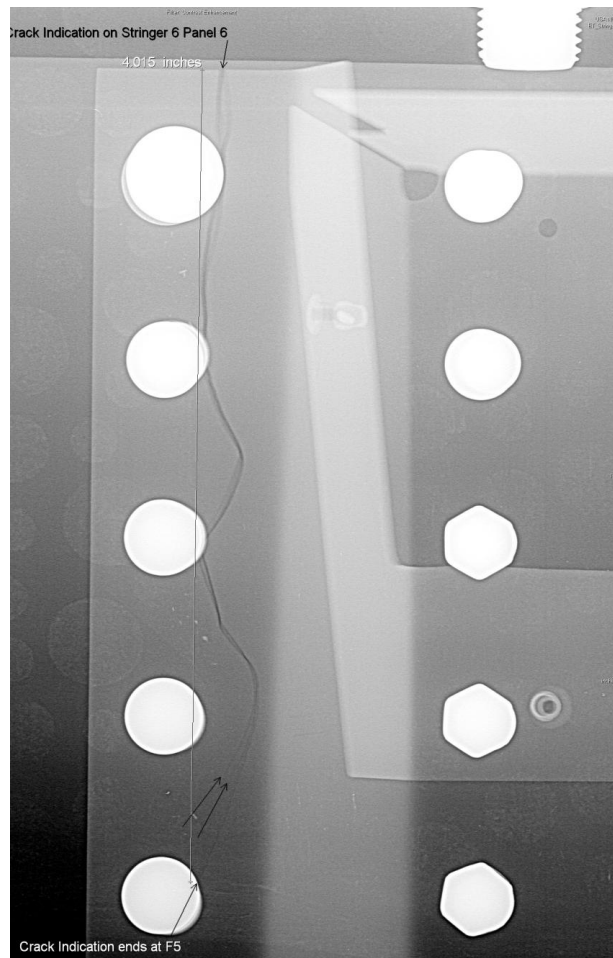
While the tanking test achieved all goals and the data it provided was useful in confirming the gross structural response of the intertank during propellant loading, it failed to provide any further insight into the cause of the stringer cracks. Following the tanking test, the program management made the decision to roll the Space Shuttle stack back to the Vehicle Assembly Building (VAB) where additional work platforms existed to perform x-ray inspections of the stringers that could not be reached on the launch pad. This inspection revealed three additional stringers with similar cracks in their feet near the LOX tank interface, making a total of five known stringer failures, two of which had already been repaired (Figures 17 and 18). All three of the newly detected cracked stringers were located in the area where good quality photogrammetry data was collected, but no indication of the stringer failures was indicated on the surface of the SOFI or in the photogrammetry data. Since these three stringers had not been inspected prior to the tanking test, it was not known if the cracks occurred as a result of the tanking test or if they occurred during LOX loading for the original launch attempt as with the other failures. The three stringers were repaired similarly to the original two cracked stringers. No cracks were detected at the stringer ends near the LH2 tank.

**Figure 17. Example stringer crack detected during post-tanking test x-ray inspection.**

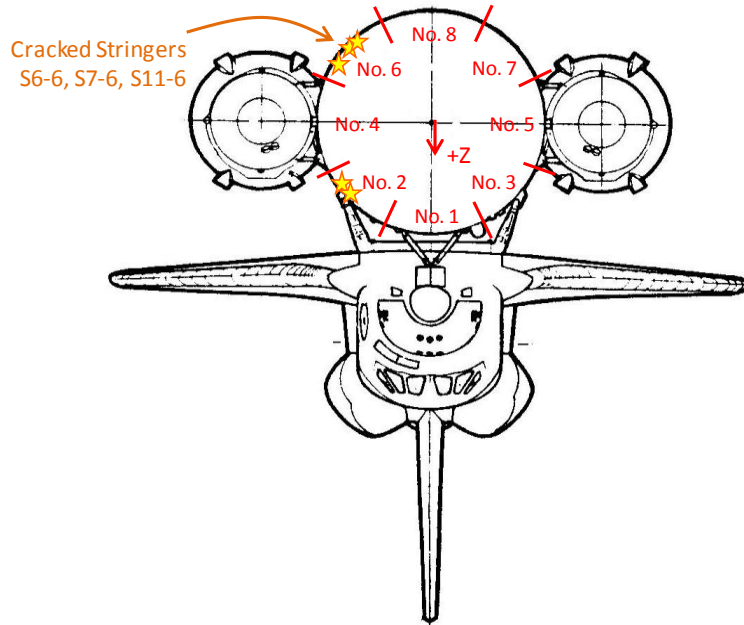
**Figure 18. Location of additional stringer cracks detected after ET-137 tanking test and roll-back to the VAB.**

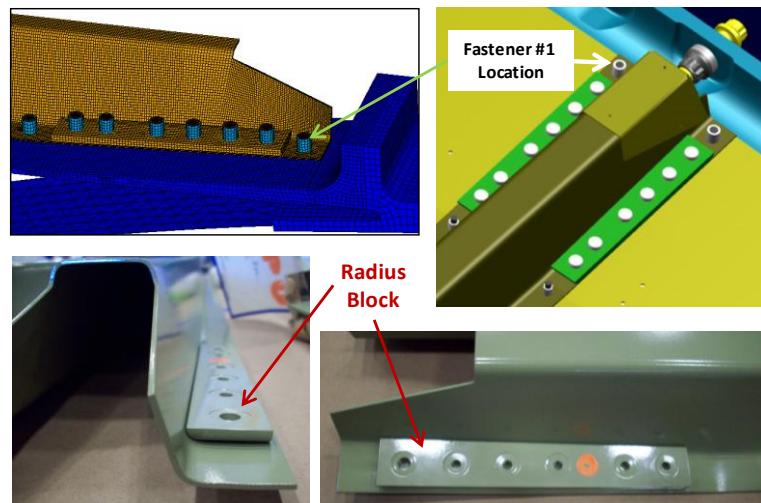
**Figure 19. Radius block reinforcement of stringer feet.**

Lockheed Martin proposed the corrective action of retro-fitting the feet on every Al-2090 stringer with structural reinforcement in the region of the first several attachment fasteners at the forward end of the intertank. These reinforcements, known as “radius blocks” because they fit into the radius between the stringer sidewall and foot, were 0.190-inch thick strips of aluminum alloy Al-2024 and were mechanically fastened to the outside of the stringer feet (Figure 19). Similar reinforcements were already in use by design on stringers near cutouts in the intertank. The repair required the removal and replacement of several of the forward stringer attachment fasteners. However, due to the risk of possible collateral damage to the LOX tank dome in removing the forward-most fastener, this fastener was untouched, and the radius blocks did not cover the stringer feet at the forward fastener.

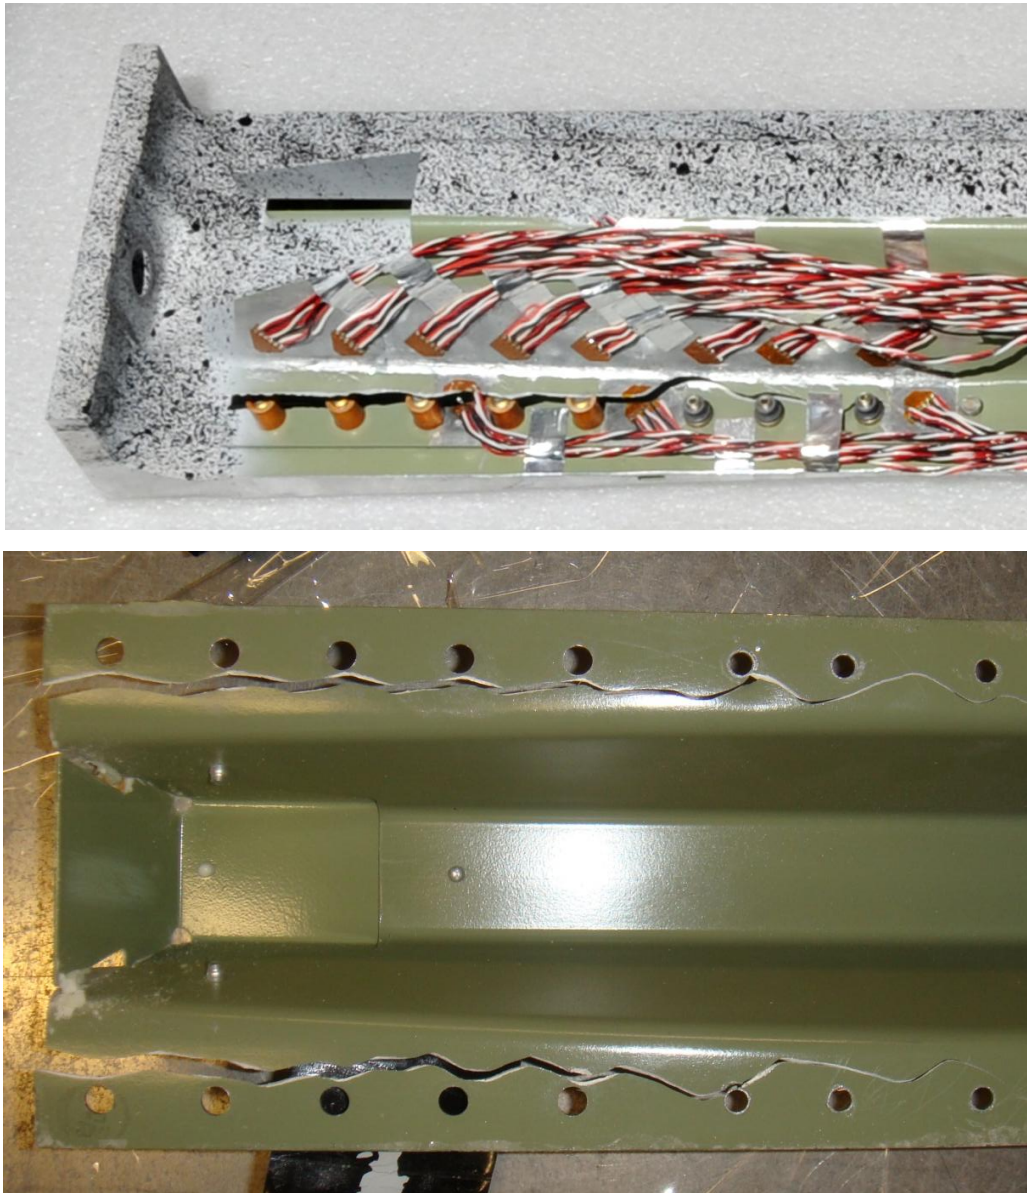
**Figure 23. Similarity of failure between cracked stringer removed from ET-137 (bottom) and stringer bending test article after failure (top).**

- Stringers fabricated from suspect material, and without added radius block modifications, failed in a sudden brittle fracture;
- Stringers fabricated from nominal (non-suspect) material, and without radius blocks, failed in a progressive manner until rupture, which generally occurred at a higher load than unreinforced suspect material stringers;
- Stringers fabricated from suspect material, but reinforced with radius blocks, failed at loads comparable to unreinforced, nominal material stringers, but the failure mode at rupture was still sudden brittle fracture; and
- Stringers fabricated from nominal material, but reinforced with radius blocks, demonstrated as good or better performance than unreinforced, nominal material stringers.

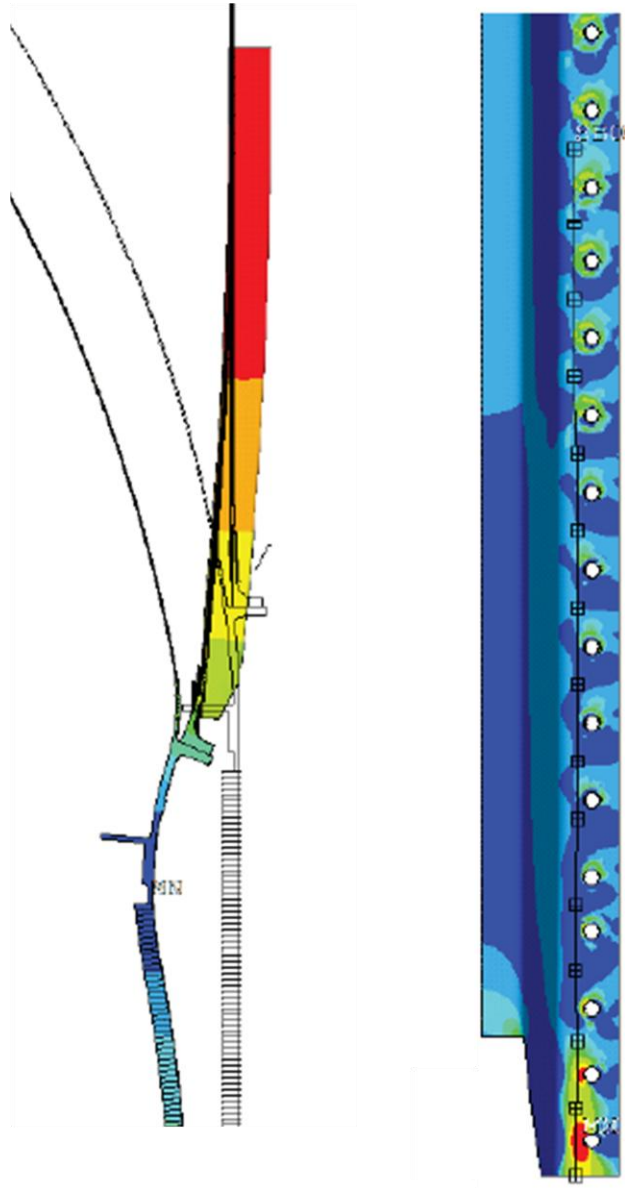
- The most limiting location/load combination in regard to the propensity for stringer cracking was determined to be at fastener location 1 for the LH2 propellant fill transient at the time of 4960 seconds. The worst case LH2 tank flange rotation, stringer tensile radial force, and stringer tensile tangential stress all occurred at this location and transient time. At this time in the fill transient, the average fastener location 1 temperature was still relatively warm at 11° F.

- The most limiting location for ascent in regard to the propensity for stringer cracking was determined to be at fastener location 3 at transient time equal to T+175 seconds. The stringer tensile radial force and stringer tensile tangential stress are approximately 14% and 8% less (respectively) than the worst case values resulting at fastener location 1 for the fill transient. However, the average temperature at fastener location 3 was still relatively cold at -254° F compared to the 11° F temperature at fastener location 1. Note that material testing by the FAT indicated a trend of decreasing fracture toughness with decreasing temperature [18]. For this reason, it could not be decisively concluded that the fill transient was a bounding event at fastener location 3. Otherwise, the fill transient was generally a bounding event, and was a significant bounding event at fastener locations 1 and 2.

- The LH2 tank fill loading condition was significantly greater in severity compared to the ascent loading for the first 2 fastener locations. For fastener locations 3 through 6, the ascent loading condition was more severe. Stringer forces and stresses at fastener locations greater than 6 were negligible relative to peak values at the other locations.
- The results indicated that the operational loading at the LH2 tank end of the stringer was significantly greater in severity compared to the LOX tank end of the stringer.

**Figure 28. Example FE results for stringer radial displacement near the LH2 Tank (left) and hoop-direction stress on the under side of the stringer foot (right).**
