Stringer Bending Test Helps Diagnose and Prevent Cracks in the Space Shuttle's External Tank

Joseph B. Saxon¹, Gregory R. Swanson², William P. Ondocsin³, and Robert J. Wingate⁴
NASA Marshall Space Flight Center, Huntsville, AL

Extended Abstract of Proposed Paper for the 53rd AIAA/ASME/ASCE/AHS/ASC Structures, Structural Dynamics, and Materials Conference, April 23-26, 2012, Honolulu, Hawaii

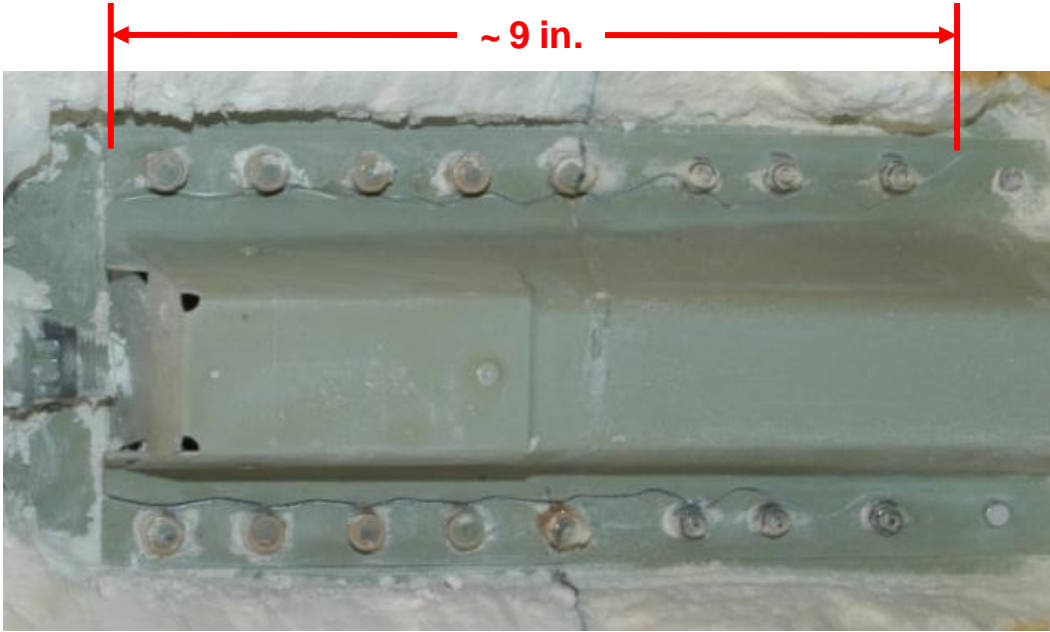
When the propellants are loaded, both ends of the Intertank approach cryogenic temperature and contract inward. The center of the Intertank remains at warmer temperature and resists contraction, causing considerable bending of the stringers, especially at the ends. Figure 3 shows cracks on the LOX end of a stringer that are consistent with this loading scenario, appearing as if the stringer end pulled away from the skin, fracturing the stringer foot along the fastener line. Fractography analysis indicated the ET-137 fractures were static, initiating on the bottom of the stringer foot (the tensile side of bending) between the 2nd and 3rd fasteners from the end. The video footage of the launch attempt indicated that the fracture occurred precisely when the LOX level should have reached the Intertank/LOX tank interface. No cracks were detected at the LH2 end of the ET-137 Intertank.

Figure 3. Cracks at LOX end of ET-137 stringer S7-2.

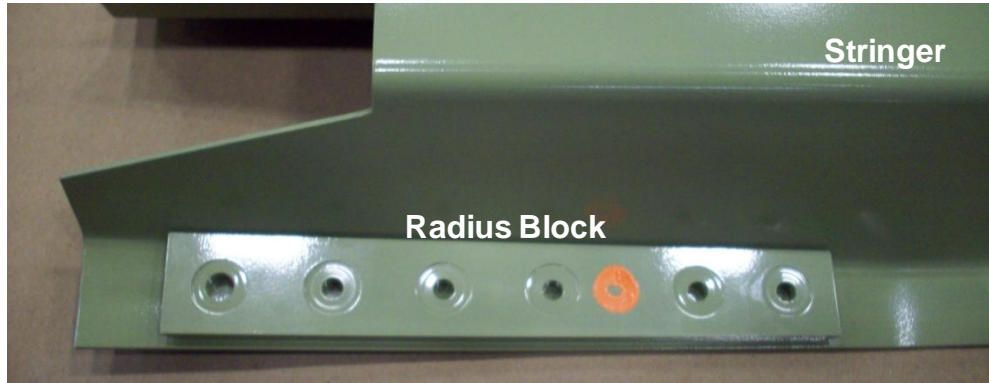
Figure 5. Radius block for proactive stringer repair.

Based on early indications from the crack investigation, NASA management made the proactive decision to reinforce all of the stringers on ET-137 by installing so-called radius blocks. The radius block (RB) placement is shown in Figure 5. Stringers with RB’s became another configuration that required testing.

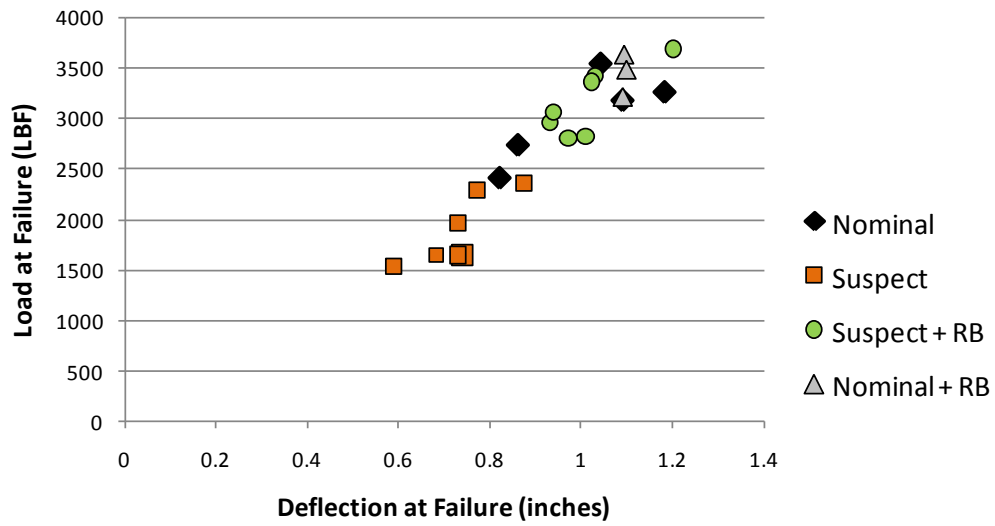
Comparative results from the stringer bending tests are summarized in Figure 6, where each article's failure point is plotted in load-deflection space. Three observations are noted:

- Suspect stringers as a group sustained less bending load and/or deflection prior to failure than nominal stringers.
- Suspect stringers reinforced with radius blocks demonstrated improved bending capacity, on par with that of the nominal stringers.
- Nominal stringers reinforced with radius blocks suffered no detrimental effects to bending capacity.

Figure 6. MSFC bending test results.
