VIIRS on-orbit optical anomaly – lessons learned

Glenn Iona^a, James Butler^a, Bruce Guenther^b,
Larissa Graziani^c, Eric Johnson^d, Brian Kennedy^e, Craig Kent^b, Robert Lambeck^f,
Eugene Waluschka^{a,} Xiaoxiong Xiong^a

SPIE Earth Observing Systems XVII 12-16 August 2012, San Diego, USA

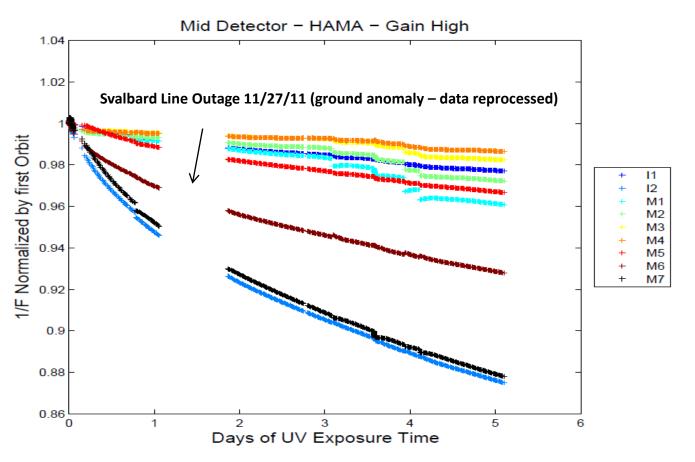
Upon opening the SNPP VIIRS Nadir doors on-orbit, analysis of VIIRS data revealed accelerated and continued degradation of Visible/Near Infrared (VisNIR) bands throughput. The degradation was correlated with UV exposure.

Degradation is measured from value first observed upon sensor activation

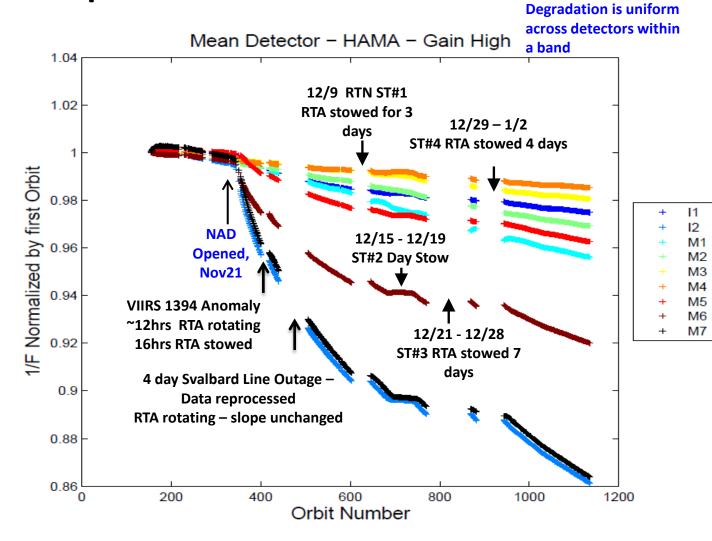
Anomaly Investigation(5) VisNIR Response vs Orbit Time Trends

- Rate of NIR response degradation significantly increased with nadir door opening. Note discontinuity in trend for NIR bands (M7/I2, M6, M5)
- NIR Degradation paused when in darkness or stowing telescope, stopping UV exposure.
- Degradation of short wavelength bands (M1-M3) relatively constant through stows and strongly correlated w/ drop in SD reflectance measured by SDSM.
- Data shows 1/F-factor for solar observations. Should be 1 for new sensor.
- VIIRS optics are exposed to UV in earthshine is 0.5*(124.2°/360°) = 0.18 UV day/calendar day

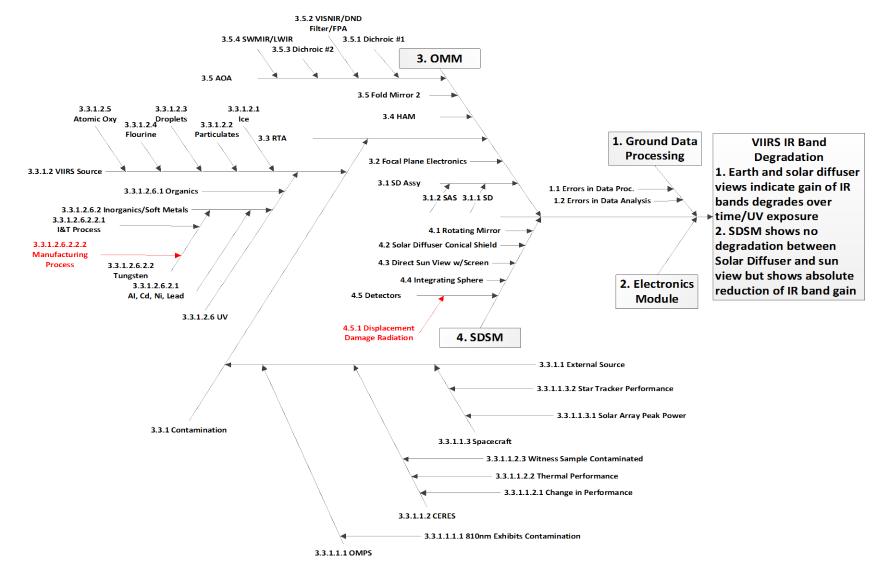
Fishbone Development and Disposition

- The fishbone illustrates the various bones that were investigated to varying degrees based on what we learned incrementally through the anomaly investigation.
- The final fishbone identifies the proximate causes
 - tungsten film contamination on the VisNIR/DNB RTA mirrors and
 - displacement damage for the SDSM in Silicon PIN photodiode.
- There was a significant amount of effort expended by the team, that is not discussed in this or other papers, on how the various possible causes were discounted.

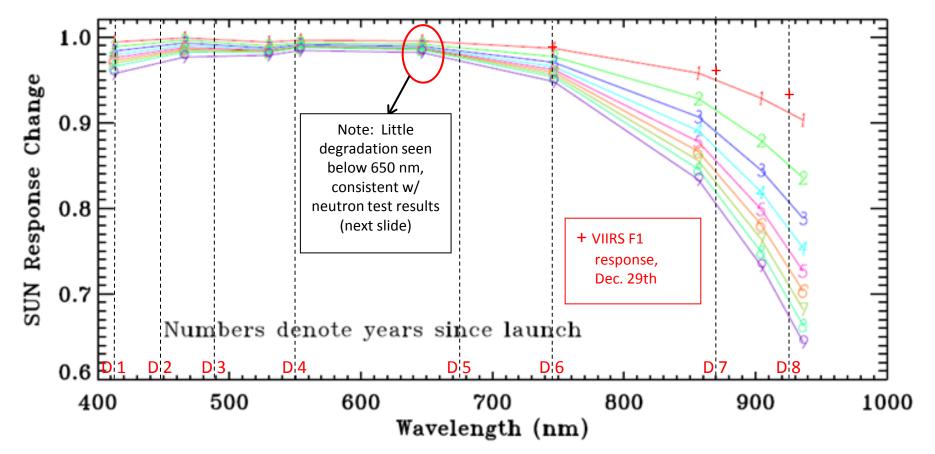
Discovery of the Smoking Guns and Root Cause Analysis (4) VIIRS vs MODIS Aqua SDSM Response Degradations:

- MODIS Aqua trend data courtesy of Jack Xiong and Amit Angal (MCST)
 - Similar degradation also seen for MODIS Terra
- Values for VIIRS detectors D6, D7 & D8 measured on Dec. 29th overlayed (~ 2 months since launch)
 - Est. degradation in response is <1% for D1-D5 (412-676 nm) after correction for SD degradation, not shown
- The SDSM detector vendor and part number are identical across all missions

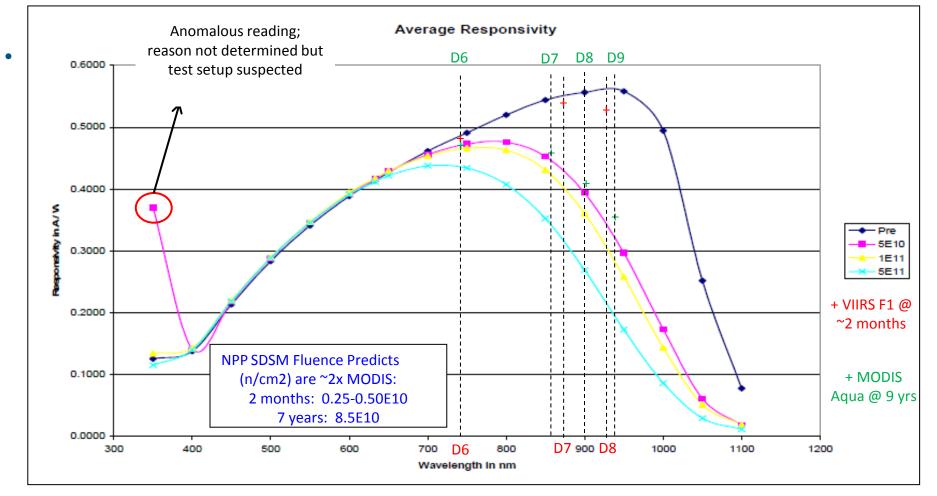
Discovery of the Smoking Guns and Root Cause Analysis (5) VIIRS & MODIS SDSM Degradation vs. Neutron Test Results

- Results provided by E. Johnson/Raytheon are for average of 4 detectors radiation tested
- Values for VIIRS D6-D8, as measured on Dec. 29th and MODIS Aqua D6-D9 @ 9 yrs overlayed on plot assuming initial on-orbit responsivity ="Pre" values
 - Est. degradation response is negligible for D1-D5 (412-676 nm) after correction for SD degradation

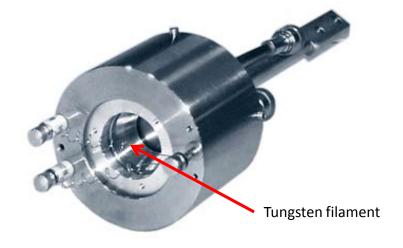
<u>Issue Description:</u> There was a FSS99 silver coated mirror reflection degradation issue. The root cause was determined to be Tungsten Oxide film on the surface of the FSS99 coated mirrors that was introduced after the coating was applied in an attempt to increase reflection.

- Ion gun used for substrate deposition per normal FSS99 process
- Deviation: gun used for oxygen ion bombardment to improve reflectivity

<u>Containment Action:</u> Upon original notification of the anomaly, records of the coating run were reviewed to determine if tungsten oxide could have been deposited during the standard FSS99 process. Additional records for other FSS99 coating runs for other programs were also located in order to determine if there were any coating deficiencies or anomalies present during these events. It was determined that there were no issues with subsequent coating runs for any specific program.

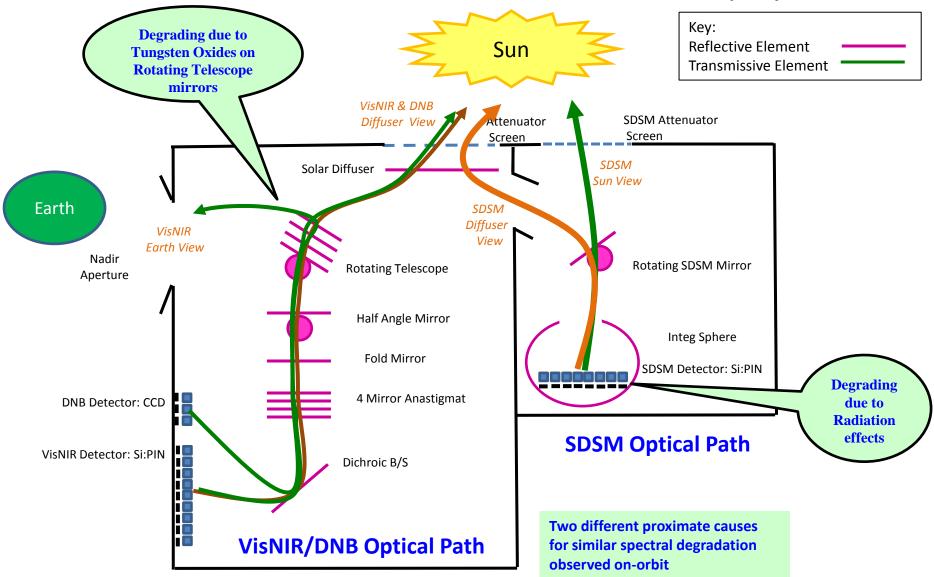
Conclusion (3) Two Proximate Causes Identified

- VIIRS degradation traced to two different proximate causes
 - 1. VisNIR/DNB degradation was conclusively traced to the photochromic effects of tungsten on SNPP VIIRS RTA mirror surfaces. Through inspection of Denton (now Quantum) build documentation it was isolated to a 1-time process deviation (i.e. root cause) to improve surface reflectance during the mirror coating process.

- JPSS-1 VIIRS RTA mirror tested and are unaffected
 - 2. The VIIRS SDSM proximate cause was degradation due to displacement damage in the Silicon PIN photodiodes induced by the ~2-times radiation environment, both ionizing dose & equivalent neutron fluence, when compared to the MODIS/Aqua orbit.

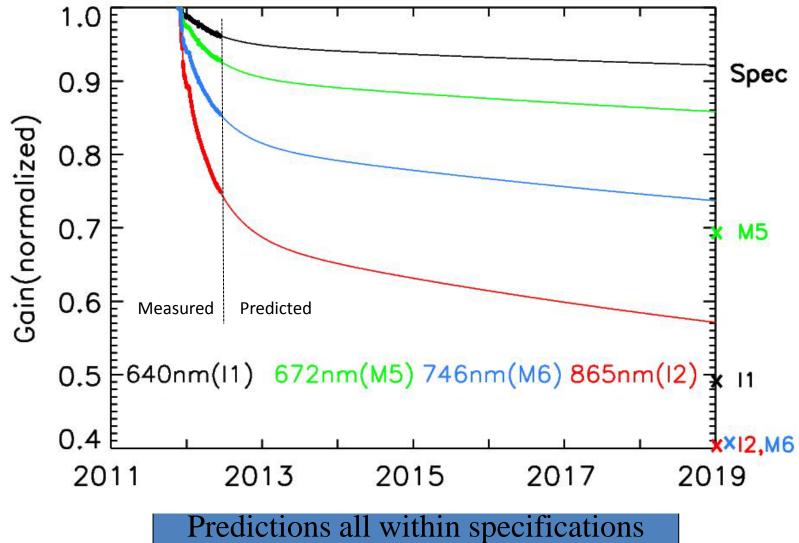
Conclusion (4) VIIRS measured and degradation prediction

- The Science team measured and predictions show the normalized gain will remain above specifications beyond 2019
