RECENT OPTICAL AND SEM CHARACTERIZATION OF GENESIS SOLAR WIND CONCENTRATOR DIAMOND-ON-SILICON COLLECTOR. J. H. Allton¹, M. C. Rodriguez², P. J. Burkett³, D. K. Ross³ and C. P. Gonzalez³ and K. M. McNamara¹, ¹NASA/Johnson Space Center, 2101 NASA Parkway, Mail Code KT, Houston, TX 77058, USA, Judith.h.allton@nasa.gov, ²ESGC Geocontrol Systems- ESCG at NASA/JSC, ³Jacobs- ESCG at NASA /JSC.

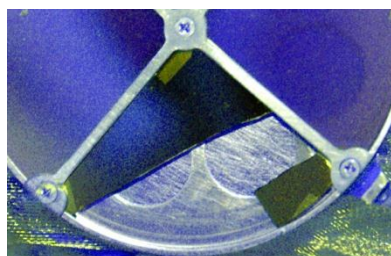
Description of collector 60000: Fig. 1 shows the largest piece of the concentrator DOS collector, as recovered in Utah. This piece was located at the focal point of the concentrator; thus, having the greatest concentration of solar ions. Additionally, this piece had two areas inadvertently not covered by the carbon coating and, thus exposing the silicon to capture solar ions. The exposed silicon, set up a potential opportunity to measure solar carbon. Fig. 2 shows sample 60000 prior to subdivision.

Fig. 1. False color image of DOS collector fragment 60000 mounted in frame and location of frame shadow. Green areas show solar-wind-exposed silicon.

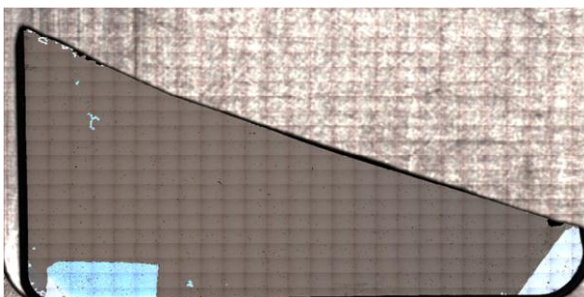
Fig. 2. Fragment 60000 color-enhanced to show increased blueness of silicon areas near focal point, presumably due to irradiation. The bright areas are silicon, called “heel” and “toe” of sock shape.

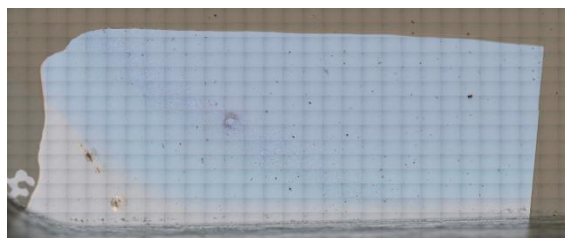
Typical post-landing particulate contamination. Optical imaging of 60000 reveals glass microsphere shards and carbon fibers (both return capsule structural materials), dried droplets, miscellaneous fibers, smears and particles. Near the frame attachments, on the silicon “heel” and “toe” surfaces, smears of gold-colored material are noted (Figs. 3 & 4). A brief survey of related fragment, 60737, was undertaken via SEM (JEOL 7600F). Most abundant particles were gold (with nickel and/or aluminum) and GaZnAl-oxide bearing paint. Less abundant particles consisted of silicate glass, germanium metal, stainless steel, and terrestrial soil.

Fig. 3. Silicon “heel” showing frame shadow and gold-colored smears.

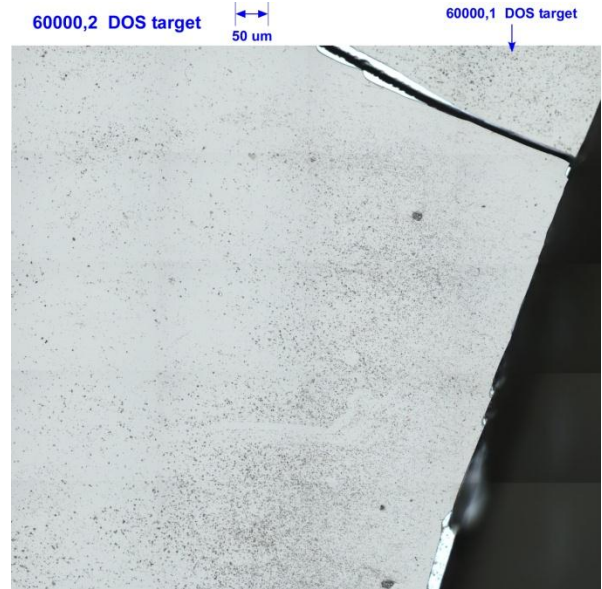
Imaging after subdivision: Fig. 6 shows solar wind surface after subdivision by laser scribe/cleaving. The subdivision process [4, 5] produces silicon/silicon oxide debris which gets onto the solar wind surface (Fig. 7) and needs to be removed. Further imaging of the subdivided surfaces is in progress.

Fig. 7. Subdivision process debris added near edges.
