# **Nondestructive Testing As a Tool in the Space Shuttle *Columbia* Accident Investigation**

Steven J McDanel  
NASA  
Kennedy Space Center, Florida, 32899, USA  
321.861.8969  
321.867.1407  
Steve.mcdanels@nasa.gov

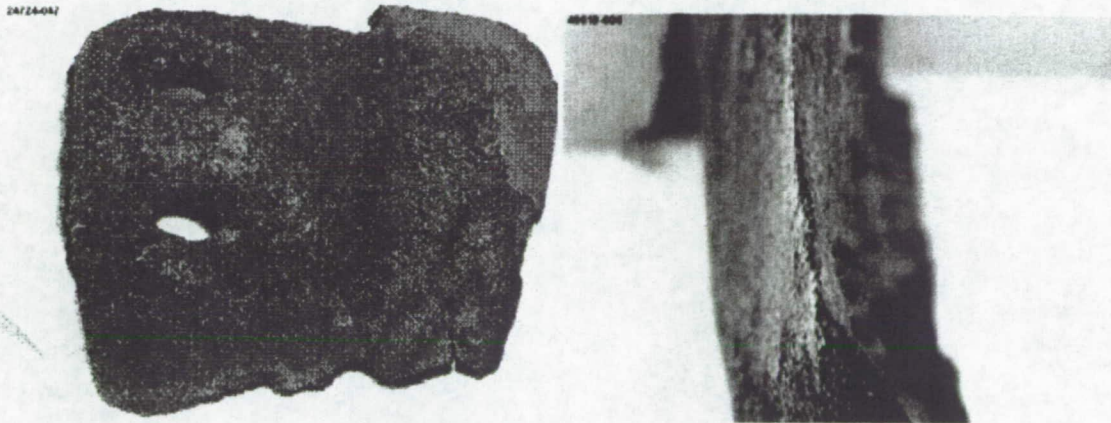
Figure 1

Visual NDT of the debris revealed localized areas of unique damage, such as erosion, excessive heating, and knife edging, as well as mechanical damage (Figure 1). The erosion, heating, and knife edging were results of the extreme re-entry of the *Columbia*; the mechanical fractures generally resulted from either impact with other pieces of debris on descent or impact with the ground.

Visual Examination of *Columbia* Left Wing Leading Edge Panel Piece Showing Evidence of Erosion, Excessive Heating, and Mechanical Damage (right) and Knife Edging (left).

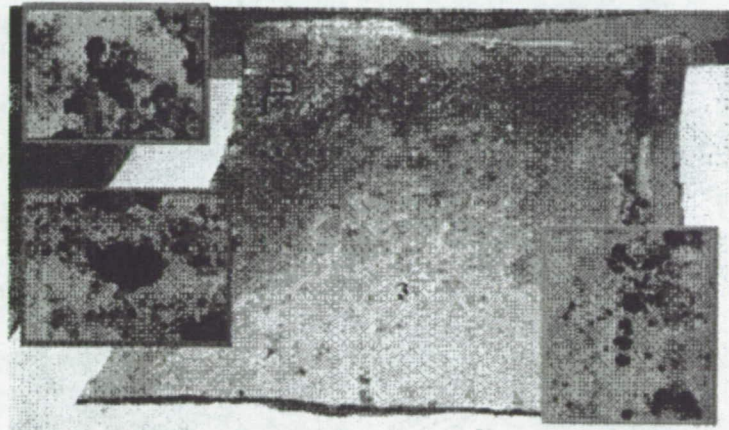
Figure 4

Inverse Radiograph of a Left Hand RCC Upper Apex Displaying Three Distinct Deposition Types and Locations

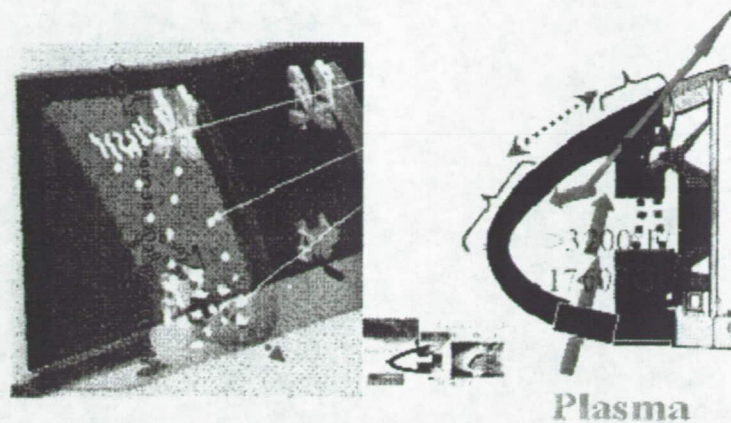
Figure 5

The combination of visual evidence, inverse radiography, virtual reconstruction, and chemical analysis allowed the forensic scientists to verify not only that a breach had occurred in the leading edge of the orbiter's left wing, but also the path the plasma followed (Figure 5), and the sequence of failure events that ultimately led to the loss of the *Columbia*.

Schematic Representation of Events within the Left Wing Leading Edge of the Space Shuttle *Columbia*

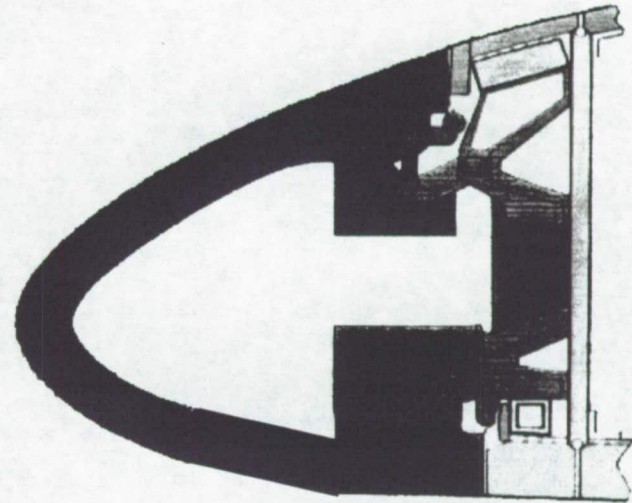
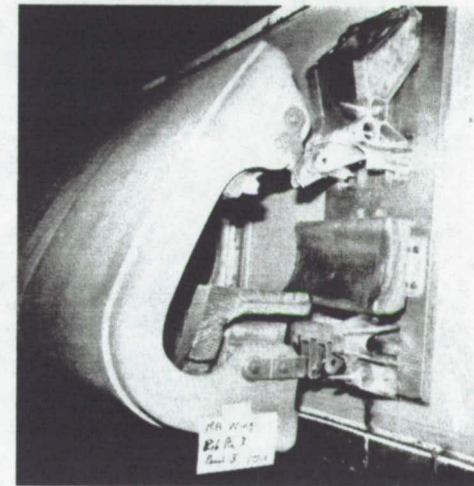
- Unique indications of heat damage:
  - ◆ Excessive overheating and slumping of carrier panel tiles
  - ◆ Eroded and knife-edged RCC rib sections
  - ◆ Heavy deposits on select pieces of RCC panels

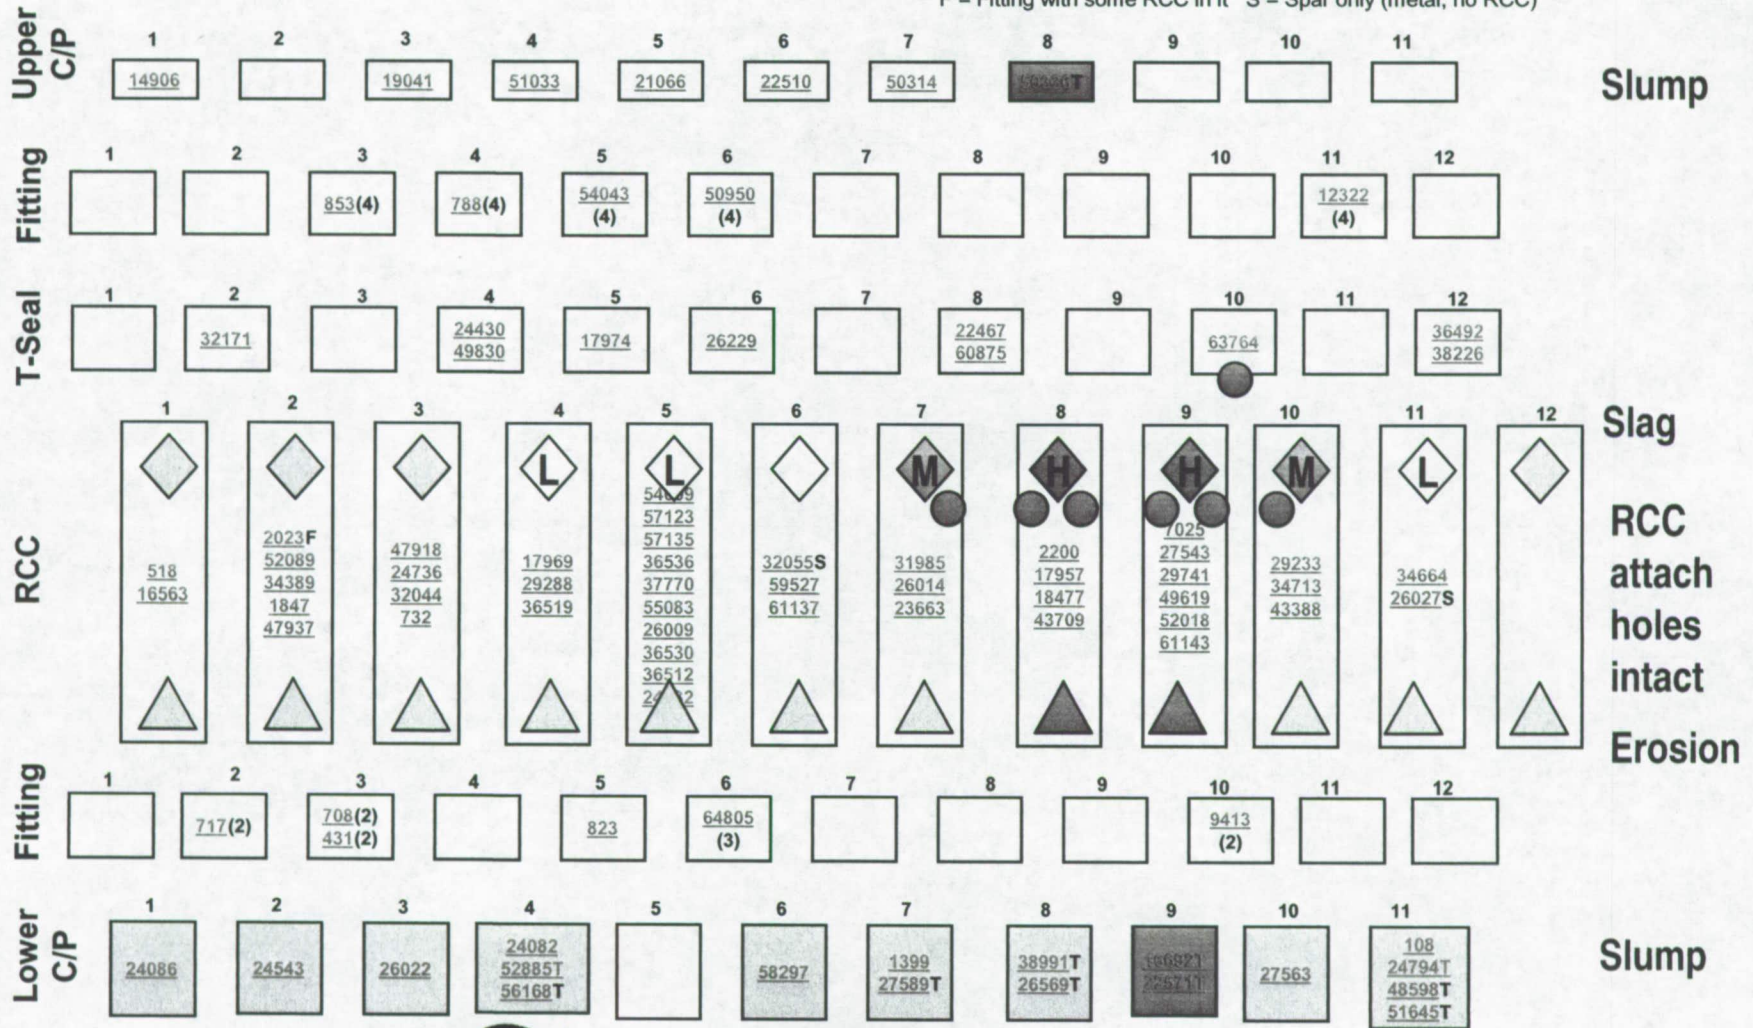
# Left Hand Wing Debris Points to RCC 8/9

(#) = Number of attach fitting bolts on the piece T = Tile piece, no structure  
 F = Fitting with some RCC in it S = Spar only (metal, no RCC)

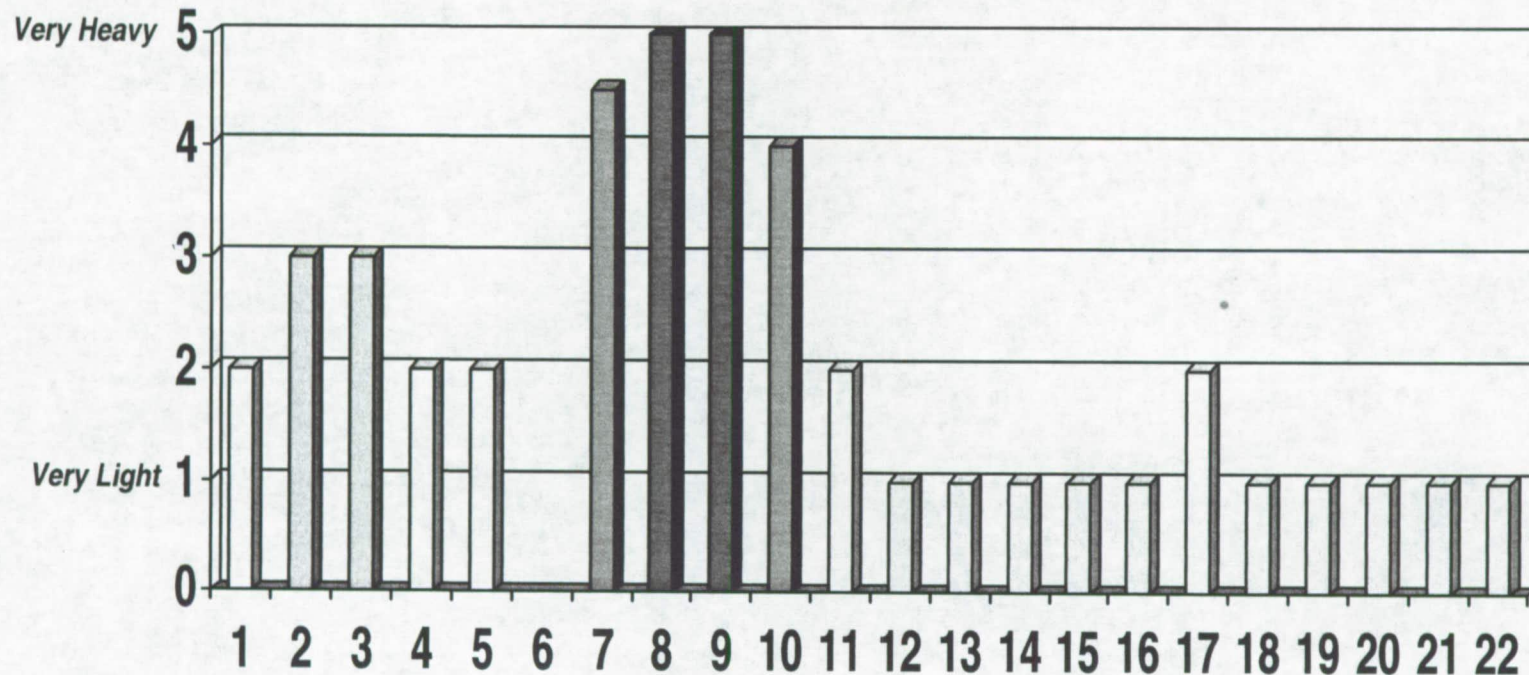
*Qualitative deposition assessment:  
from "Very Light" to "Very Heavy"*

**Distribution of metallic deposition volume  
was centered around panels 8 & 9**

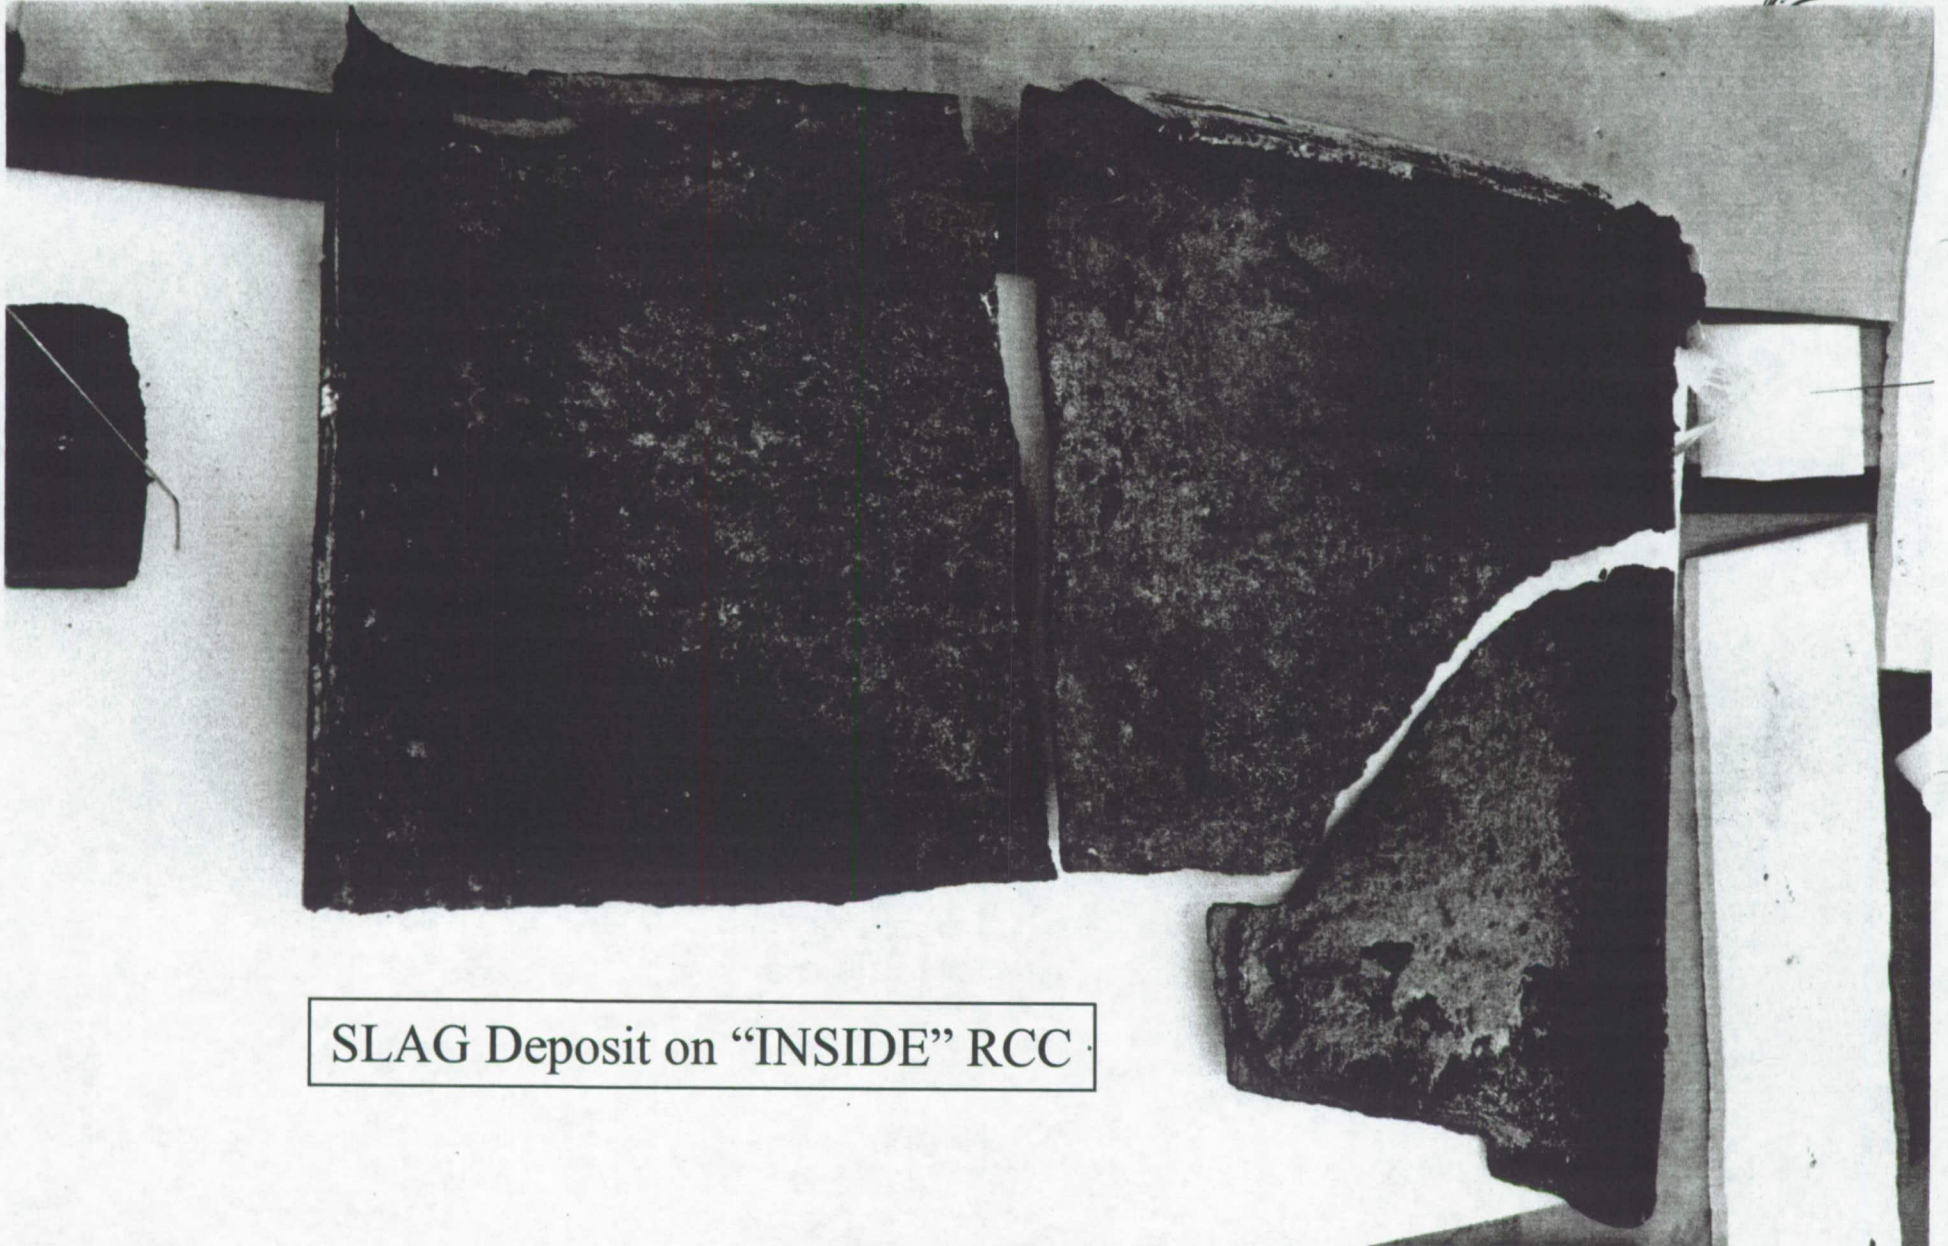
# Slag Deposit Example, LH RCC 8

SLAG Deposit on "INSIDE" RCC

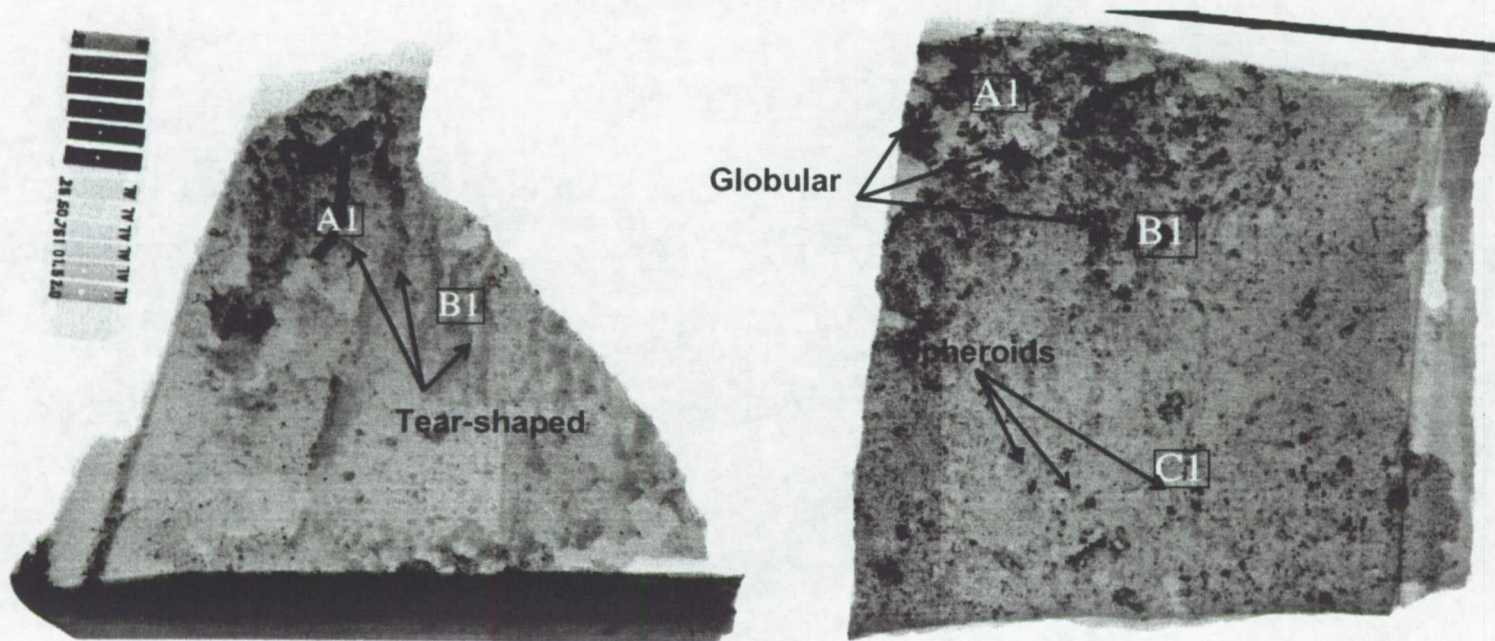
- Four types of deposit patterns were identified from LH RCC Panel 8:
  - ◆ Uniformly thick; Spheroidal; Tear-shaped; Globular

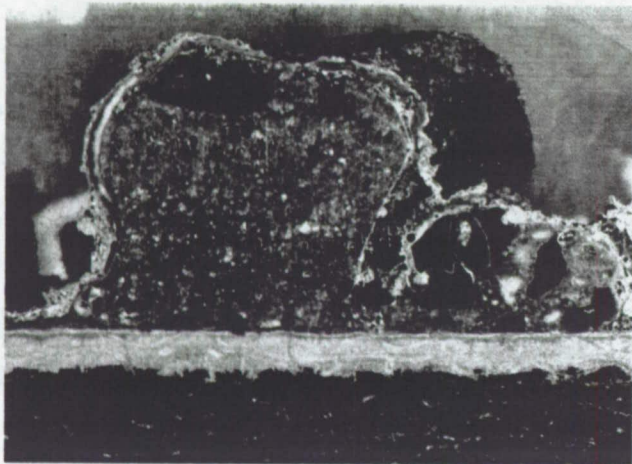
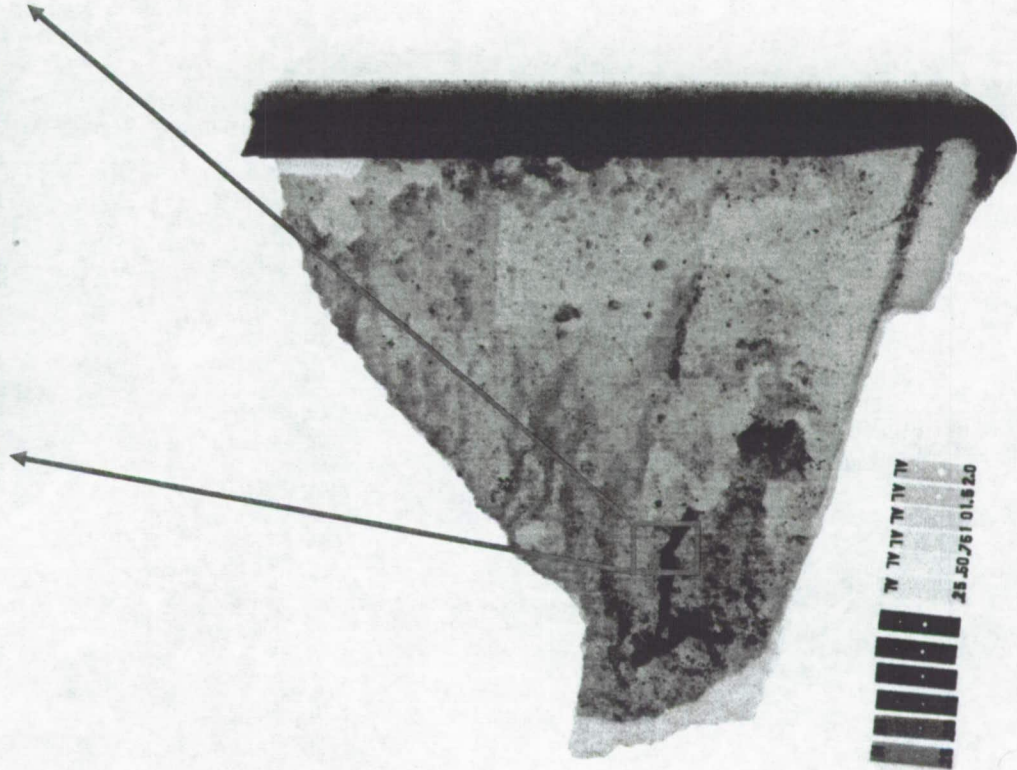
Slag Item 43709, Sample 2A1

# LH RCC 8 – Slag Feature: Thick Tear Shaped

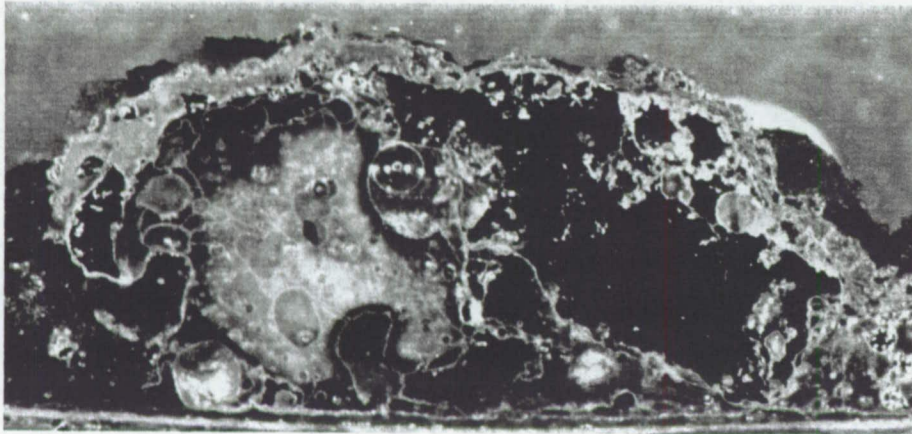
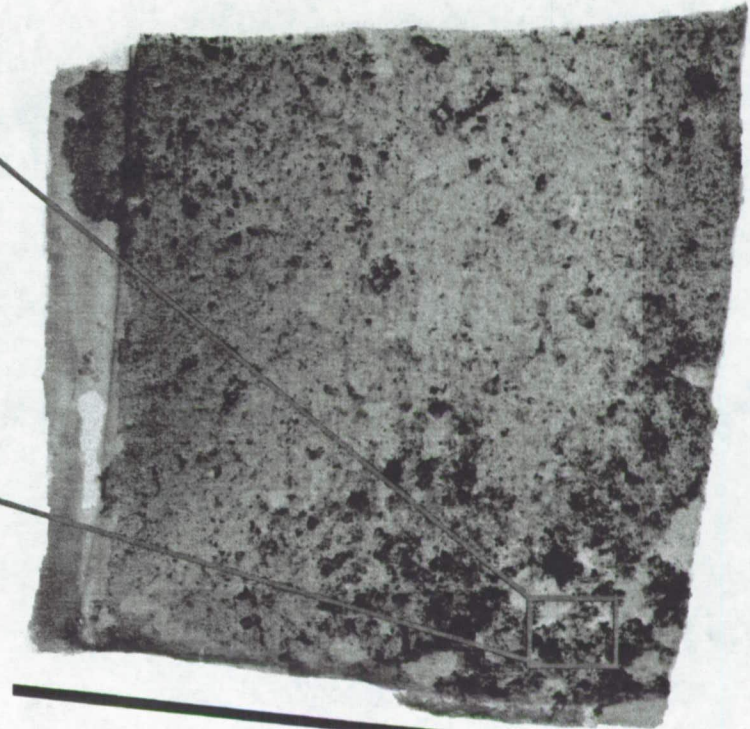
Slag Item 2200, Sample 6A1

# LH RCC 8 – Slag Feature: Thick Globules

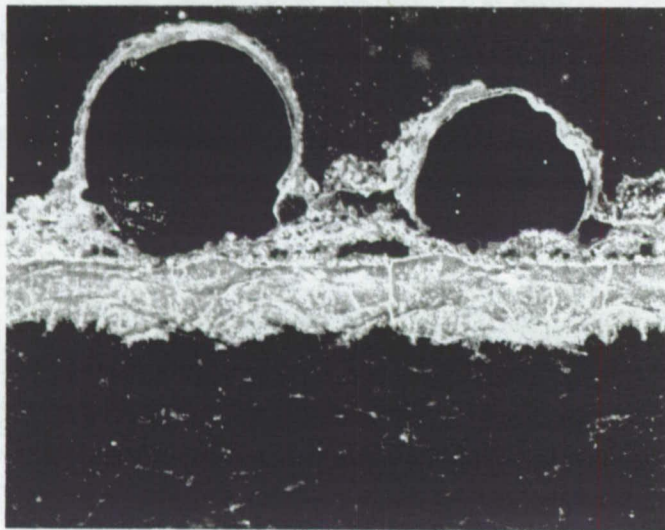
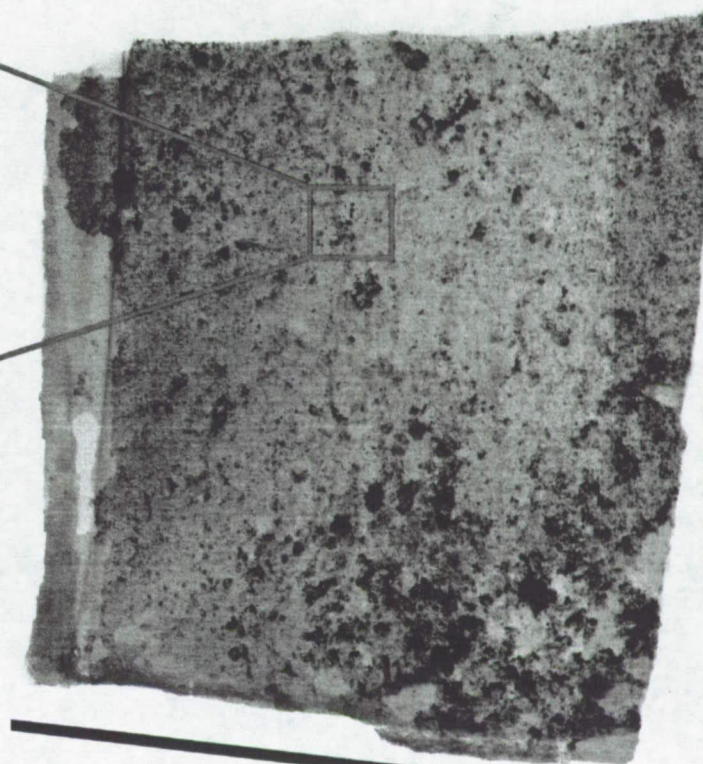
Slag Item 2200, Sample 6C1

# LH RCC 8 – Slag Feature: Spheroids

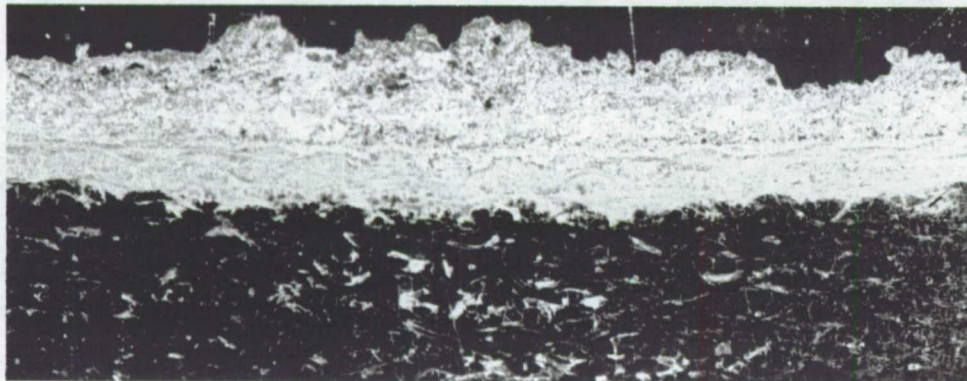
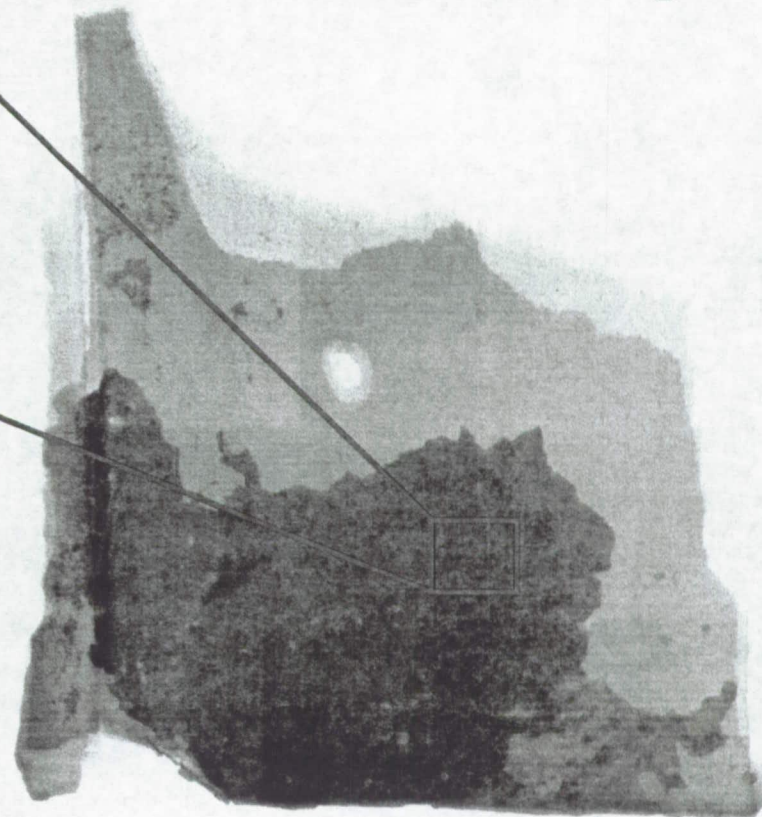
Slag Item 16523, Sample 4A1

# LH RCC 8 – Slag Feature: Uniform Deposit

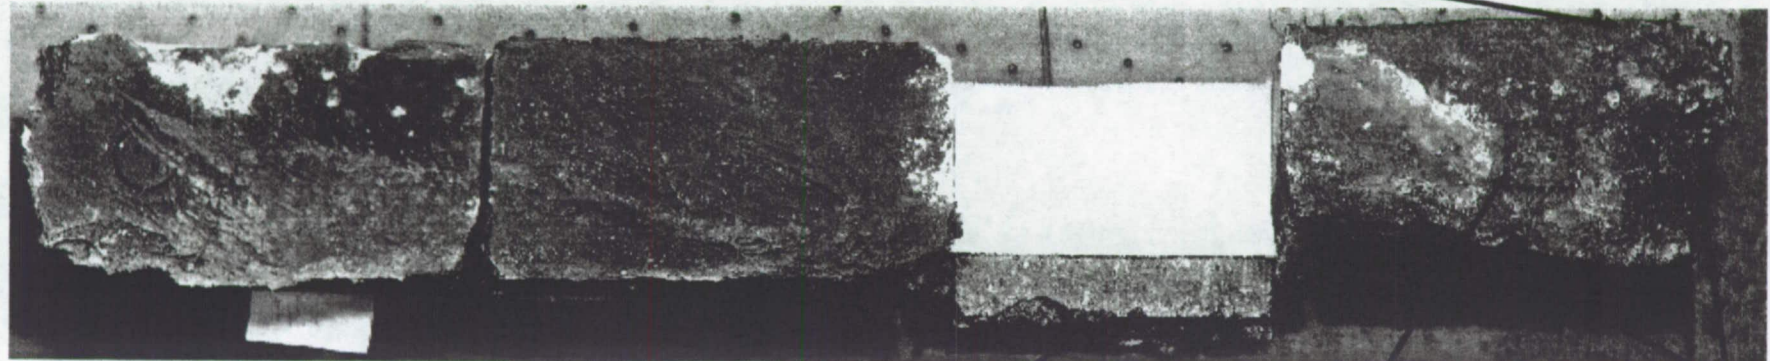
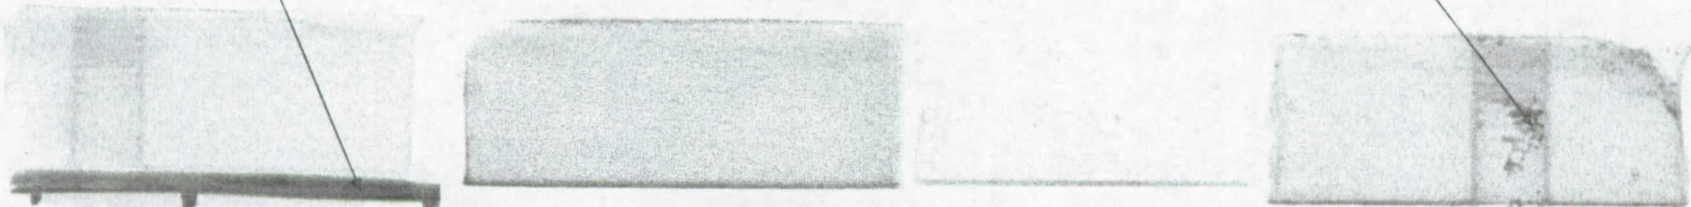
# LH RCC Panel 9 Lower CP Tiles

Horse Collar Fabric Deposit

Tile Slumping

Molten Slag on Tile

High-Z material

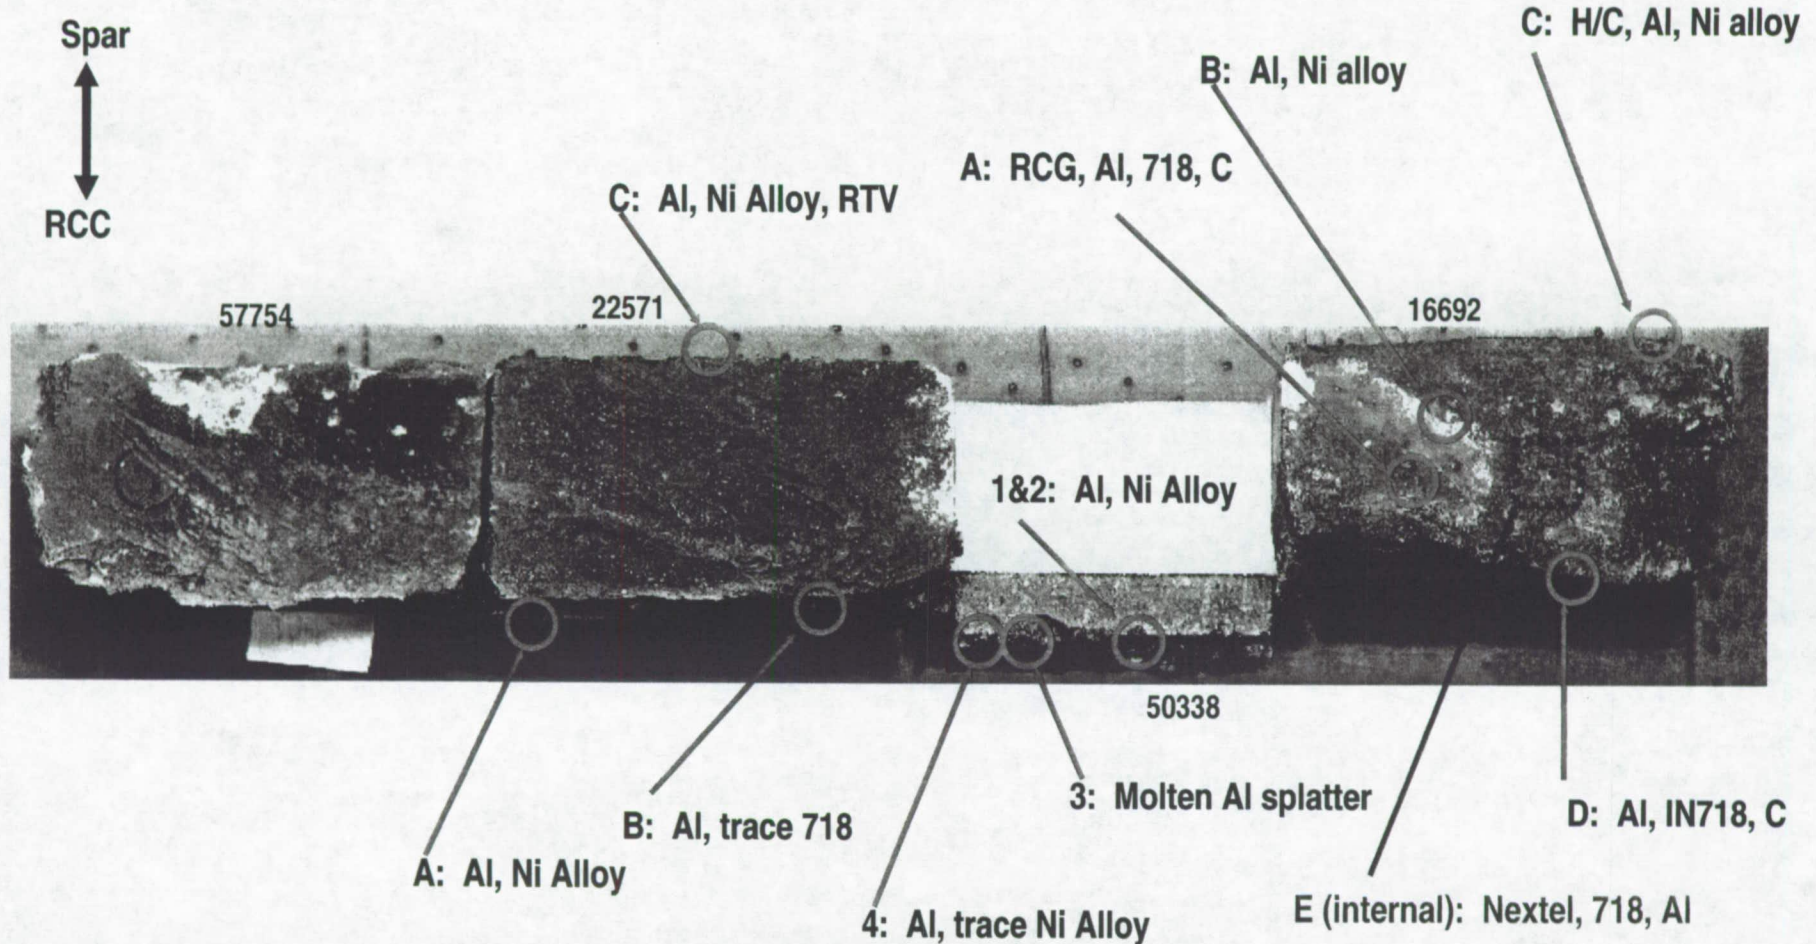
**These findings suggest flow of material from inside the RCC out through the upper and lower CP locations.**

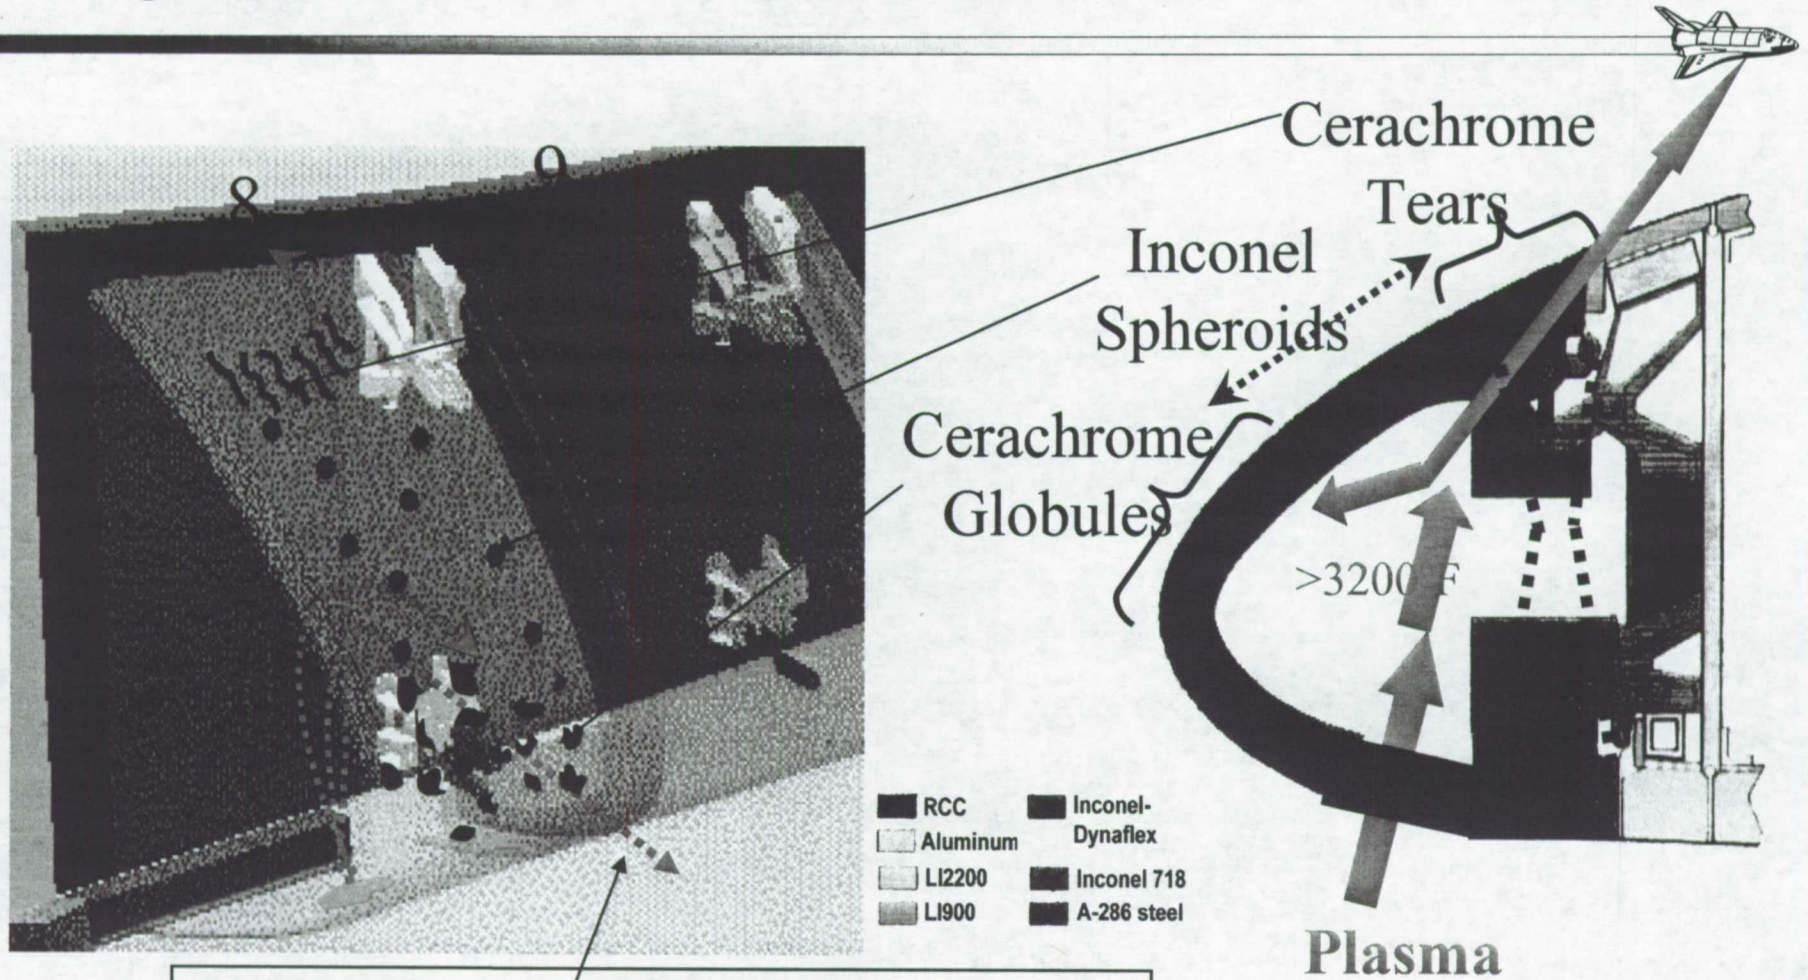
Flow Exiting through RCC 8 on to lower Carrier Panel 9 tiles

- Overall forensic assessment is consistent with M&P Team conclusions
- All forensic evidence suggests a breach occurred on the lower surface of the LH RCC panel 8, close to the T-seal with panel 9
- The breach was present early during reentry allowing the ingestion of hot gasses into the wing leading edge cavity, which continued for several minutes prior to vehicle breakup
- Sequence of events:
  - ◆ Melting and vaporizing the Inconel 601 foil-covered cerachrome insulation blankets
  - ◆ Slumping the wing carrier panel tile immediately aft of the breach
  - ◆ Eroding the RCC adjacent to, and downstream of, the breach
  - ◆ Melting and/or weakening the Inconel 718 and A286 leading edge attach hardware
  - ◆ Destroying the nearby instrumentation and wire bundles
  - ◆ Penetrating the aluminum wing leading edge spar
