# International Space Station Crew Quarters On-Orbit Performance and Sustaining

The International Space Station (ISS) Crew Quarters (CQ) is a permanent personal space for crew members to sleep, perform personal recreation and communication, as well as provide on-orbit stowage of personal belongings. The CQs provide visual, light, and acoustic isolation for the crew member. Over a 2-year period, four CQs were launched to the ISS and currently reside in Node 2. Since their deployment, all CQs have been occupied and continue to be utilized. This paper will review failures that have occurred after 4 years on-orbit, and the investigations that have resulted in successful on-orbit operations. This paper documents the on-orbit performance and sustaining activities that have been performed to maintain the integrity and utilization of the CQs.

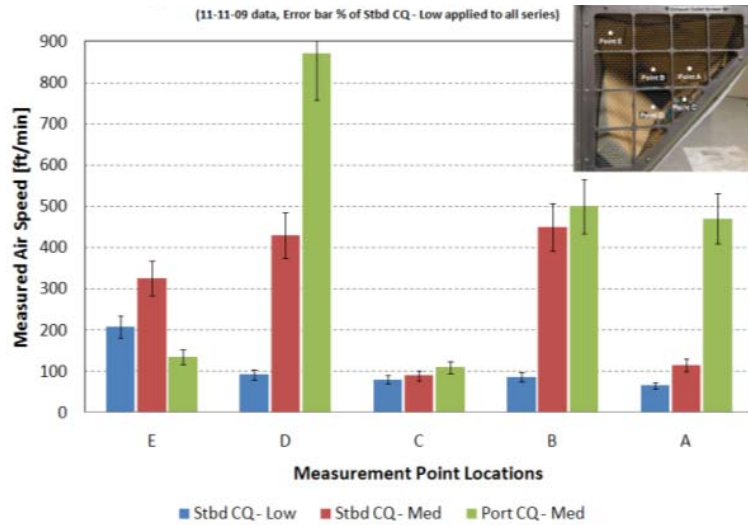
Figure 2. CQ on-orbit exhaust duct outlet air speed measurements.

The crew was tasked to record airflow measurements in the starboard and port CQ. Measurements were taken at the intake duct outlet and the exhaust duct outlet as seen in **Error! Reference source not found.** and **Error! Reference source not found.** using a Velocicalc<sup>®</sup> ventilation meter. More variability in air speed readings than expected was experienced due to positioning of the instrument, complexity of CQ flow field, air turbulence, and low range of instrument capability. Although solid conclusions could not be made, general conclusions could be extrapolated. The data indicated that the fans were outputting acceptable airflow rates; however, the airflow in the starboard CQ seemed degraded when compared to the port CQ. As a result of this troubleshooting, a detailed CQ fault tree was developed and all possible failures identified. These included: 1) System effects that are causing the airflow sensor to sense low flow (such as foreign object damage); 2) Airflow sensor hardware has been degraded/damaged; or 3) Other system effects such as a failure of the CQ power supply. As the CQ team conducted the failure investigation, the leading candidate for the cause of this anomaly was dirt/dust buildup on the air flow sensors, which would require increased air flow to prevent the alarm from occurring.

The CQ team recommended a forward plan to perform a cleaning of the starboard CQ to troubleshoot the anomaly. In November 2010, the starboard cleaning tasks were performed on-orbit. The first step was to determine the location of the failure (intake or exhaust duct) by placing a Ziploc<sup>®</sup> bag over the exhaust airflow sensor. Covering the exhaust airflow sensor would prevent airflow from reaching the sensor and would cause a “2 Fan Failed” alarm if the anomaly was due to a failure in the intake duct. The test did not result in a “2 Fan Failed” alarm and, therefore, the team concluded that the “1 Fan Failed” alarm was the result of a failure in the exhaust duct. Cleaning of the exhaust flow sensor and exhaust fan area was conducted. Once the cleaning was complete, the CQ was powered back on and the alarm had cleared. However, a few minutes later, another “1 Fan Failed” signal was received and did not clear at any fan speed.

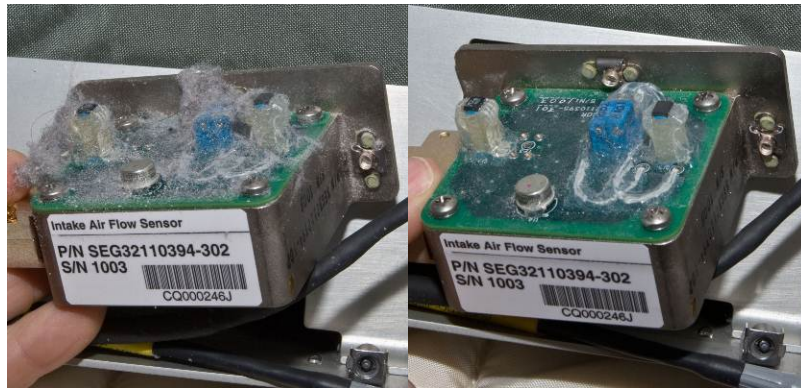
and exhaust duct is cleaner, resulting in a more effective cleaning. In September 2011, both ducts were cleaned. The crew photo documented the areas before and after cleaning. They commented that there was a significant buildup of dust on the abatements, flow sensors, and duct surfaces, as photographed in Fig. 4 and Fig. 5. After this thorough cleaning, the fans were set to low speed and the “1 Fan Failed” alarm did not re-annunciate.

**Figure 2. Starboard CQ intake air flow sensor (pre and post cleaning).**

Based on the significant amount of dust accumulation on the sensors, abatements, and fans located in both the exhaust and intake ducts, it was recommended that cleaning of both duct systems be conducted on a regular basis. Regularly scheduled cleaning activities to clean the CQ duct systems have been included in the ISS Preventative Maintenance Assessment, recommending that the intake and exhaust ducts be cleaned every 9 months.

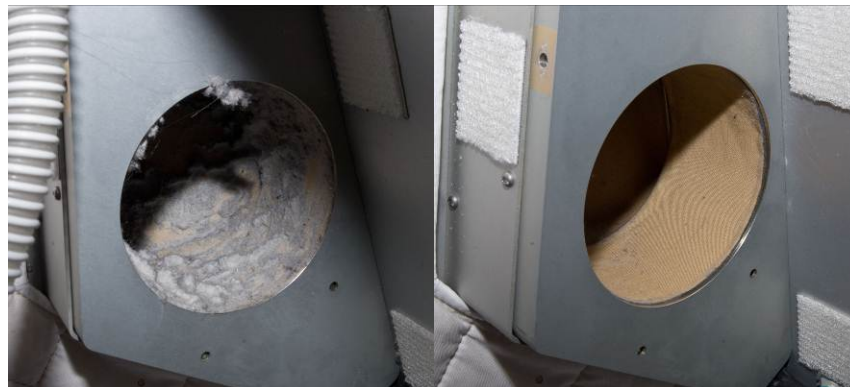
**Figure 3. Starboard CQ intake duct (pre and post cleaning).**

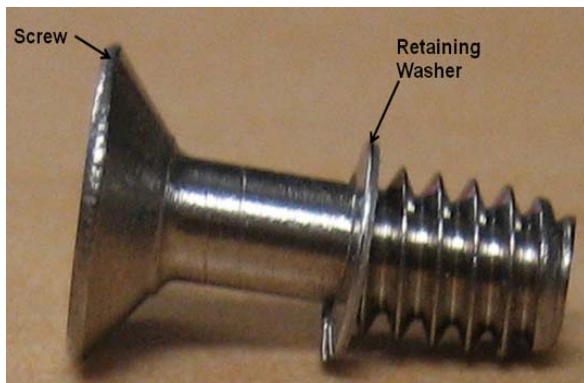
Figure 6. Phillips® head captive machine screw.

The crew identified a total of six fasteners as non-captive during three separate on-orbit cleaning operations to clean the starboard CQ intake and exhaust ducts. The crew photo documented the discrepant fasteners and marked them as non-captive. The fasteners were originally launched as captive fasteners installed in the starboard CQ. The captive features are either washers or retaining rings that allow the fastener to be removed from the substructure but remain attached to the panel so that it would not get lost. Since some of the fasteners were found to be non-captive, the crew had to show care when removing them and would temporarily store them.

Troubleshooting included checking with the vendors on the failures modes of the captive features as well as consulting with the installation technician to investigate possible failure modes. The root cause could not be directed at the type of fastener used since the captive feature was lost on different types of fasteners. The ISS Crew Quarters Strength and Fracture Assessment confirms that the areas of concern are capable of withstanding kick loads (where applicable) and launch loads, which are significantly higher than on-orbit loads with the possible exception being during maintenance.

Two general types of fasteners became non-captive. One was a Phillips® head captive machine screw and the other was a Live Lock™ stud. For the Phillips® head captive machine screw, the washer (captive feature) is installed by screwing it onto the fastener threads (Fig. 6). Just as it is easily screwed on, if the fastener is loosened out of the substructure but is continued to be loosened against the panel, it is possible to back out (unscrew) the washer during removal. If the crew is removing a panel and is unable to determine whether the fastener is completely removed from the substructure, the crew could continue to loosen the fastener while unfastening the captive washer. It is recommended to remove the Phillips® fasteners one turn at a time to avoid overloosening and backing out the captive washer during removal. For the Live Lock™ Studs (Fig. 7), failure modes include backward installation of the wire form ring (captive feature) on the fastener or the incorrect drill hole size of the retaining ring counterbore. Backward installation of the captive feature could cause misalignment and possible failure. The incorrect sizing of the counterbore could cause overstressing, thereby leading to failure. Build paperwork and drawings show that the correct instructions were given for the installation of these fasteners, but there is not enough detail on individual fastener inspection to determine whether one of the above issues occurred.

All four of the CQ cleaning procedures have been updated to instruct the crew to loosen the Phillips® head captive machine screws one turn at a time to prevent the washers (captive features) from backing out during removal. The procedure also instructs the crew that the fasteners are susceptible to becoming non-captive and, therefore, the crew should show care when un-installing to prevent fasteners from getting lost. Spares are available on the ground to replace the captive features for all four types of fasteners, but it is not recommended that they be replaced at this time.
