NASA/TM—2013–216321

Refractory Materials for Flame Deflector Protection System Corrosion Control: Flame Deflector Protection System Life Cycle Cost Analysis Report

January 2009

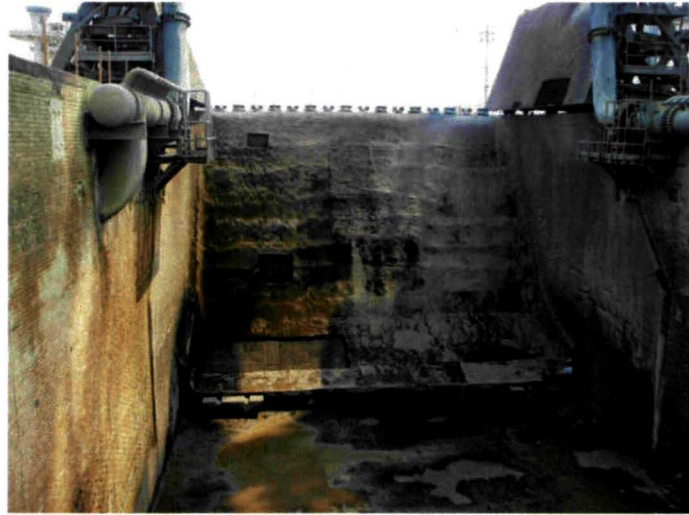
NASA uses refractory concrete to protect the steel base structure of the flame deflectors that receive and deflect the flames and exhaust from the SRBs and Space Shuttle main engines (SSME) during launch, thereby protecting the Space Shuttle and surrounding facilities. The current refractory concrete material, Fondu Fyre®, was developed solely for NASA, and is the only material available for use. However, it does not meet qualification requirements of the current specification, KSC-SPEC-P-0012 (April 25, 1979). Fondu Fyre was grandfathered into the qualified products list; was never tested for resistance to SRB acidic exhaust; and loses strength as a function of time. Refractory material failures, the size of the damaged area, the loss of strength, and frequency, cost, and extent of repairs are increasing with every launch. The continued use of this product has resulted in NASA spending significant effort and capital to repair the refractory concrete protective lining and the steel base structure. In addition to increased efforts and costs, the failure of the refractory concrete during launch results in foreign objects and debris (FOD) that can damage ground support equipment (GSE) and the Shuttle. Figure 1 clearly shows the extent of degradation to Fondu Fyre.

Figure 1. Degradation to Fondu Fyre on the SRB Flame Deflector

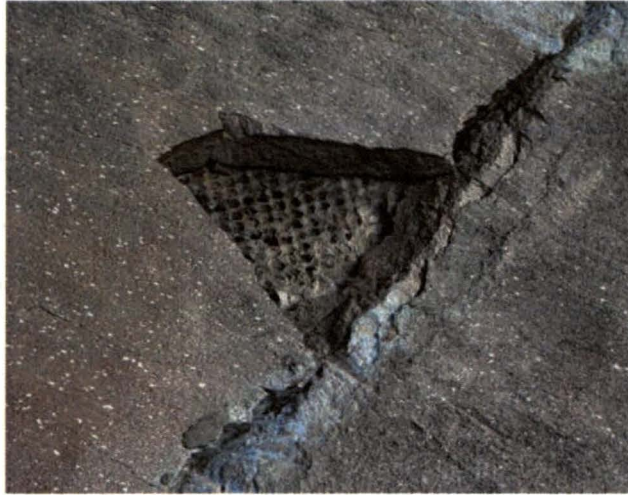
Figure 6. STS-126 Spalled and Dislodged Concrete Section

This anomaly may have resulted from the seepage of water through the cracked refractory concrete. It is possible that corrosion of the grid steel reduced the adhesion between the refractory and base material. During launch, the water under the concrete section may have turned to steam, lifting the section from the surface.

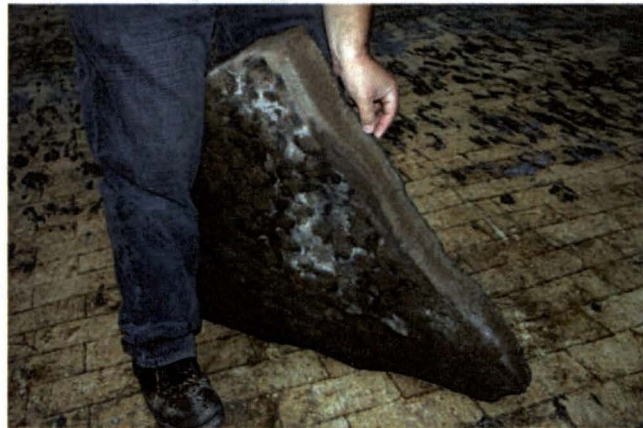
halfway down the length of the flame trench. A picture of the dislocated concrete section is shown in Figure 7.

Figure 7. Section of Refractory Concrete Dislodged During the Launch of STS-126

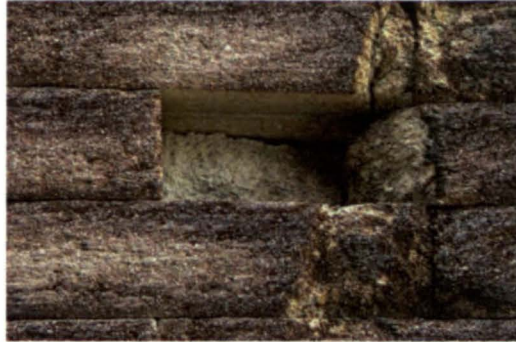
Firebrick that has been dislodged from the walls of the flame trench is another anomaly that is frequently seen after a Shuttle launch. An example of this phenomenon witnessed on the SRB side of the LC 39A flame deflector after STS-126 is shown in Figure 8

Figure 8. Missing Refractory Brick at LC 39A

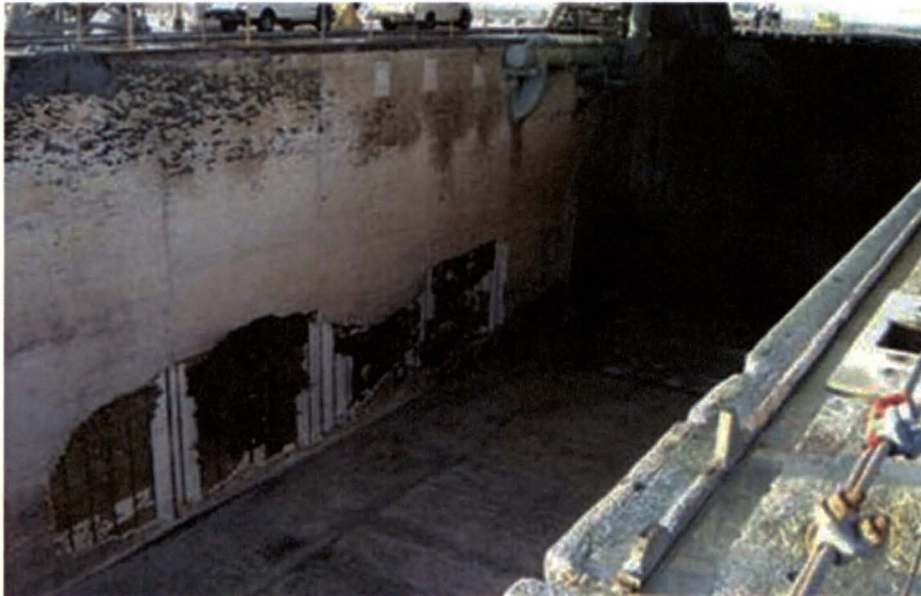
A non-typical example of flame trench degradation occurred during the launch of STS-124 on May 31, 2008 when serious damage to the east walls of the flame trench occurred during the launch of the Space Shuttle Discovery. Blast from the SRBs resulted in the expulsion of around 3,540 firebricks (16 percent of the wall) from the flame trench walls (Figure 9). The interlocking firebricks were attached to the 3 foot thick concrete substructure with epoxy and dove-tail metal clips. The metal clips, attached to slotted channel embedded in concrete, are installed horizontally to every other brick, and vertically at every sixth row.¹⁰

Figure 9. Extensive Dislocation of Firebrick on May 31, 2008

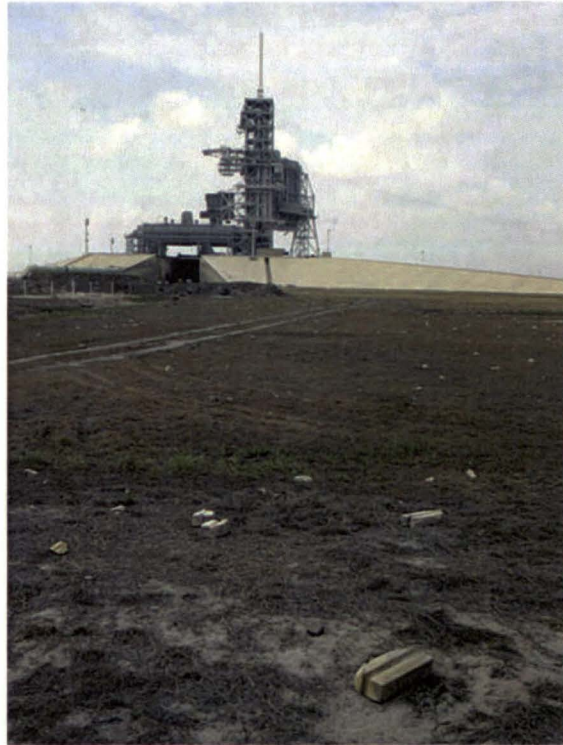
These sections of refractory brick were ejected downrange from the launch site and beyond the perimeter fence at LC 39A. The total distance traveled by some of the firebrick was over 1,500 feet.¹¹ Figure 10¹² and Figure 11¹³ show the extent of FOD that was produced by the bricks that were torn away from the flame trench walls.

Figure 10. Refractory Concrete Bricks Torn Away From the Flame Trench

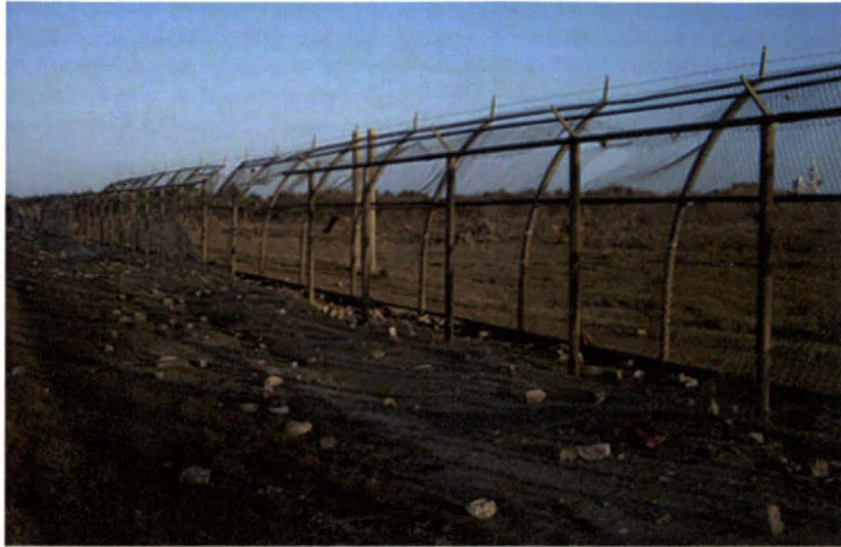
Figure 11. Refractory Concrete Bricks Around Fences

While this example of extensive destruction of refractory structures is not the norm, the cost associated with its repair was very high (estimated at 2.7 million U.S. dollars). Ultimately, the firebrick was replaced with Fondu Fyre refractory concrete that was gunned in place.

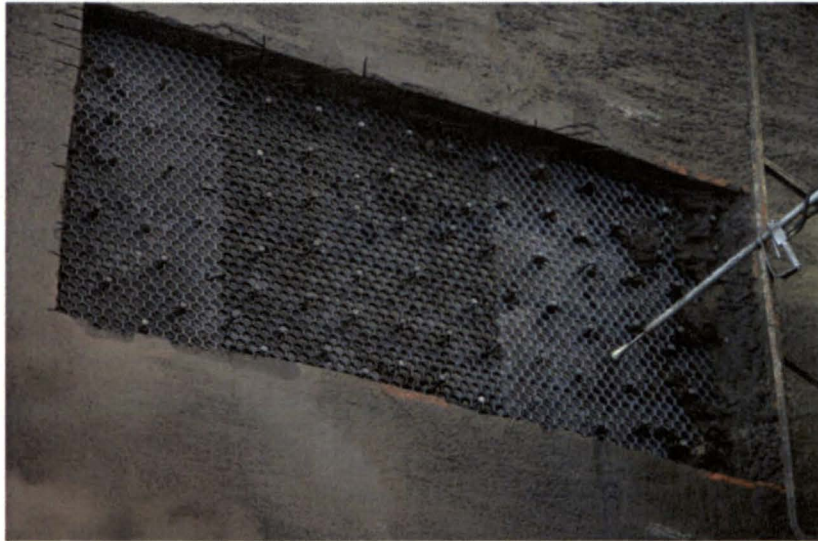
Figure 12. Cut-Out Section of a Refractory Material on LC 39A Repair, Showing the Underlying Grid Steel Honeycomb Structure With Steel Nelson Studs Protruding Outward
