LOGISTICAL AND ANALYTICAL APPROACH TO A FAILURE ABOARD THE INTERNATIONAL SPACE STATION

Steve McDanel, M. Clara Wright, Victoria Salazar, David Lubas, Bryan Tucker
National Aeronautics and Space Administration (NASA)
Kennedy Space Center, Florida

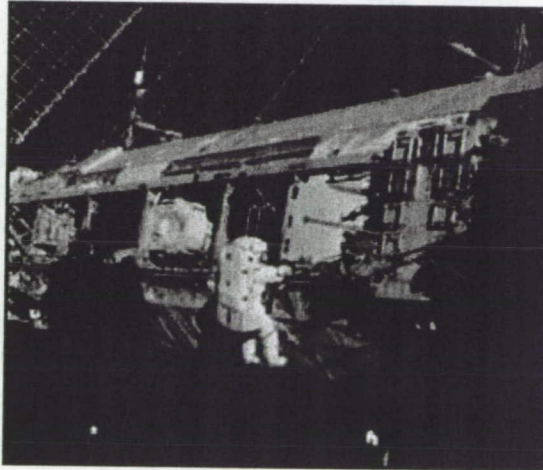
Figure 4
Astronaut Dan Tani, Expedition 16 flight engineer, harvesting debris from the SARJ.

During this and subsequent EVAs, as Dan Tani removed insulation covers protecting the SARJ and its hardware, he found that the outboard raceway of the SARJ appeared mottled. The inboard race ring and gear teeth did not display similar damage. Likewise, he reported the appearance of metallic debris decorating portions of the race, particularly near TBAs 4 and 5. Areas away from the TBAs and DLAs still appeared damaged although they did not display as much contamination. After photographing the assembly, Astronaut Tani collected samples of the debris on adhesive tape for later analysis back on Earth. He replaced the covers and completed a nearly seven hour EVA. The collected samples were returned to Earth aboard the shuttle *Discovery*. Figure 5 shows the general area where damage and debris was observed, along with a larger picture of the debris area.
