KSC Engineering Directorate  
Materials Science Division

# Space Spalls

STS-120 International Space Station (ISS) Starboard Solar Alpha  
Rotary Joint (SARJ) Debris Analysis

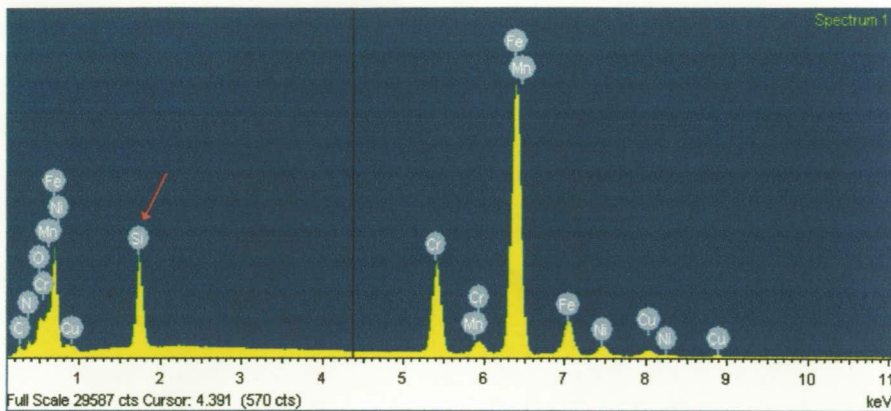
Representative spectrum from debris – corresponds most closely to nitrided 15-5 PH. The silicon peak is due to the silicone adhesive on the Kapton tape.

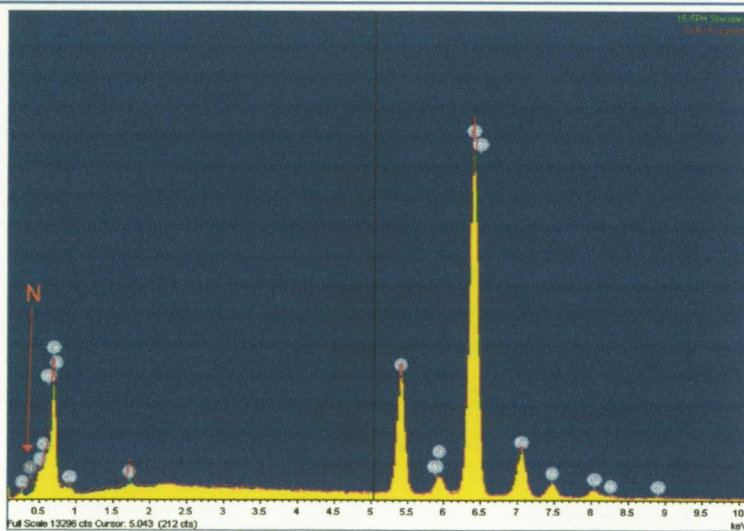
Overlay of representative spectrum from debris (red) on the baseline 15-5 PH spectrum. N peak indicates that the debris is from the nitrided layer.

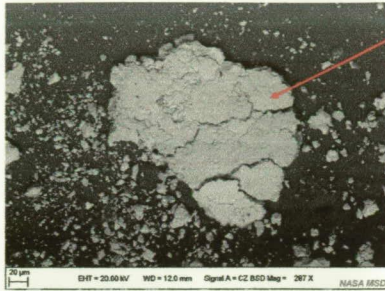
"Extrusion-like" damage; possible agglomeration.

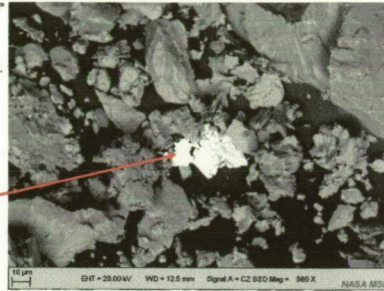
Gold particle showing atomic contrast.

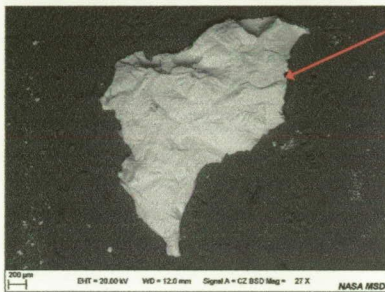
Evidence of possible cleavage.

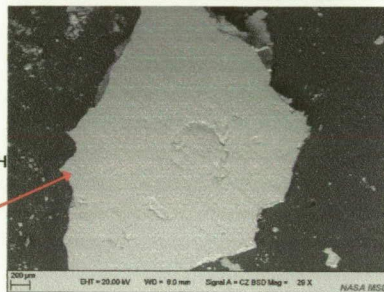
Original 15-5 PH nitrided surface with machine markings.

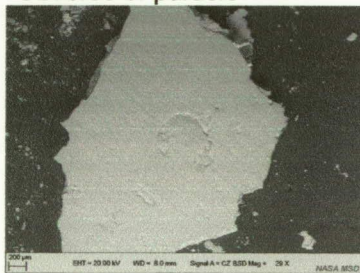
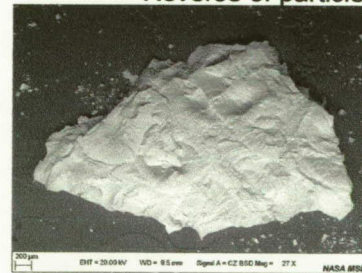
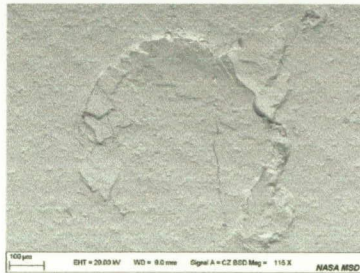
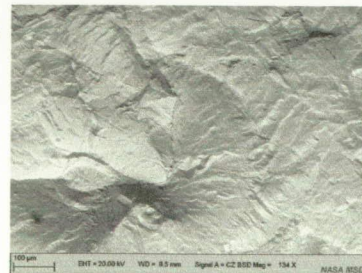
### SEM Images of Large Particle from Short Front Sample

Nitrided 15-5 PH surface with machine markings on obverse (L) and flipped over revealing scalloped reverse (R).

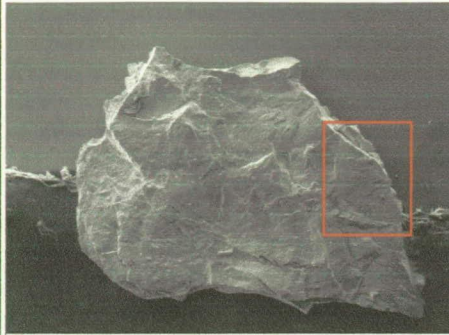
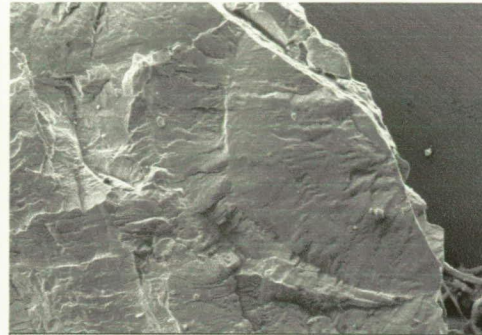
SEM image of fragment removed from tape imaged under high vacuum in secondary electron (SE) mode. Area in red box appears to be a fracture initiation site and fan-shaped region within the box suggests crack arresting.

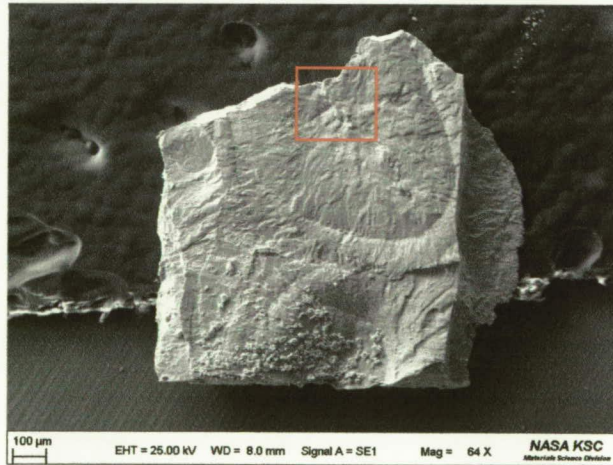
SEM image of fragment removed from tape and imaged under high vacuum in secondary electron (SE) mode. Area in red box appears to be a fracture initiation site and elliptical region suggests crack arresting. Features typical of spalled fragments.

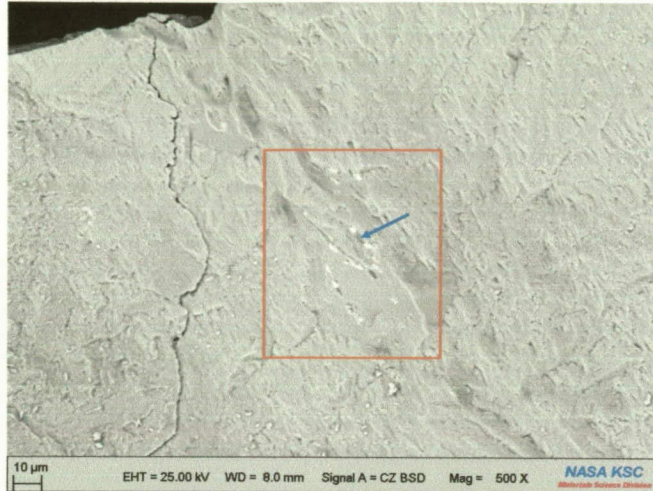
Backscattered electron image of outlined area in red box from slide 21 showing atomic contrast. The white constituent in the box is primarily niobium (Nb), and the black constituent next to the blue arrow is MnS, as confirmed by EDS. 21

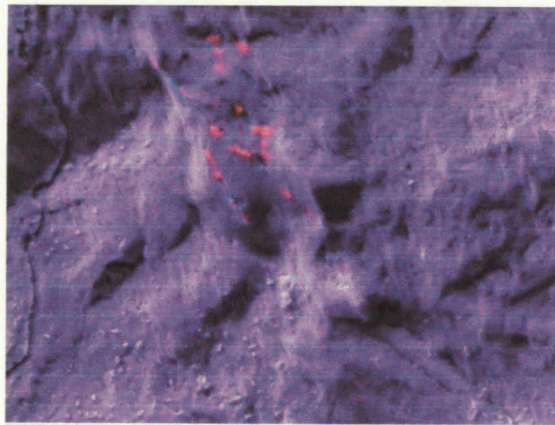
X-ray elemental dot map of same apparent initiation site outlined in slide 21, showing Nb-rich precipitates in an Fe-rich matrix. Note: Mn and S pixels are masked in this image. 22

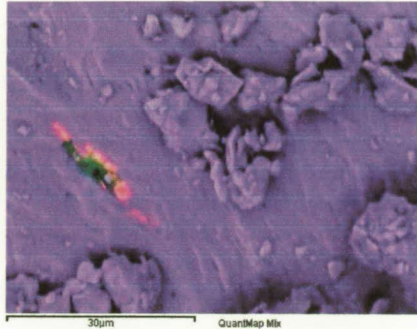
### X-Ray Elemental Dot Map

X-ray elemental dot map showing Nb-rich precipitates in an Fe-rich matrix and a MnS inclusion. MnS inclusions were often located in the vicinity of the Nb-rich precipitates.

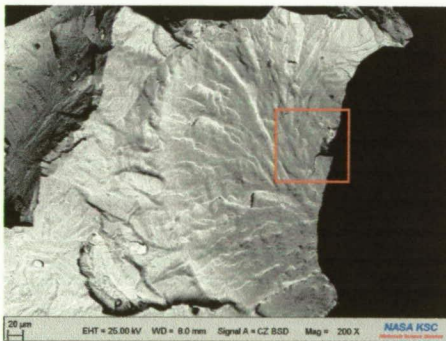
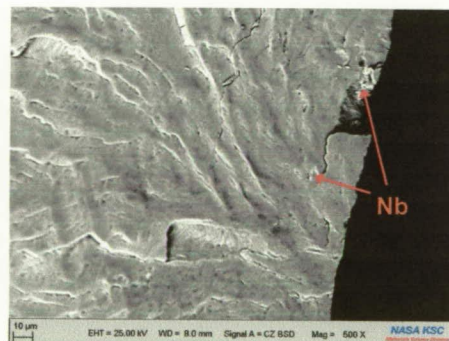
### Additional Fracture Initiation Sites with Nb-Rich Precipitates

Backscattered electron image showing atomic contrast of the Nb-rich precipitates at a typical subsurface fracture initiation site.

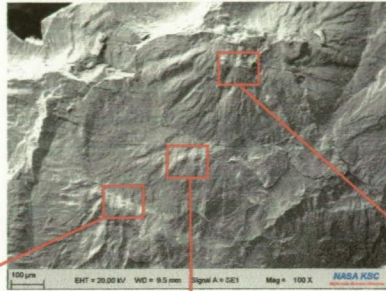
### Additional Fracture Initiation Sites with Nb-Rich Precipitates

Backscattered electron image showing atomic contrast of the Nb-rich precipitates at typical subsurface fracture initiation sites.

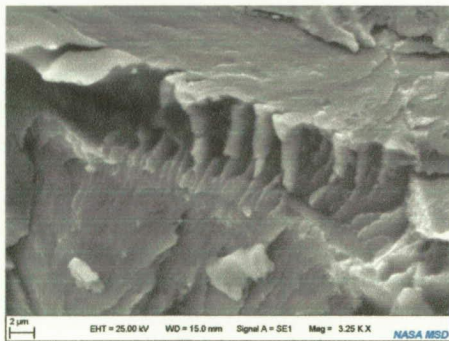
Cleavage steps

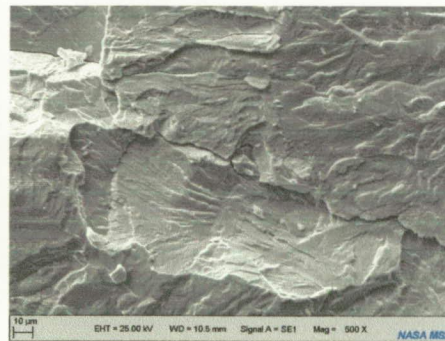
Cleavage feather pattern

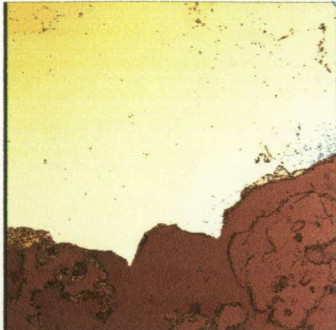
- Confocal microscopy was used for in-situ (non-destructive) thickness measurements at 100X magnification of several particles.
- Particle thickness ranged from 100 to 260  $\mu\text{m}$ , however minor margin of error may exist from the possibility of particles lifting off tape or being imbedded into tape.

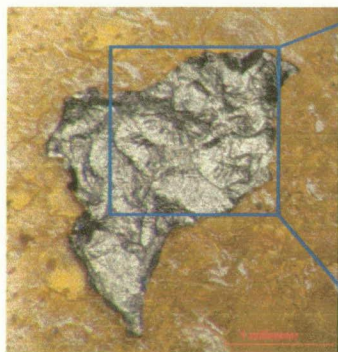
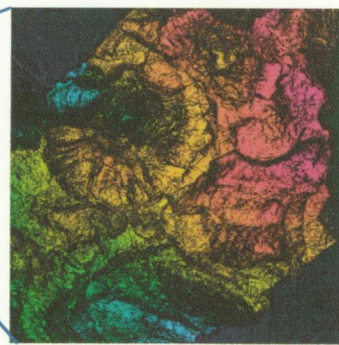
### Confocal Microscopy for Surface Topography

Confocal microscopy was used to study the relative heights on the fragment fracture surface. Image on right shows the topography using the visible spectrum, with the highest areas in red/pink and the lowest areas in dark blue (background).

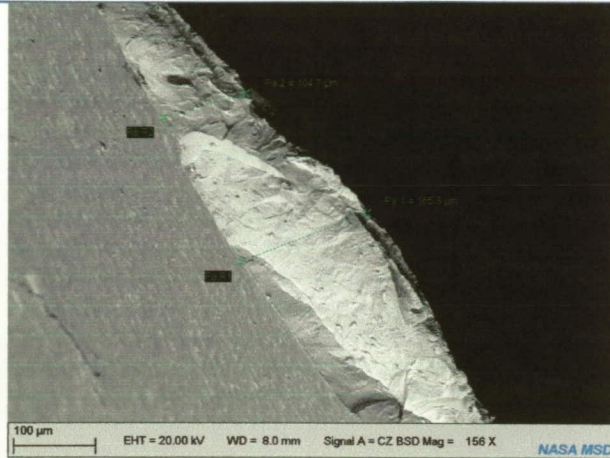
Particle thickness measurements of large particle in the SEM correlated with measurements taken using laser confocal microscopy, which were 100 to 165  $\mu\text{m}$  for this particle.

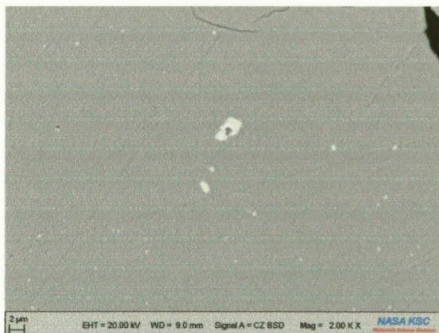
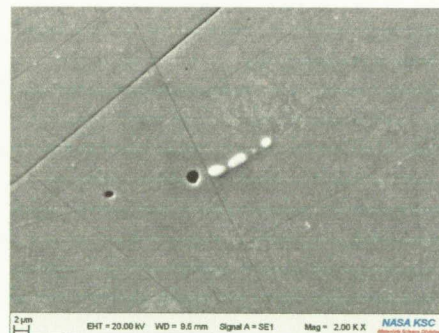
Backscattered electron image showing atomic contrast of typical Nb-rich precipitates (white) and MnS inclusions (black) in the 15-5 PH matrix (gray). The geometry and length scale of the SARJ fragment precipitates were comparable with those of stock 15-5 PH. The hardness of the stock 15-5 PH indicated that it has a similar heat treatment as the SARJ specification.

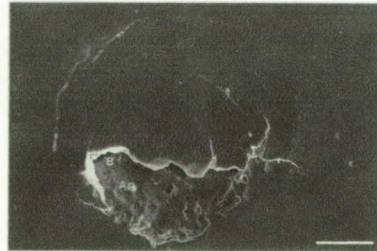
- Contact stress fatigue, i.e. spalling, with subsurface initiation
  - Location of origin – “Short distance below surface, usually at a nonmetallic inclusion”
  - Initial size – “Small”
  - Initial shape – “Irregular”
  - Crack angle with respect to surface – “Roughly parallel at bottom, perpendicular at sides”
  - Apparent occurrence – “Sudden”
