# Testing and Analysis Validation of a Metallic Repair Applied to a PRSEUS Tension Panel

**A design and analysis of a repair concept applicable to a stiffened composite panel based on the Pultruded Rod Stitched Efficient Unitized Structure was recently completed. The damage scenario considered was a midbay-to-midbay saw-cut with a severed stiffener, flange and skin. Advanced modeling techniques such as mesh-independent definition of compliant fasteners and elastic-plastic material properties for metal parts were utilized in the finite element analysis supporting the design effort. A bolted metallic repair was selected so that it could be easily applied in the operational environment. The present work describes results obtained from a tension panel test conducted to validate both the repair concept and finite element analysis techniques used in the design effort. The test proved that the proposed repair concept is capable of sustaining load levels that are higher than those resulting from the current working stress allowables. This conclusion enables upward revision of the stress allowables that had been kept at an overly-conservative level due to concerns associated with repairabi

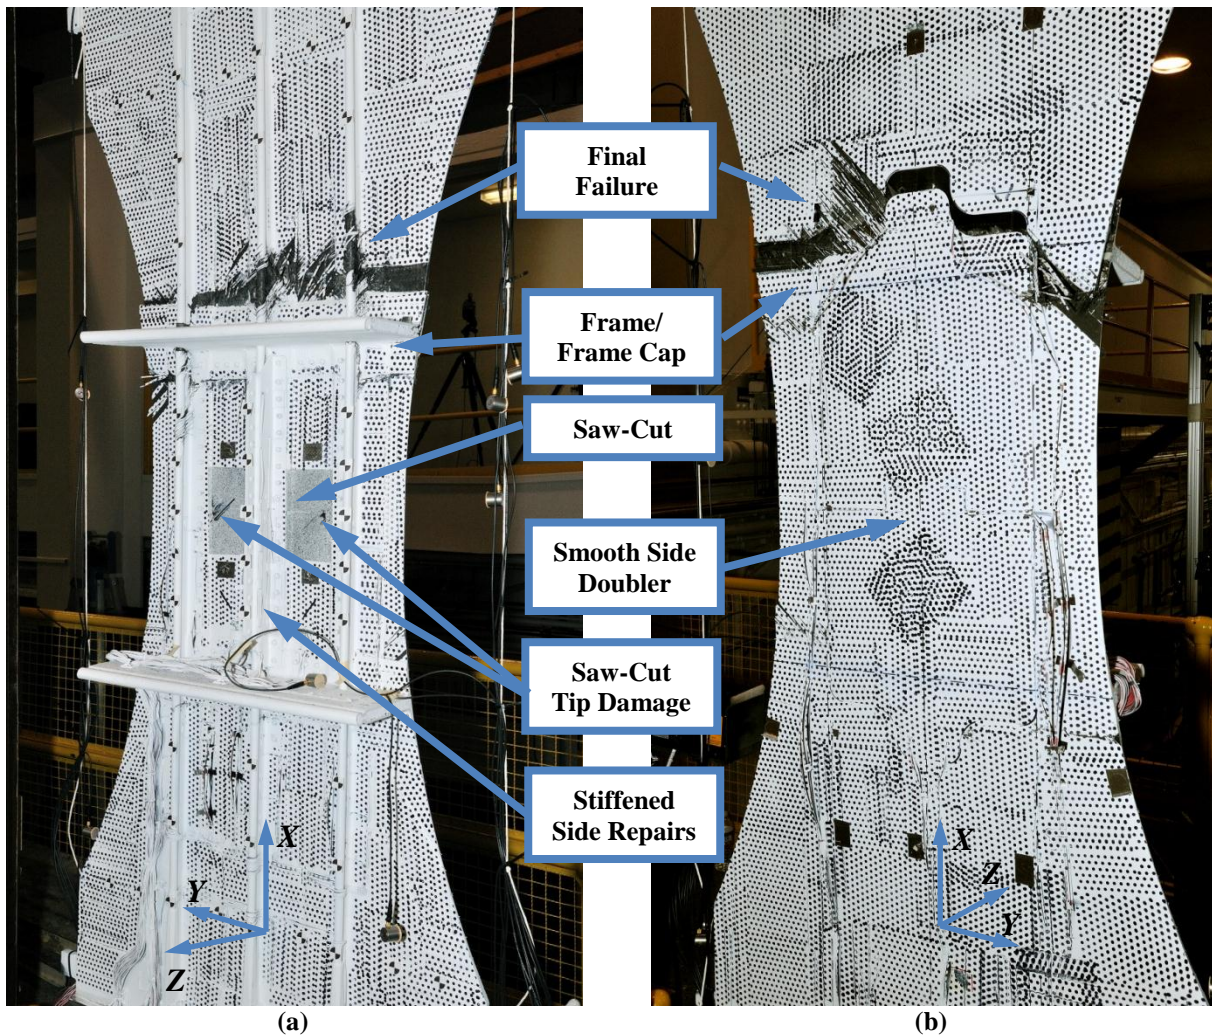
The final panel failure occurred at the loading of 243,992 lb. Failure mode is illustrated in Figure 9. The failure occurred away from the center section of the panel, i.e., away from the initial saw-cut damage, generally in the vicinity of the top foam-filled frame. While pin-to-pin elongation of the panel presented in Figure 10 shows linear global behavior up to approximately 213.5 kip load level, i.e., greater than DUL+10%, subsequent sections detail several localized effects not identifiable in the global displacement plot. Some of these local events did not significantly influence the final failure, but nevertheless it is worthwhile to trace the damage progression, as it helps in understanding the mechanics of the structure. Identification of test behavior before embarking on FE predictions assessment is also helpful in the process as the adopted modeling assumptions and analysis fidelity can be placed in the context of the actual article behavior.

**Figure 9. Failure of the repaired tension PRSEUS panel: (a) stiffened side, (b) smooth side. The speckle pattern applied for VIC-3D measurements is visible.**

As indicated before, the final failure of the panel occurred in the vicinity of the top foam-filled frame away from the repaired saw-cut area. The final failure mode was presented in Figure 9. The panel and the repair components were disassembled after the test to allow examination for damage modes not visible in the assembled configuration and to correlate gage readings, especially their discontinuities, with a probable damage sequence scenario. The two general areas where additional examination was enabled by disassembling the repair were the center stringer and fastener holes.

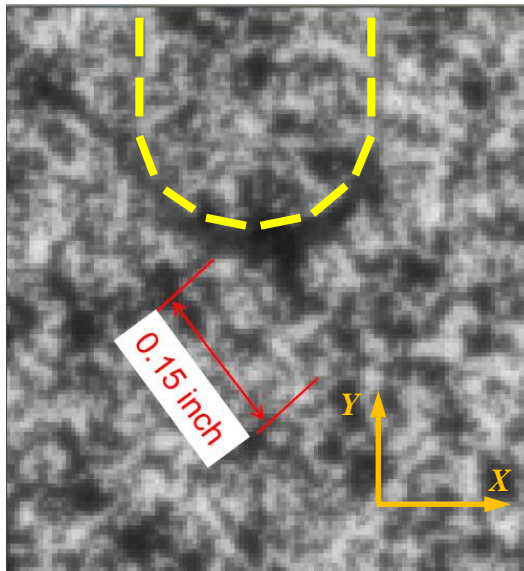
The first identifiable local failure was initiated in the region of the right-hand-side saw-cut tip (when looking at the panel from its stiffened side) at a load of 102.5 kip or 86.1% of DLL and is shown in Figure 11. The tip of the saw-cut is highlighted with a yellow dashed line in Figure 11 and the speckling visible inside the saw-cut area is on the smooth side doubler. The surface fiber splitting is not easily visible in Figure 11, however, the extent of the splitting was 0.15 in. and was determined based on displacement contours from the high-resolution VIC-3D acquisition. Both left- and right-hand-side saw-cut tip openings and surface splitting lengths were traced using the high-resolution VIC-3D acquisition throughout the entire loading sequence. For brevity, only the surface openings are presented in Figure 12 along with strain readings from the two closest strain gages, SG-155 and -156, located one inch to the side of the left- and right-hand side saw-cut tips, respectively. It is seen in Figure 12 that the initial saw-cut tip event at 102.5 kip was so minor that it did not result in a noticeable strain reading disruption in the two aforementioned strain gages. It is therefore concluded that this local event did not significantly affect the behavior of the panel away from the saw-cut for load less than DLL.

Figure 11. Initial surface opening at the right saw-cut tip at 102.5 kip.

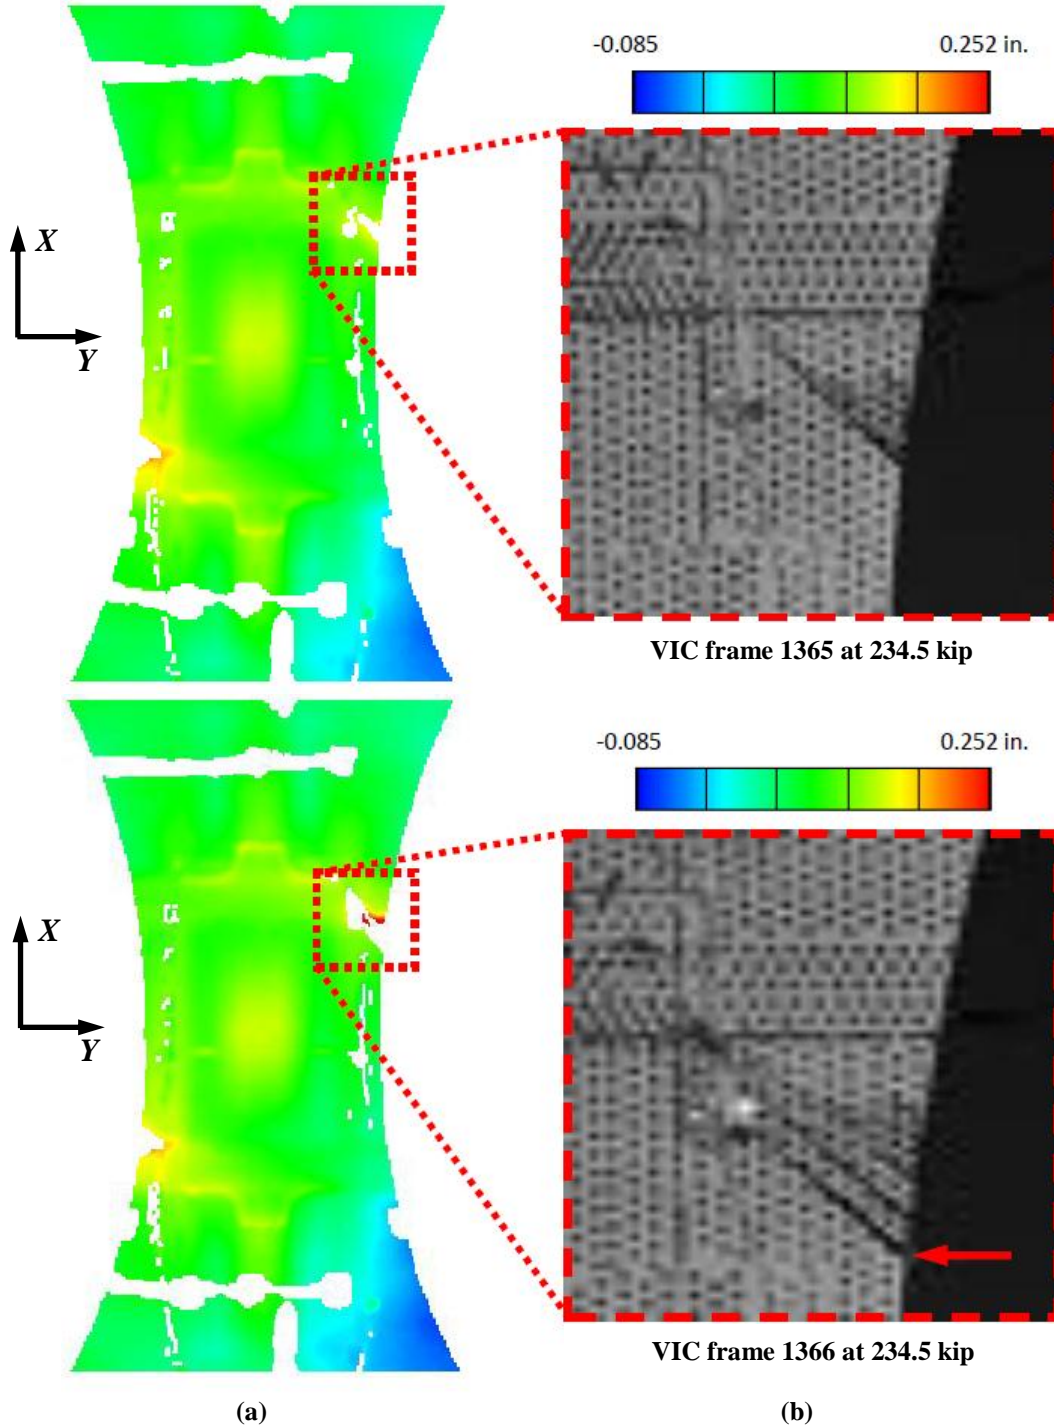
Video recordings and VIC-3D images indicated that prior to the final failure, damage was gradually introduced from the lateral free edges of the panel in the vicinity of the frame caps. Since the first three out of four above-mentioned events were very similar in nature, only the third one (i.e. the first event in the second load reduction at 234.5 kip) is illustrated in Figure 17. Figure 17 comprises of the VIC-3D out-of-plane displacement plots presented along with close-up images of the section of the panel where the damage was introduced. Two consecutive frames captured by the VIC-3D system in one second interval are presented. The two top images show the pre-existing damage that occurred at the 213.5 kip load (the aforementioned first event associated with the first load reduction) and did not progress any further up to the load of 234.5 kip. It is seen that the initial cracks in the skin section of the panel developed at the 45-degree angle and arrested in the vicinity of the top frame cap and the right-hand-side stringer flange intersection, where the through-the-thickness stitching is present. The bottom images in Figure 17 show additional damage in the form of a new distinct 45-degree crack highlighted with a red arrow in the VIC-3D image. Local change in the out-of-plane displacement is also visible in the area highlighted in the left plot. Recall that the panel frame caps were four stacks thick (0.208 in.) and their intersections with stringer flanges were six stacks thick (0.312 in.) while the skin was only one stack thick (0.052 in.). These abrupt changes in the panel thickness near the frame caps likely resulted in stress concentrations that contributed to damage initialization. Finally note that shortly after the first crack shown in the top images of Figure 17 developed, a second event (i.e., the second event very similar in nature to the first in the first load reduction) occurred on the opposite side of the panel near the bottom frame. The damage was nearly identical to the one shown in the top section of Figure 17 and its presentation is omitted here for brevity.

**Figure 17. Edge failures as first event in the second load reduction: (a) out-of-plane displacement, (b) close-up image.**

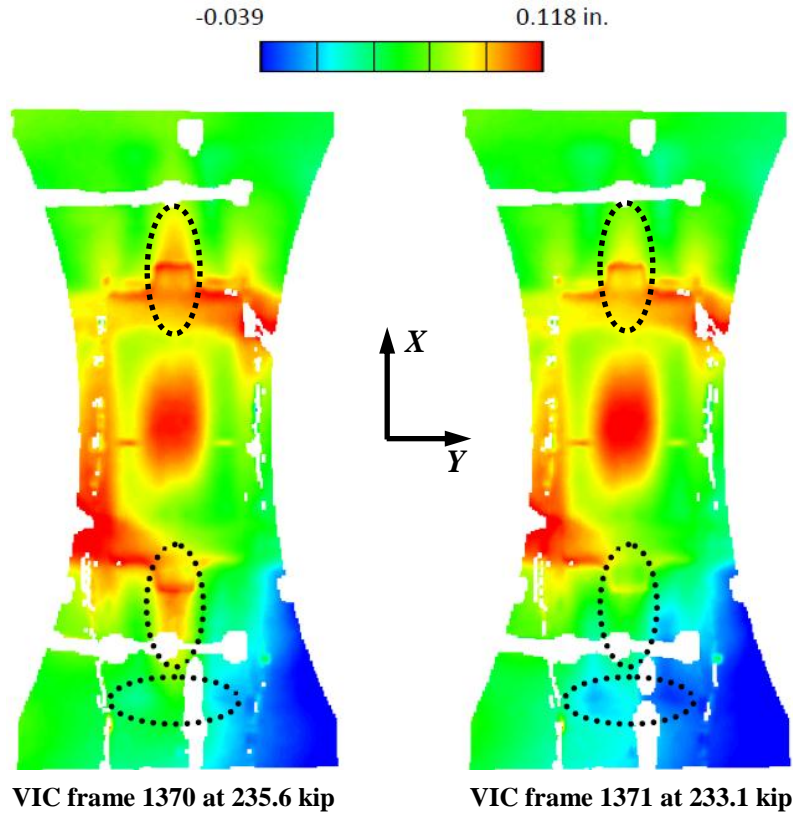
While the first three out of four previously mentioned events associated with the two load reductions in Figure 10 were similar in nature, the last event could not be traced to regions near the free lateral side edges of the panel. However, the event was also identified by examining the out-of-plane displacement fields acquired from the VIC-3D system. This change in displacement field is illustrated again with two consecutive frames in Figure 18. Sections of the panel where the change was most noticeable are enclosed within dashed contours. It is observed that the event had its predominant impact in the vicinity of the center severed stringer.

**Figure 18. Second event of the second load reduction: out-of-plane displacement, regions of dominant displacement change highlighted with dashed contours.**

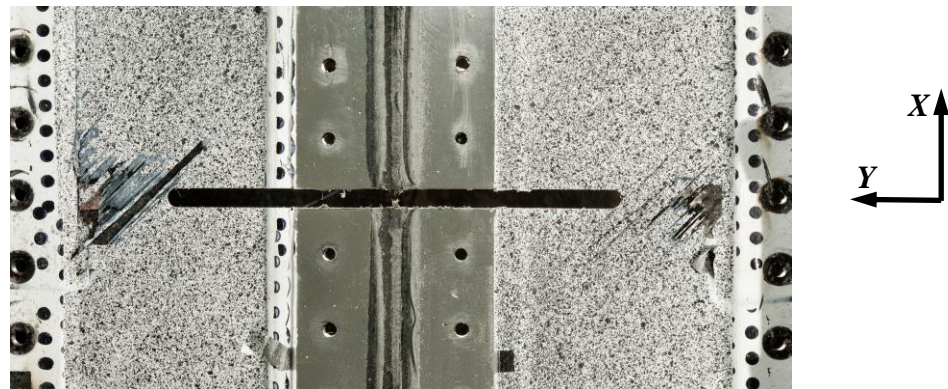
Fastener joints were examined next. While the titanium fasteners were compromised during the disassembling process, examination of fastener holes yielded meaningful observations. No visible elongations of fastener holes were observed in the composite panel, as shown in Figure 20 for highly-loaded fastener holes in the direct vicinity of the saw-cut. In the same figure it is also seen that extensive surface splitting in the saw-cut area developed further beyond those previously shown in Figure 15 and Figure 16. Despite the much larger extent, splitting propagation was also arrested by the through-the-thickness stitching reinforcement at the side flanges.

**Figure 20. Fastener holes in the center stringer of the panel in the vicinity of the saw cut.**

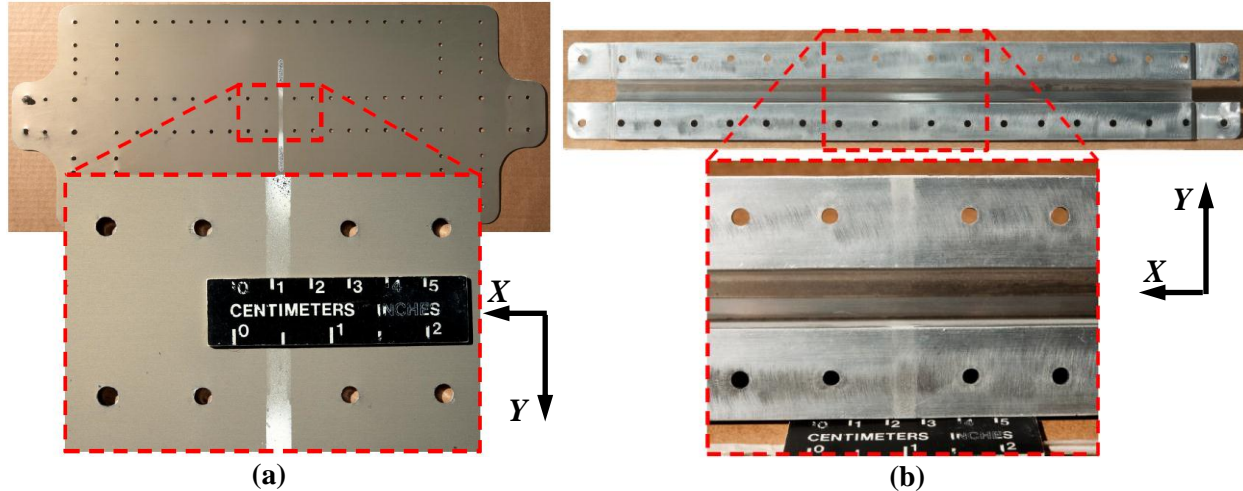
Fastener holes in the composite panel showed no signs of damage while some highly-loaded holes in the metallic components of the repair assembly revealed elongations as shown in Figure 21(a) for the doubler and in Figure 21(b) for the two repair angles. The above behavior was predicted by a supplemental hand calculations to be discussed at the end of section V.E. Close-up sections in Figure 21 show the eight fastener holes corresponding to the fastener holes in the center section of Figure 20 near the saw-cut. A careful examination of the metallic repair assembly components clearly shows the elongations but they are difficult to see in photographs. While the exact

elongations in the metallic repair components were not measured, their presence was verified by inserting pristine fasteners into the holes while orienting them vertically. The holes which did not elongate during the test would not permit fasteners sliding freely due to tight initial tolerances being maintained. Elongated holes were not able to sustain fasteners as they would easily slide out from the holes under their own weight. Note that the close-up areas in Figure 21 are only selected examples and do not show all the elongated fastener holes. Additional elongated fastener holes were identified at the end sections of the doubler and the two angles.

**Figure 21. Elongated fastener holes in the repair assembly: (a) smooth side doubler and (b) stiffened side angles.**

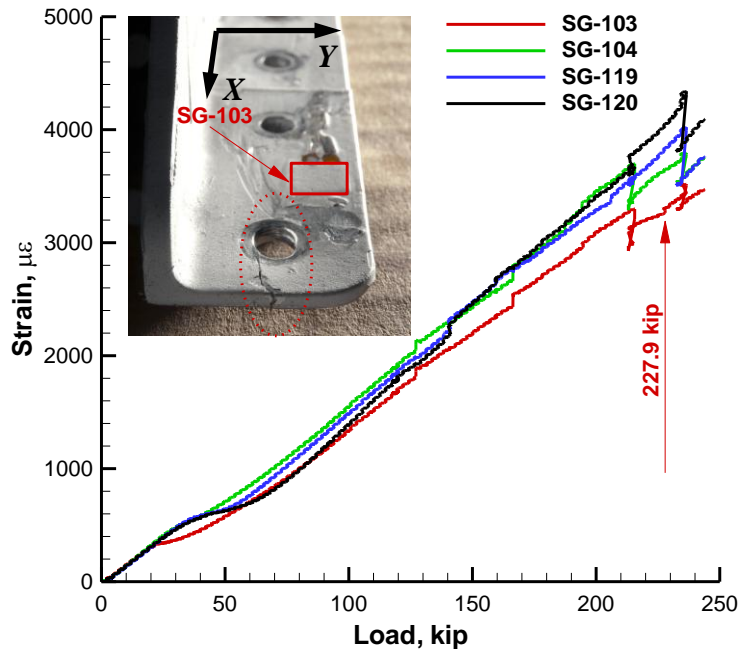
Finally, one more isolated example of a damage mode was noticed when examining fastener holes. Namely, a crack in the top left fastener hole propagated to the end of the angle is shown in Figure 22. The crack occurred on the side of the fastener hole closer to the fillet between the web and flange section of the angle, i.e., closer to a more rigid angle section due to the fillet thickness build up. To identify a possible load at which this event occurred, the closest strain gage SG-103 recording was examined and compared to the other three similarly placed strain gages SG-104 (top right), -119 (bottom left) and -120 (bottom right). Figure 22 shows that SG-103 recorded a small discontinuity at 227.9 kip which was not identified in the other three gages at this load level. Therefore, it is likely that the fastener hole crack developed gradually over lower load levels and reached the free edge of the angle at 227.9 kip.

**Figure 22. Crack at the top fastener hole of the left repair angle and pertinent strain gage data.**
