NASA Case Study

SCSC-R-0213

STS-114: Engine Cut-Off Sensors Are a No-Go

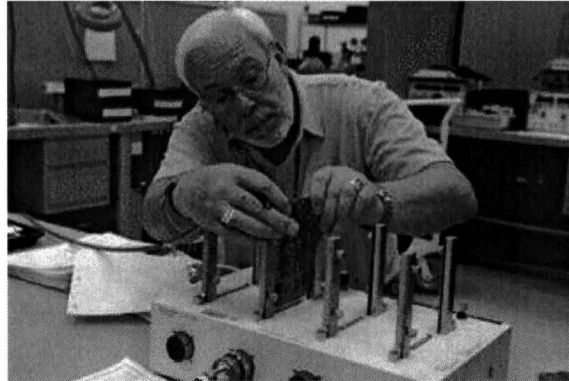
Fig. 5. NASA test engineer Lloyd Pierce checks electronic components related to the faulty sensor readings in the LH₂ tank low-level fuel cut-off sensor [5].

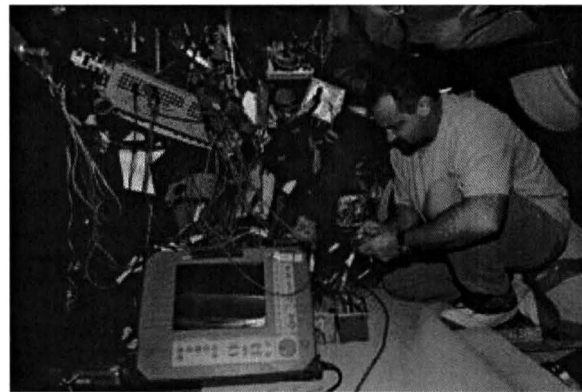
Fig. 6. Jack Colella, with United Space Alliance, conducts electromagnetic interference and ground resistance testing on wiring in the aft engine compartment on Space Shuttle Discovery [6].

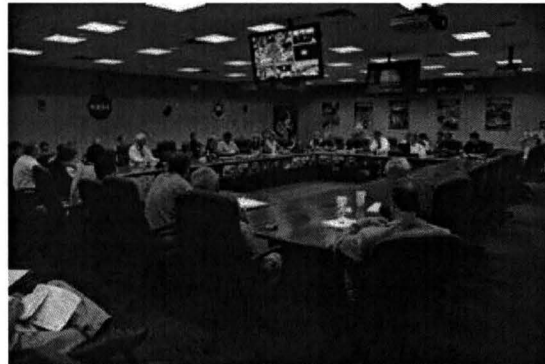
Fig. 7. Members of the engineering team are meeting in the Launch Control Center to review data and possible troubleshooting plans for the liquid hydrogen tank low-level fuel cutoff sensor [4].
