## **Non- destructive characterization of carbon fiber composite/Cu joints for nuclear fusion applications**

## **Abstract**

Several non-destructive testing methods, lock-in thermography, ultrasonic inspection, microtomography and microradiography, were used to assess the manufacturing quality of joints between carbon fiber reinforced carbon composites and Cu/ CuCrZr.

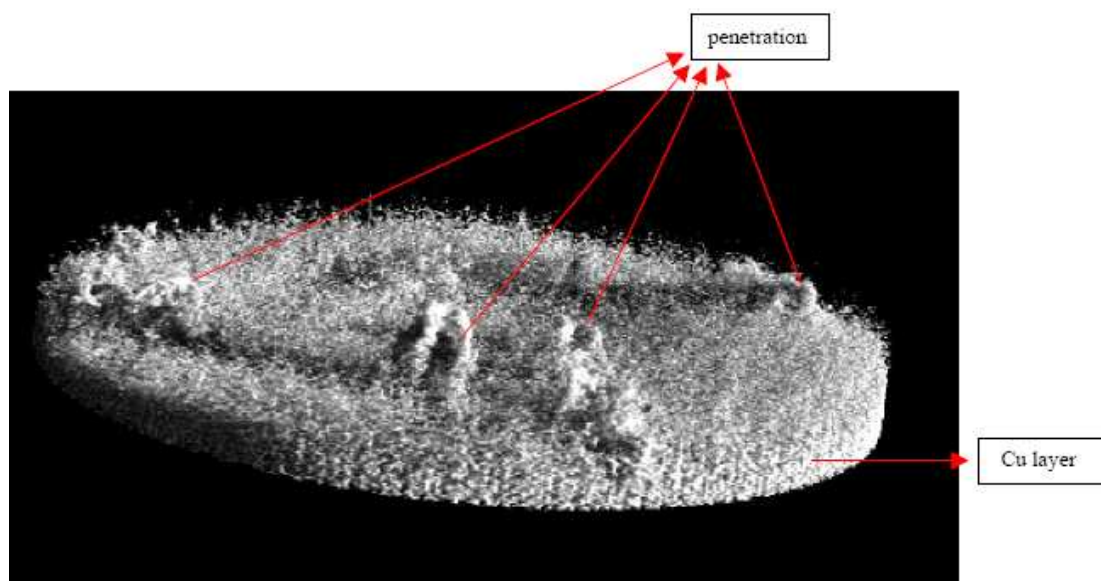
Figure 12 shows a tomographic reconstruction of the interface region, where CFC was intentionally removed by image processing; the “finger-like” penetration of Cu in CFC bulk is outlined.
